MINERALS PROGRAM INSPECTION REPORT

MINE NAME: Perdue	MINE/PROSPECTING ID#: M-2000-089	MINERAL: Sandstone (silica, stone, quartzite)	COUNTY: Boulder
INSPECTION TYPE: Monitoring	INSPECTOR(S): Amy Eschberger	INSP. DATE: September 6, 2018	INSP. TIME: 13:15
OPERATOR: Mary Vasquez	OPERATOR REPRESENTATIVE: Ignacio Vasquez	TYPE OF OPERATION: 110c - Construction Limited Impact	
REASON FOR INSPECTION: Normal I&E Program		BOND CALCULATION TYPE: None	BOND AMOUNT: \$12,500.00
DATE OF COMPLAINT: NA		POST INSP. CONTACTS: None	JOINT INSP. AGENCY: None
WEATHER: Clear	INSPECTOR'S SIGNATURE:

M-2000-089 / Perdue / Mary Vasquez

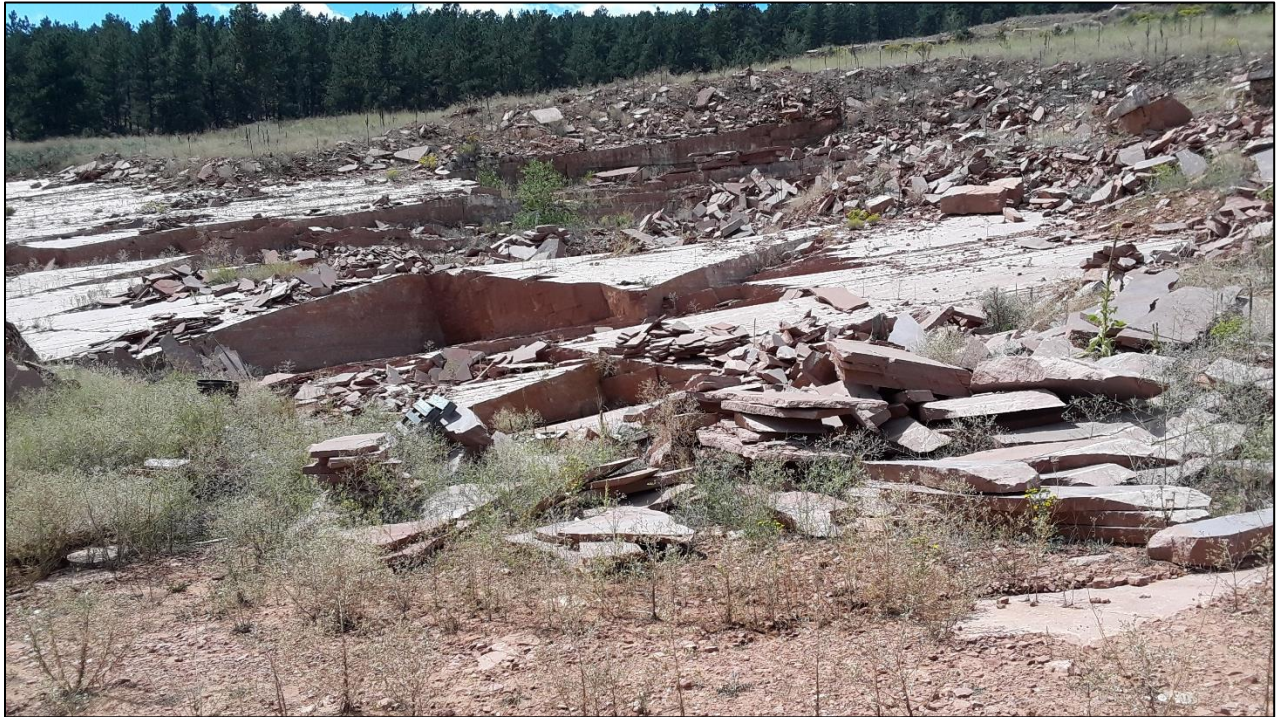
Photo 1. View looking west across pit located at southeastern edge of permit area, showing 3-4 foot high mine walls that will need to be backfilled for reclamation. Note the presence of waste rock/overburden material in this area which could be used as backfill material.

To complete final reclamation of the site, the operator will need to backfill the steep mine faces present at the southeastern and southwestern edges of the permit area. Plenty of waste rock and overburden material is available near these mine faces to be used as backfill material. Any large stones present in these areas could be placed at the base of the pits prior to backfilling. All disturbed slopes will need to be graded to 3H:1V or flatter. Any available topsoil should be spread across disturbed areas, then the areas seeded with the approved seed mixture. Mr. Vasquez intends to complete the required reclamation earthwork this year, and hopes to mulch and seed the areas next spring.

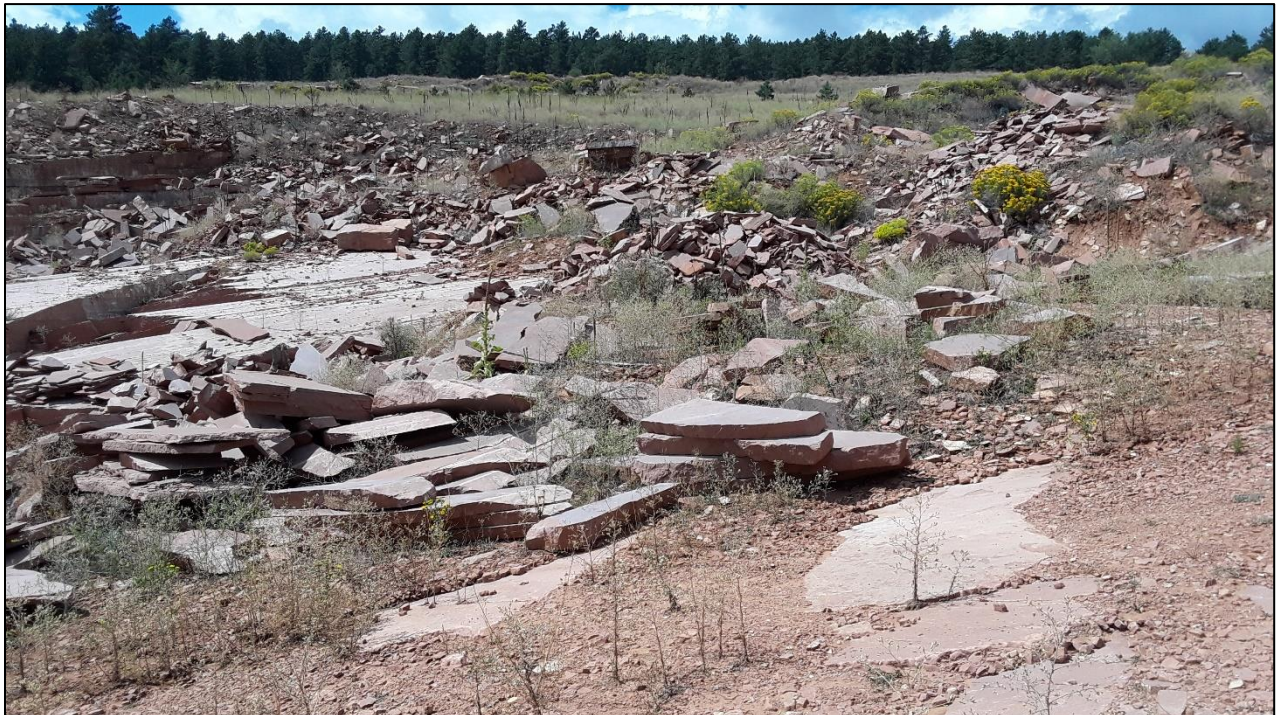
Photo 2. View looking west across pit located at southeastern edge of permit area, showing plenty of waste rock/overburden material available in this area for use in backfilling steep mine walls.

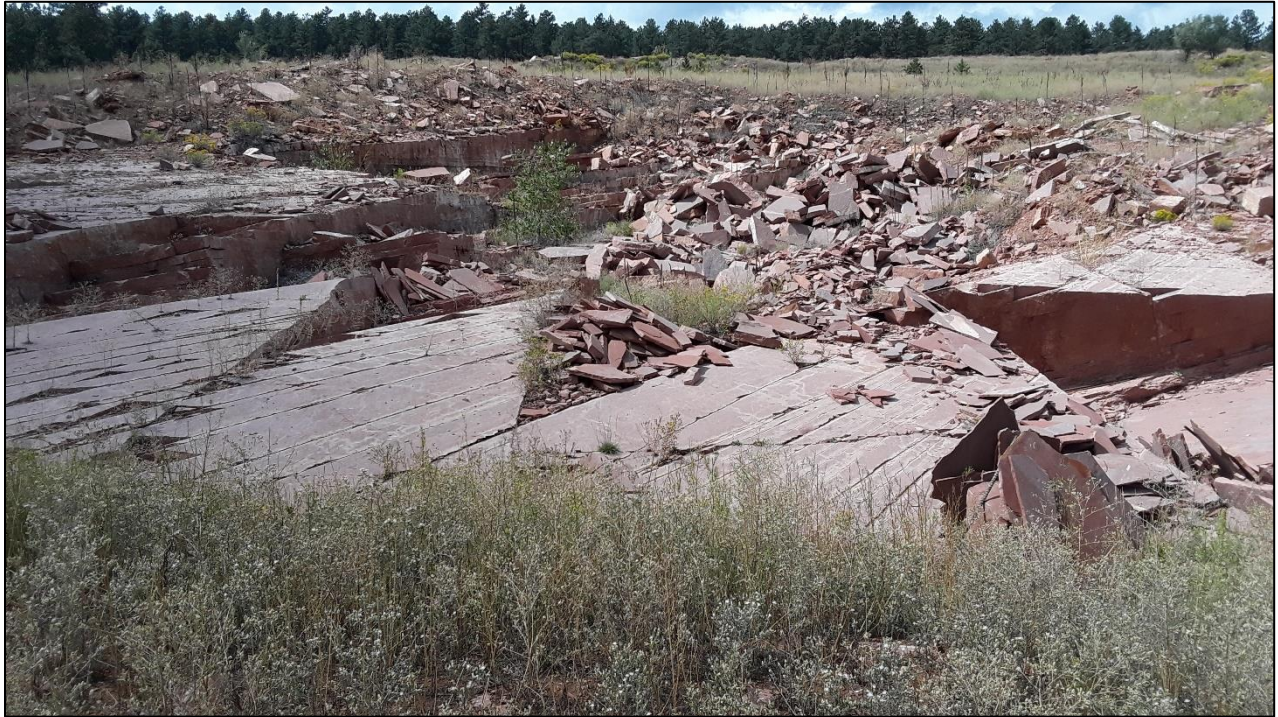
Photo 3. View looking west across southern edge of pit located at southeastern edge of permit area, showing 3-4 foot high mine walls that will need to be backfilled for reclamation. Note the presence of waste rock/overburden material in this area which could be used as backfill material.

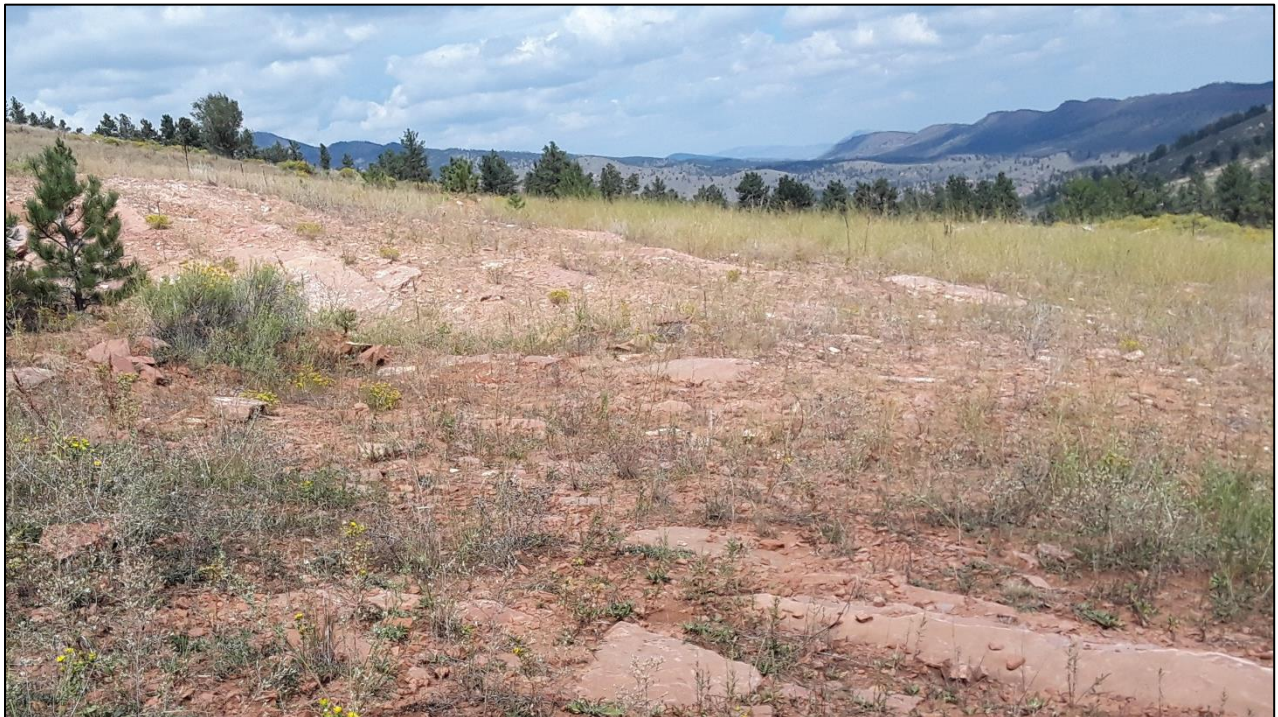
Photo 4. View looking north across reclaimed central portion of site.

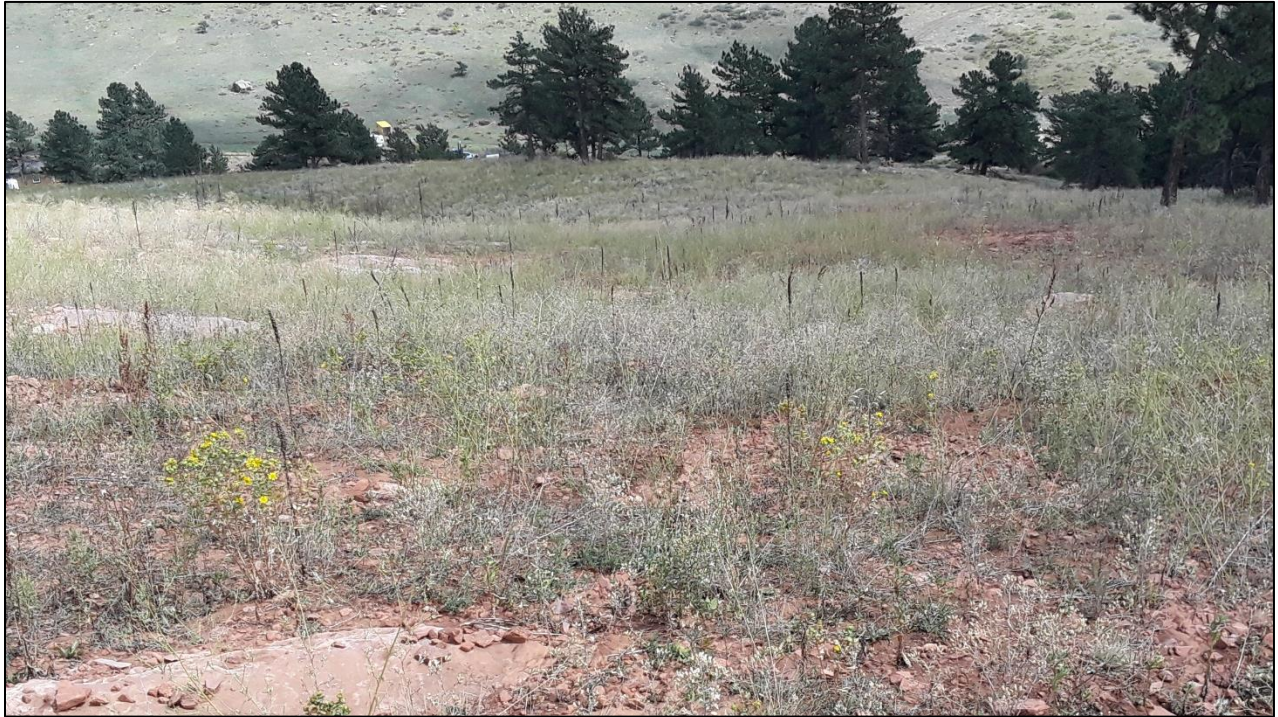
Photo 5. View looking east across reclaimed southern portion of site.

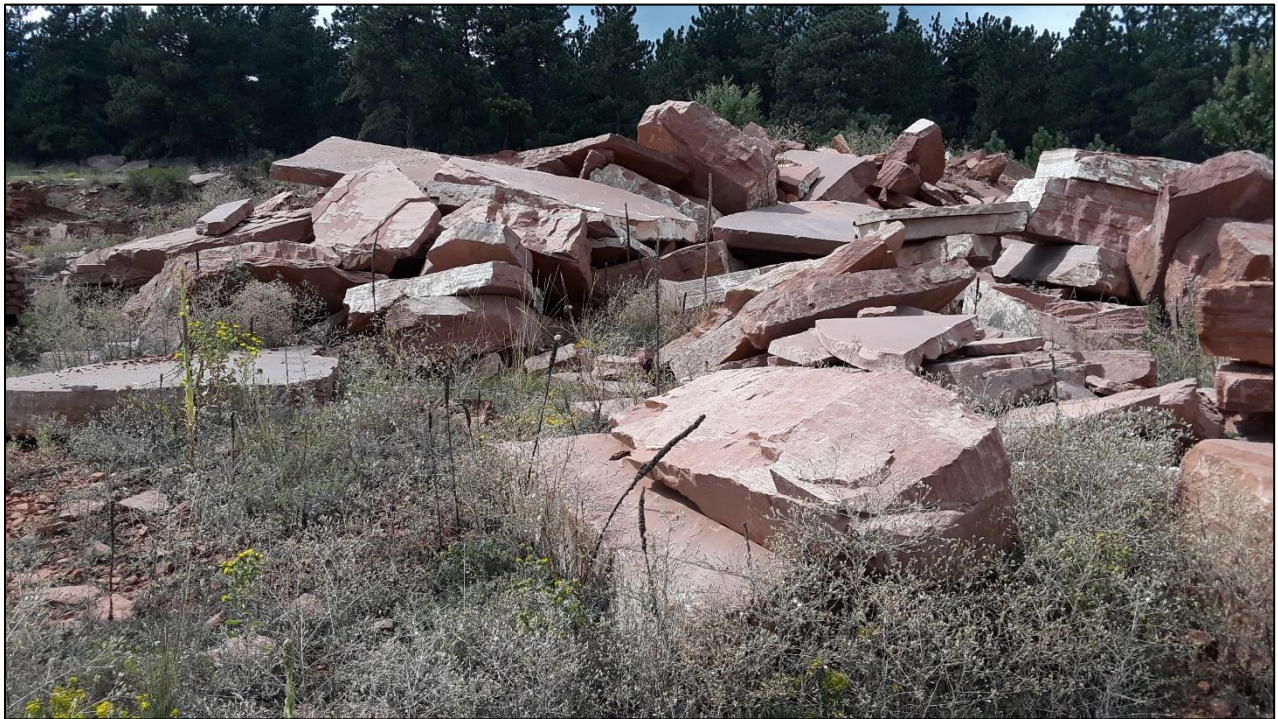
Photo 6. View looking west across pile of large stones adjacent to pit located at southwestern edge of permit area. These rocks could be placed on the pit floor prior to backfilling the pit with smaller waste rock/overburden material.

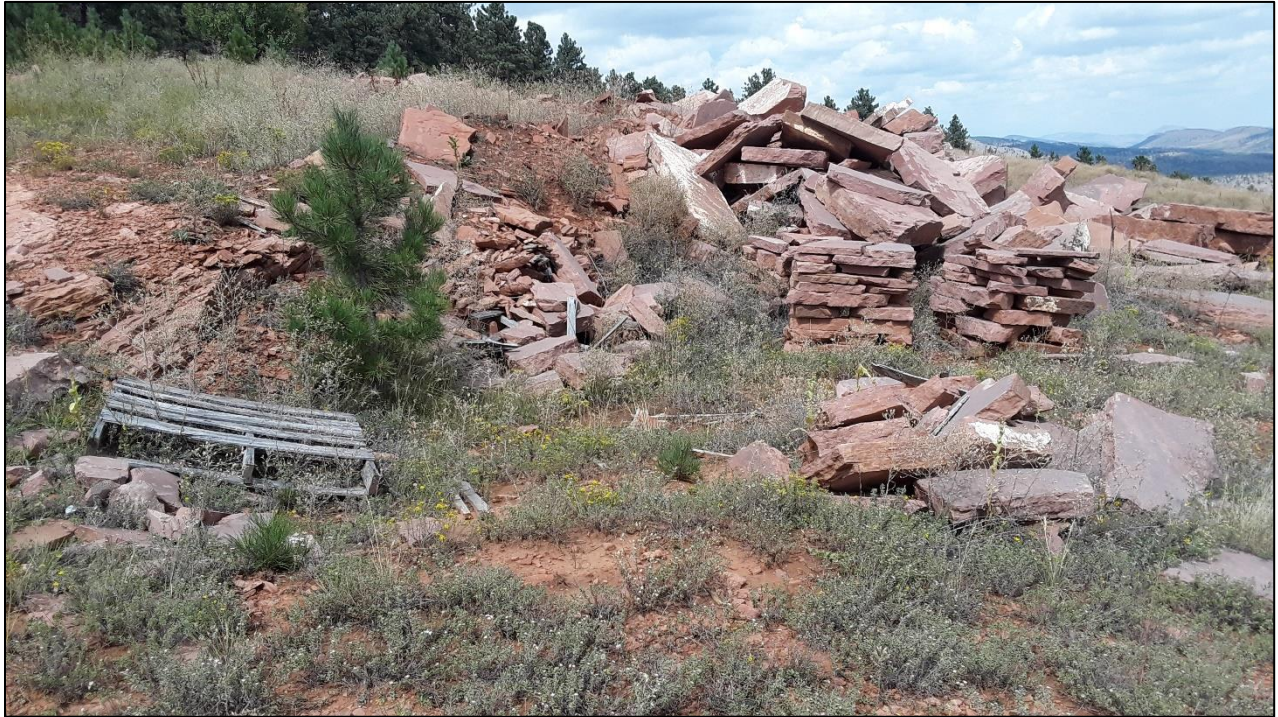
Photo 7. View looking northwest across pile of large stones and some stacked product adjacent to pit located at southwestern edge of permit area. After any remaining product is sold, large waste rocks could be placed on the pit floor prior to backfilling the pit with smaller waste rock/overburden material.

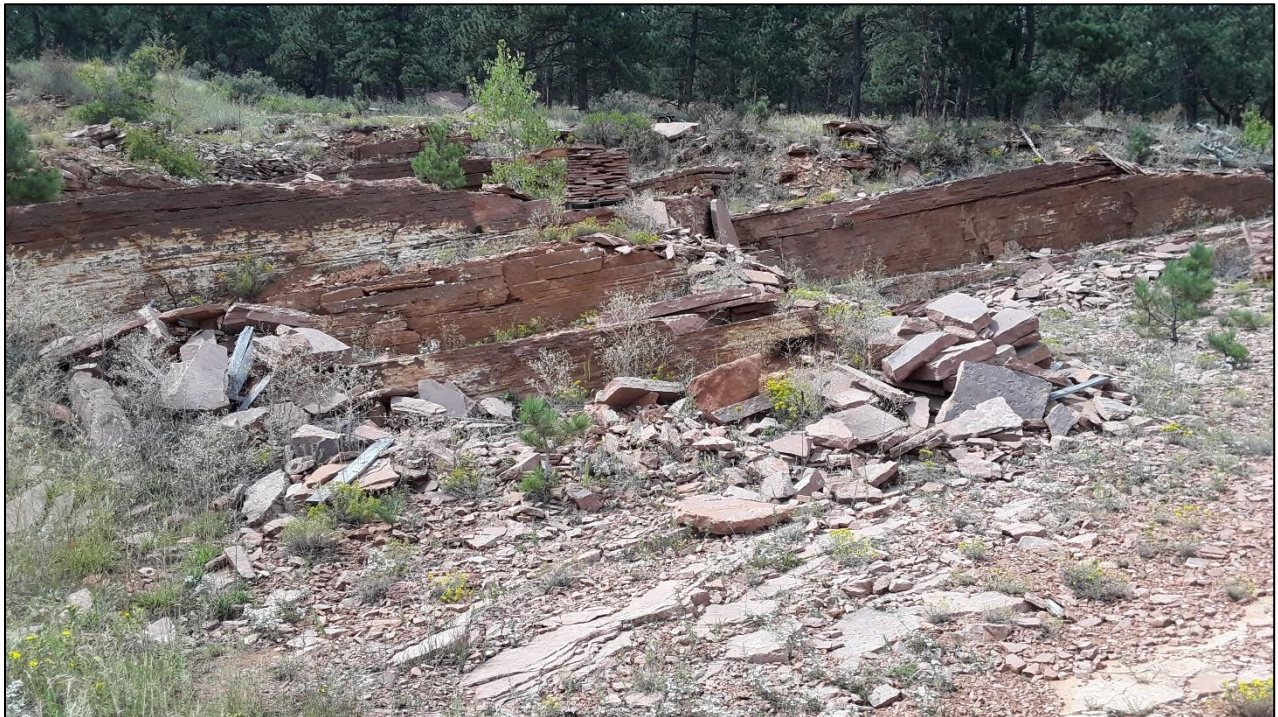
Photo 8. View looking west across pit located at southwestern edge of permit area, showing 3-4 foot high mine walls that will need to be backfilled for reclamation. Some waste rock/overburden material is available in this area for use as backfill material.

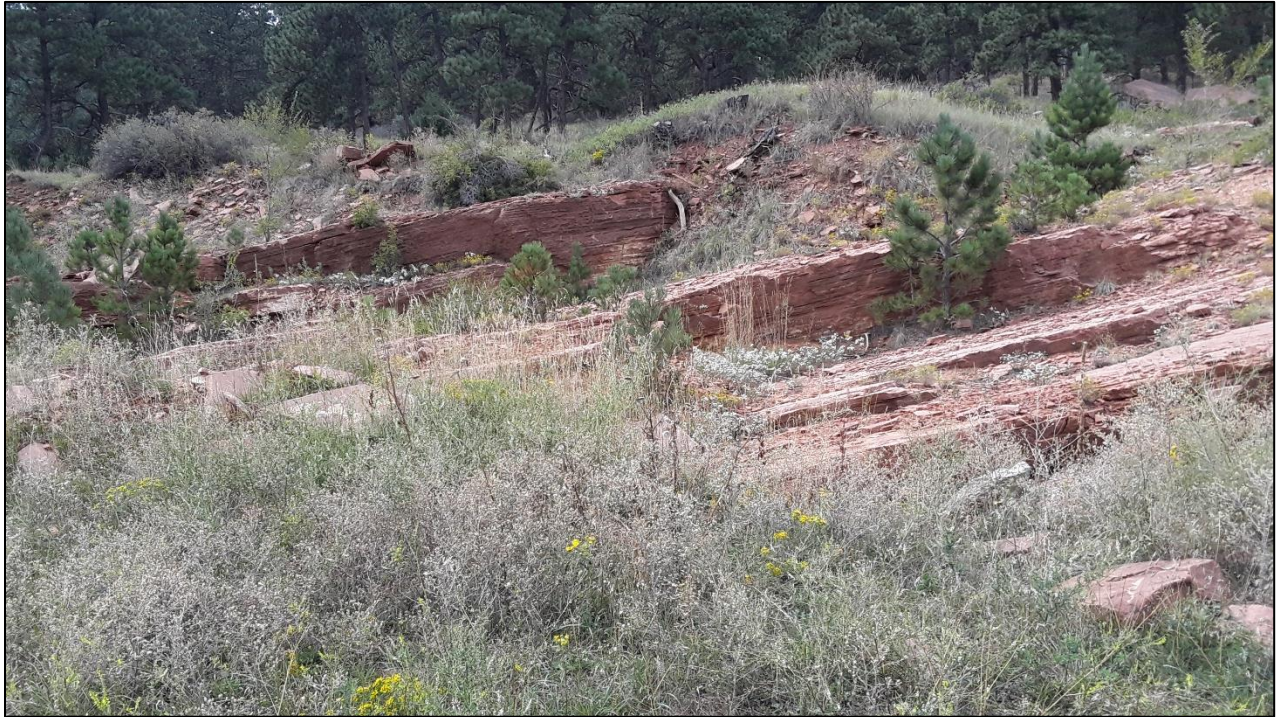
Photo 9. View looking west across southern edge of pit located at southwestern edge of permit area, showing 3-4 foot high mine walls that will need to be backfilled for reclamation.

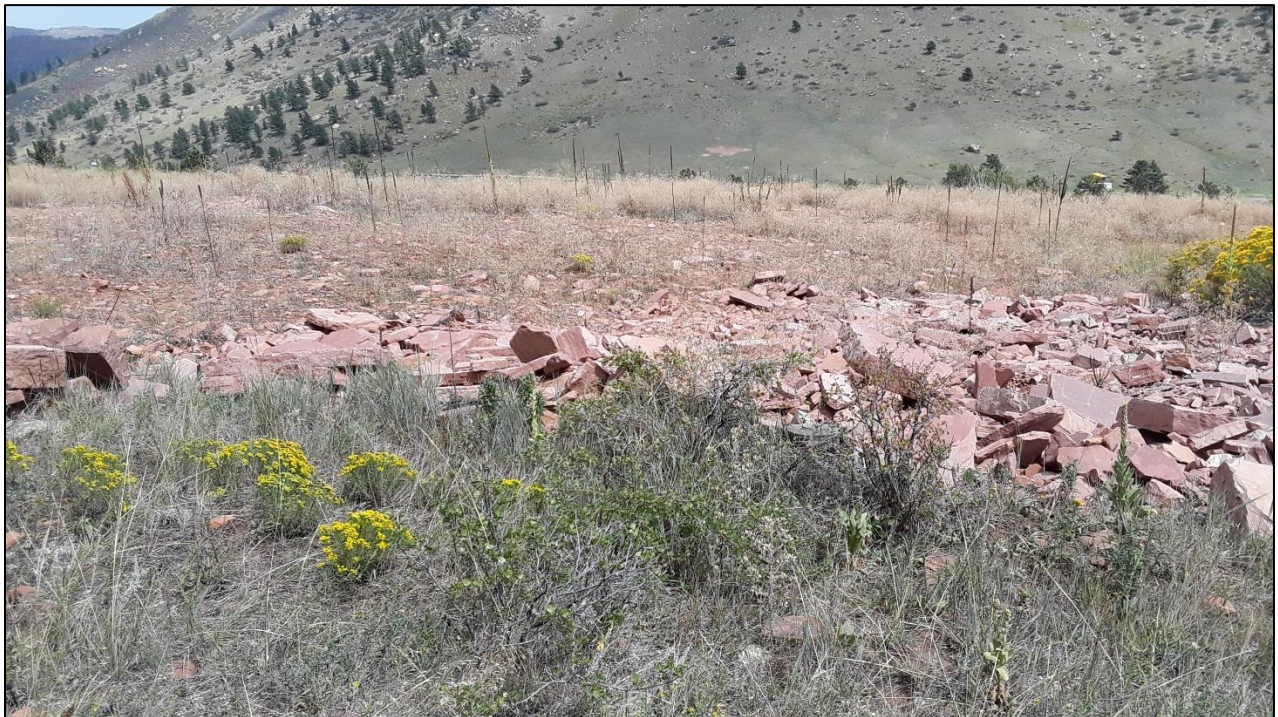
Photo 10. View looking east across northwestern portion of permit area where large overburden/waste rock stockpile was removed and the area graded to flatter than 3H:1V.

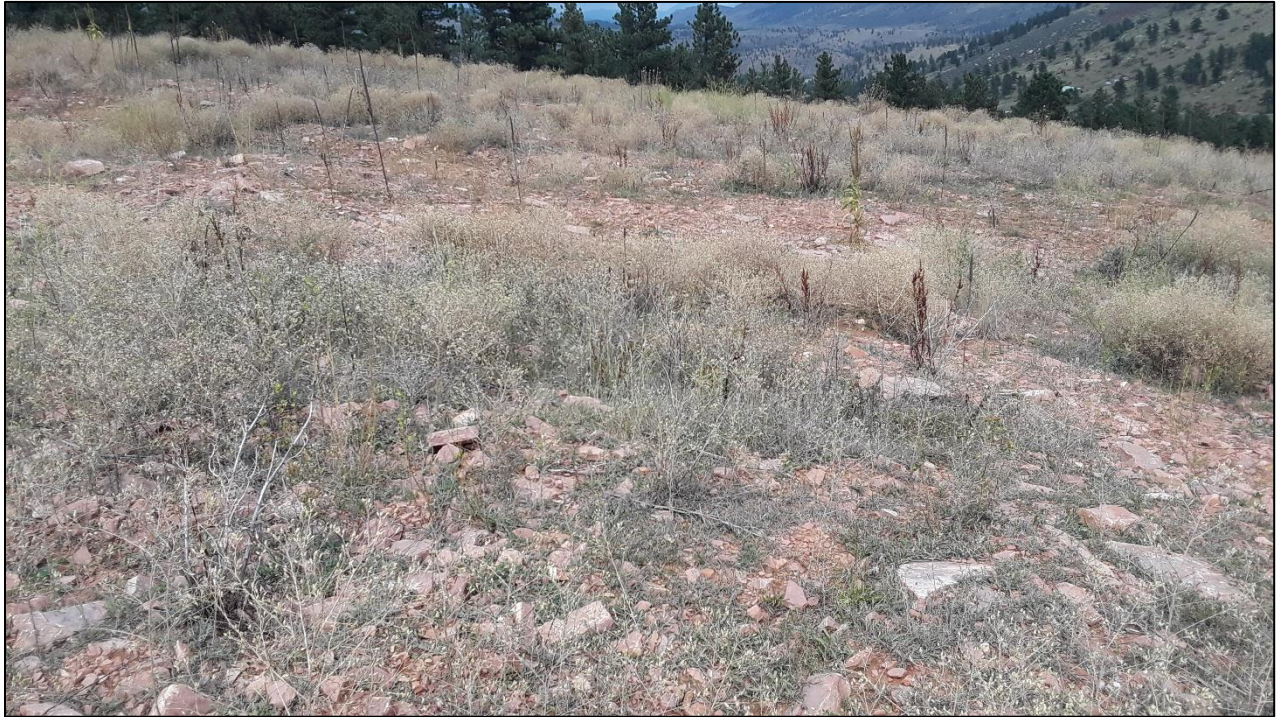
Photo 11. View looking north across northwestern portion of permit area where large overburden/waste rock stockpile was removed and the area graded to flatter than 3H:1V.

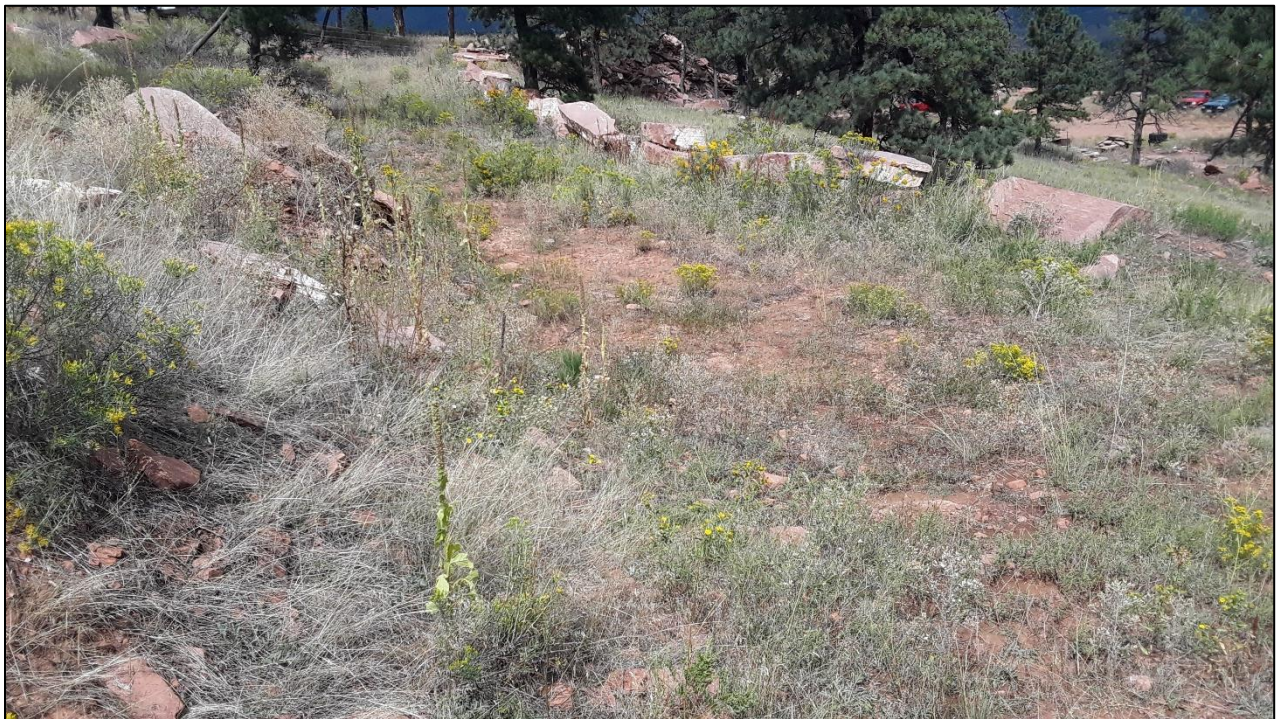
Photo 12. View looking east across mine haul road covered with volunteer grasses, forbs, and shrubs.
