**COLORADO**Division of Reclamation,  
Mining and Safety

**MINERALS PROGRAM INSPECTION REPORT****PHONE: (303) 866-3567**

<b>MINE NAME:</b> Iverson Mine	<b>MINE/PROSPECTING ID#:</b> M-2011-001	<b>MINERAL:</b> Borrow material	<b>COUNTY:</b> Weld
<b>INSPECTION TYPE:</b> Monitoring	<b>INSPECTOR(S):</b> Peter S. Hays	<b>INSP. DATE:</b> August 10, 2018	<b>INSP. TIME:</b> 09:30
<b>OPERATOR:</b> Martin Marietta Materials, Inc.	<b>OPERATOR REPRESENTATIVE:</b> Julie Mikulas	<b>TYPE OF OPERATION:</b> 112c - Construction Regular Operation

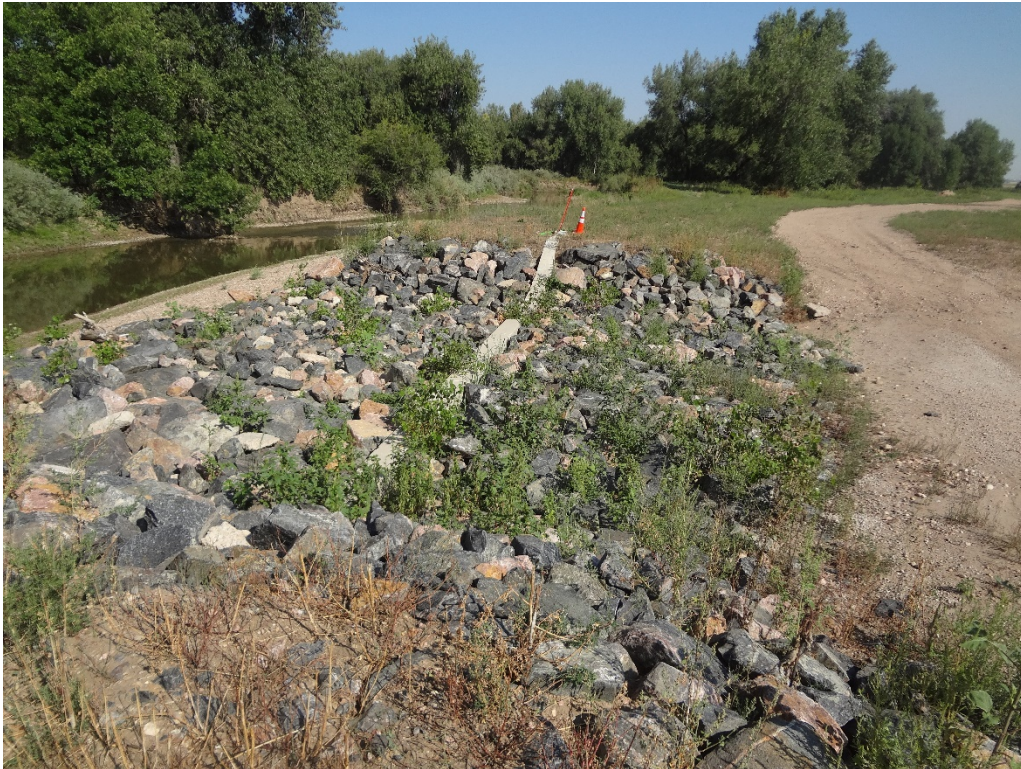
View of inlet structure

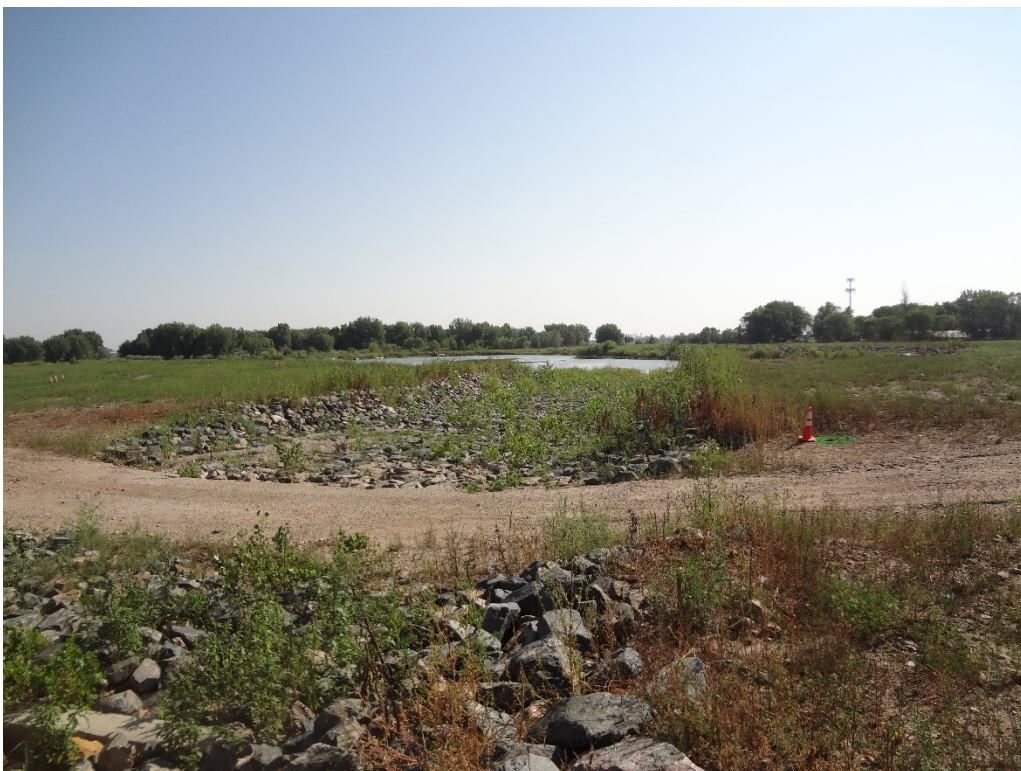
View of inlet structure

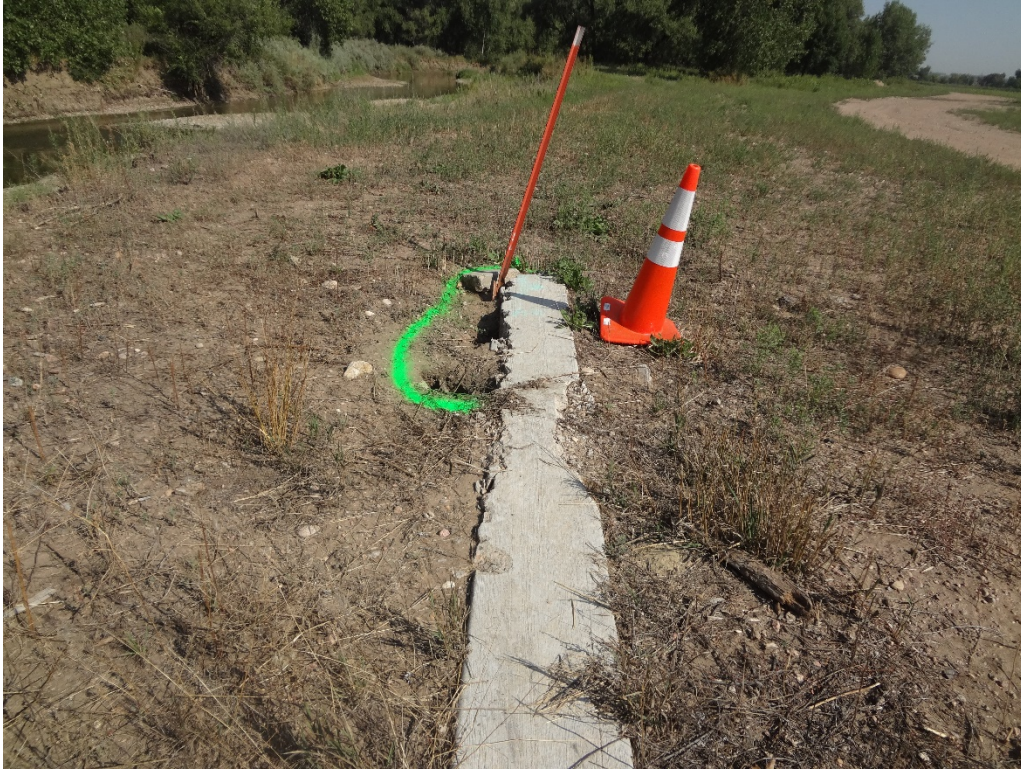
**PROBLEM:** Areas of settling near the inlet and outlet structures were marked by Mr. Iverson and observed during the inspection. The settled area need to be backfilled to stabilize the areas.

Mr. Iverson stated the east end of the west inlet spillway is settling based on survey data. The Division requests Mr. Iverson submits the survey data indicating the settling for review.

View of settling at the north end of the west inlet cutoff wall

**CORRECTIVE ACTIONS:** The Operator must submit proof of backfilling the areas by the corrective action date.

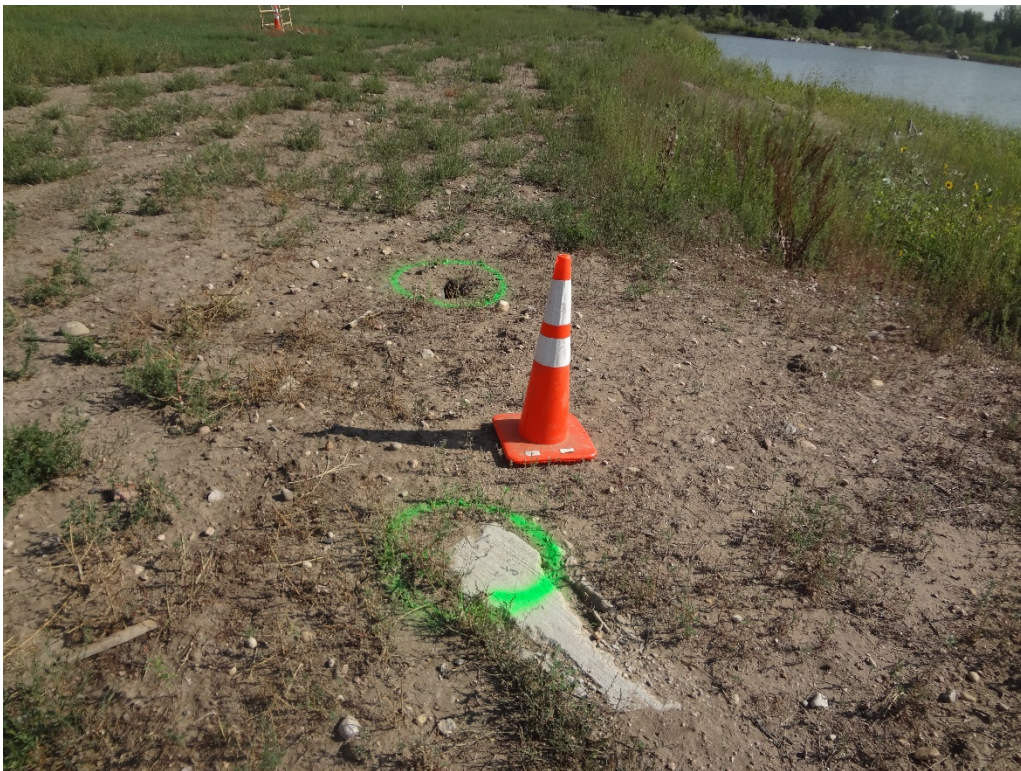
View of settling and survey mark at the north end of the east inlet cutoff wall

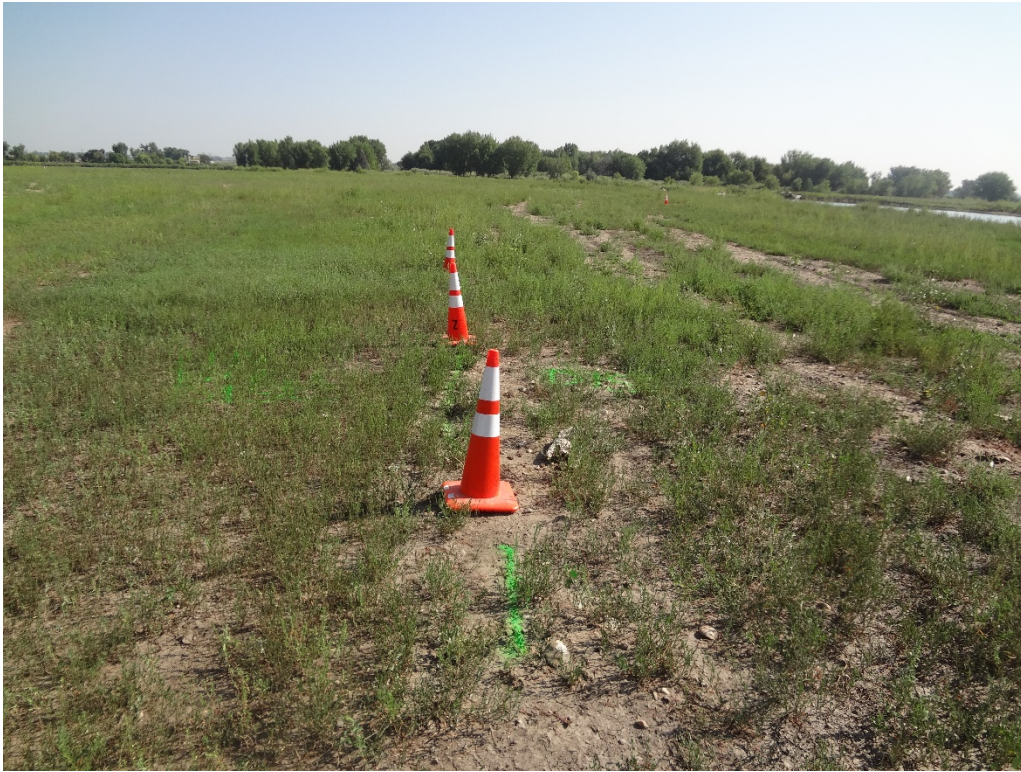
On June 18, 2018, the Operator submitted a final reclamation release request for the site. In the request letter the Operator stated Mr. Iverson tilled back up approximately half of the site with a disc or a harrow without discussing it with MMM. The tilling turned up larger rocks from below the surface, mixed the overburden and topsoil layers and limited the viability of the seed according to the Operator. On June 29, 2018, Mr. Iverson submitted a response to the release request stating the disc harrow reach is 4 to 6 inches, which is not deep enough to mix or reach the overburden, MMM removed and never replaced the topsoil at the site and large rocks and debris from the three (3) prior reclamation attempts are making agricultural activities unsafe for equipment and the equipment operator. MMM withdrew the final release request on July 23, 2018.

View of untilled area on left and tilled area on right

The approved post-mining land use for the Iverson Mine is wildlife habitat, not agriculture. Therefore, the Division will not require MMM to reclaim the site for agricultural use. The Division suggests Mr. Iverson allow MMM to complete reclamation at the site and not till the site.

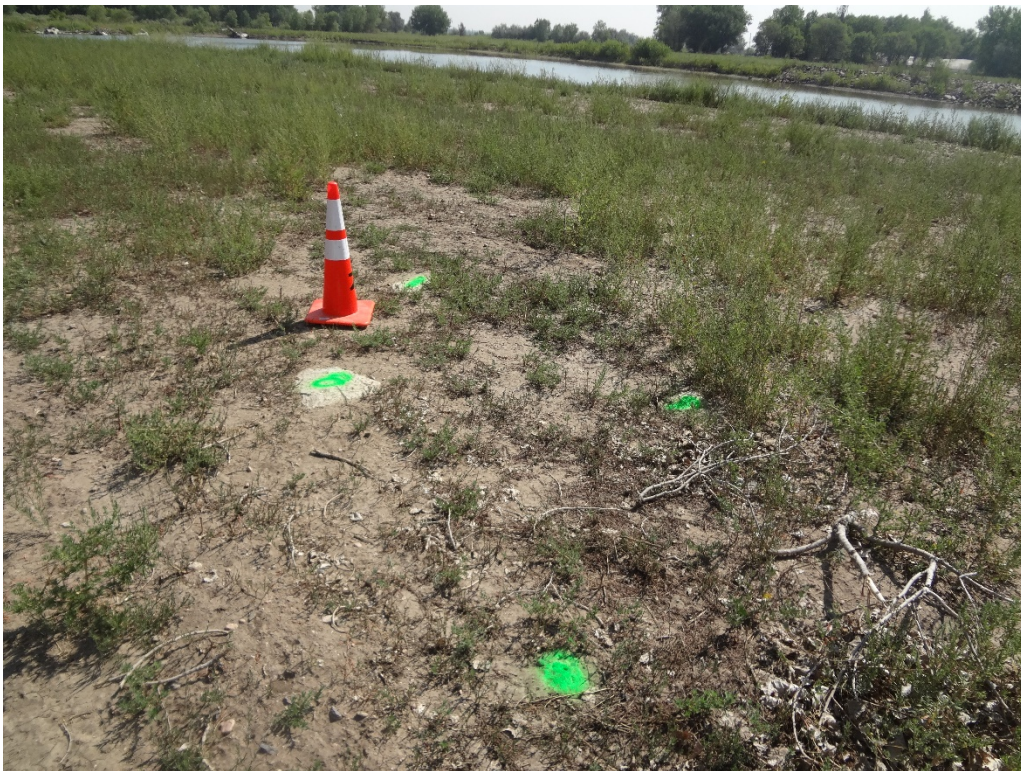
Mr. Iverson marked the locations of large rocks and concrete chunks with orange cones. MMM requested Mr. Iverson leave the orange cones in place so a drone survey of the site could be completed to locate the rocks and concrete to allow MMM to return in the future to remove the debris.

View of large rocks and concrete in the southeast corner of the site

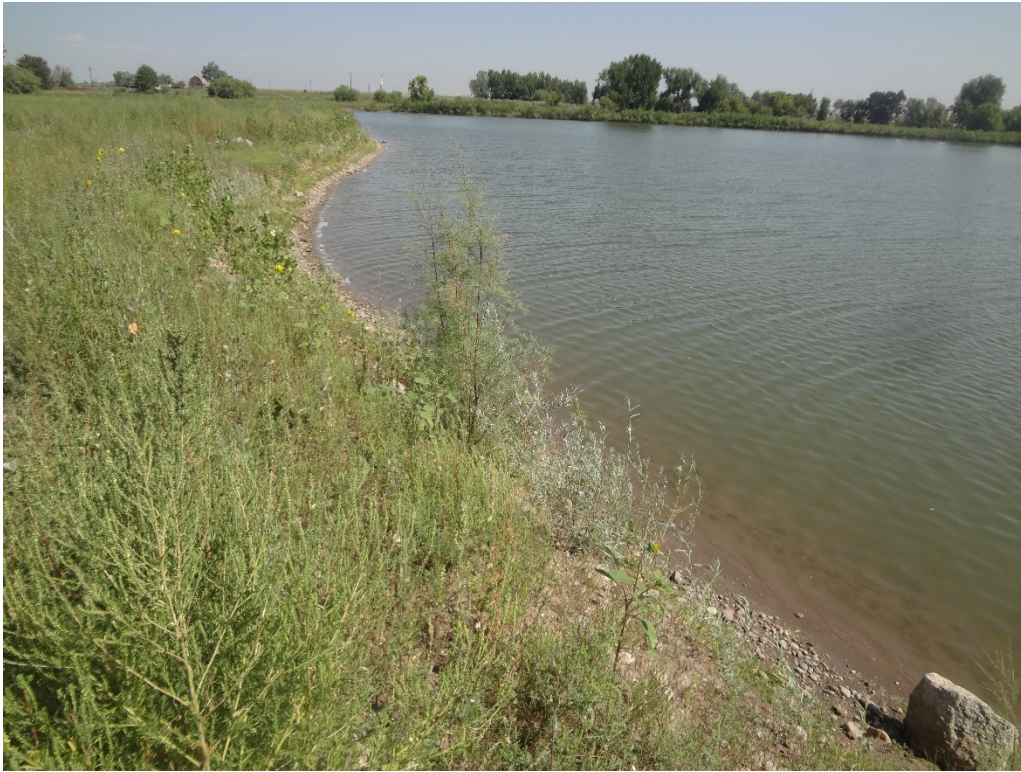
**PROBLEM:** Tamarisk (salt cedar) trees are present within or have volunteered into the permit area and are becoming established. This is a problem for failure to employ weed control methods for a state listed noxious weed species within the permitted area, and to reduce the spread of weeds to nearby areas as required by Rule 3.1.10(6).

Tamarisk, as Colorado Weed Management Association List B noxious weed was observed along the lake shoreline. As cited as a problem above, the Operator must implement the approved weed control plan for the site and submit proof of Tamarisk treatment by the corrective action date.

Tamarisk located on the west shoreline of the lake

**CORRECTIVE ACTIONS:** The Operator shall implement the existing weed control plan and submit proof of the Tamarisk treatment by the corrective action date.

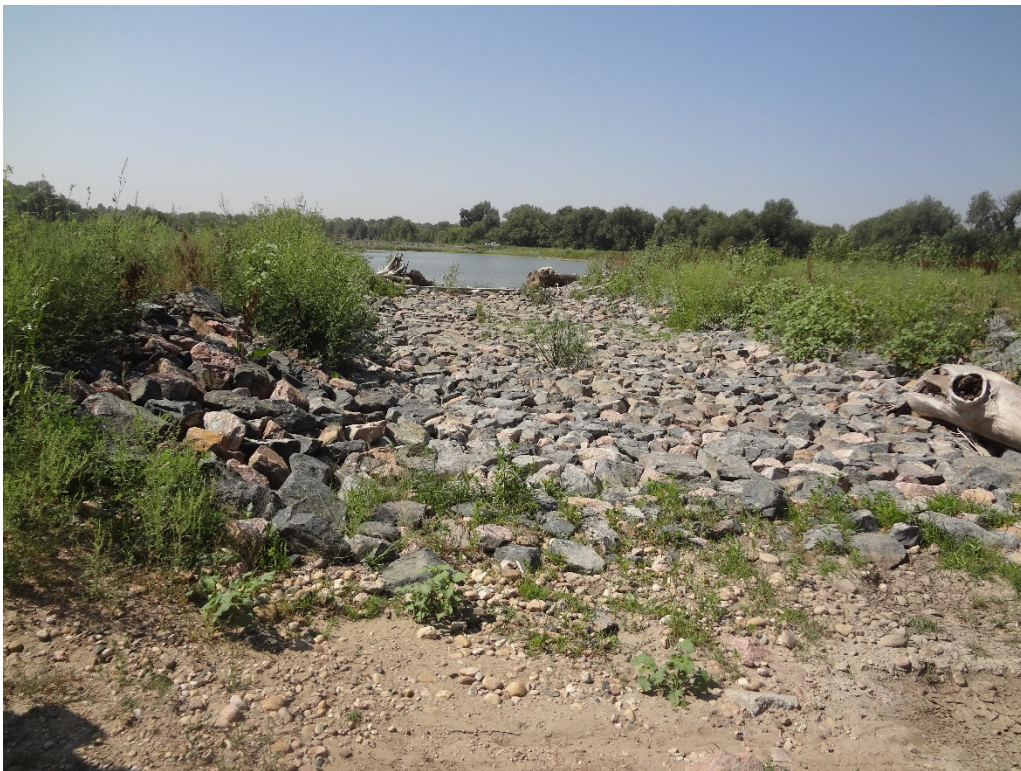
View of outlet spillway from road looking at the lake

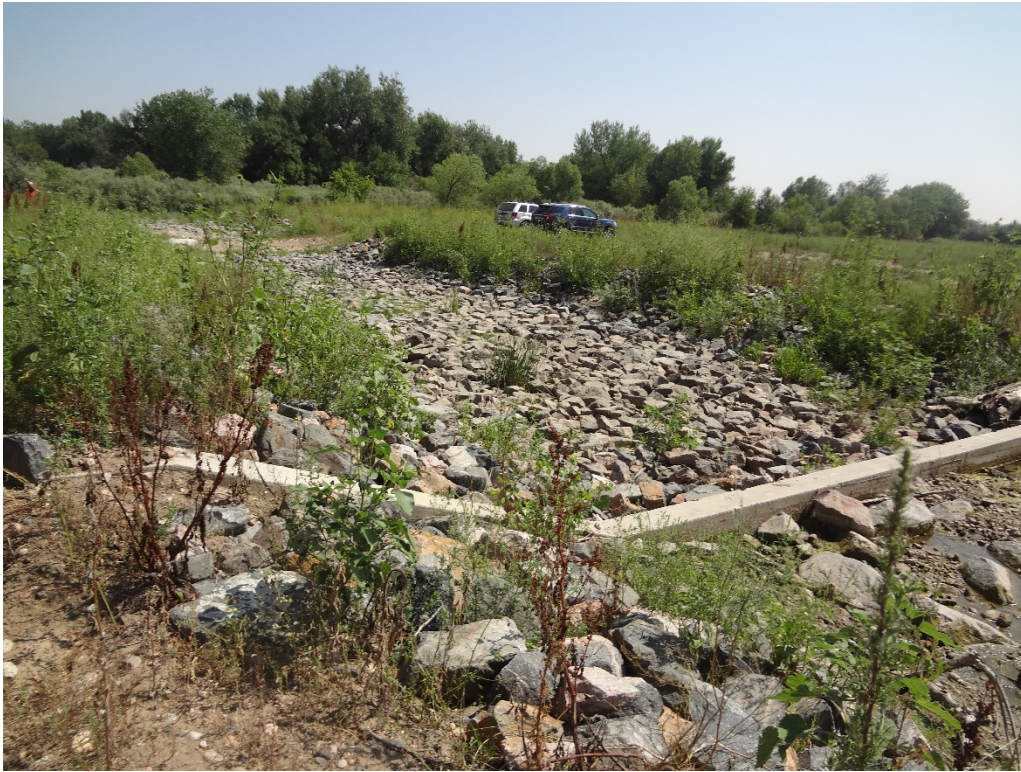
View of the outlet spillway looking toward the river

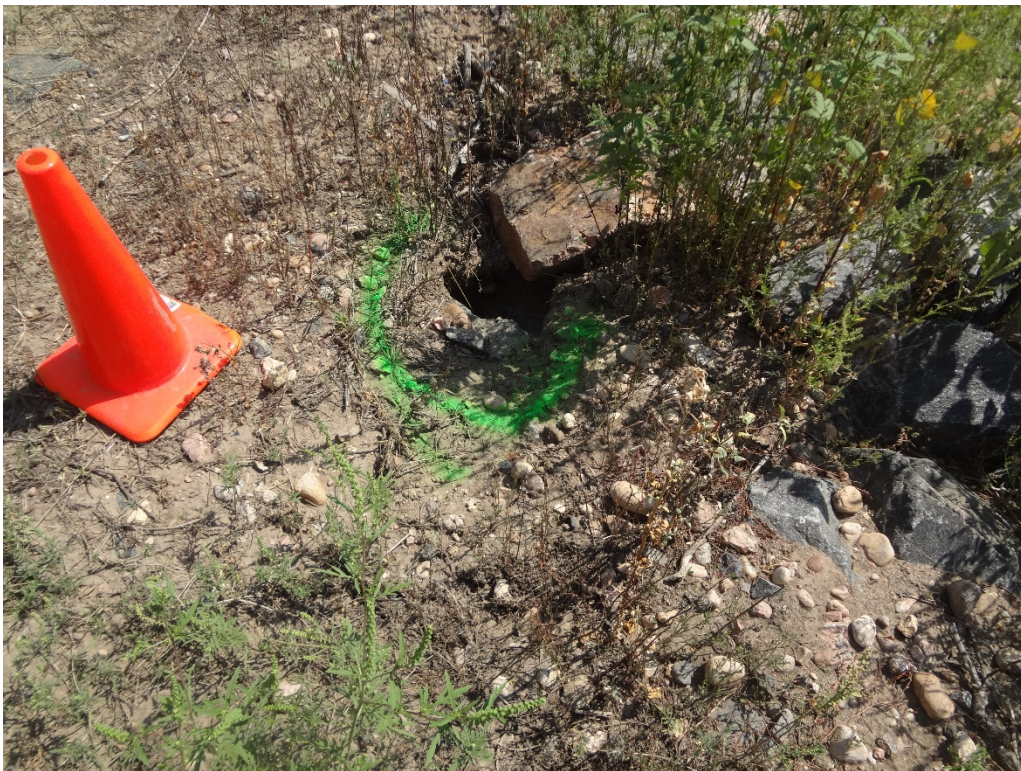
Mr. Iverson marked areas of settling on his property with spray paint near the inlet and outlet structures. The Division agrees the settled area needs to be backfilled to stabilize the areas. MMM agreed to backfill the settled areas around the inlet and outlet spillways. As cited as a problem above, the Division will require MMM to submit proof of backfilling the areas by the corrective action date.

View of typical settling near the outlet spillway

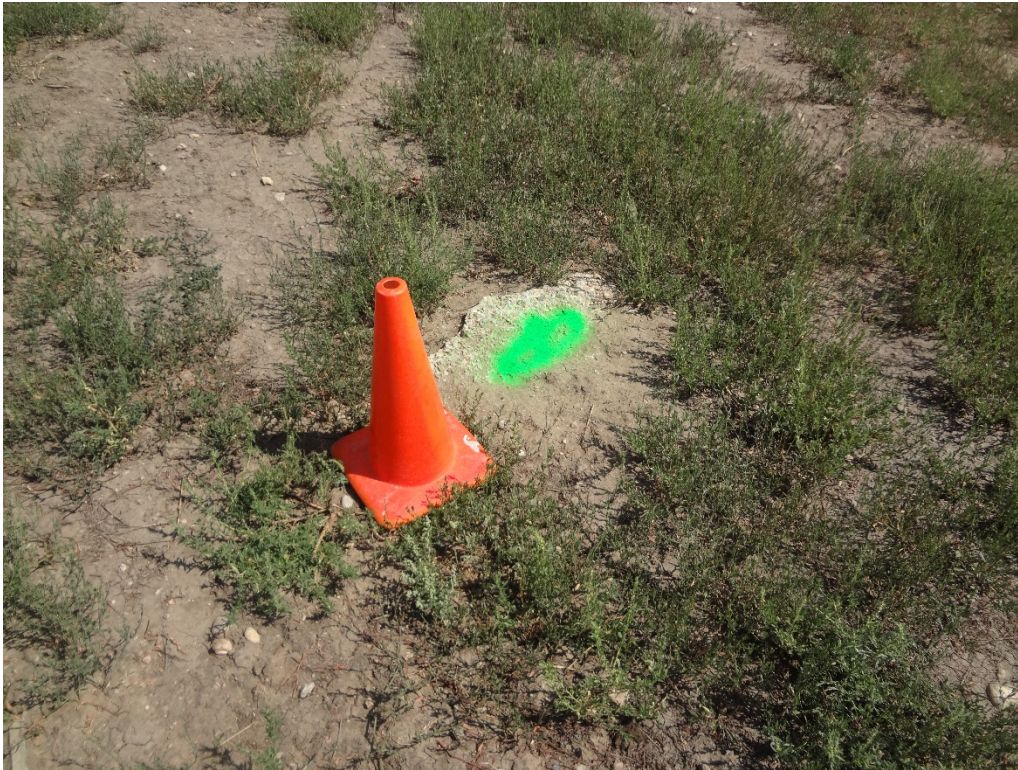
View of concrete in the eastern portion of the site
