MINERALS PROGRAM INSPECTION REPORT
PHONE: (303) 866-3567

MINE NAME: Hobo 2	MINE/PROSPECTING ID#: M-2017-044	MINERAL: Gemstones	COUNTY: San Juan
INSPECTION TYPE: Monitoring	INSPECTOR(S): Lucas J. West	INSP. DATE: August 28, 2018	INSP. TIME: 09:15
OPERATOR: McFarland Enterprises, Inc.	OPERATOR REPRESENTATIVE: None	TYPE OF OPERATION: ILL - Illegal	
REASON FOR INSPECTION: Normal I&E Program	BOND CALCULATION TYPE: None	BOND AMOUNT: \$10,000.00	
DATE OF COMPLAINT: NA	POST INSP. CONTACTS: None	JOINT INSP. AGENCY: None	
WEATHER: Clear	INSPECTOR'S SIGNATURE:

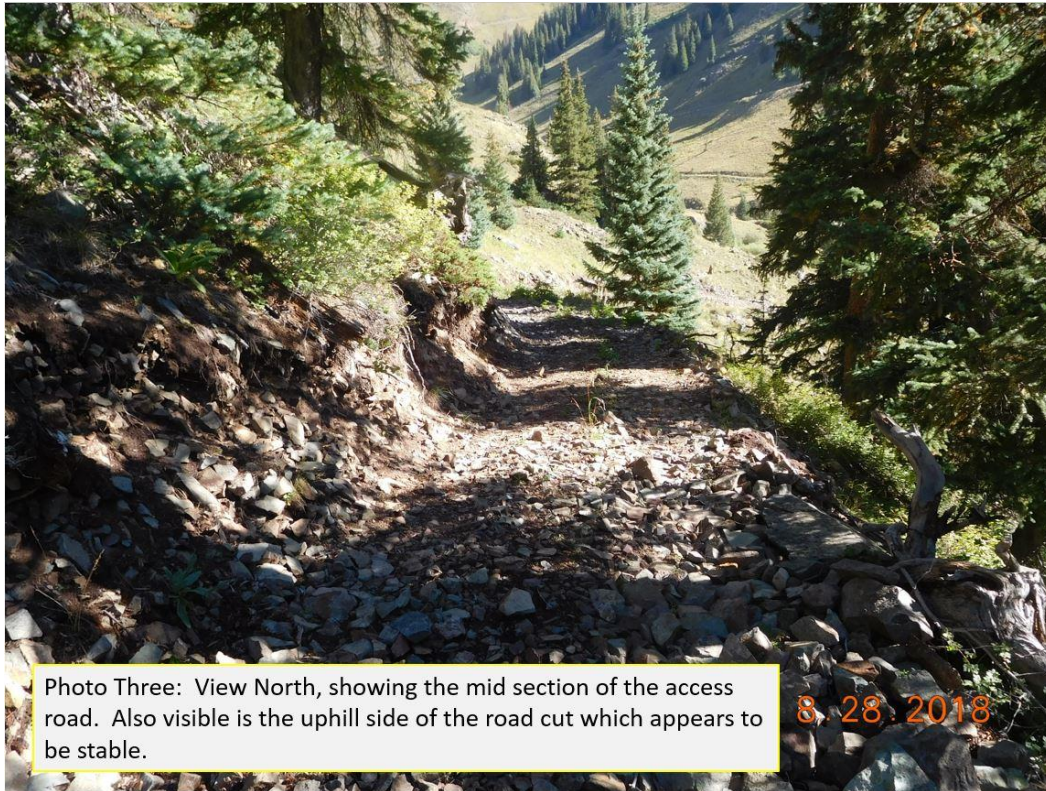
Photo Three: View North, showing the mid section of the access road. Also visible is the uphill side of the road cut which appears to be stable.

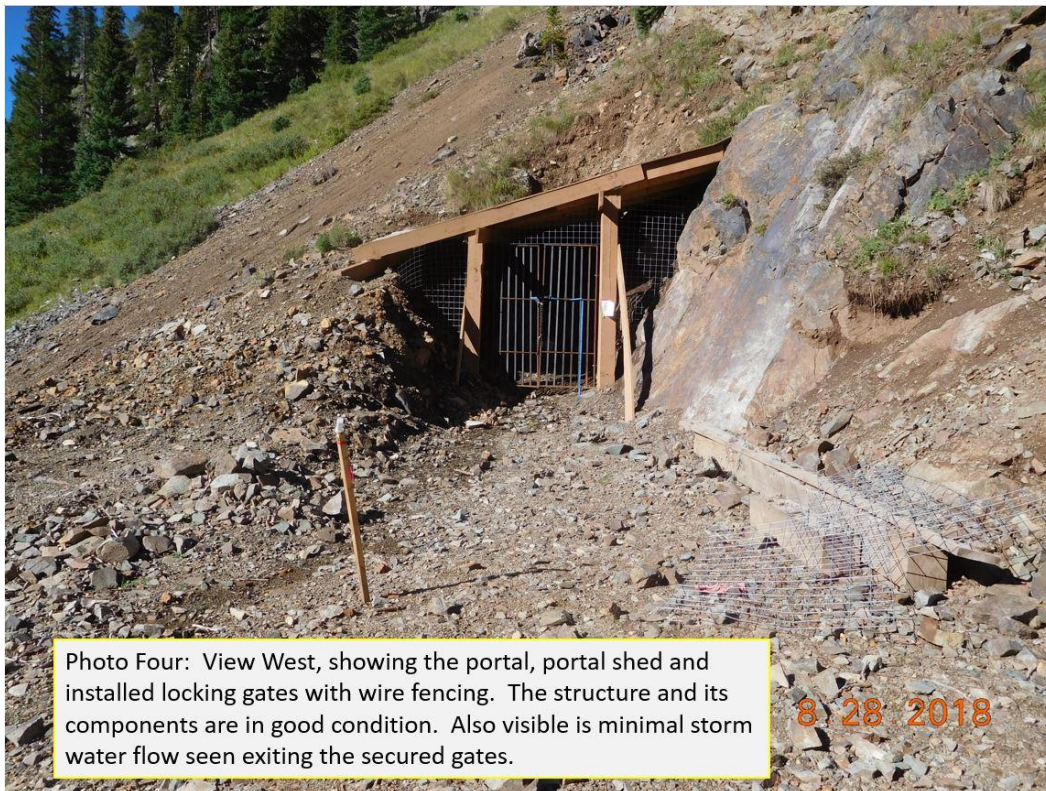
The main purpose of this inspection was to monitor the status of the site, as well as serve as the pre-operational inspection that is required in the permitting process. The access road leading up to the portal from the Toltec Tunnel area appears to be stable and in good condition. No significant signs of settling, slumping or erosion were noted at this time. The initial area of concern, the uphill side of the road, also appears to be stable at this time. Photos One through Three show the condition of the road. The portal pad and work area appear to be in the same condition as the previous inspection. The Portal shed structure has had metal gates installed which were approved by the Division in writing, and locked the day of the inspection. Along with the gates the Operator has attempted to control access by installing wire grating on the open areas. The gates, metal grating and portal shed can be seen in Photo Four. Proper notices as required by the BLM are posted on the portal shed.

A small amount of water was seen flowing out of the portal, which is also visible in Photo Four. This water was confirmed to be storm water flow that is entering the portal shed and flowing out of the gates, not discharge water from the portal itself. This is not considered a problem at this time however the situation will be closely monitored in the future. The waste rock dump area that was used during the initial operations was observed and appears to be stable at this time.

Photo Four: View West, showing the portal, portal shed and installed locking gates with wire fencing. The structure and its components are in good condition. Also visible is minimal storm water flow seen exiting the secured gates.
