**COLORADO**Division of Reclamation,
Mining and Safety

MINERALS PROGRAM INSPECTION REPORT**PHONE: (303) 866-3567**

MINE NAME: Surface Rock Pit	MINE/PROSPECTING ID#: M-1984-001	MINERAL: Sand and gravel	COUNTY: Mesa
INSPECTION TYPE: Surety-Related Inspection	INSPECTOR(S): Amy C. Yeldell	INSP. DATE: September 4, 2018	INSP. TIME: 10:00
OPERATOR: Kilgore Companies LLC dba Elam Construction	OPERATOR REPRESENTATIVE: None	TYPE OF OPERATION: 112c - Construction Regular Operation	
REASON FOR INSPECTION: Priority	BOND CALCULATION TYPE: Complete Bond	BOND AMOUNT: \$17,024.00	
DATE OF COMPLAINT: NA	POST INSP. CONTACTS: DRMS	JOINT INSP. AGENCY: None	
WEATHER: Cloudy	INSPECTOR'S SIGNATURE:

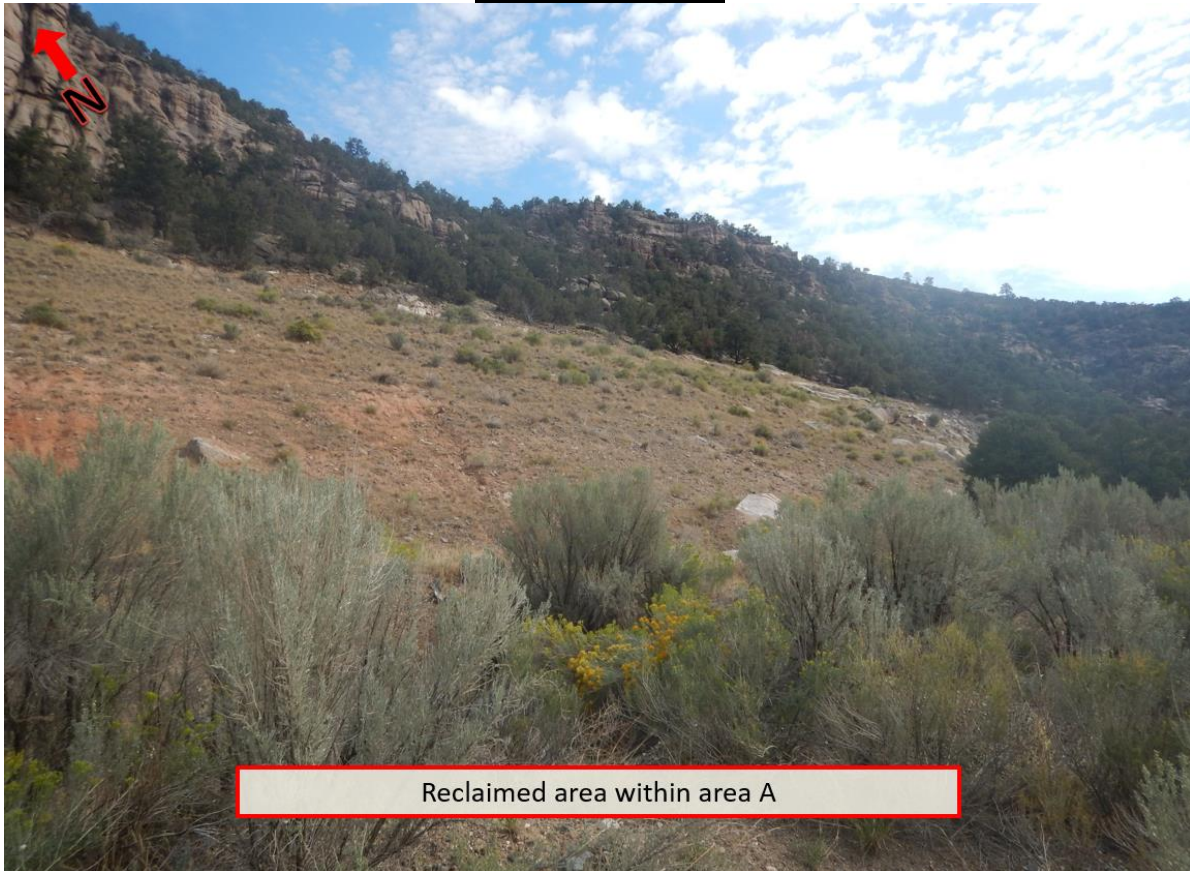
To the east of the active highwall was a sloped and revegetated area approximately two and half acres in size. There is no exposed water or water used for washing of material. Lots of Russian thistle was observed on site. A few mullein plants were also observed.

Reclaimed area within area A

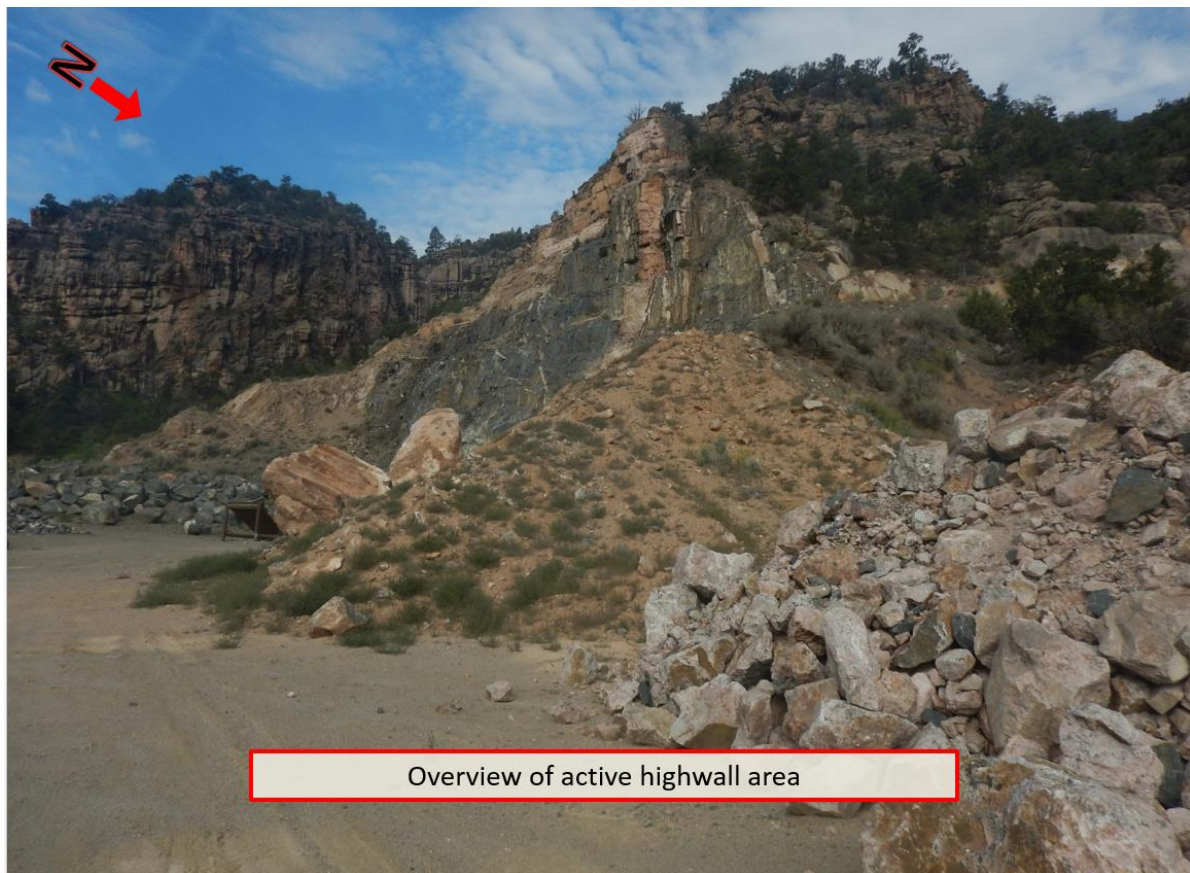
The active highwall consists of several benches of varying heights and slopes. This site is a blend of igneous and metamorphic rocks. Benches are mined according to rock type. Generally the highwall is sloping at a 1:1 and is approximately 150-200 feet tall. According to the mine plan benches should be no more than 15' wide by 40' high.

Overview of active highwall area
