MINERALS PROGRAM INSPECTION REPORT
PHONE: (303) 866-3567

MINE NAME: C Road Pit	MINE/PROSPECTING ID#: M-2016-050	MINERAL: Sand and gravel	COUNTY: Mesa
INSPECTION TYPE: Surety-Related Inspection	INSPECTOR(S): Amy C. Yeldell	INSP. DATE: September 4, 2018	INSP. TIME: 11:00
OPERATOR: Kilgore Companies LLC dba Elam Construction	OPERATOR REPRESENTATIVE: None	TYPE OF OPERATION: 112c - Construction Regular Operation	
REASON FOR INSPECTION: Priority	BOND CALCULATION TYPE: None	BOND AMOUNT: \$241,201.40	
DATE OF COMPLAINT: NA	POST INSP. CONTACTS: DRMS	JOINT INSP. AGENCY: None	
WEATHER: Cloudy	INSPECTOR'S SIGNATURE:

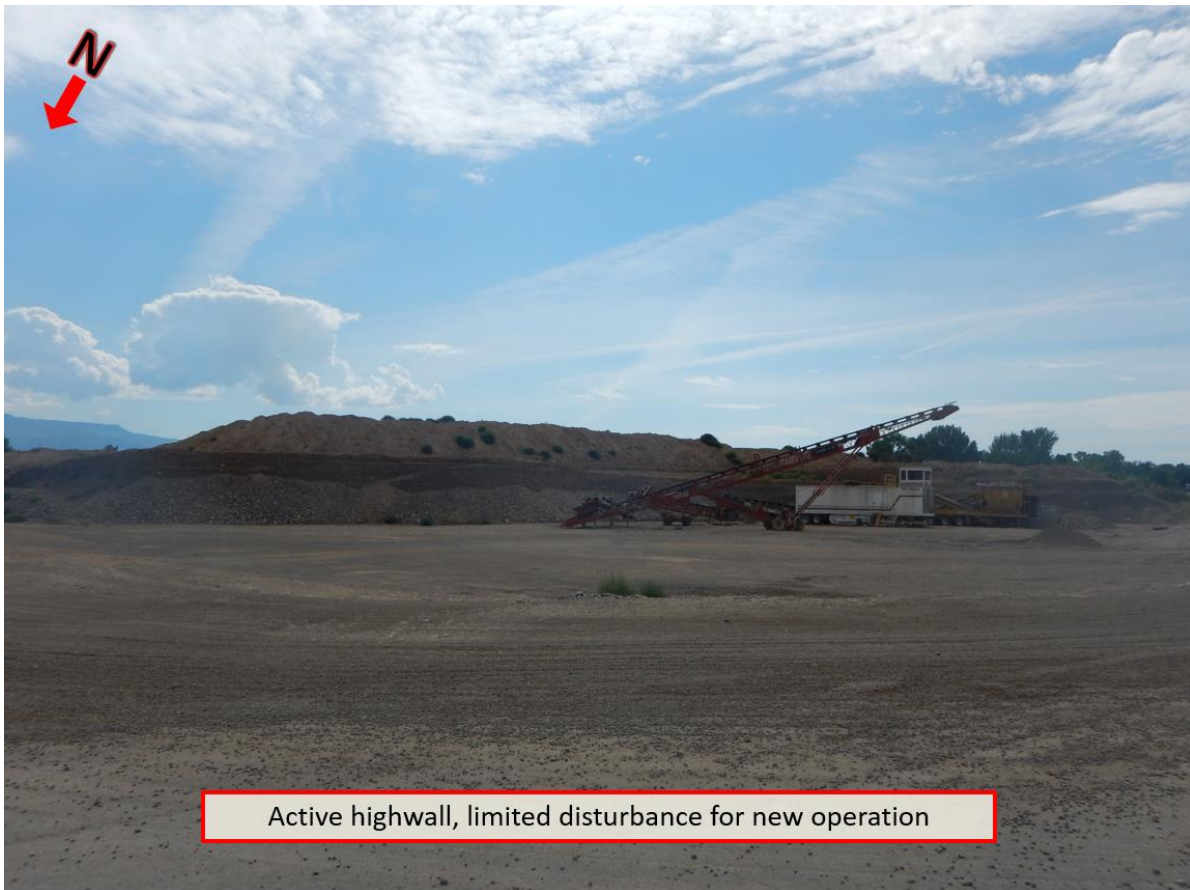
The site was active at the time of the inspection. Four feet of overburden had been stripped and approximately a 300 LF highwall existed. The highwall was near vertical and 15-20 feet tall. The area stripped has not increased since the previous inspection this spring. However the mined highwall and pit floor area has increased. Topsoil and overburden were stored to the east of the active pit area. A conveyor and crusher were on site within the pit floor area. No fuel or permanent structures are on site.

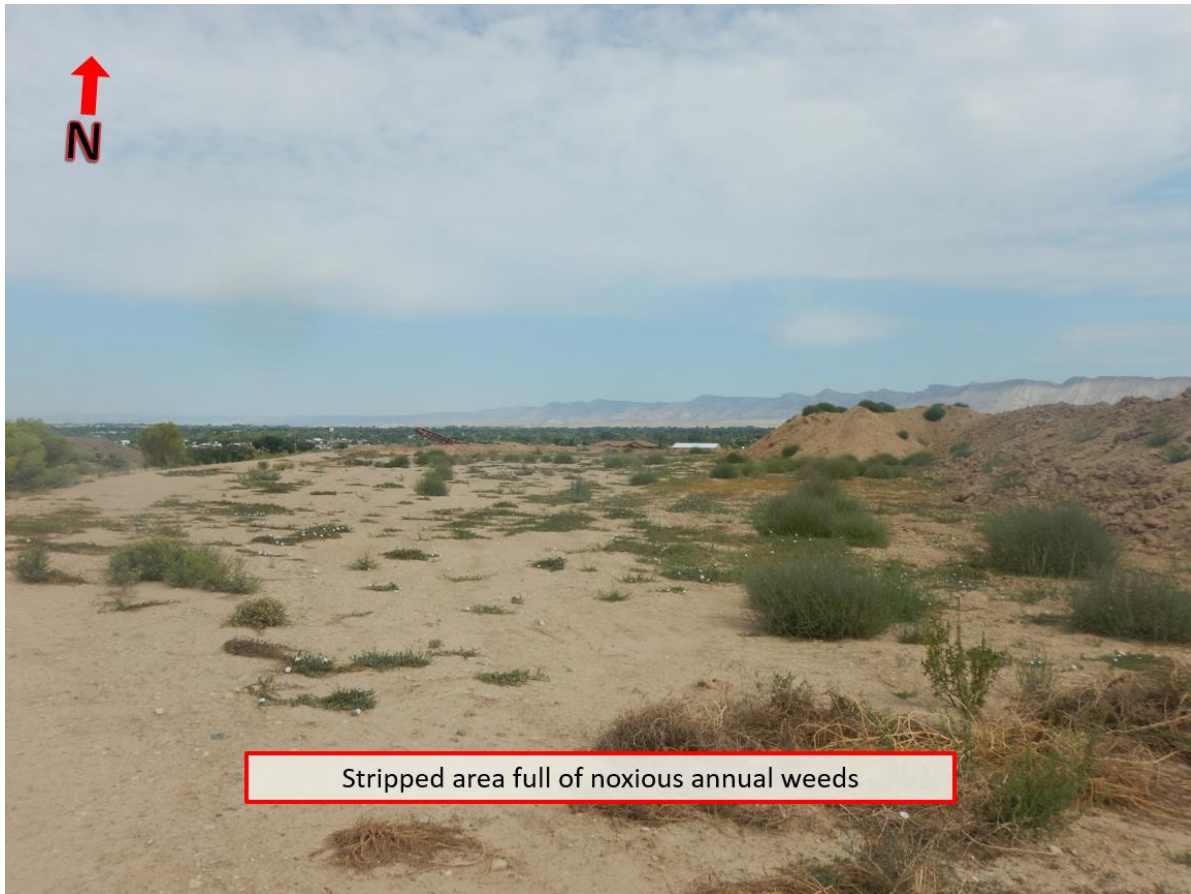
There were lots of annual weeds present in the stripped area. Specifically large amounts of Kochia, Field bindweed and Russian Thistle. The plants had begun to wilt but there was no evidence of dye. The Division cannot tell if these plants were stressed from a weed treatments or the summer heat/drought. When possible theses noxious weeds should be managed to avoid creating a seed bank on site. No interim or final reclamation has been complete. The topsoil pile did not appear to be reseeded yet. If topsoil will not be reapplied for final reclamation this fall then it should be reseeded per Rule 3.1.9(1)
