MINERALS PROGRAM INSPECTION REPORT**PHONE: (303) 866-3567**

MINE NAME: Toltec No 2	MINE/PROSPECTING ID#: M-1984-039	MINERAL: Silver, gold, copper,	COUNTY: San Juan
INSPECTION TYPE: Monitoring	INSPECTOR(S): Lucas J. West	INSP. DATE: August 28, 2018	INSP. TIME: 10:15
OPERATOR: Wilbur F Benham	OPERATOR REPRESENTATIVE: None	TYPE OF OPERATION: 110(2) - Hard Rock Limited Impact	
REASON FOR INSPECTION: Normal I&E Program	BOND CALCULATION TYPE: None	BOND AMOUNT: \$1,012.00	
DATE OF COMPLAINT: NA	POST INSP. CONTACTS: None	JOINT INSP. AGENCY: None	
WEATHER: Clear	INSPECTOR'S SIGNATURE:

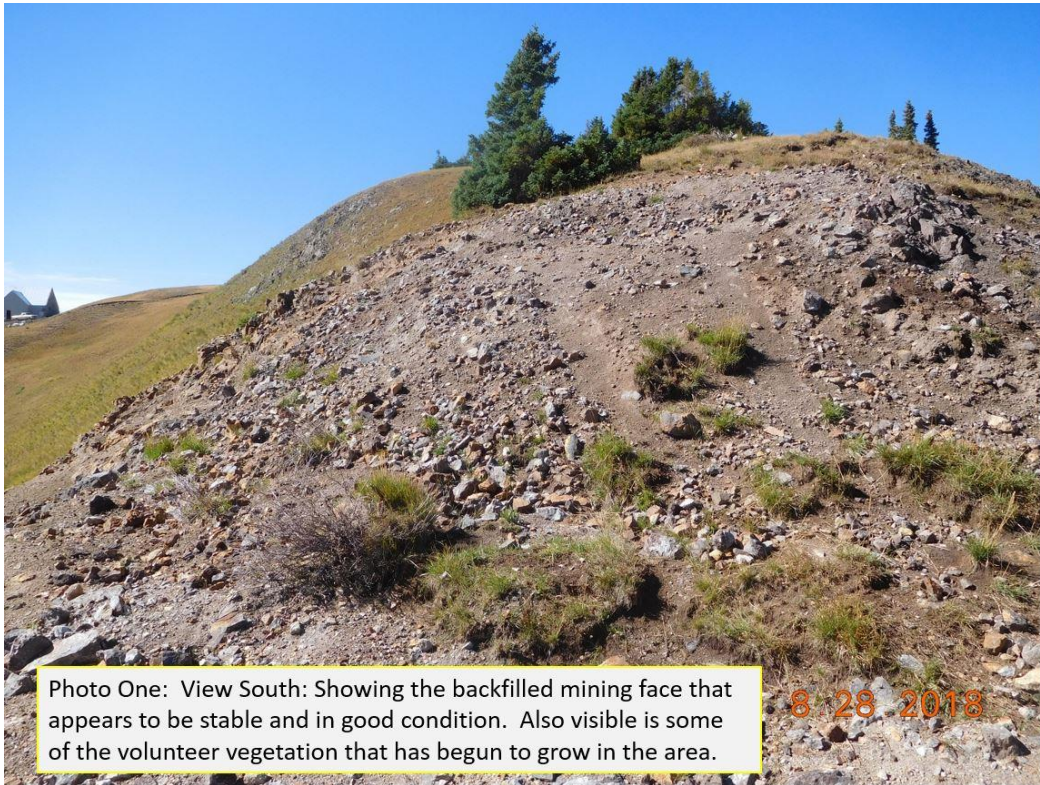
Reclamation activities were completed in 2016. The waste rock pile located on site has been blended into the rock face to match the surrounding topography. The backfilling and blending appears to be stable and in good condition. Photos One and Two show the backfilled area. The main work area adjacent to the rock face has been graded to ensure positive drainage. Topsoil has been replaced throughout the site. The grading of the topsoil appears to be stable and no erosional issues were noted on site. All earthwork and grading has been completed according to the approved reclamation plan that was recently modified through TR-02. The main work and parking area appears to be stable and in good condition and can be seen in Photo Three. Two stockpiles of dimensional stone are located on the work area. These are being stored by the adjacent property owner who is constructing a cabin. This is not considered a problem at this time. Revegetation is the only remaining task to achieve final reclamation of the site. In some small sections of the reclaimed area, some volunteer vegetation is beginning to grow. The species include various types of alpine grasses that were likely seeded from surrounding undisturbed areas. No State listed noxious weeds were observed during the inspection.
