MINERALS PROGRAM INSPECTION REPORT
PHONE: (303) 866-3567

MINE NAME: Silt Pit	MINE/PROSPECTING ID#: M-1981-202-SG	MINERAL: Sand and gravel	COUNTY: Garfield
INSPECTION TYPE: Surety Release Inspection	INSPECTOR(S): Amy C. Yeldell	INSP. DATE: September 11, 2018	INSP. TIME: 08:00
OPERATOR: Flag Resources Inc.	OPERATOR REPRESENTATIVE: Eric Frei	TYPE OF OPERATION: 112c - Construction Regular Operation	
REASON FOR INSPECTION: Surety Release Requested	BOND CALCULATION TYPE: Complete Bond	BOND AMOUNT: \$468,320.00	
DATE OF COMPLAINT: NA	POST INSP. CONTACTS: None	JOINT INSP. AGENCY: None	
WEATHER: Clear	INSPECTOR'S SIGNATURE:

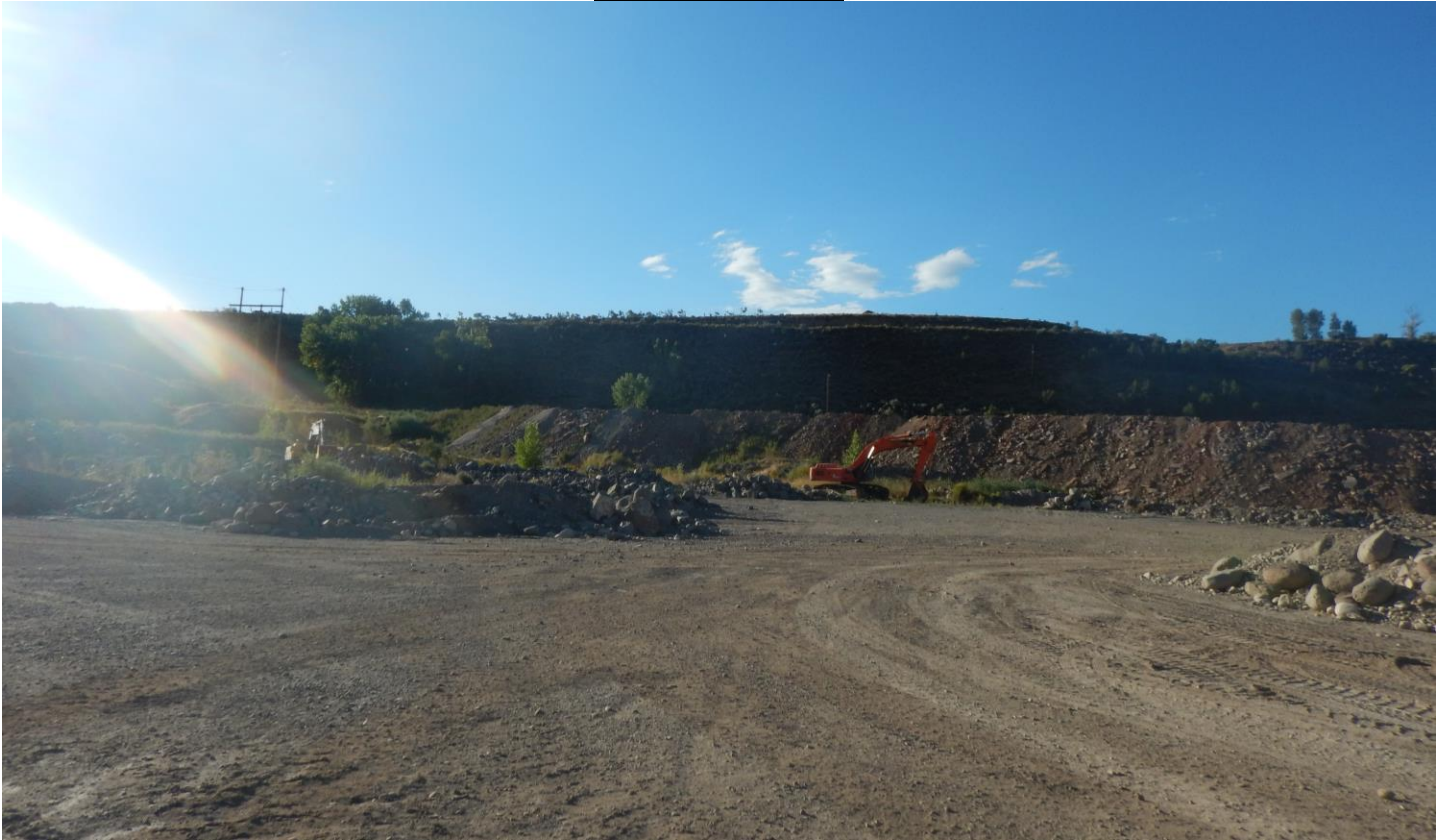
Southern highwall adjacent to office

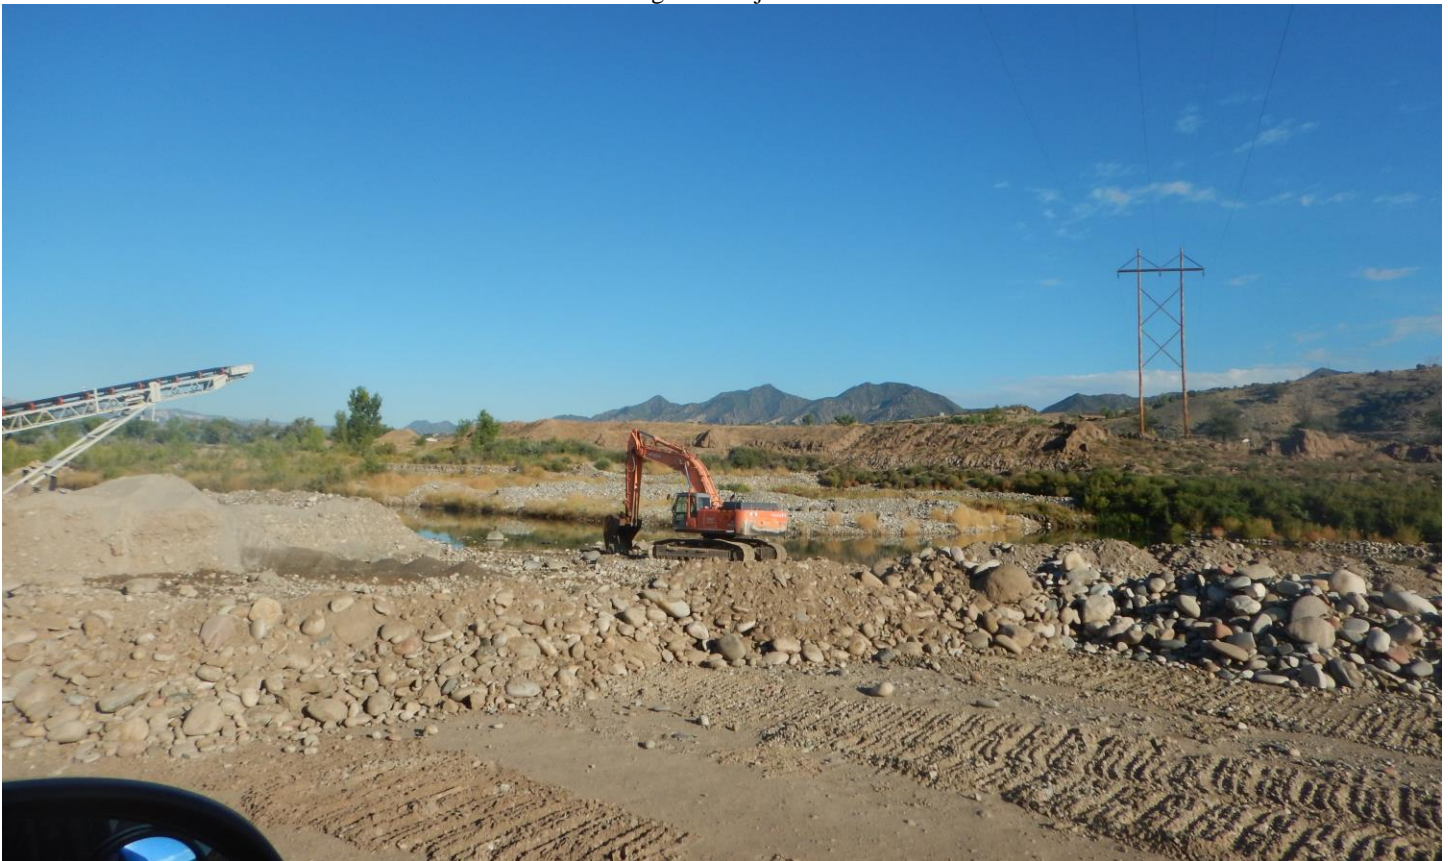
Most notably the excessive vertical highwall that resulted in a significant bond increase has been reclaimed. The northeast highwall has been backfilled. The entire slope has been backfilled and graded to a 3:1. The northwest corner of the east pond still has an active highwall. That slope is approximately 200 LF at a 2:1 slope and 20 feet high. Additionally the south highwall adjacent to office area is at a 2:1, 20 feet high and needs to be sloped using cut fill. All slopes surrounding the east lake will need to be topsoiled and seeded. Topsoil is stored in berms along the rim of the highwalls. Only the south and west highwall will require topsoil to be transported, all other slopes it can be slot dozed down.

Remaining highwall in the NW corner of the east pit

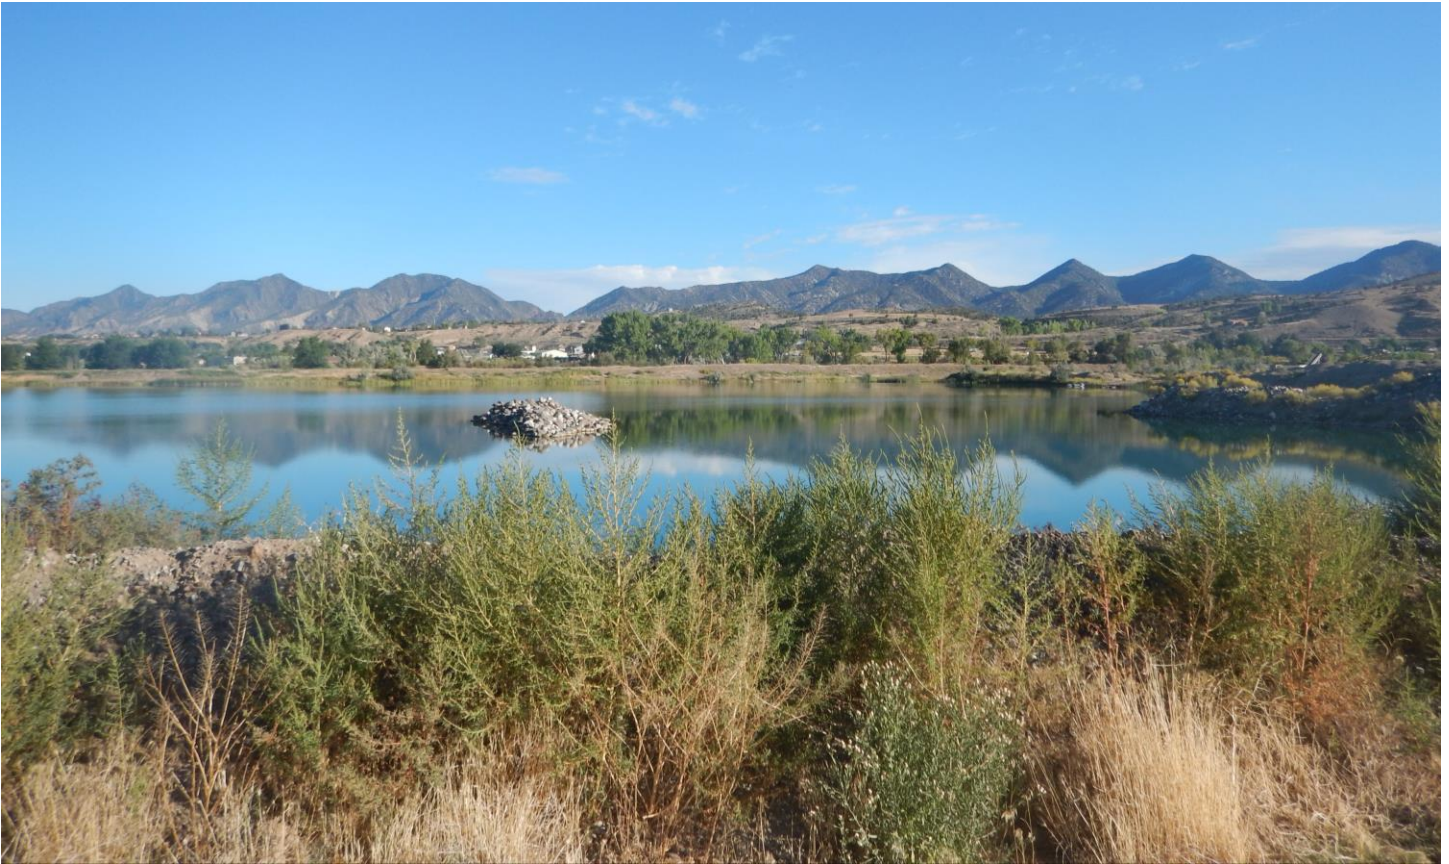
The west lake is completely graded and mostly revegetated. And area adjacent to the swim beach needs to be seeded. Vegetation has been established around the western lake with a road that goes all the way around. In some areas native vegetation is being displaced by annuals and noxious weeds. Overall slopes area stable. Knapweed was observed in several areas throughout the site and should be treated immediately. Diligent weed management is not only essential for successful reclamation but it is required by Rule 3.1.10(6).

Noxious and state listed weeds that are displacing successful reclamation on the west pond

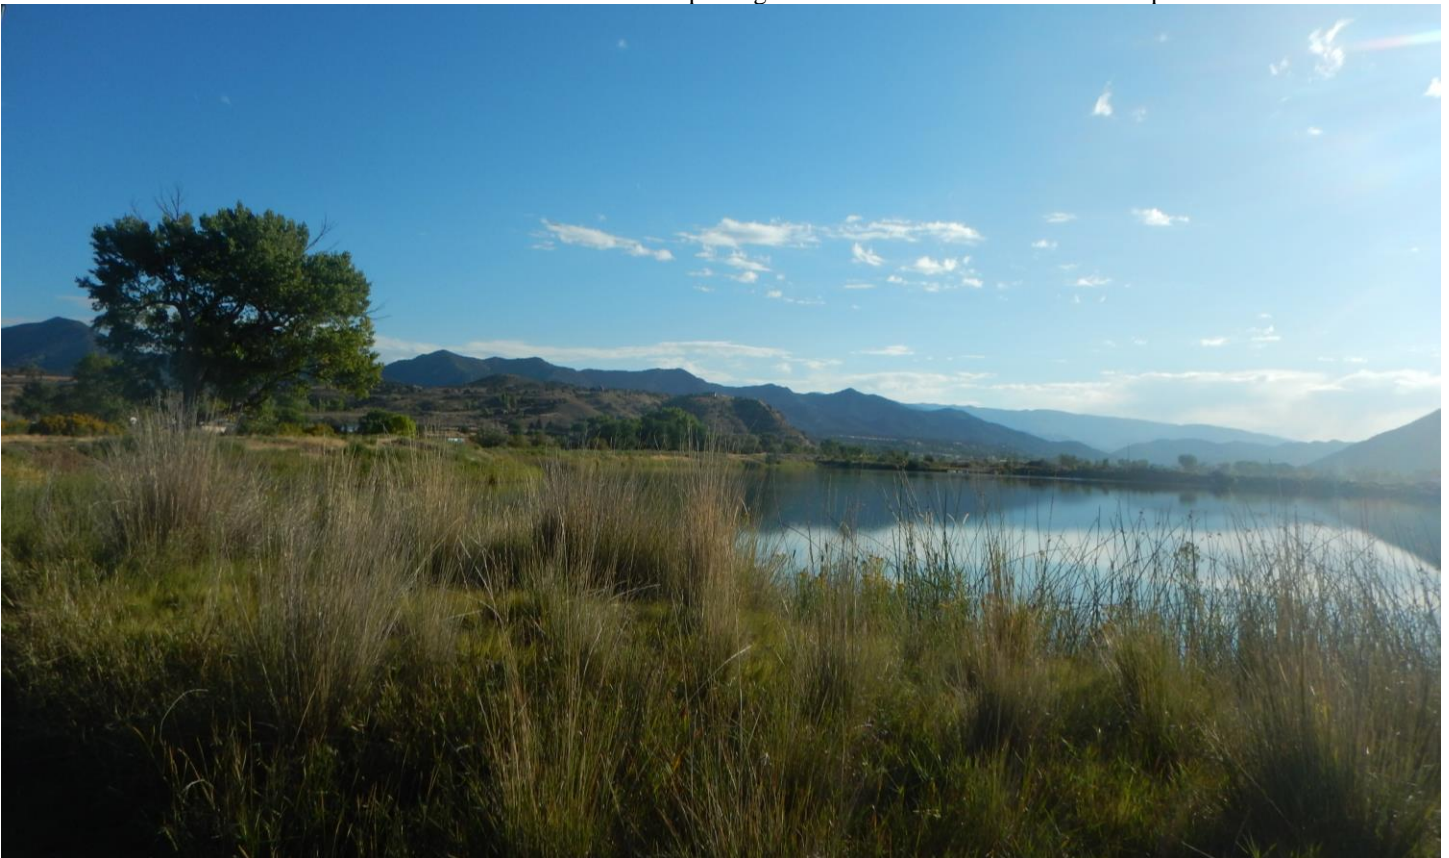
Reclaimed shores of the west pond
