**COLORADO**  
Division of Reclamation,  
Mining and Safety  
Department of Natural Resources

<b>Permit Number:</b> C-1996-084 <b>Mine Name:</b> Lorencito Canyon Mine <b>Operator:</b> New Elk Coal Company, LLC <b>Operator Address:</b> Mr. Louis Head 12250 Highway 12 Weston, CO 81091	<b>County:</b> Las Animas <b>Operation Type:</b> Surface <b>Permit Status:</b> Permanent Cessation <b>Ownership:</b> Private
	<b>Operator Representative Present:</b>  Nick Mason
<b>Operator Representative Signature: (Field Issuance Only)</b>

<b>Inspection Start Date:</b> September 20, 2018 <b>Inspection Start Time:</b> 09:00 <b>Inspection End Date:</b> September 20, 2018 <b>Inspection End Time:</b> 11:00		<b>Inspection Type:</b> Coal Partial Inspection <b>Inspection Reason:</b> Normal I&E Program <b>Weather:</b> Raining	
<b>Joint Inspection Agency:</b>  None		<b>Joint Inspection Contacts:</b>  	
<b>Post Inspection Agency:</b>  None		<b>Post Inspection Contacts:</b>  	
<b>Inspector(s):</b>  Robert D. Zuber, P.E.	<b>Inspector's Signature:</b>

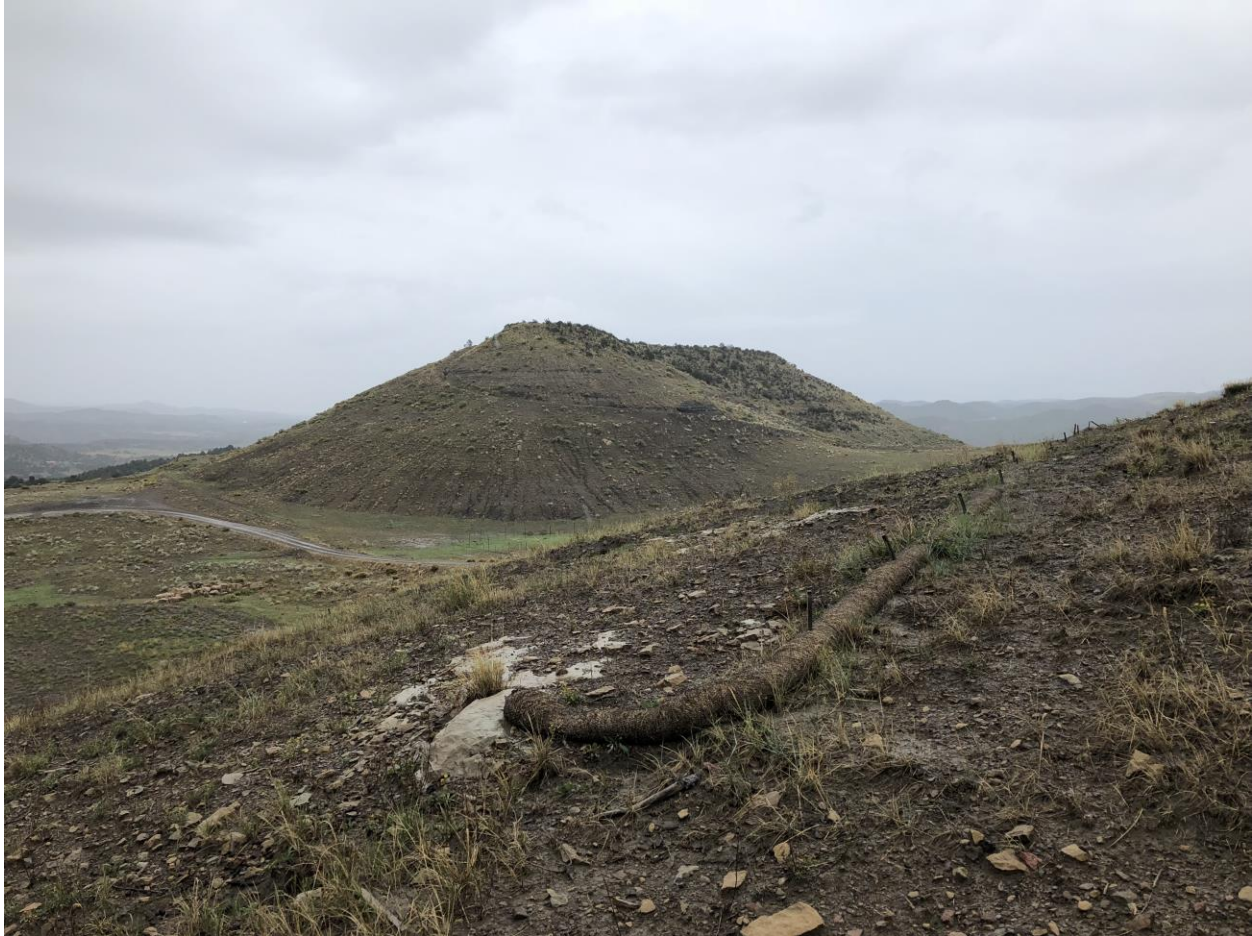
The hill known as “the knob” looked to be stable. It was viewed from all sides but the east side. Some rills remain, especially on west side.

West side of “the knob”

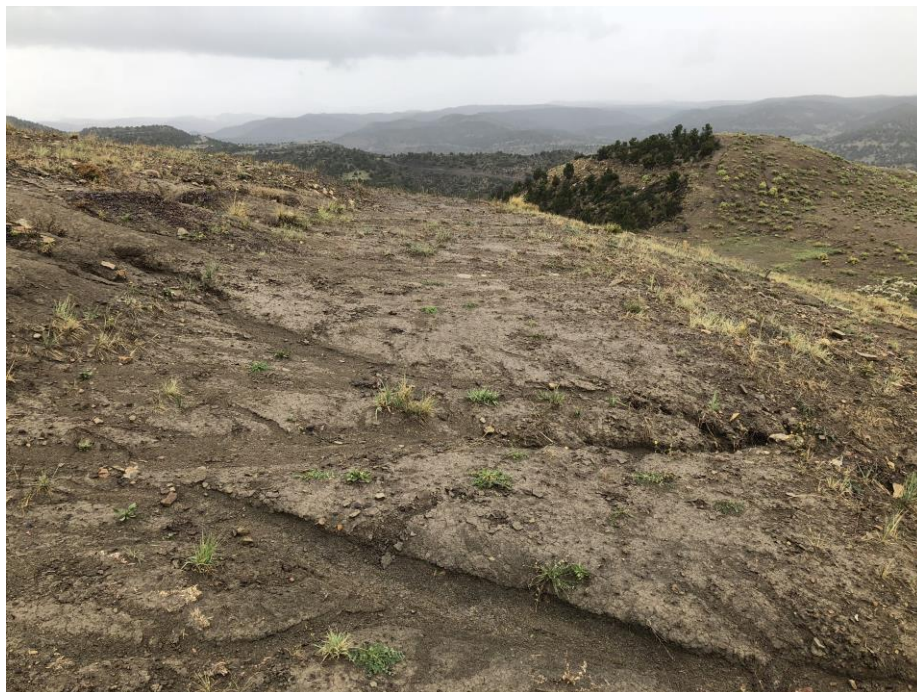
No problem was found with ditch D71. **However, ditch D10 is completely filled with sediment. DRMS and NECC need to discuss this ditch (and the surrounding area) in depth. It could be problematic for the undisturbed area below it (to the northwest) if it is cleared of sediment, but the fact that it is not functioning is problematic for the disturbed hill directly below it (to the northeast), where erosion has been a problem.**

**Ditch D10, filled with sediment**

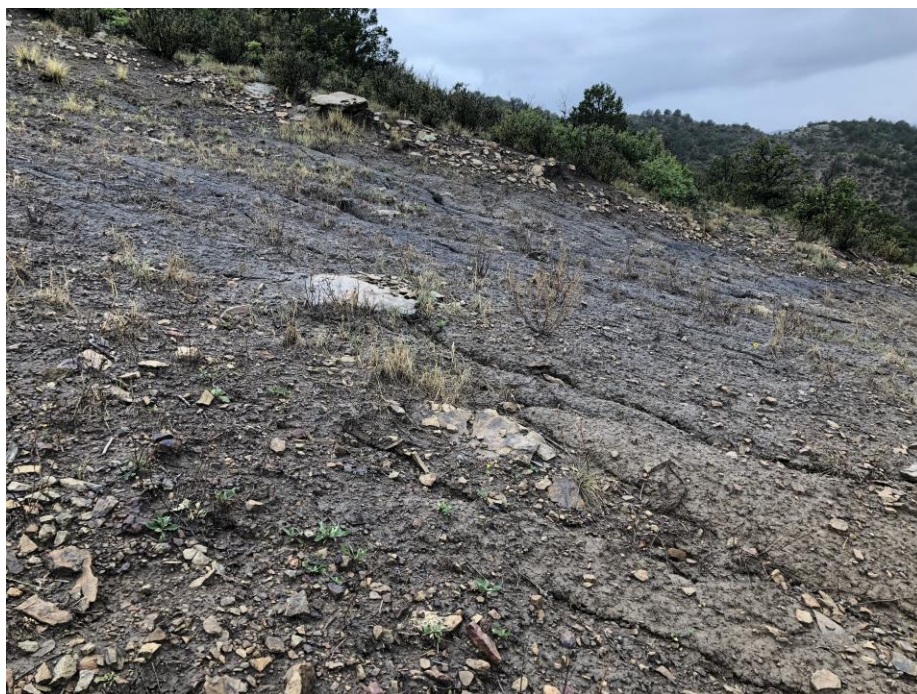
**The hillside above the pond cleaning dump area and below ditch D10 continues to have erosion problems. Also, the hill above D10 is bare and contains rills; some of this may be outside of the designated disturbance area. This issue needs to be discussed in conjunction with the maintenance of ditch D10.**

**Rills on bare area above ditch D10**

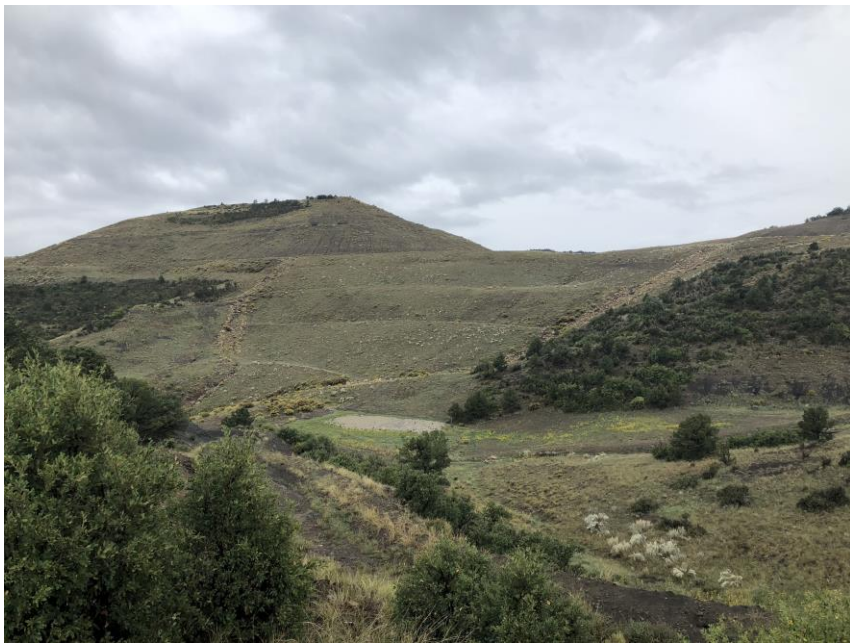
Fills 8 and 9 were inspected. No large rills or gullies were seen.

**Fill 8 with north side of “the knob” in background**

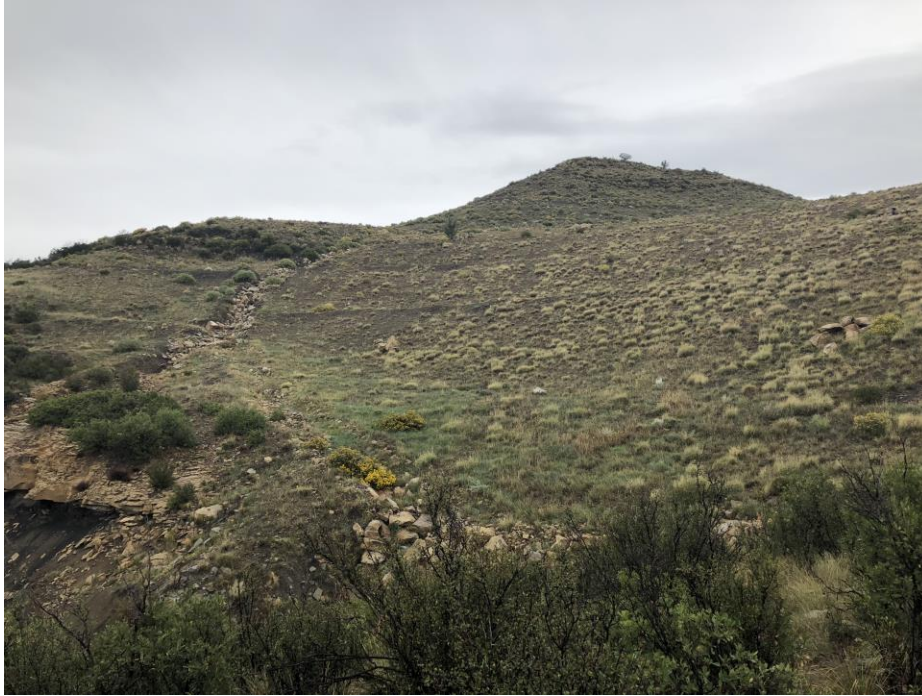
**Fill 9, including ditch D94 (side ditch on southwest side of fill)**

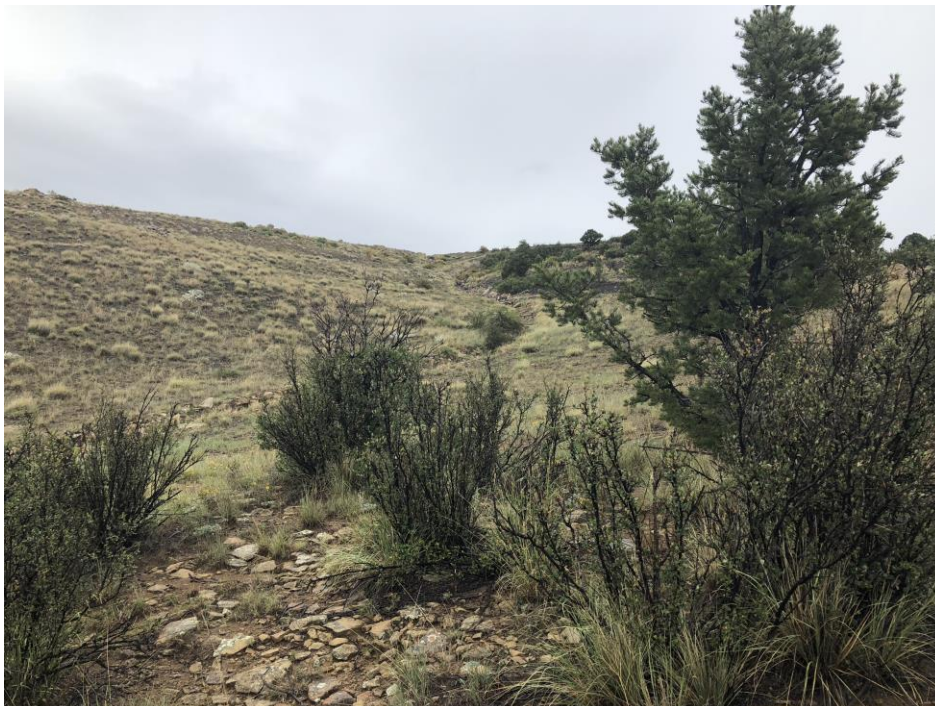
**Fill 9, including ditch D92 (side ditch on east side of fill)**
