**COLORADO**Division of Reclamation,
Mining and Safety

MINERALS PROGRAM INSPECTION REPORT**PHONE: (303) 866-3567**

MINE NAME: Varra Resources Project 110 (Dakolios)	MINE/PROSPECTING ID#: M-1984-036	MINERAL: Sand and gravel	COUNTY: Weld
INSPECTION TYPE: Surety-Related Inspection	INSPECTOR(S): Peter S. Hays, Patrick Lennberg	INSP. DATE: September 20, 2018	INSP. TIME: 10:00
OPERATOR: Varra Companies, Inc.	OPERATOR REPRESENTATIVE: Brad Janes, Brad Jones	TYPE OF OPERATION: 112c - Construction Regular Operation

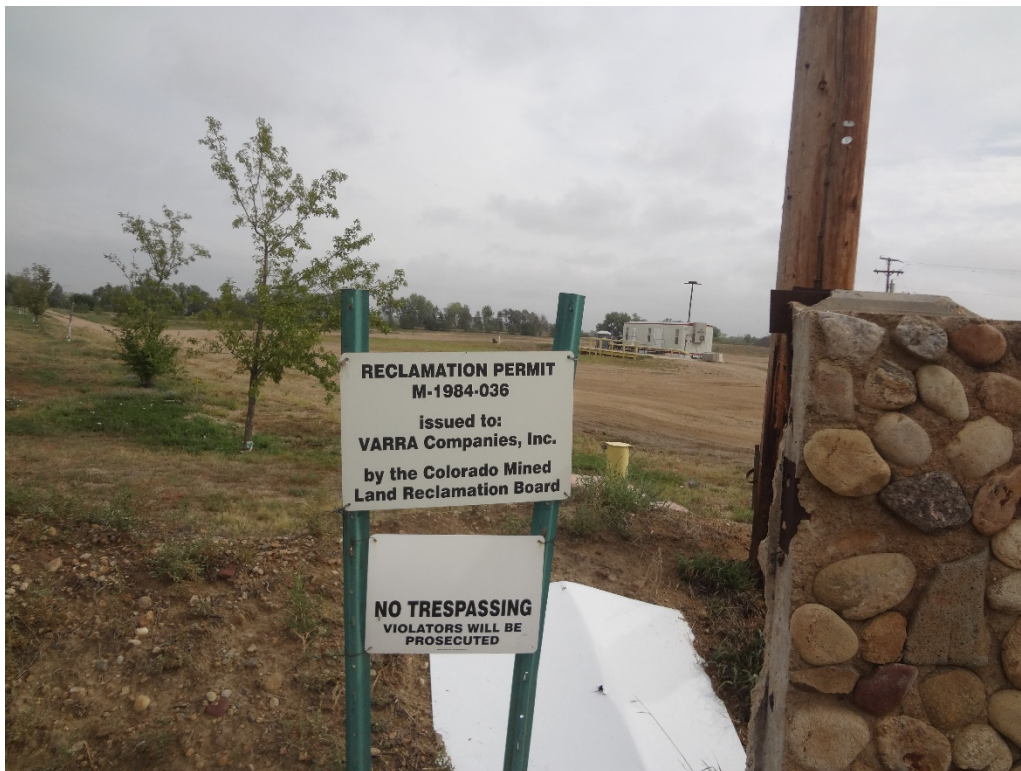
The Varra Resources Project 110 is located north of the Town of Firestone and southeast of the intersection of Weld County Road 13 and St. Vrain Creek in Weld County, Colorado. The mine permit sign was posted at the entrance gate and the permit boundaries were well-defined as required by Rule 3.1.12.

Varra Resources Project 110 mine sign

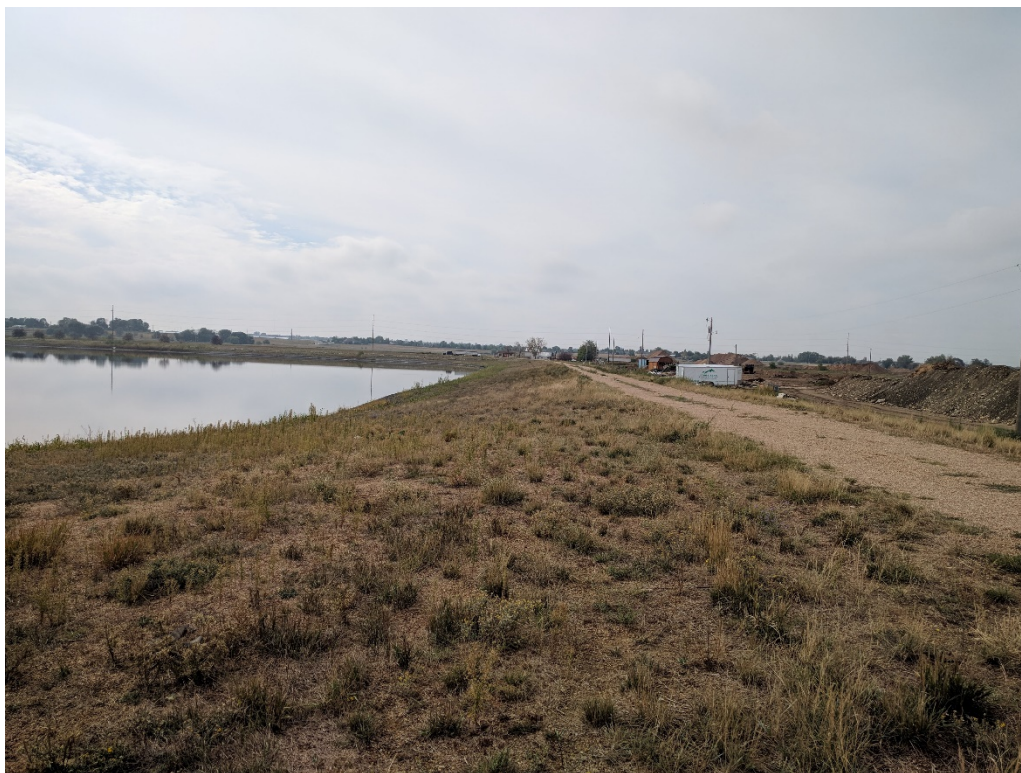
View of the west bank of the southeast reservoir looking south from the NW corner

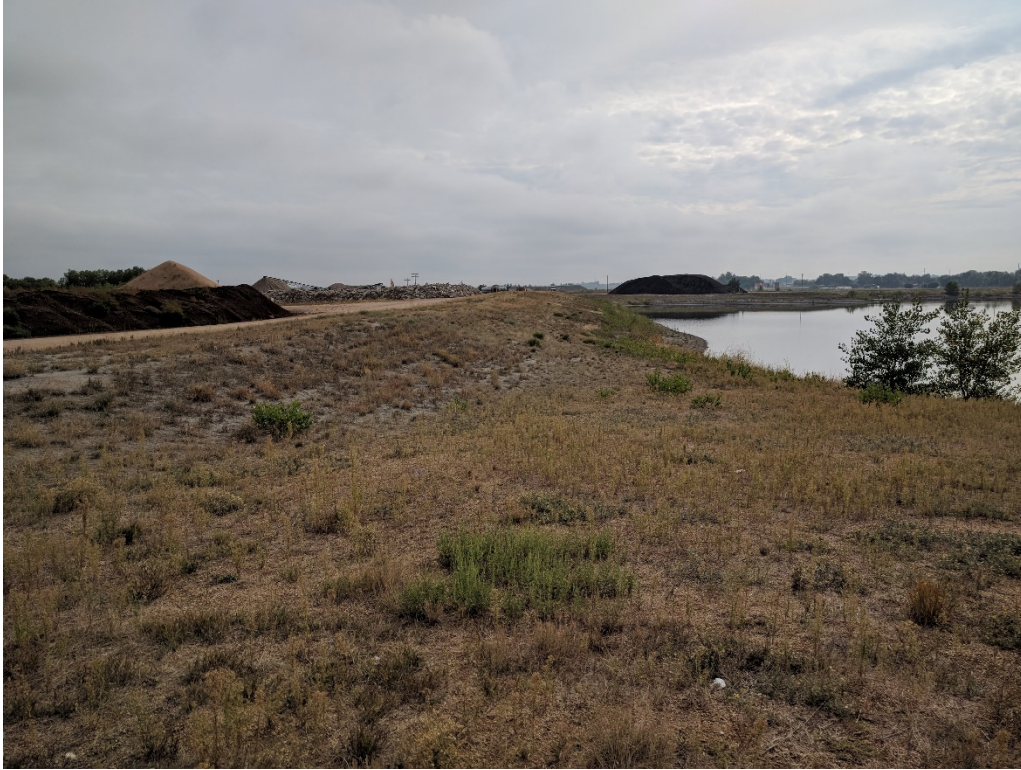
View of the north bank of the southeast reservoir looking east from the NW corner

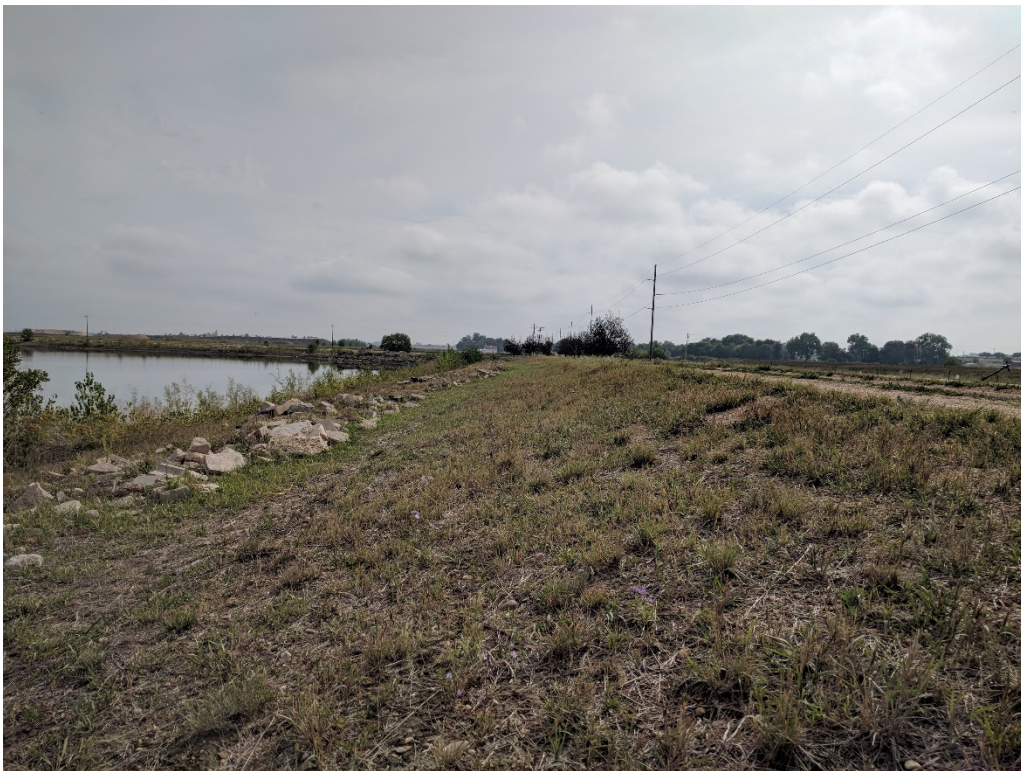
View of the south bank of the southeast reservoir looking east from the SW corner

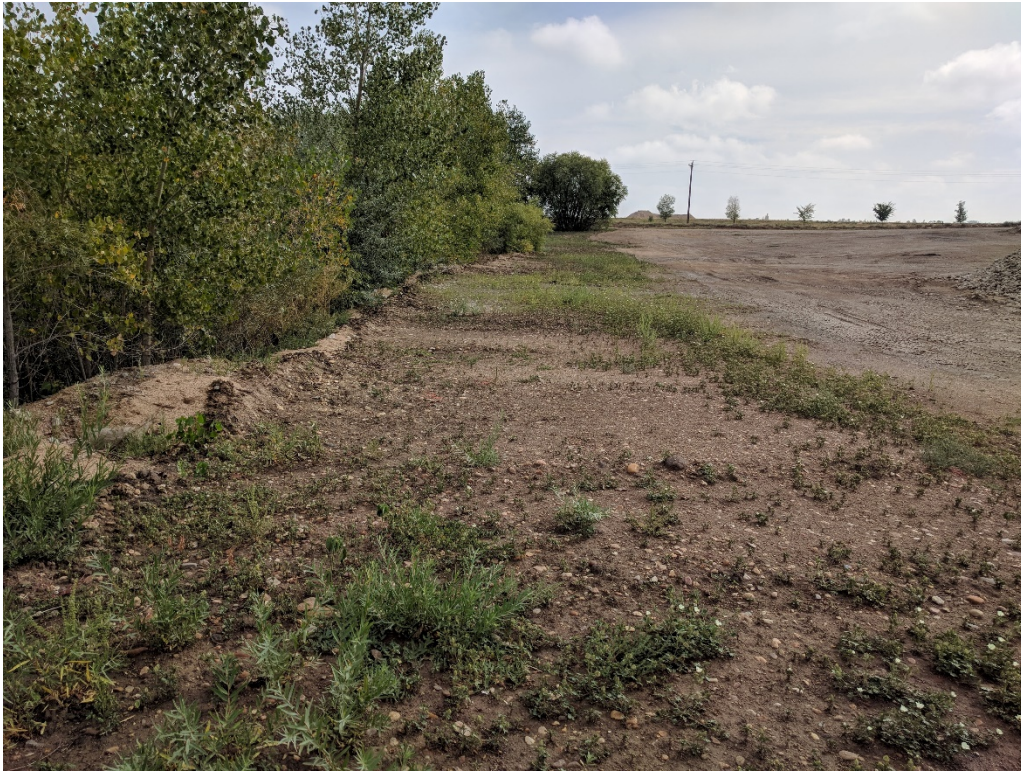
The proposed seep ditch buffer zone relocation would move the zone from along the southern boundary of Area 3 to an area 25 feet on either side of the ditch. The buffer zone area was disc harrowed ahead of seeding. The area will be seeded this fall by the Operator. Annual weeds have volunteered in the buffer zone, which may require the Operator to re-disc the area before seeding the area.

View of the seep ditch buffer looking east along the south side of the ditch

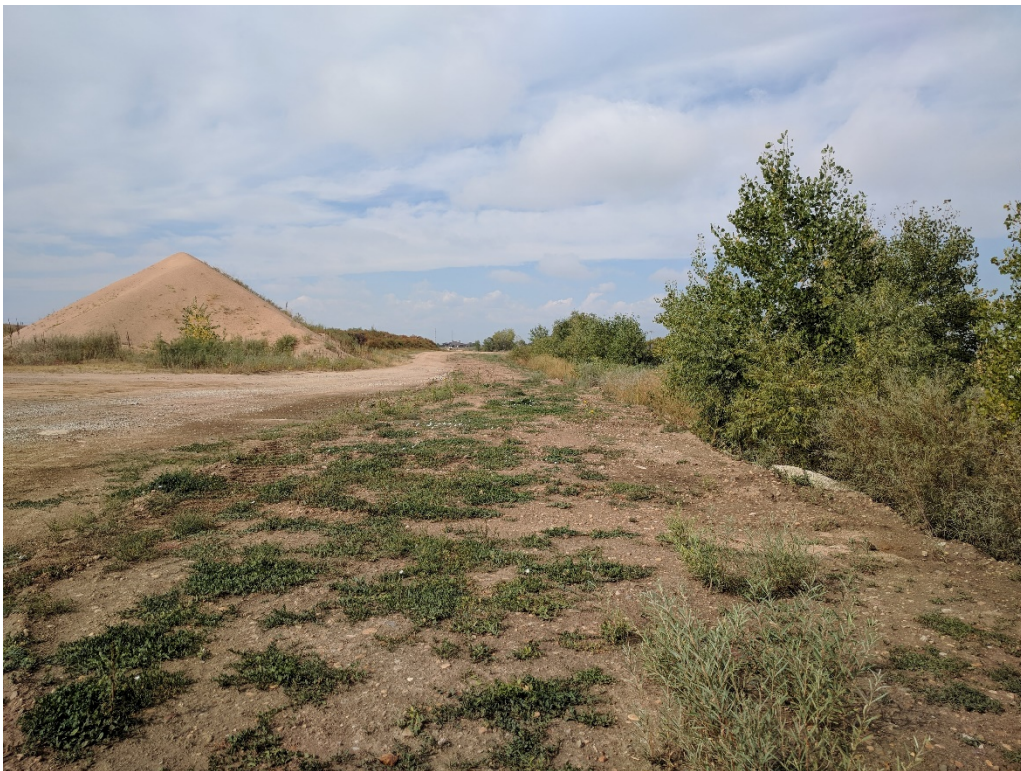
View of the seep ditch buffer looking west along the south side of the ditch

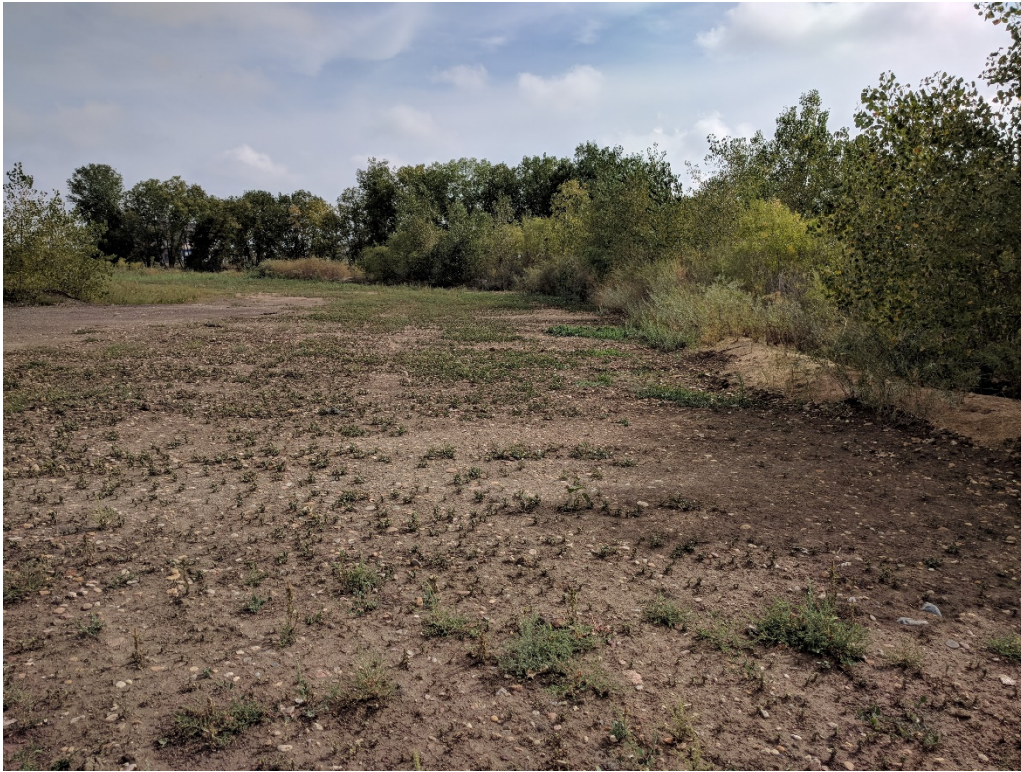
View of the seep ditch buffer looking east along the north side of the ditch

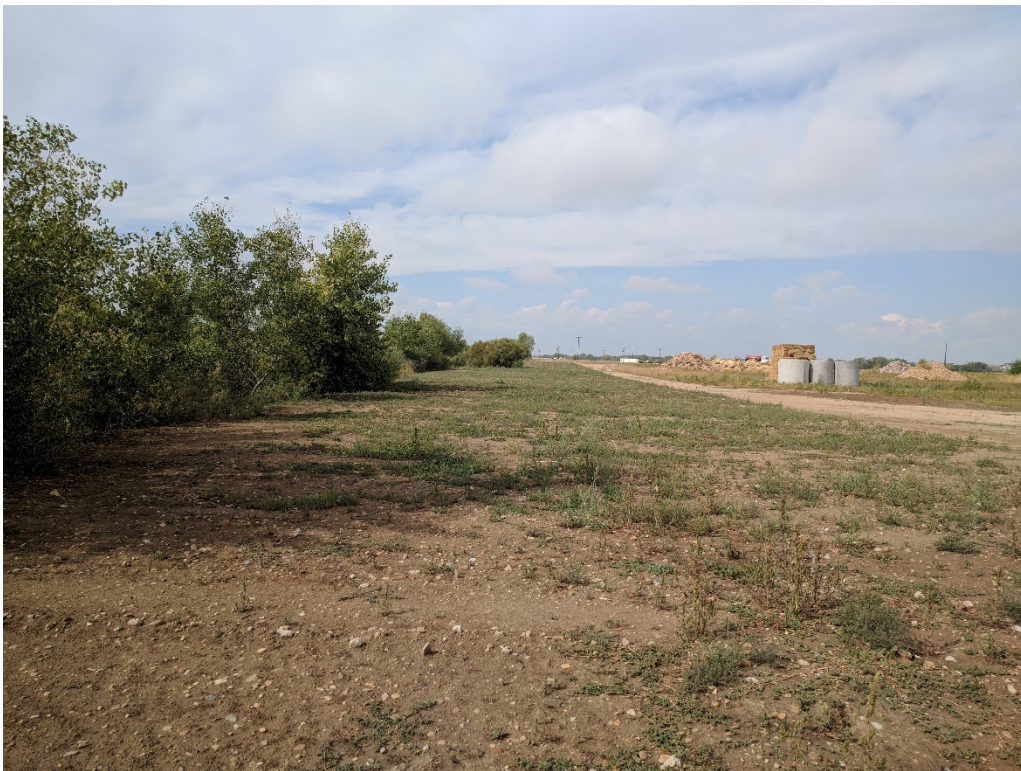
View of the seep ditch buffer looking west along the north side of the ditch

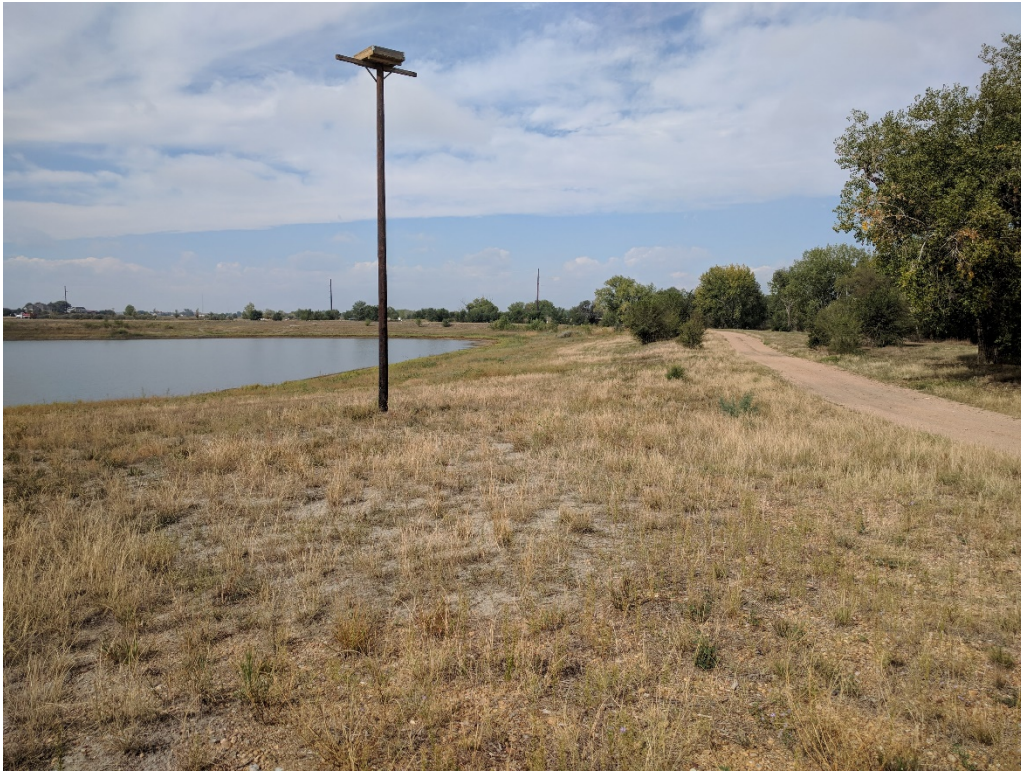
View of the north bank of the northwest reservoir looking west from the NE corner

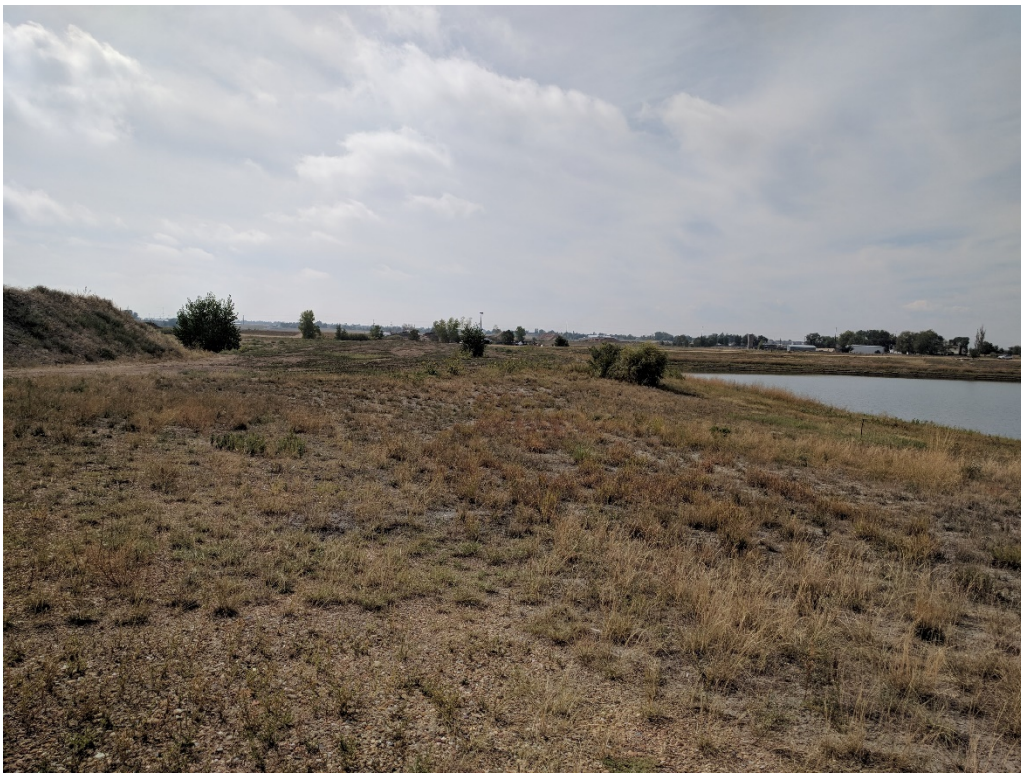
View of the west bank of the northwest reservoir looking west from the NE corner

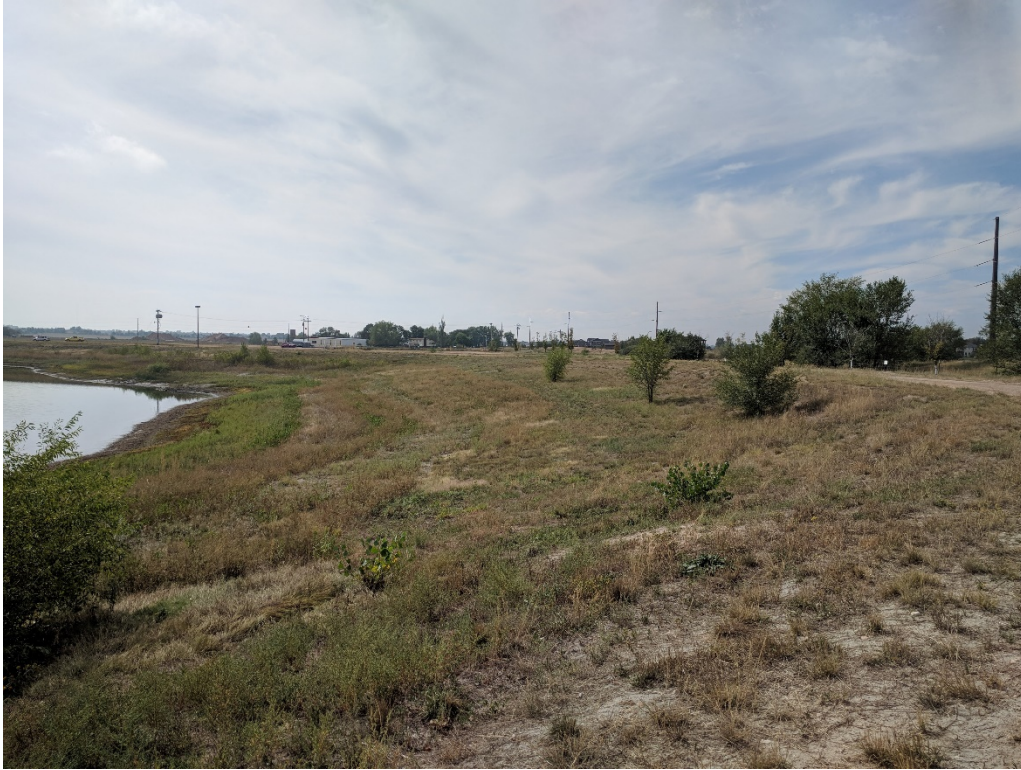
View of the west bank of the northwest reservoir looking south from the NW corner

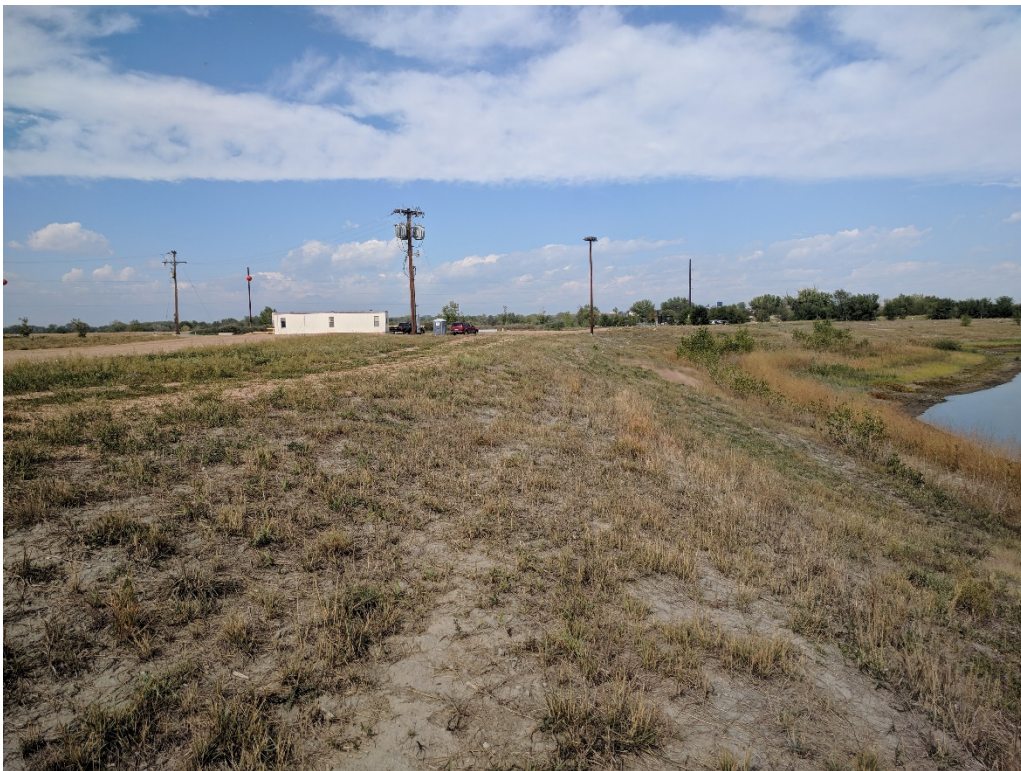
View of the south bank of the northwest reservoir looking west along the south side
