MINERALS PROGRAM INSPECTION REPORT
PHONE: (303) 866-3567

MINE NAME: 5 Mile Pit	MINE/PROSPECTING ID#: M-2016-026	MINERAL: Sand and gravel	COUNTY: Garfield
INSPECTION TYPE: Monitoring	INSPECTOR(S): Amy C. Yeldell	INSP. DATE: September 11, 2018	INSP. TIME: 10:40
OPERATOR: Elam Construction, Inc.	OPERATOR REPRESENTATIVE: None	TYPE OF OPERATION: 112c - Construction Regular Operation	
REASON FOR INSPECTION: Normal I&E Program	BOND CALCULATION TYPE: Complete Bond	BOND AMOUNT: \$240,629.00	
DATE OF COMPLAINT: NA	POST INSP. CONTACTS: None	JOINT INSP. AGENCY: None	
WEATHER: Clear	INSPECTOR'S SIGNATURE:

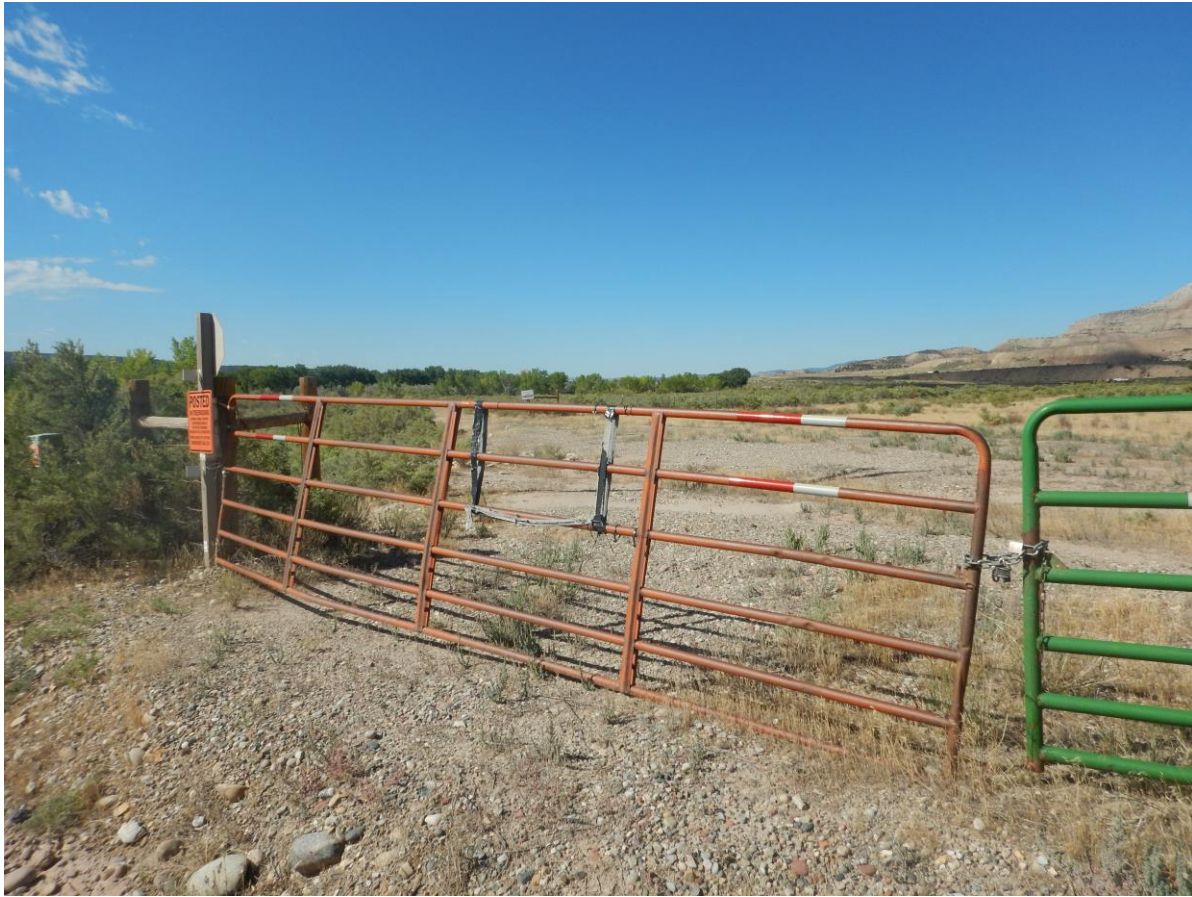
PROBLEM: The mine identification sign was not posted at the entrance of the mine site. This is a problem for failure to post a mine identification sign as required by Section 3.1.12(1) of the rule.

No mine site was present. This is cited as a problem. Pursuant to Rule 3.1.12(1), regardless of if mining has begun, all permitted sites will to have a mine sign posted.

No mine sign present

CORRECTIVE ACTIONS: The operator shall, at the entrance of the mine site, post a sign which shall be clearly visible from the access road with the following: the name of the operator, a statement that a reclamation permit for the operation has been issued by the Colorado Mined Land Reclamation Board; and the permit number. The operator shall submit photo documentation that a proper sign has been posted by the corrective action date.

CORRECTIVE ACTION DUE DATE: 11/23/18

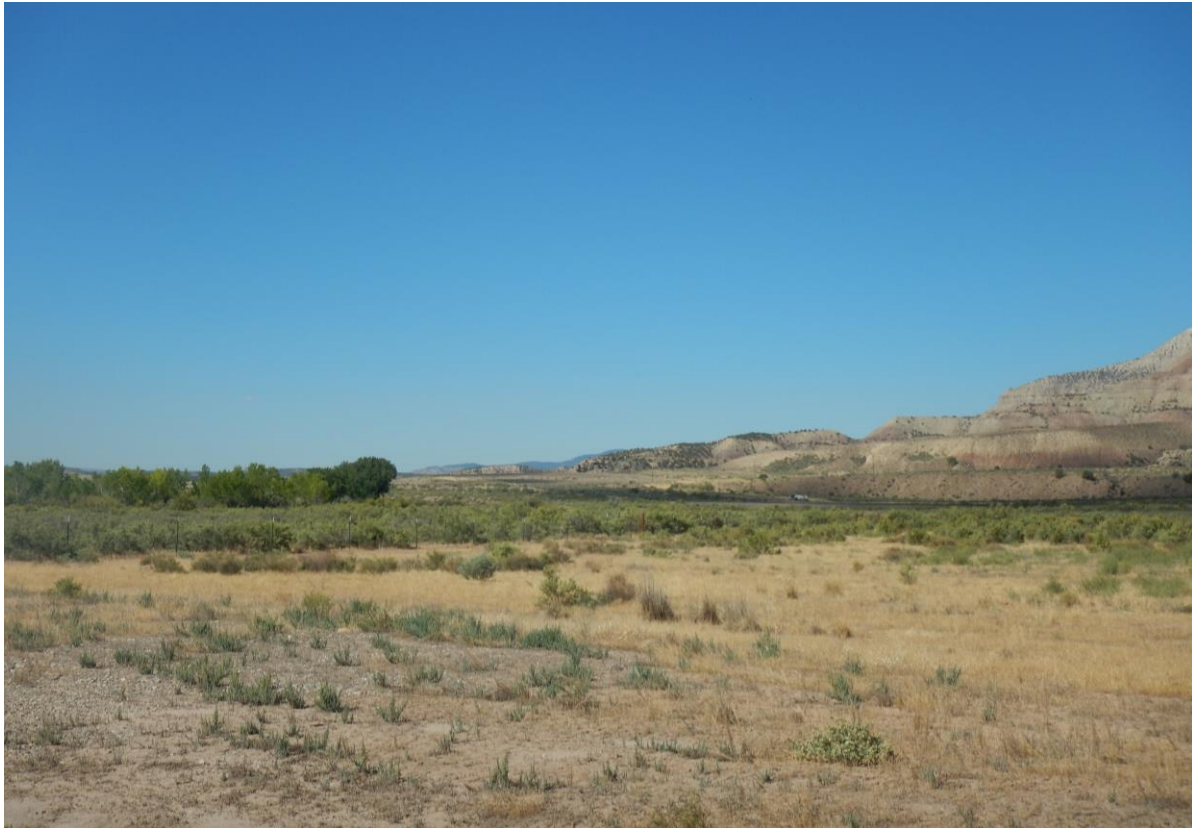
No mining conducted to date

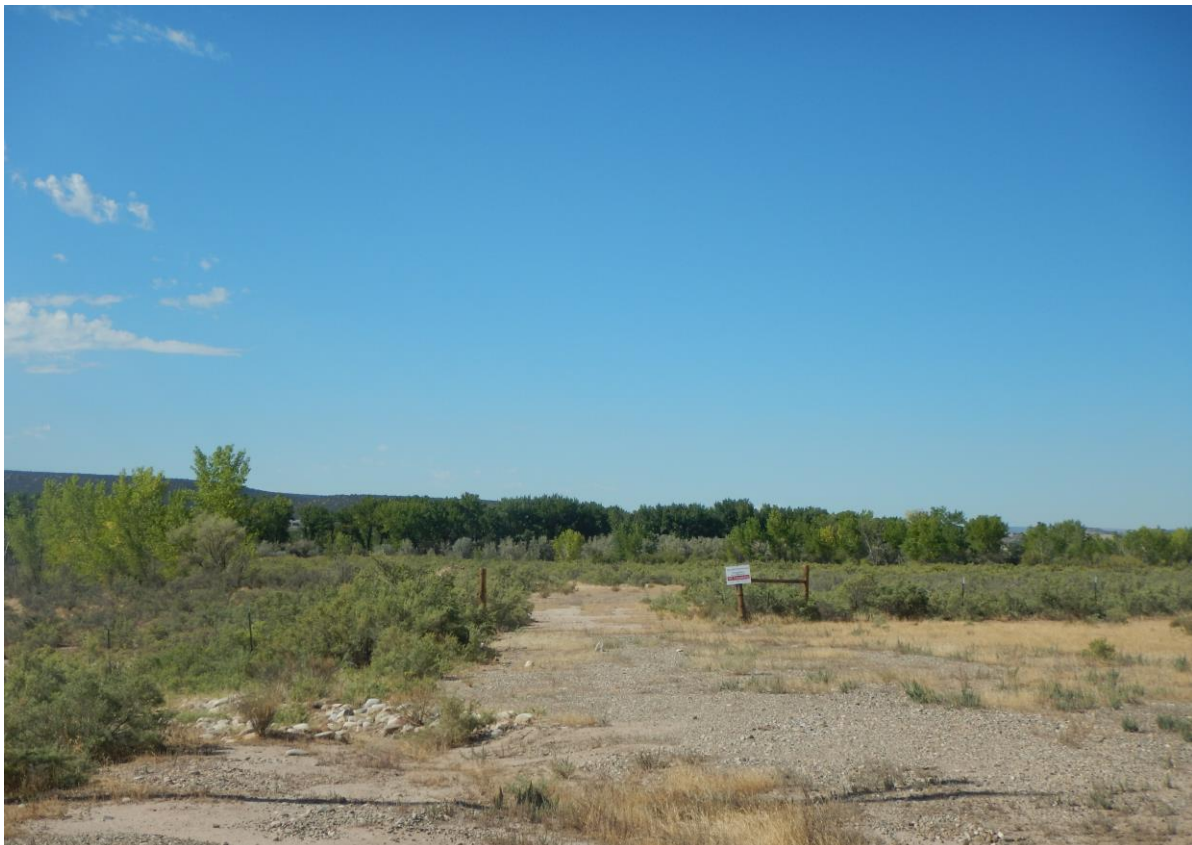
No additional disturbances since pre-operational inspection
