MINERALS PROGRAM INSPECTION REPORT**PHONE: (303) 866-3567**

MINE NAME: Upper Animas Sand and Gravel Pit	MINE/PROSPECTING ID#: M-2005-065	MINERAL: Sand and gravel	COUNTY: San Juan
INSPECTION TYPE: Monitoring	INSPECTOR(S): Lucas J. West	INSP. DATE: August 30, 2018	INSP. TIME: 12:10
OPERATOR: Jack Clark, Jr.	OPERATOR REPRESENTATIVE: None	TYPE OF OPERATION: 112c - Construction Regular Operation	
REASON FOR INSPECTION: Normal I&E Program	BOND CALCULATION TYPE: Complete Bond	BOND AMOUNT: \$20,404.67	
DATE OF COMPLAINT: NA	POST INSP. CONTACTS: None	JOINT INSP. AGENCY: None	
WEATHER: Clear	INSPECTOR'S SIGNATURE:

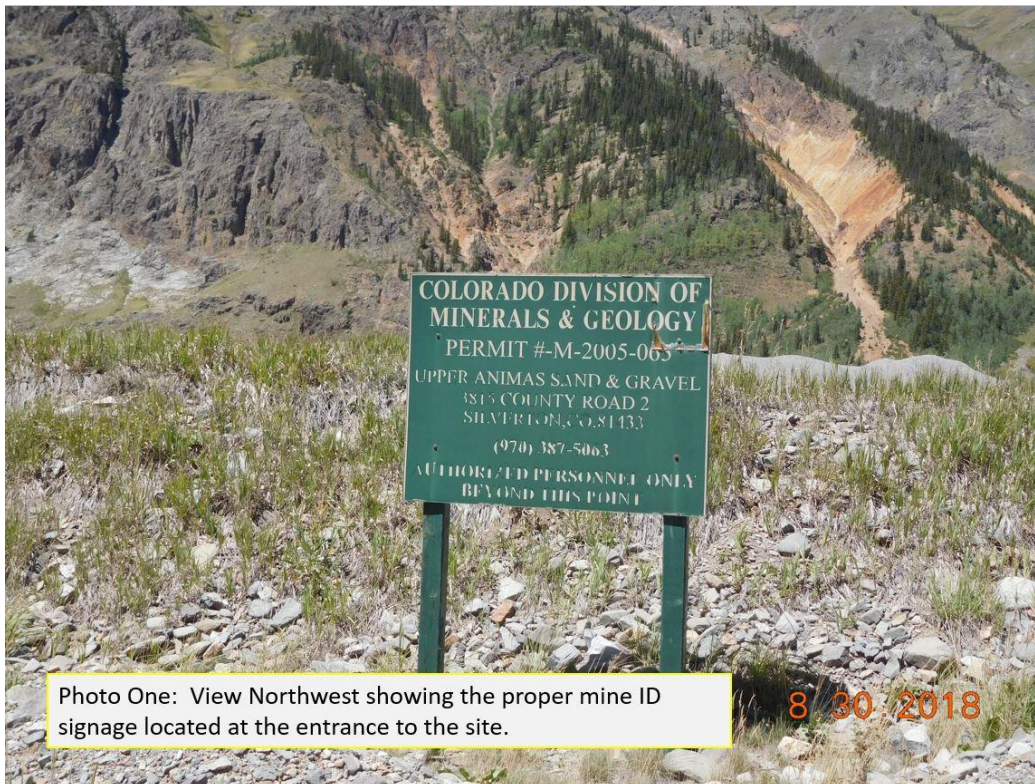
The proper mine identification signage is posted at the entrance to the site and can be seen in Photo One. The permit boundaries are also clearly marked with a combination of T-posts and earthen berms. The active mining area is located within the Pit 1 area. Pit one lies within the active floodplain of the Animas River and will be reclaimed to a developed water resource. The side slopes of the pit appear to be stable, in good condition and are in their final reclamation configuration of 3H: 1V. The southern and western portions of pit 1 have exposed ground water in accordance with the reclamation plan. The majority of the pit floor will continue to be mined until it meets the reclamation depth. Photo Two shows an example of the exposed water as well as the pit floor which is in good condition.

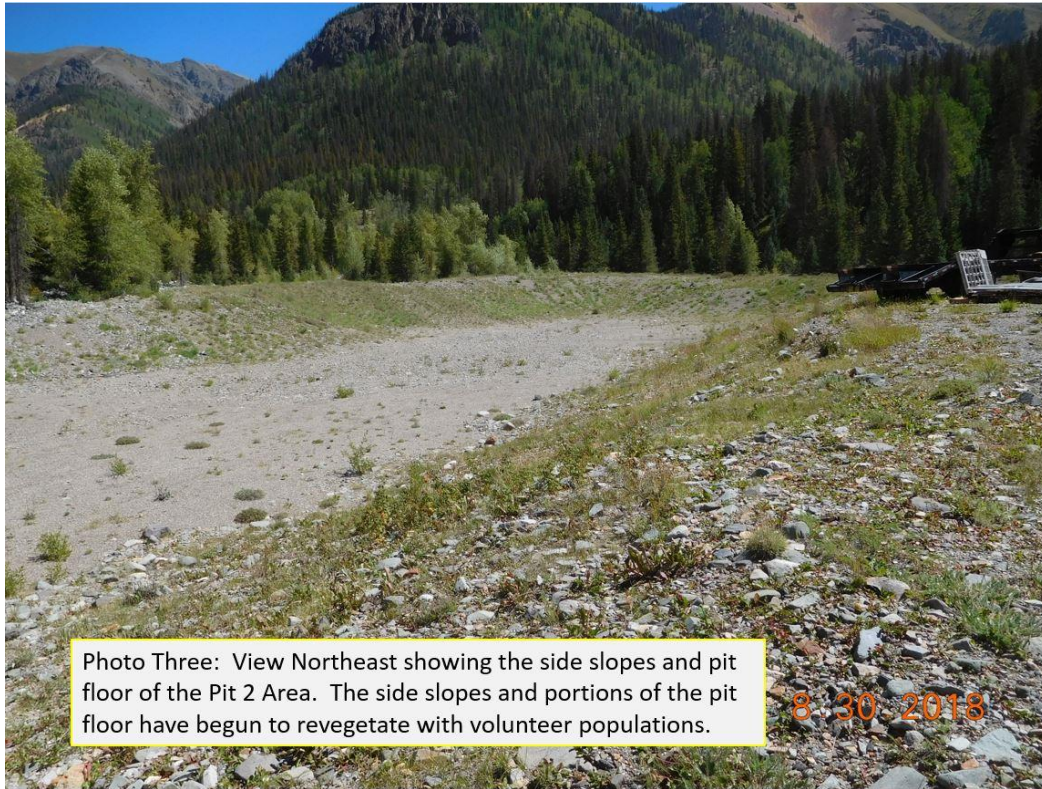
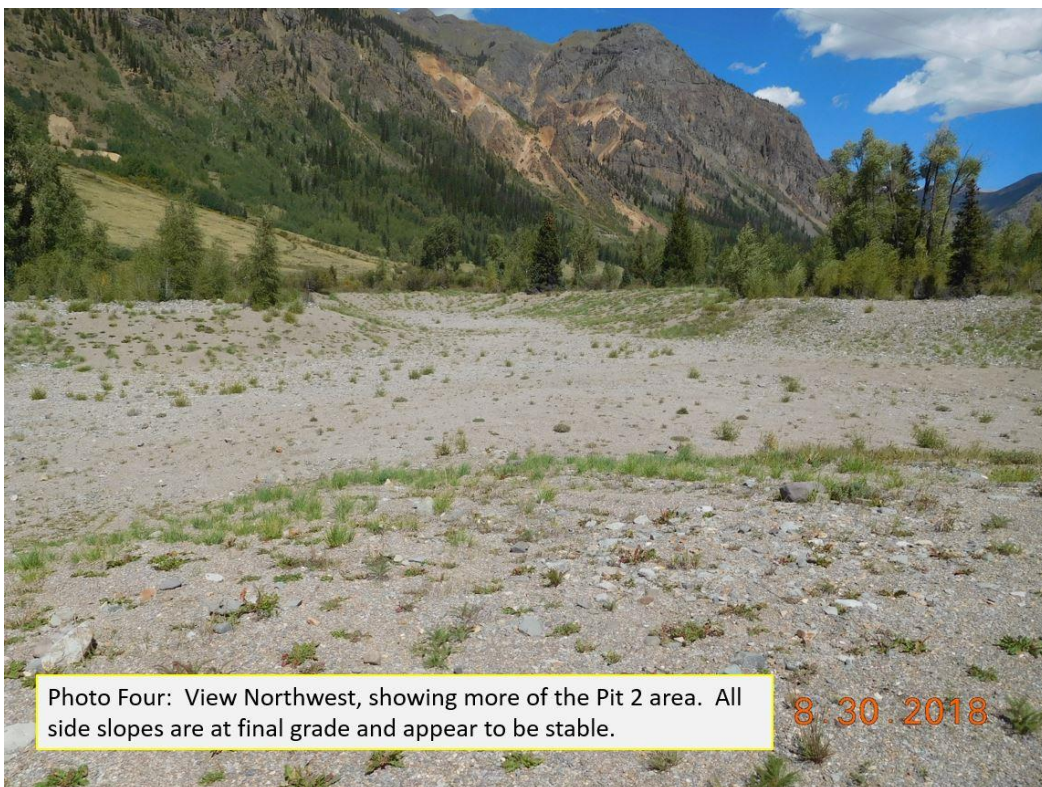
The Pit 2 area appears to be in similar condition as it was the previous inspection. Pit two will be mined to create a developed water resource that is not exposed groundwater but filled using surface waters from Maggie Creek. No water was present in the pit area during the inspection. The side slopes of the Pit 2 area appear to be stable and are at final grade. They are in good condition and have begun to be vegetated with volunteer vegetation species. The Pit 2 area can be seen in Photos Three and Four

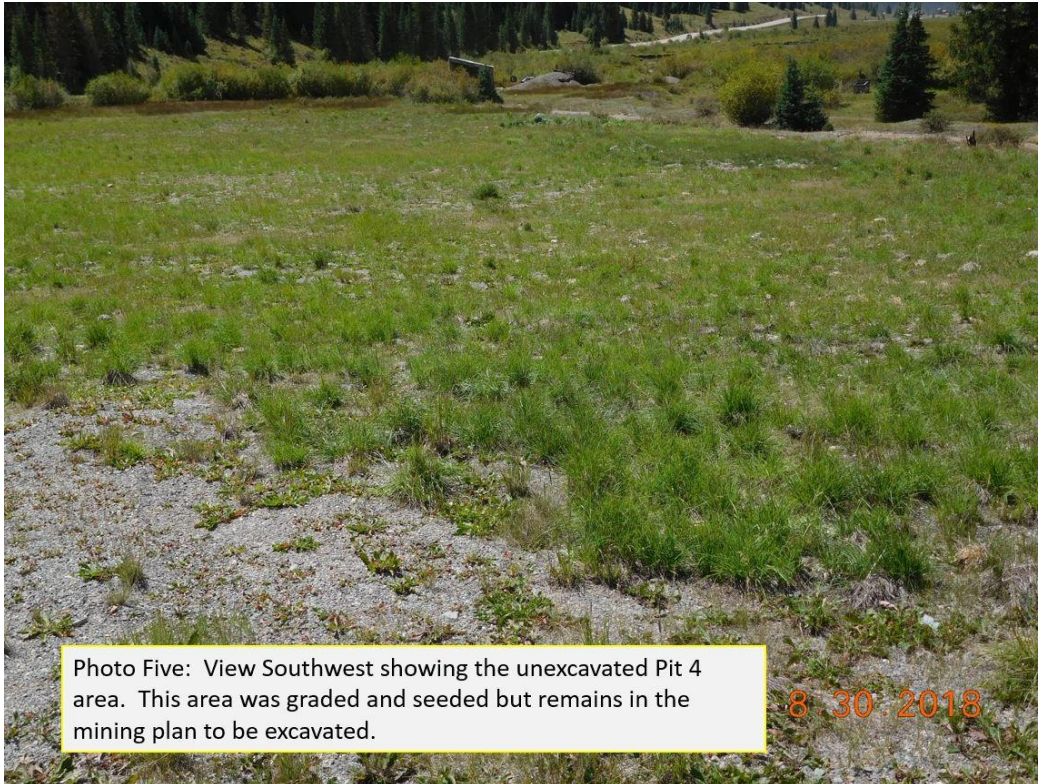
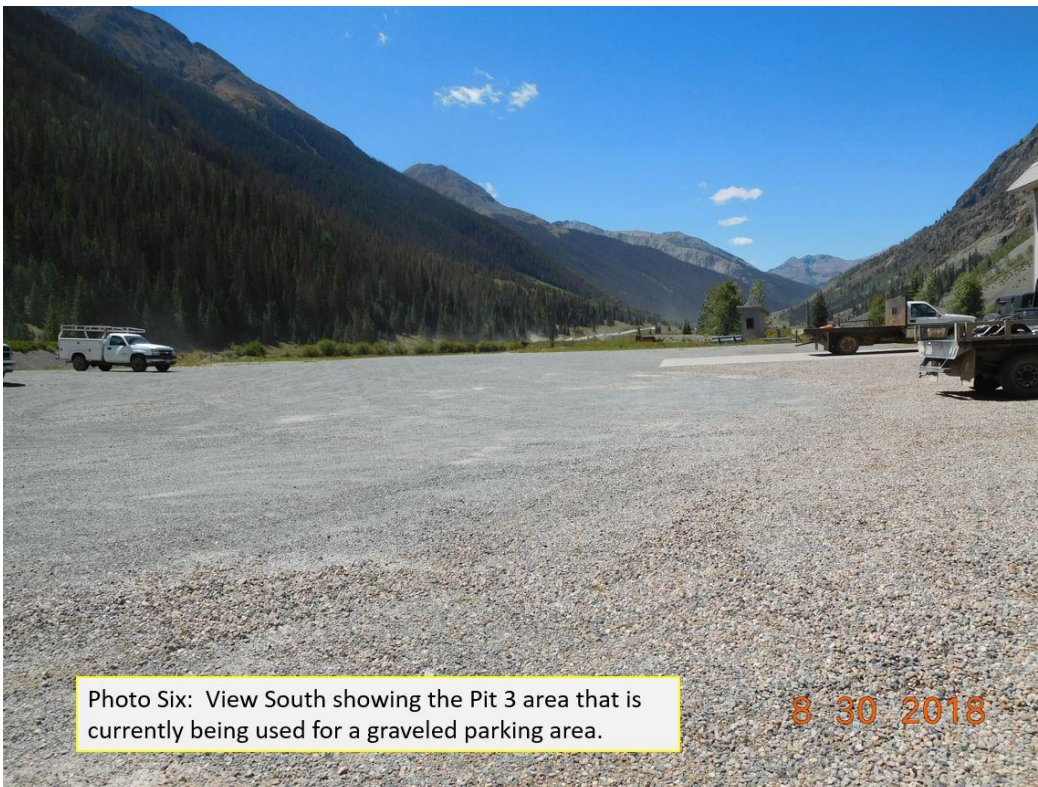
Pits 3 and 4 have not been excavated at this time. The lands have been affected only by material processing and stockpiling activities. A large stockpile of material is located in the main parking area and shows signs of recent hauling activity. Photos Five and Six show the unexcavated areas of Pits 3 and 4.
