# **PERMIT INFORMATION**

Permit Number: C-1981-012 Mine Name: New Elk Mine Operator: New Elk Coal Company, LLC Operator Address: Mr. Louis Head 12250 Highway 12	County: Las Animas Operation Type: Underground Permit Status: Active Ownership: Private  Operator Representative Present:			
Weston, CO 81091	Nick Mason			
Operator Representative Signature: (Field Issuance Only)				
INSPECTION INFORMATION				
Inspection Start Date: September 19, 2018	Inspection Type: Coal Partial Inspection

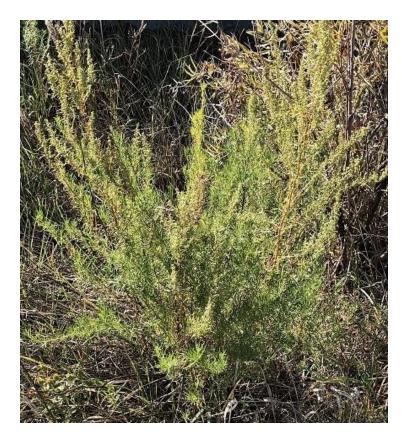
The inspectors also made note of some other plant species that are not on the noxious weed list, nor are these plants in the New Elk Mine seed mix. These included wild licorice near the DWDA#2 and other species that have not been identified at this time. Identification may be easier at another time of the year, and DRMS will plan to closely inspect applicable areas (known to contain these unknown plants) in the spring and fall of 2019.

Photo 1. Common unidentified plant around site

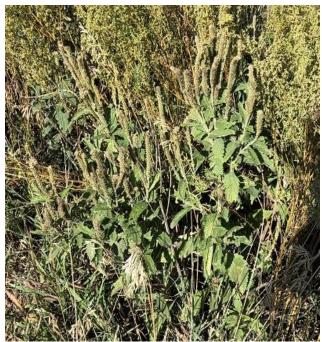
In the area near Containment Area #2, no A List or B List noxious weeds were seen. Some unidentified species were seen.

Photo 2. Unidentified plant near Containment Area #2

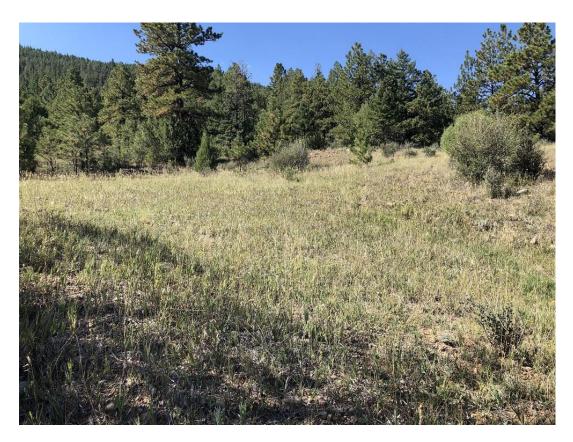
In the SAEs near the Allen Mine rail slope and near the West Fan, no weeds or other problems were seen.

Photo 4. SAE near Allen Mine portal

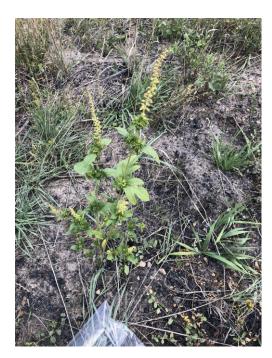
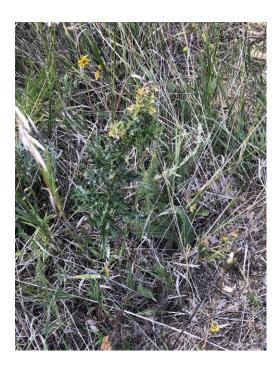
In the area near Containment Area #1, no A List or B List noxious weeds were seen. Some unidentified species were seen.

In the area near the slurry injection system, a small thistle was seen.

Photos 5.and 6. Unidentified plant near Containment Area #1 (left) and thistle by slurry injection system (right)

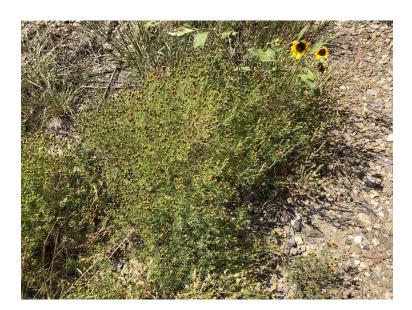
In the area around Ponds 006A and 007A, many of the same unknown species were seen as in other areas. No A List or B List noxious weeds were identified.

Photo 7. Unidentified plant near Pond 007A

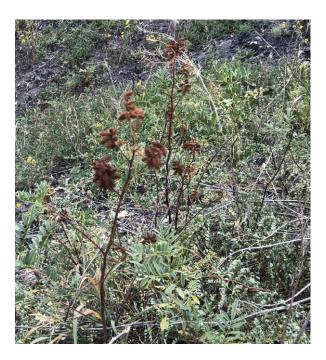
At the west end of the side of DWDA#2 by the river, wild licorice was seen, but no A List or B List noxious weeds were seen. (The east side of the pile was not inspected at this time.)

Photo 8. Wild licorice

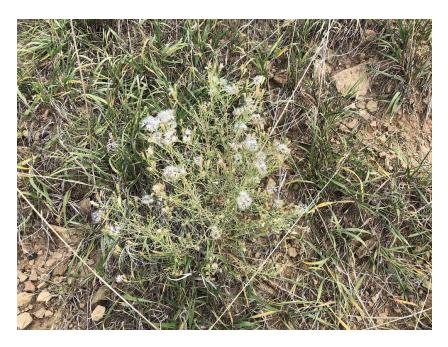
On the west side of the reclaimed Development Coal Waste Pile, on the river side and on the highway side, no A List or B List noxious weeds were seen. (The east side of the pile was not inspected at this time.) The following unidentified species was seen.

Photo 9. Unidentified plant near Development Coal Waste Pile

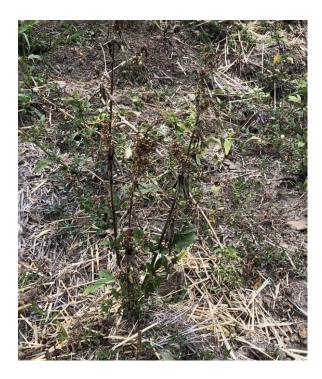
At the Northwest Air Shaft (formerly part of the Golden Eagle permit) no A List or B List noxious weeds were seen. The following unidentified species was seen.

Photo 10. Unidentified plant at Northwest Air Shaft

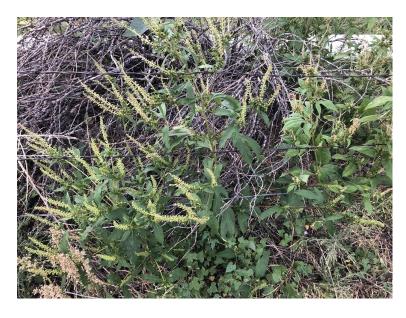
At the Jansen Loadout, Mullein, cheat grass and kochia were seen. Kochia is not a noxious weed, and it is not in the New Elk seed mix. The following unidentified species was seen.

Photo 11. Unidentified plant at Jansen Loadout
