MINERALS PROGRAM INSPECTION REPORT PHONE: (303) 866-3567

MINE/PROSPECTING ID#:	MINERAL:	COUNTY:
	M-2018-039	Aggregate	Larimer
INSPECTION TYPE:		INSP. DATE:	INSP. TIME:
	Jared L. Ebert	September 19, 2018	10:00
	OPERATOR REPRESENTATIVE:	TYPE OF OPERATION:	
	Richard Raines, Tri-Districts	112c - Construction Regular Operation	
REASON FOR INSPECTION:		BOND AMOUNT:	
	None	No Bond Held	
	POST INSP. CONTACTS:	JOINT INSP. AGENCY:	
	None	None	
INSPECTOR'S SIGNATURE:		SIGNATURE DAT	E:
Jane Ebox		September 25, 2018	
		M-2018-039 INSPECTOR(S): Jared L. Ebert OPERATOR REPRESENTATIVE: Richard Raines, Tri-Districts BOND CALCULATION TYPE: None POST INSP. CONTACTS: None INSPECTOR'S SIGNATURE:	M-2018-039 INSPECTOR(S): Jared L. Ebert

This was a pre-operation inspection of the Lamb Lakes site, Division of Reclamation Mining and Safety (DRMS or Division) application number M-2018-039. The applicant for the proposed operation is North Weld County Water District. Mr. Richard Rains with the Tri-districts and Bill Schenderlein with Blue Earth Solutions, LLC. a consultant for the applicant accompanied me during the inspection.

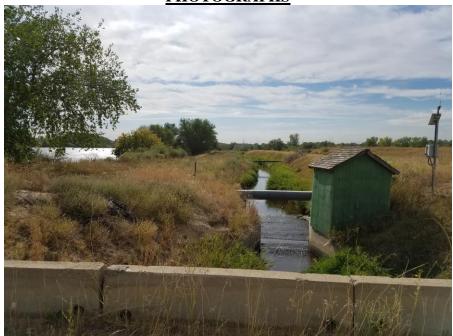
The Author Ditch is located along the west and south side of the Lamb Lakes. This ditch was flowing at the time of the inspection and it appears to be un-lined. During the inspection we drove around each of the three existing pits. The slopes above the water line for each of the pits varied over the landscape but overall appeared to be graded to a 3H:1V ratio and were stable. The pit slopes were stabilized with grasses and forbs. Also, many trees and shrubs have established around the pits. The trees primarily consisted of cottonwoods, elms and Russian olives. Willow bushes where abundantly established around the pits.

Figure 1. Arthur Ditch, from the northwest corner of Lamb A looking south.

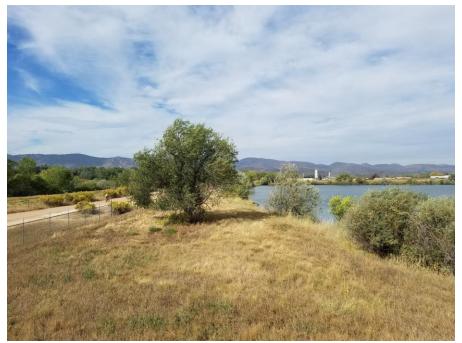
Figure 2. From the southeast corner of Lamb A pit looking west.

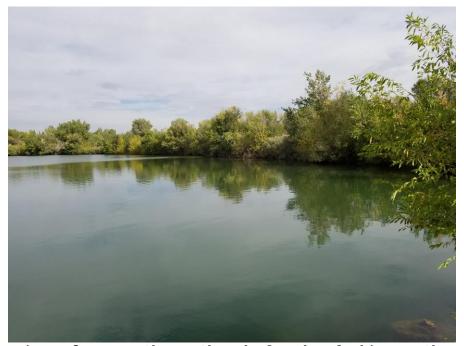
Figure 3. From the south end of Lamb A looking north.

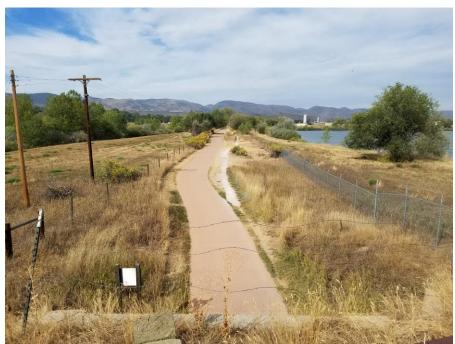
Figure 4. Poudre Trail bisecting Lamb A and Lamb B pits. From the east end of the site looking west.

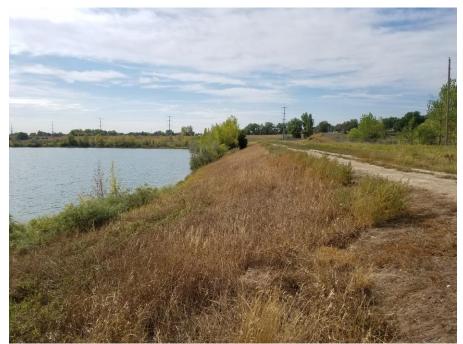
Figure 5. From the northeast corner of Lamb B looking west.

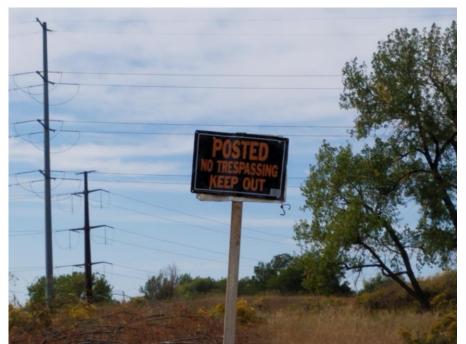
The structures identified on the Exhibit C map appears to be accurate. The only structure observed that was not depicted on the Exhibit C map was a culvert that was observed at the southwest corner of the Lamb C pit. This culvert was below the water surface and protrudes into the pit. We could not locate where the other end of the culvert daylights as the southern end of the site is fenced off. A two track trail allows access around each of the pits. At various points around the site social trails were observed leading into the site. At many of these points "No Trespassing" signs have been posted.

Figure 6. No trespassing sign on the west side of the site.

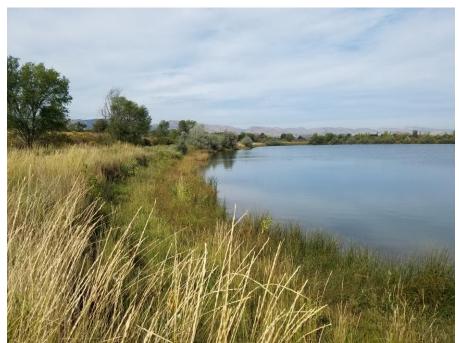
Figure 7. From the southwest end of Lamb C looking north.
