RE: Swan River Restoration Project: As-Built & One-Year Monitoring Report (SPK-2015-00780)

Monitoring Report – Swan River Restoration Project
Summit County, Colorado
As-Built & One-Year Monitoring

i. Project Overview	
1. USACE #	#SPK-2015-00780
2. Permittee	Summit County Open Space and Trails (0037 Peak One Drive, Frisco, Colorado 80443) Jason Lederer, Senior Resource Specialist (jason.lederer@SummitCountyCO.gov)
Monitoring By:	Summit County Open Space and Trails (OST) - Jason Lederer, Senior Resource Specialist (720) 467-8589 (<i>Jason.Lederer@SummitCountyCO.gov</i>) Ecological Resource Consultants Inc. (ERC) – Troy Thompson (303) 679-4820 (<i>Troy@ERCColorado.net</i>)

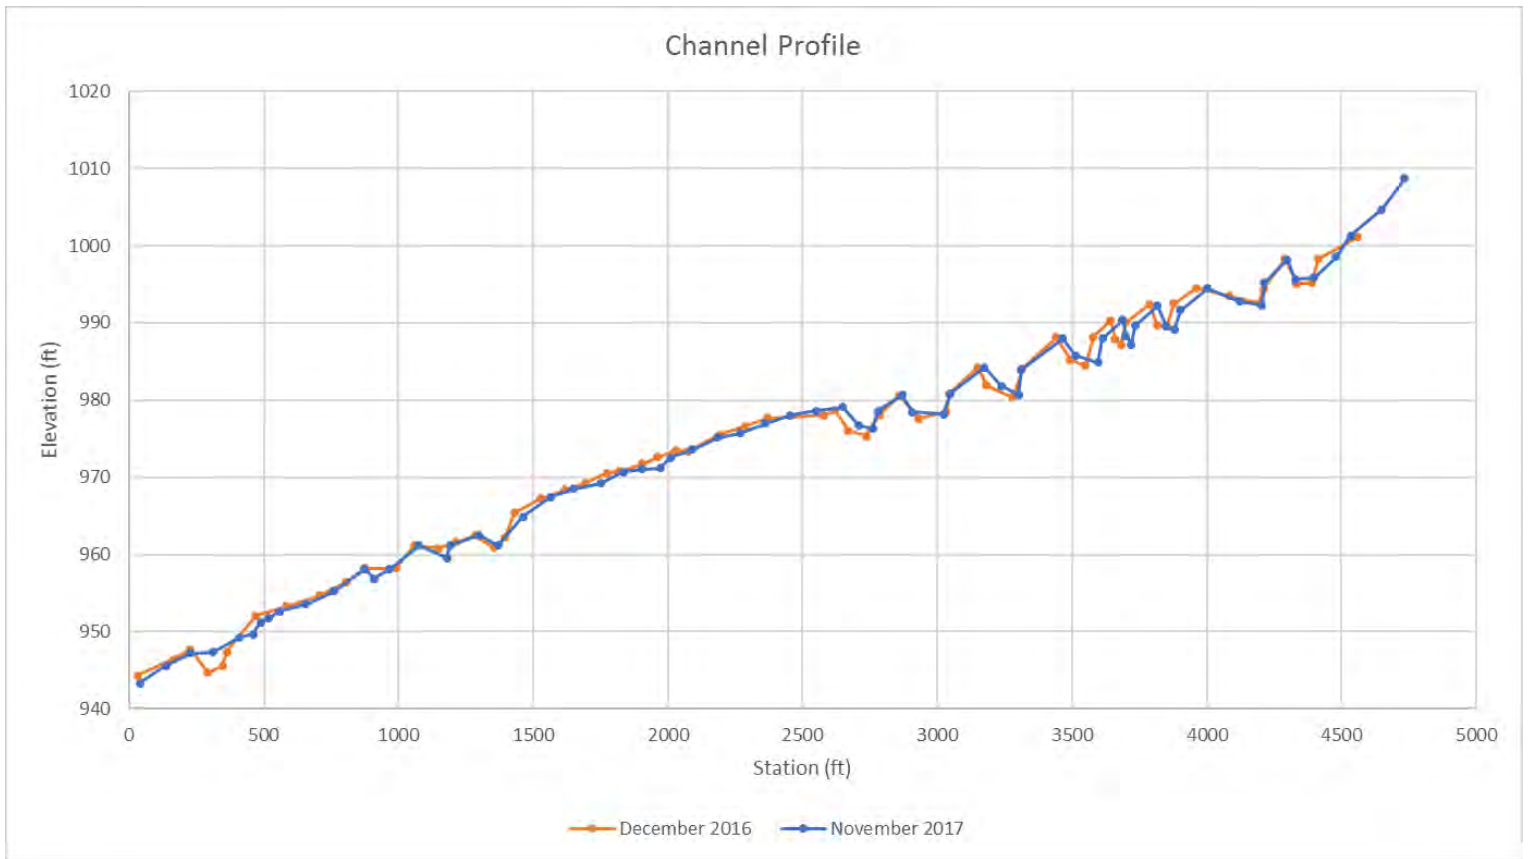
Parameter 1. Channel Profile Survey (As-built & One-Year)

6. Slight difference in the horizontal location (station) of some of the features occur towards the upstream end of the project in the vicinity of Station 26+00 to 40+00 where the 2017 data points are shifted slightly to the left (downstream) of the 2016 data points. We believe that this is attributed to slight difference in the GPS reading accuracies between the 2016 and 2017 monitoring events. Adjusting for these likely GPS accuracies, the stream has retained its constructed profile at one year of flows.

9. Parameter 1: Channel Profile Results - Results of the 2016 and 2017 as-built and 1-year channel profile surveys are presented in the Channel Profile graph, as well as in Tables 1 and 2 (see Appendix A). The channel profile was constructed to form distinct varying slopes creating the primary habitat features of riffles, pools, glides, and general bedform diversity. The as-built condition was implemented per plan with minor deviations and will be evaluated and compared in the future.

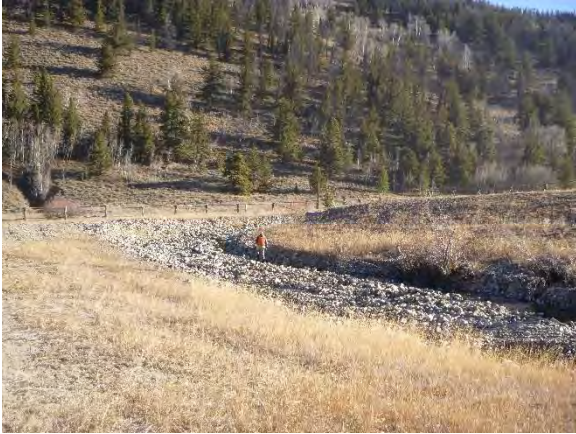
Photo 1. View of upstream end of channel from left bank looking northeast.

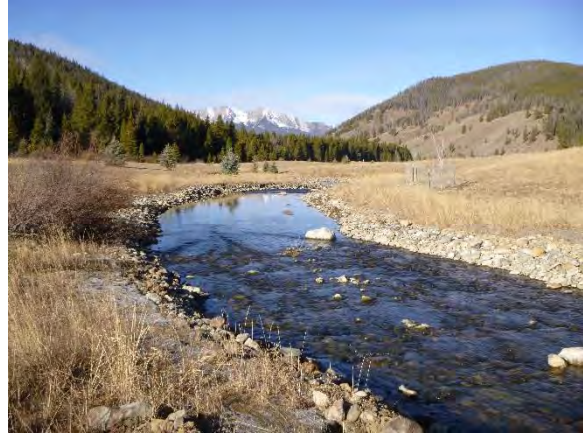
Photo 2. View of channel looking west from right bank at approximately STA 39+05.

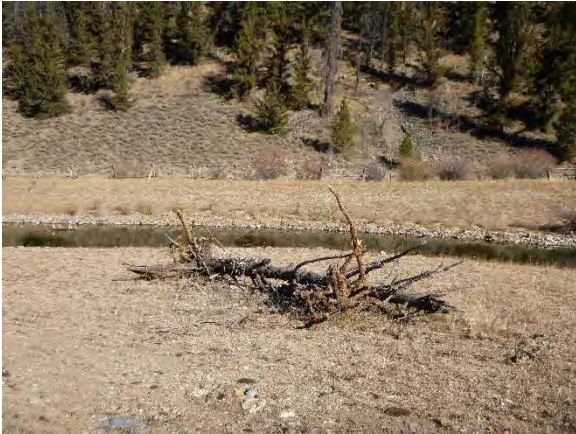
Photo 3. View of channel looking north from right bank at approximately STA 34+00.

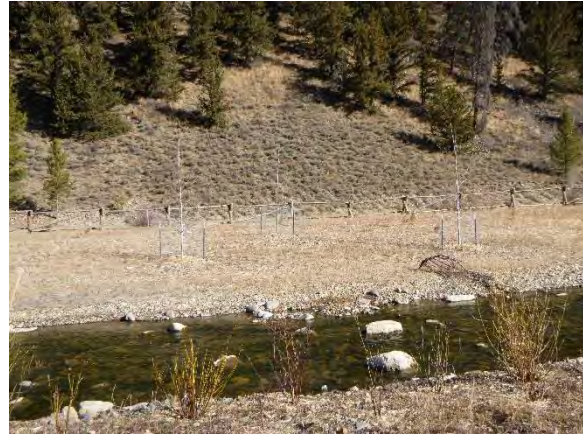
Photo 4. View of channel looking north from right bank at approximately STA 25+00.

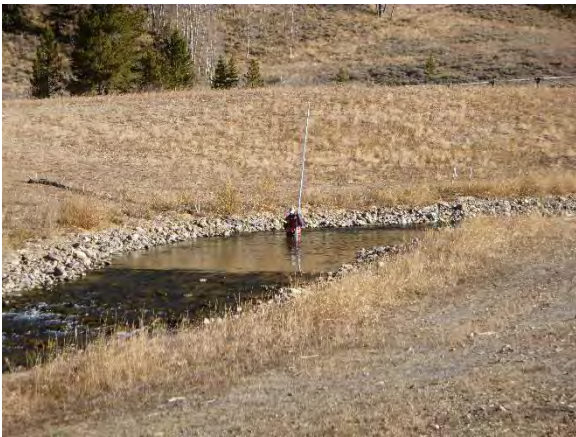
Photo 5. View of channel looking northeast from right bank at approximately STA 13+00

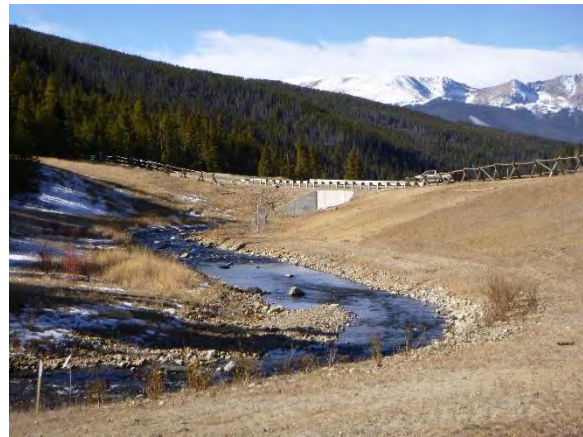
Photo 6. View of channel looking west from left bank at approximately STA 10+50

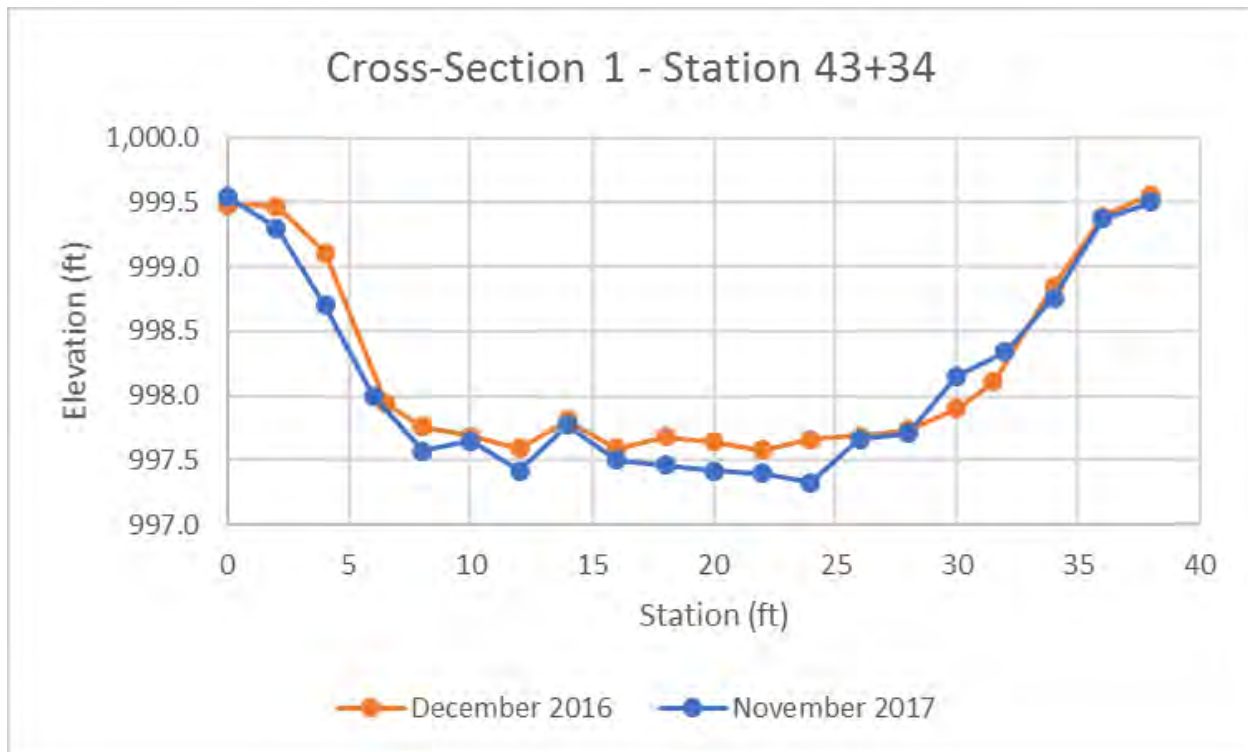
Parameter 2. Channel Cross-Section Survey (As-built & One-Year)

Cross-section graph includes top of rebar elevation control on either side.

10. Parameter 2: Channel Cross-section Results – Results of the 2016 and 2017 as-built and 1-year channel cross-section surveys are presented in Cross-section Graphs 1 – 4 and Tables 3 – 10 (see Appendix A). The channel cross-section was constructed along the entire project reach to form a district and varying cross-section. The as-built condition was implemented per plan with minor deviations and will be evaluated and compared in the future.

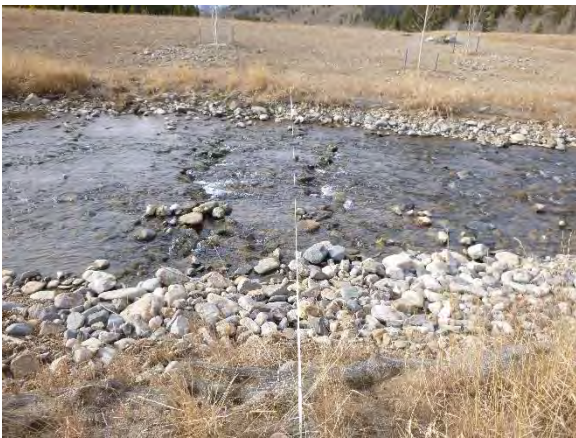
Photo 7. View from right bank looking east towards the right bank at Cross Section 1 (XS-1).

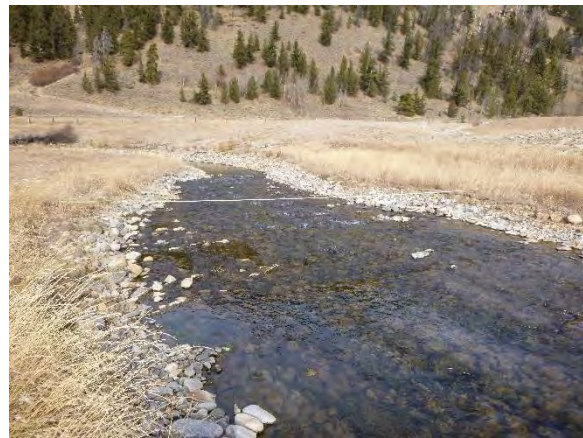
Photo 8. View looking downstream from the right bank at XS-1.

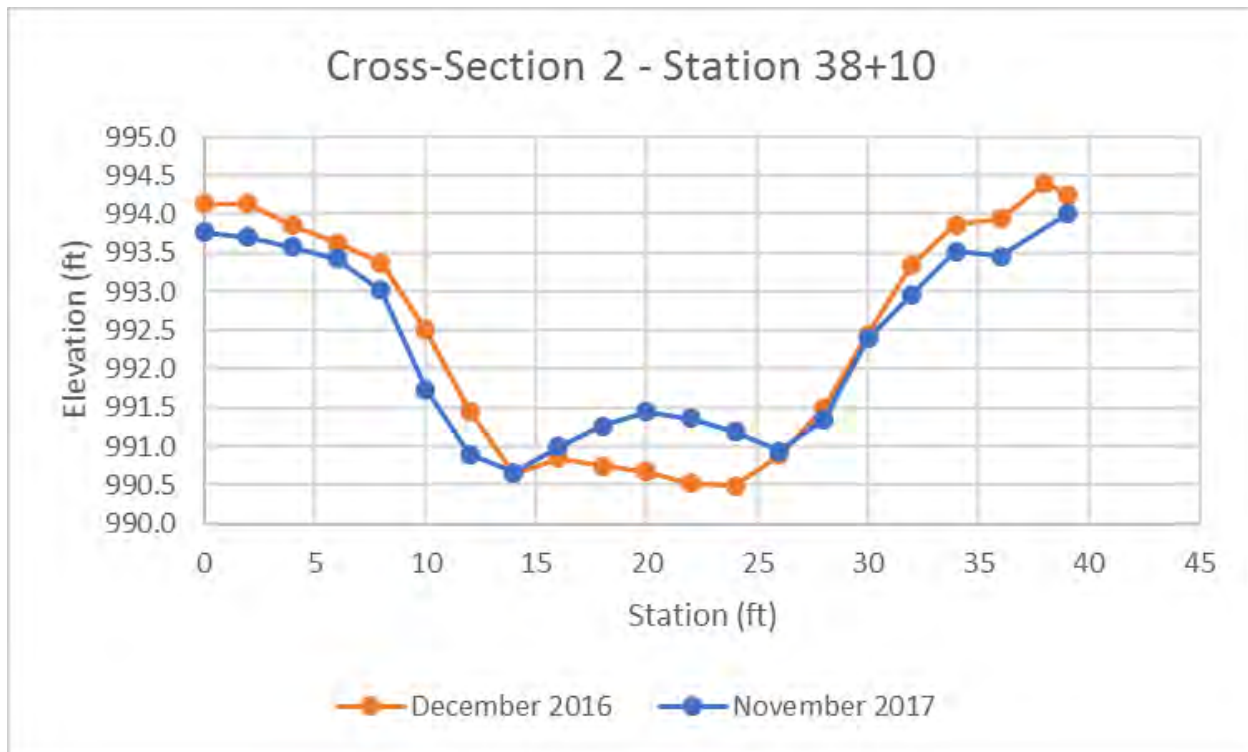
Parameter 2. Channel Cross-Section Survey (As-built & One-Year)

Cross-section graph includes top of rebar elevation control on either side.

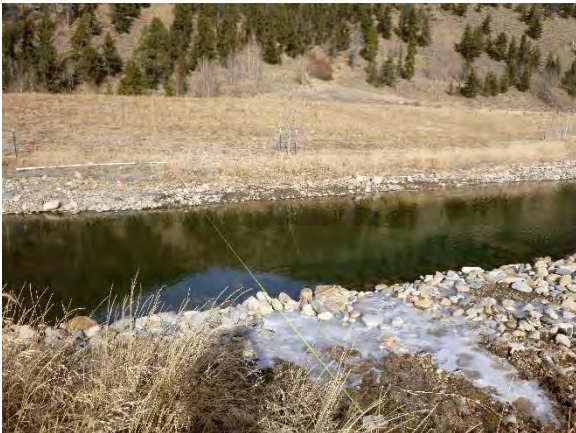
Photo 9. View from the right bank looking north towards the left bank at Cross Section 2 (XS-2).

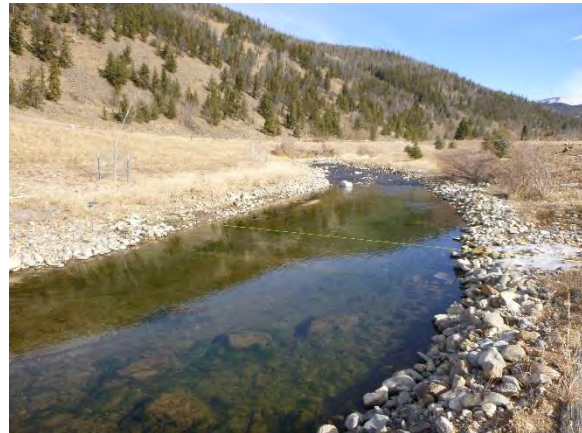
Photo 10. View looking upstream from the right bank at XS-2.

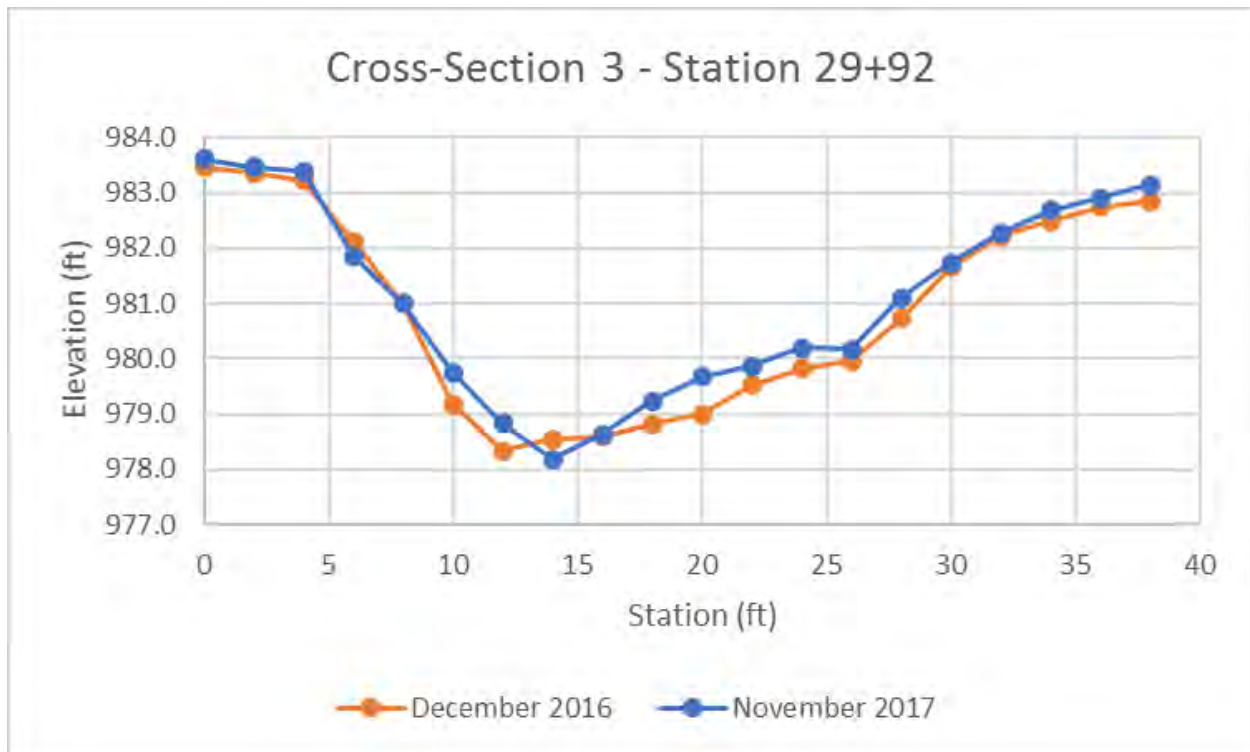
Parameter 2. Channel Cross-Section Survey (As-built & One-Year)

Cross-section graph includes top of rebar elevation control on either side.

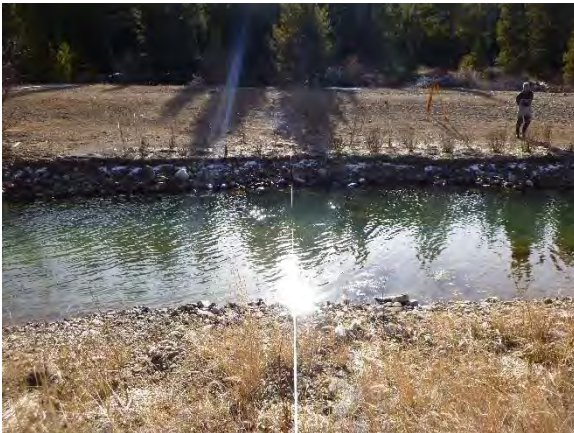
Photo 11. View from the left bank looking north towards the right bank at Cross Section 3 (XS-3).

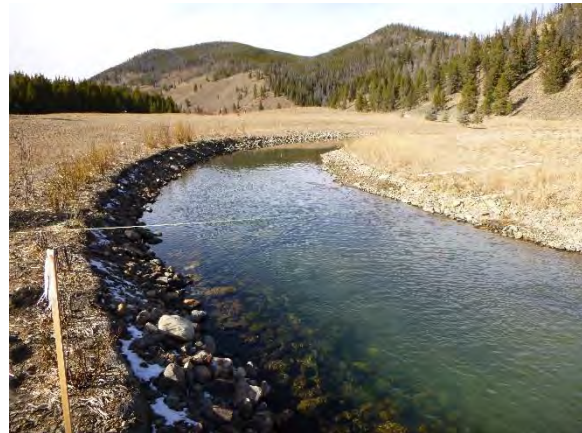
Photo 12. View looking downstream from the right bank at XS-3.

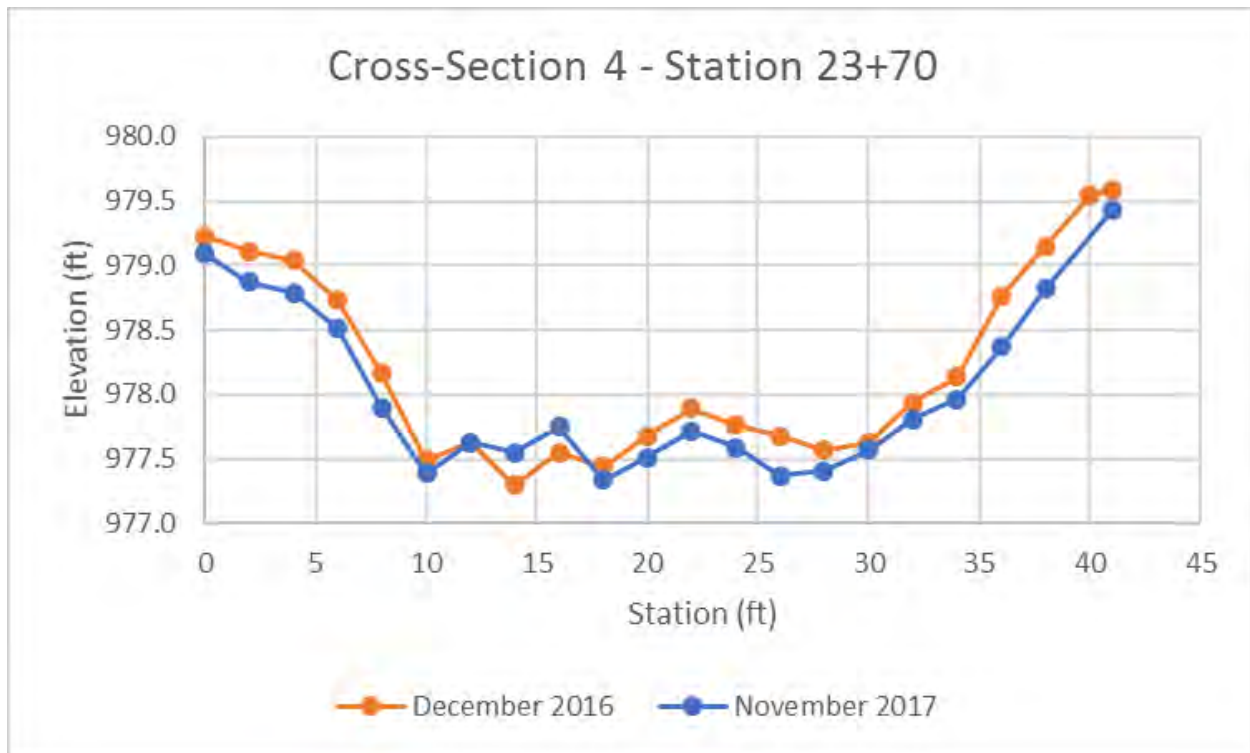
Parameter 2. Channel Cross-Section Survey (As-built & One-Year)

Cross-section graph includes top of rebar elevation control on either side.

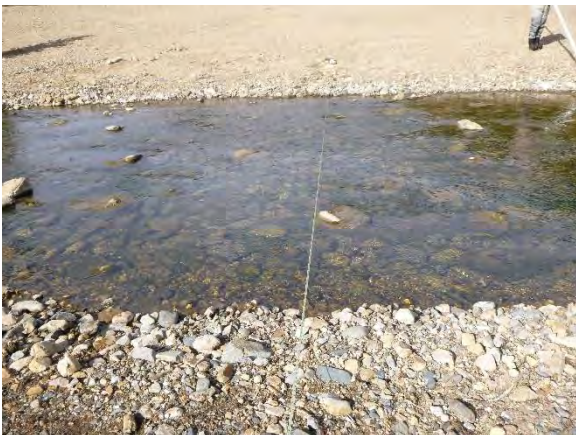
Photo 13. View from the right bank looking northwest towards the left bank at Cross Section 4 (XS-4).

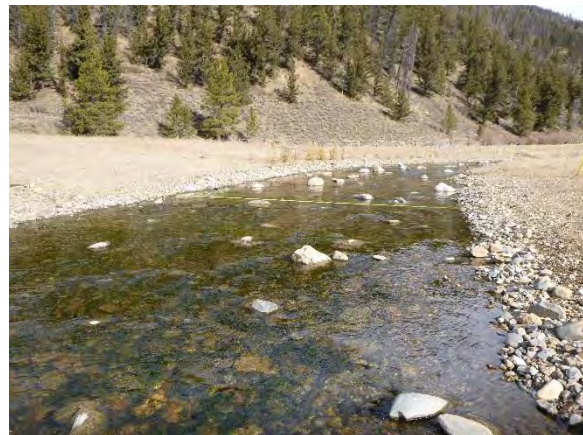
Photo 14. View looking upstream from the left bank at XS-4.
