MINERALS PROGRAM INSPECTION REPORT
PHONE: (303) 866-3567

MINE NAME: Henderson Mine	MINE/PROSPECTING ID#: M-1977-342	MINERAL: Molybdenum	COUNTY: Clear Creek, Grand
INSPECTION TYPE: Monitoring	INSPECTOR(S): Peter S. Hays	INSP. DATE: September 27, 2018	INSP. TIME: 09:00
OPERATOR: Climax Molybdenum Company	OPERATOR REPRESENTATIVE: Geoff Niggeler, Aaron Hilshorst, Amber Parmet	TYPE OF OPERATION: 112d-3 - Designated Mining Operation	
REASON FOR INSPECTION: Normal I&E Program	BOND CALCULATION TYPE: None	BOND AMOUNT: \$37,993,785.00	
DATE OF COMPLAINT: NA	POST INSP. CONTACTS: None	JOINT INSP. AGENCY: None	
WEATHER: Clear	INSPECTOR'S SIGNATURE:

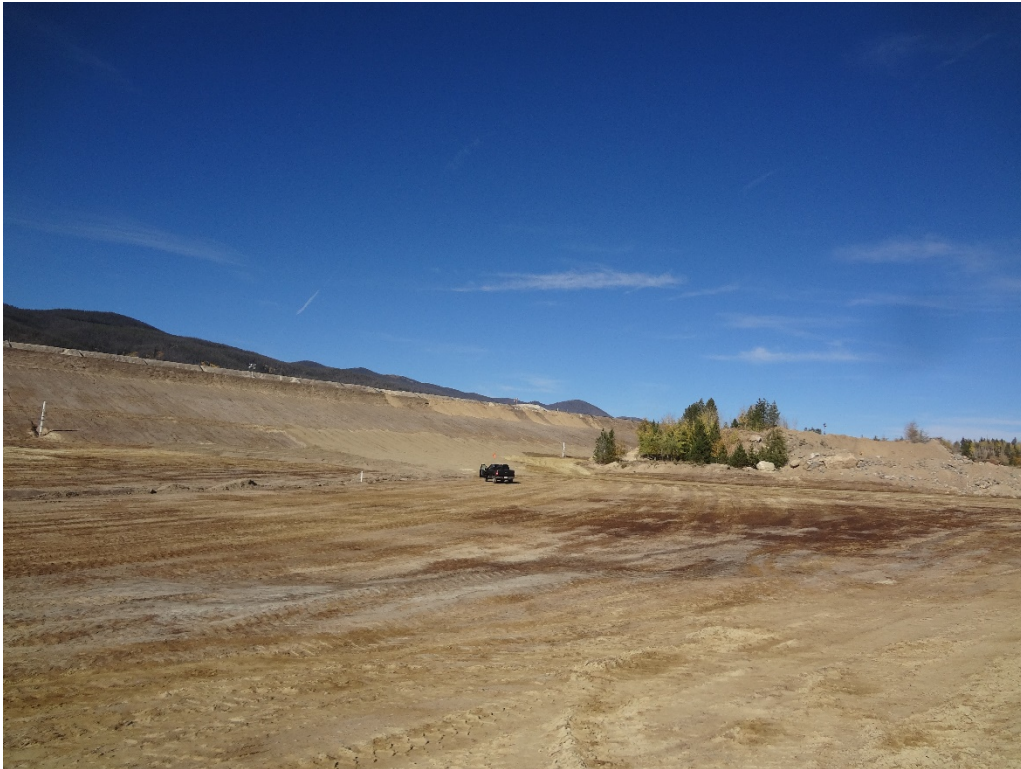
The 3-Dam Buttress Project - Stage 1 was approved by the Division under TR-29 on April 4, 2018. The placement of filter sand on the stepback area has continued since the previous inspection and was approaching the southern extent planned for 2018. The filter sand was placed in two (2), nine (9) inches lifts for a total depth of 1.5 feet.

The tailings material on the setback area was placed and compacted in 1 foot lifts. Compaction was achieved by the haul trucks, a smooth drum roller and verified by AECOM with nuclear density tests every lift. The tailings sand is required to be compacted to 95% maximum density with a moisture content within a range of the optimal moisture. The delivery of the sand by haul trucks and placement with a GPS controlled dozer were observed during the inspection. The tailings material is being placed from north to south. The start of the three benches are established in the northern portion of the stepback. Tailings material placement was continuing passed the natural feature in the middle of the stepback into the southern portion of the stepback during the inspection. The finish grading of the toe buttress areas were not complete and appeared unchanged since the previous inspection. Henderson staff stated the grading would be completed at the end of the field season this year.

View of filter sand and tailings sand placement on north 3-Dam stepback looking northwest

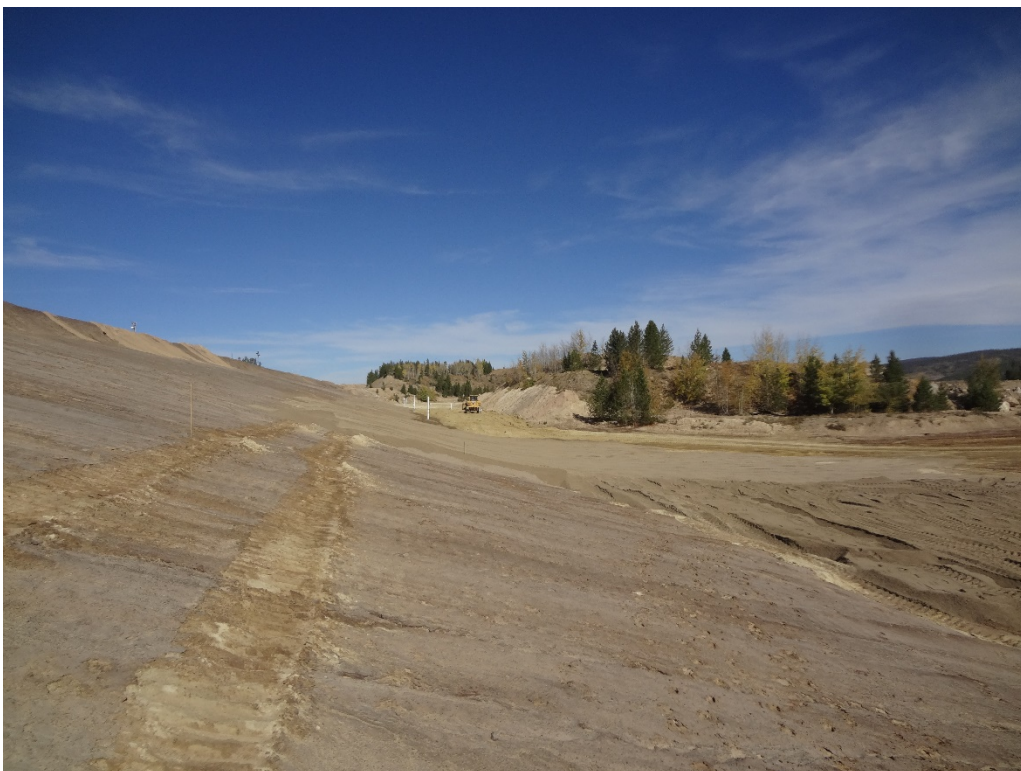
View of filter sand and tailings sand placement on north 3-Dam stepback looking north

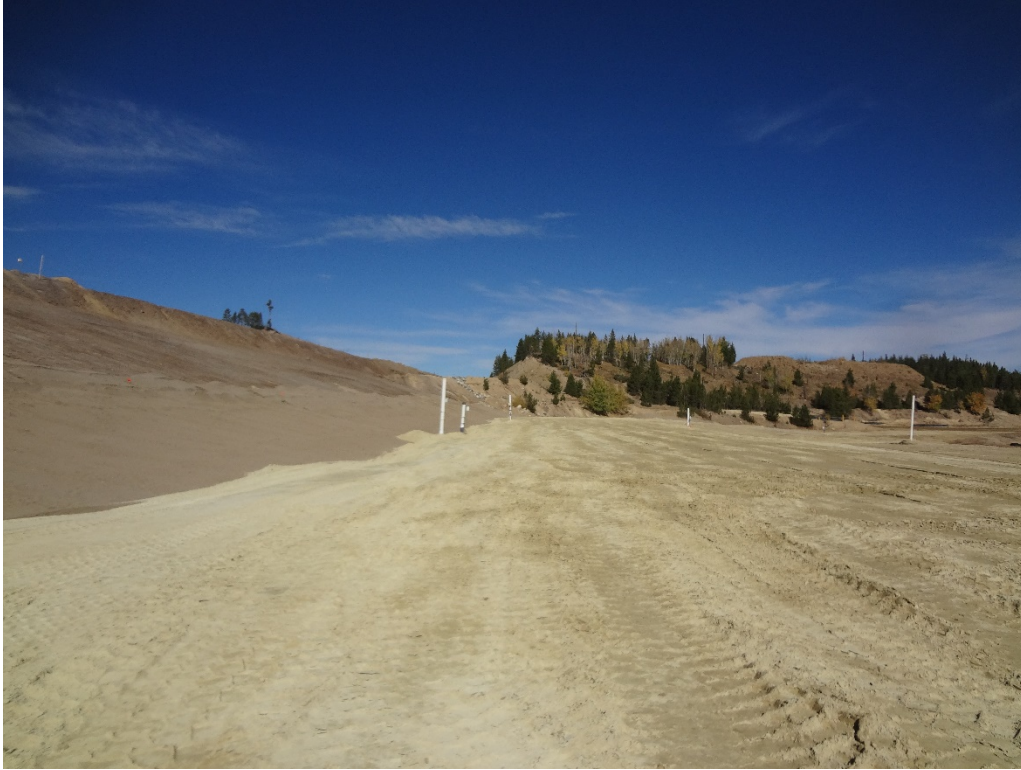
View of placed filter sand and tailings sand on south 3-Dam stepback looking north

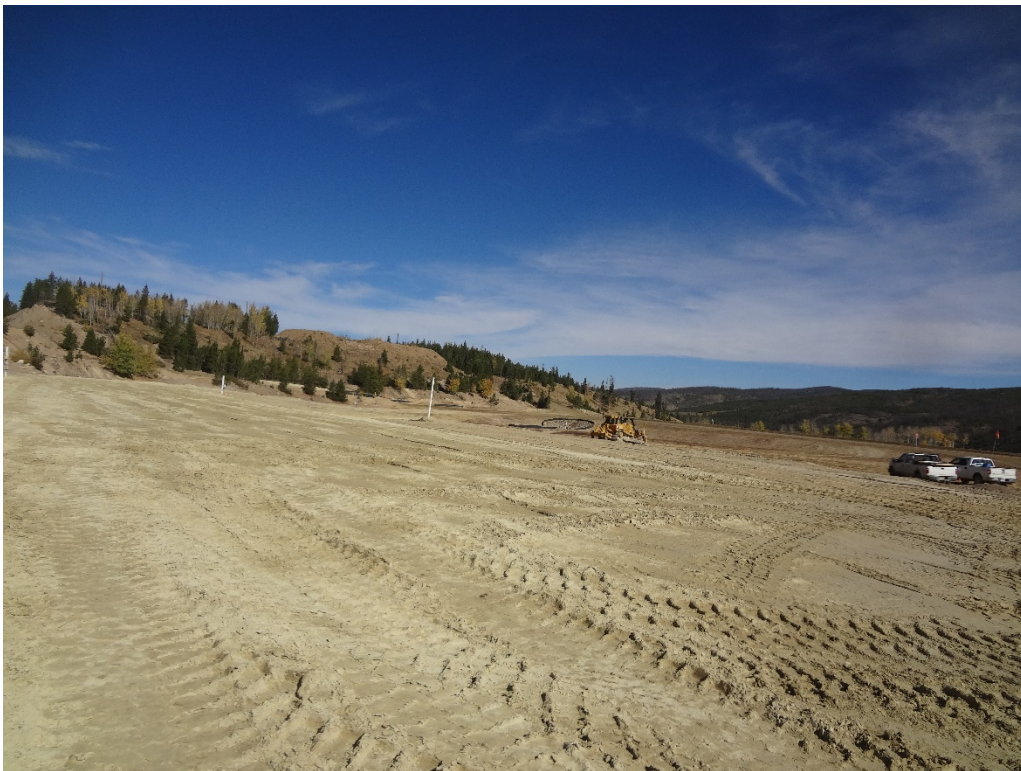
View of placed filter sand and tailings sand on south 3-Dam stepback looking northeast

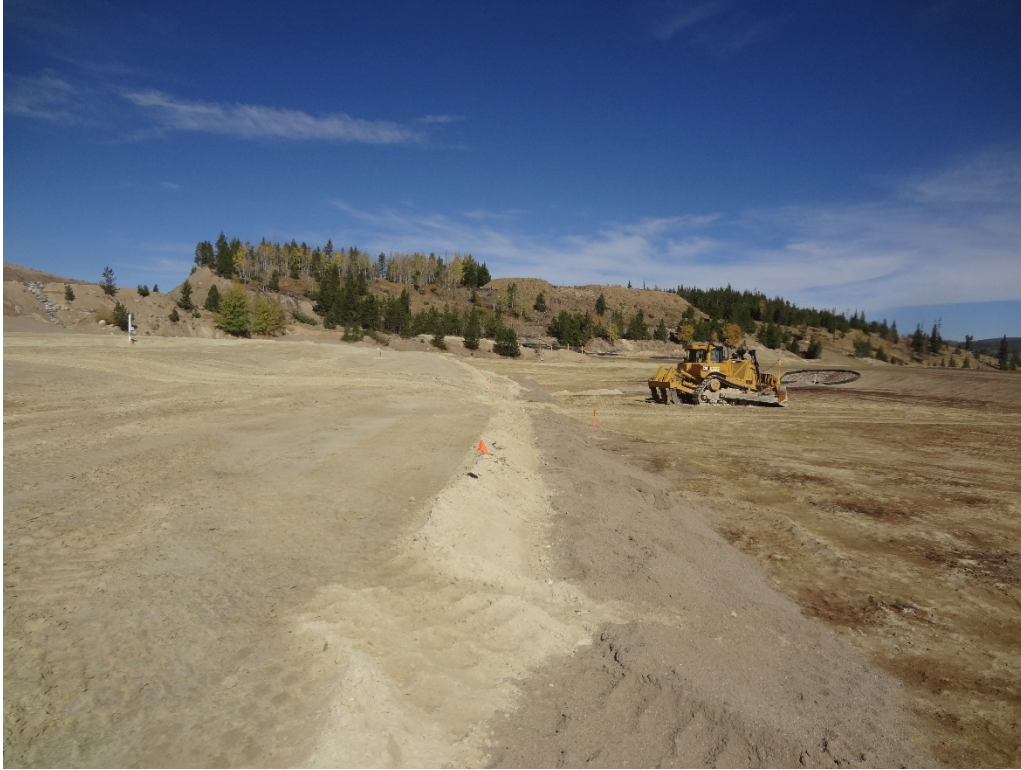
View of placed filter sand and tailings sand on south 3-Dam stepback looking north at toe

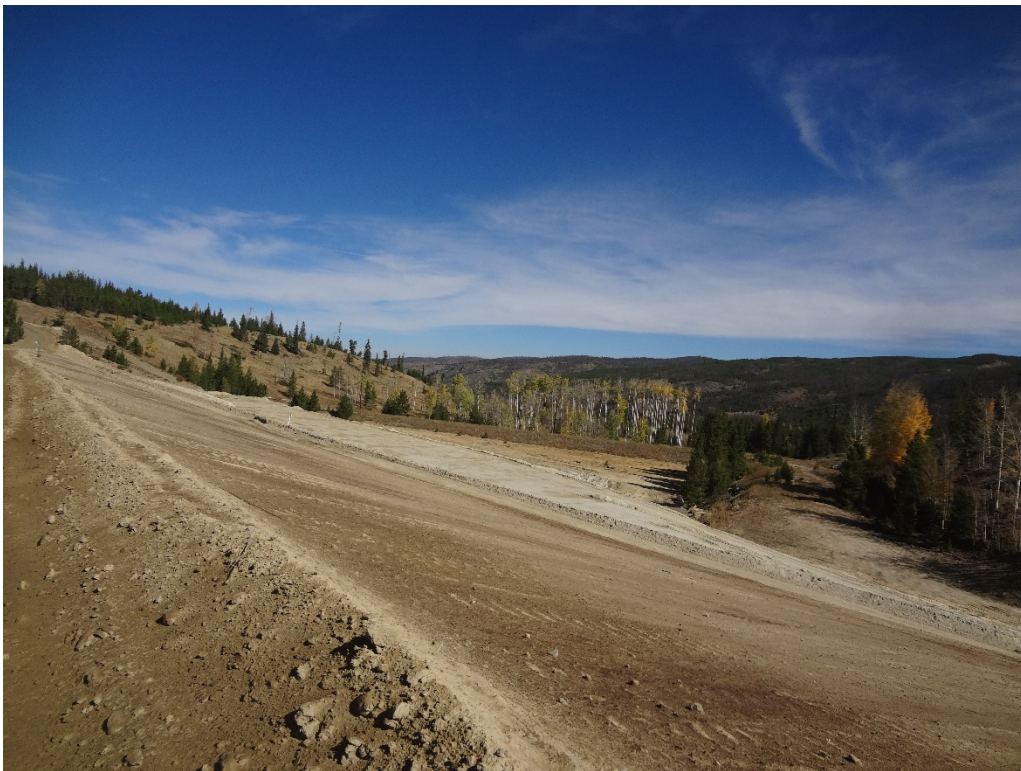
View of the north 3-Dam toe buttress

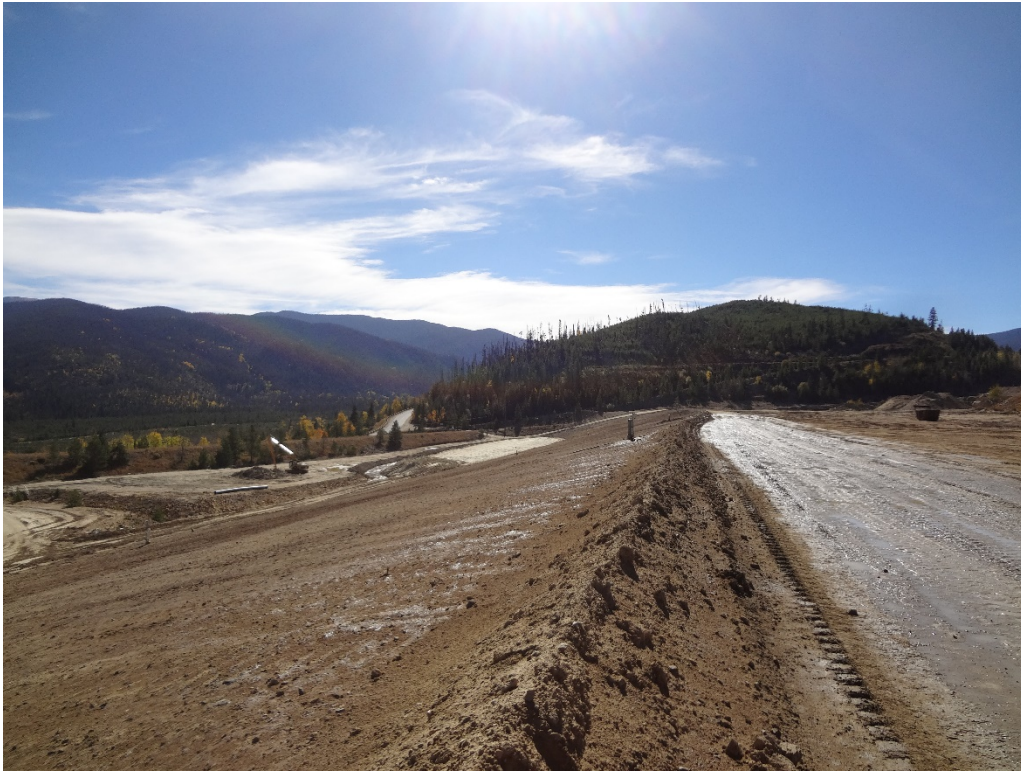
View of the south 3-Dam toe buttress

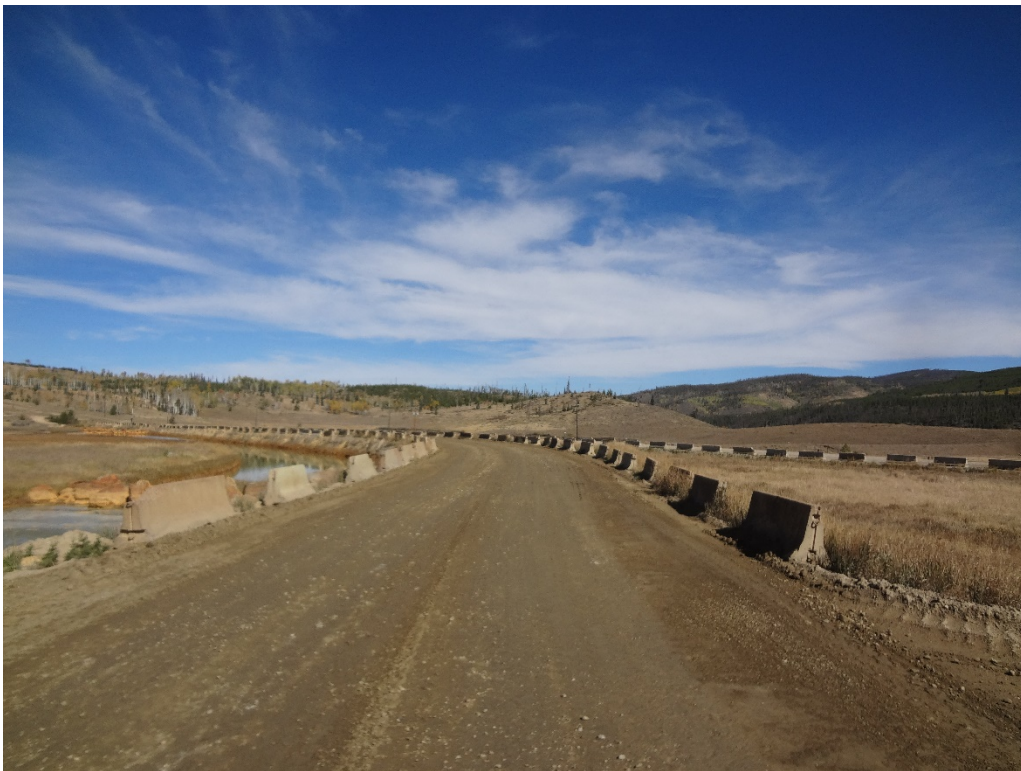
The proposed seep road project was observed and discussed from the south to north ends of the access road including; the north and south feeder channel culverts, the north and south inlet gate structures and the seep water diesel pump system. The decision date for the technical revision is October 22, 2018. Henderson staff indicated the project is scheduled to begin in a few weeks. The Division's decision letter will be sent under separate cover.

View of seep road from south end looking north

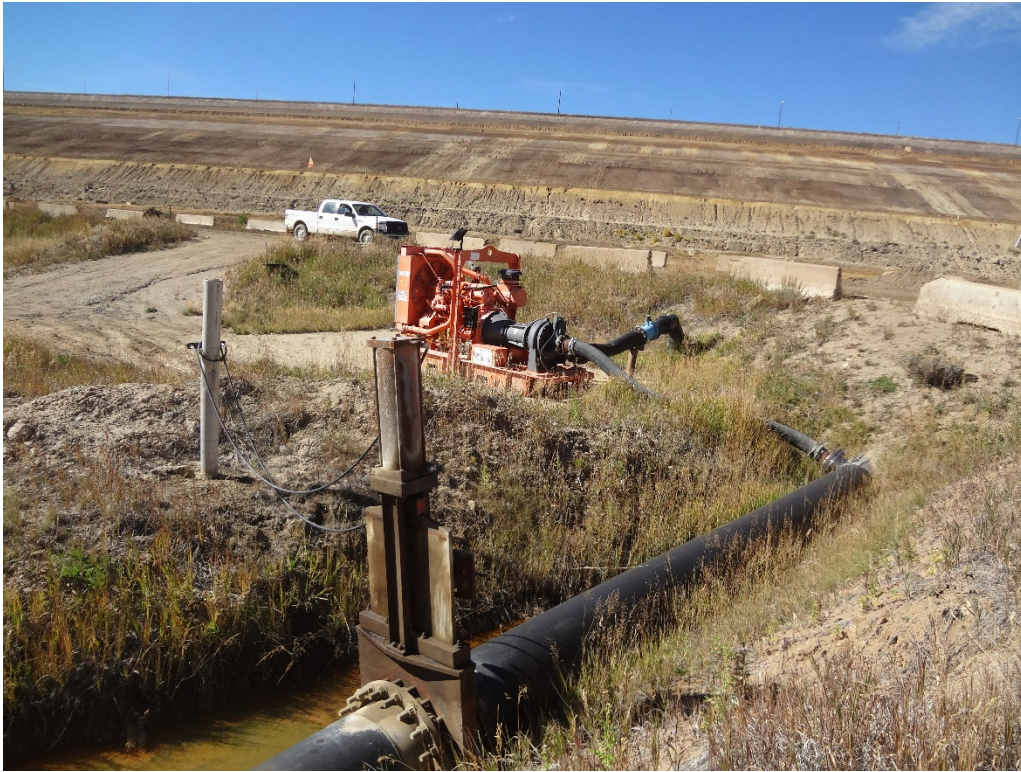
View of the south feeder channel outlet pipe and diesel pump

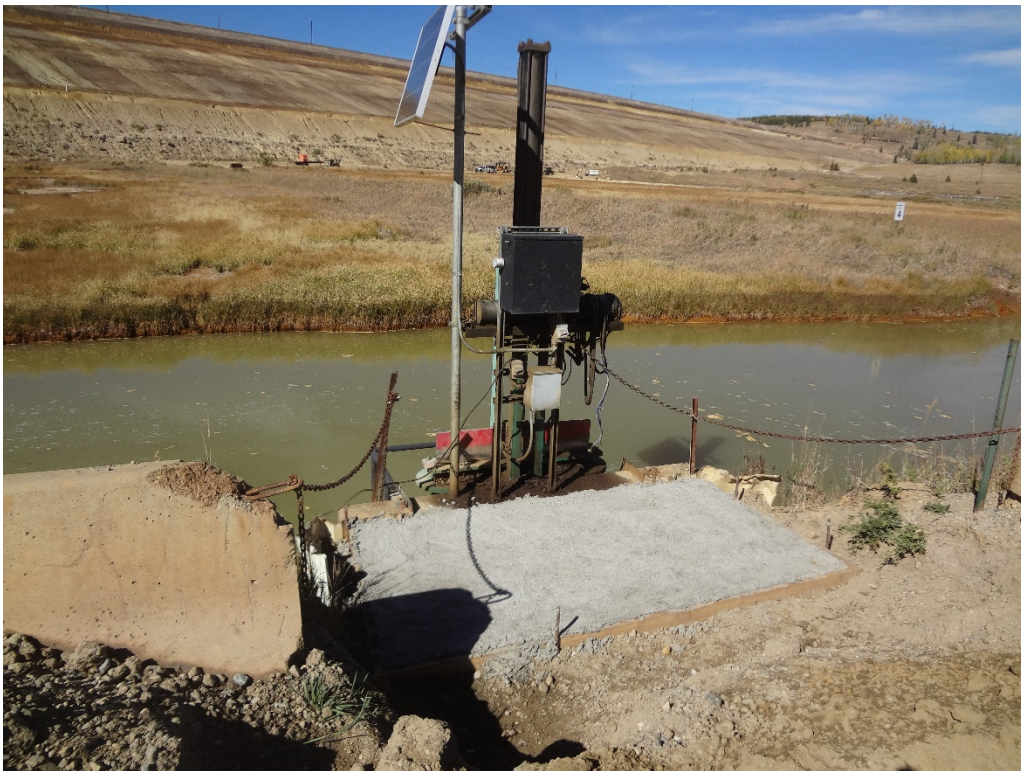
View of south feeder channel inlet gate structure

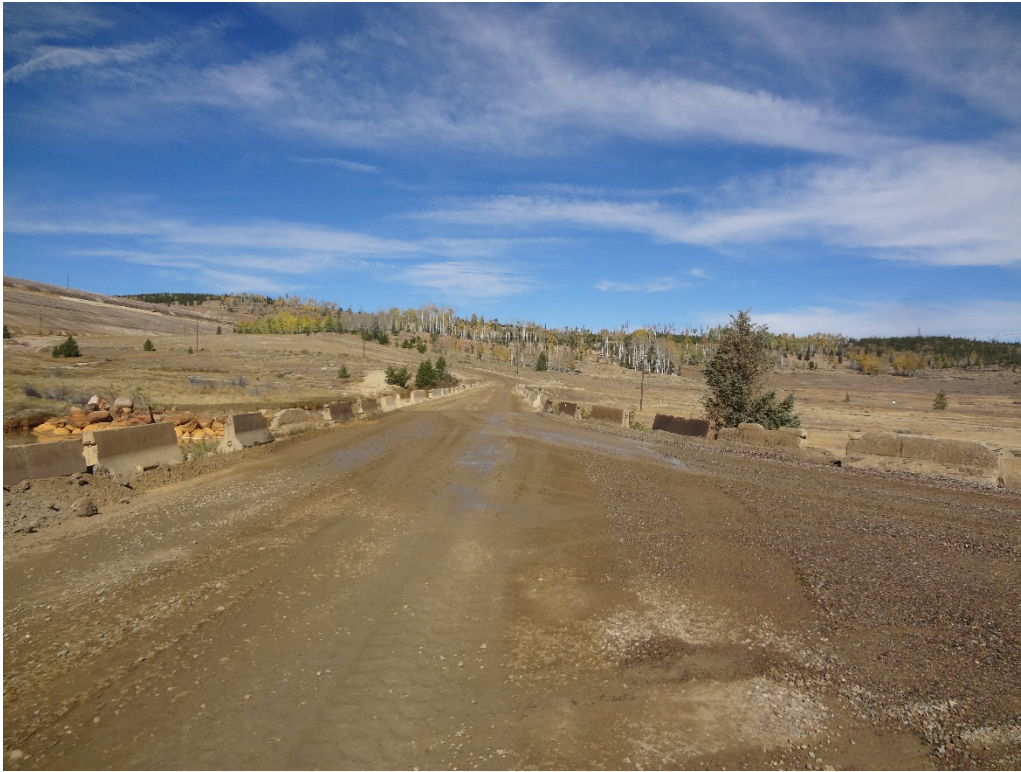
View of the north end of the seep road looking north

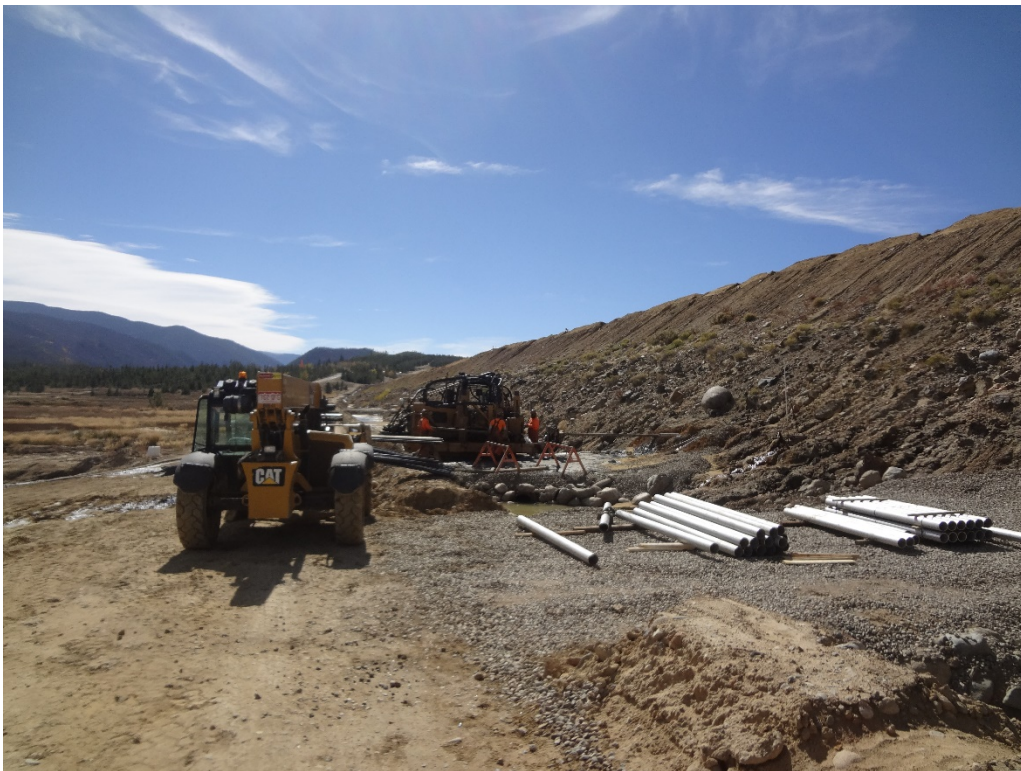
A horizontal drilling company was on-site and was actively installing drains into 1-Dam during the inspection. Two (2) drains were completed over foundation drain #4. The first of the two (2) planned drains over foundation drain #5 was being drilled during the inspection. A fifth drain was planned over foundation drain #6.

View of horizontal drilling above foundation drain #5

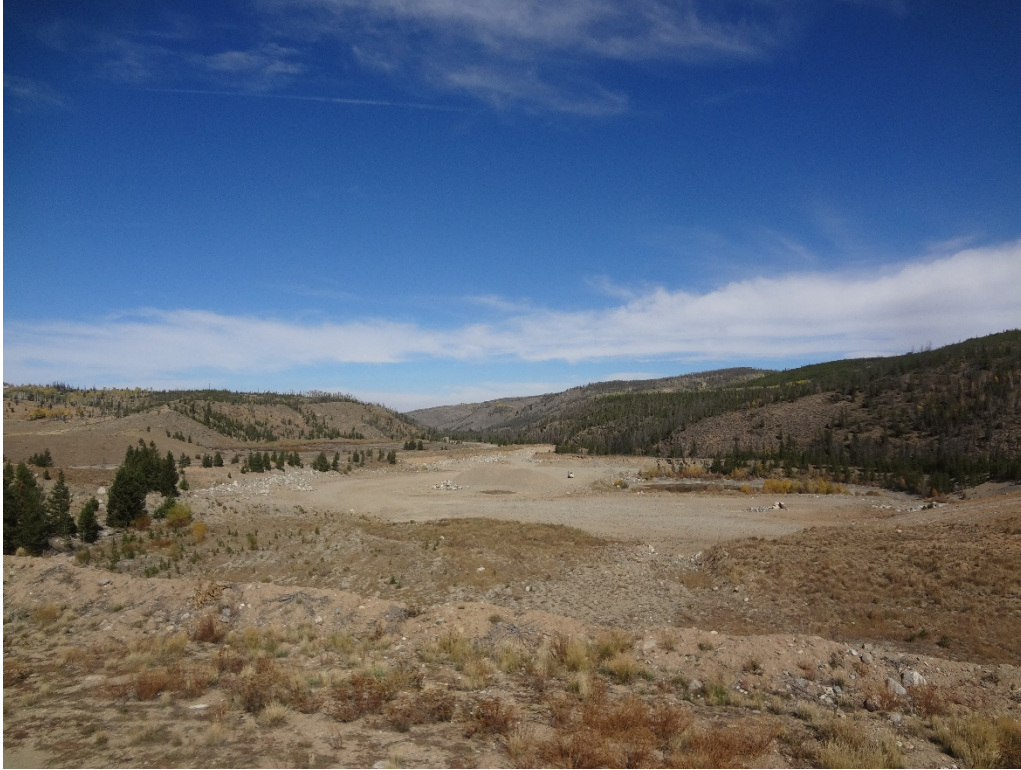
The Henderson gravel pit was observed during the inspection. Henderson staff stated the gravel pit was last active in 2014 and 2015. Google Earth images from 2011 and 2015 show the mining activity at the pit to the north. The maps are attached for reference. The groundwater pond was estimated at 1.0 acres, which is less than the allowed pre-law exposure limit of 2.64 acres. Road base and cobble stockpiles were observed on the pit floor. The highwall elevations in the northern portion of the pit were estimated at 10 feet at a 1H:1V slope. The highwalls appeared stable with no observed erosion features. Evidence of noxious weed control spraying was observed in the pit. Henderson staff stated weed control measures for the entire site had been completed for the year. The southern portion of the pit was being used to stockpile imported filter sand material for the 3-Dam Buttress Project.

View of the gravel pit from overburden stockpile looking north

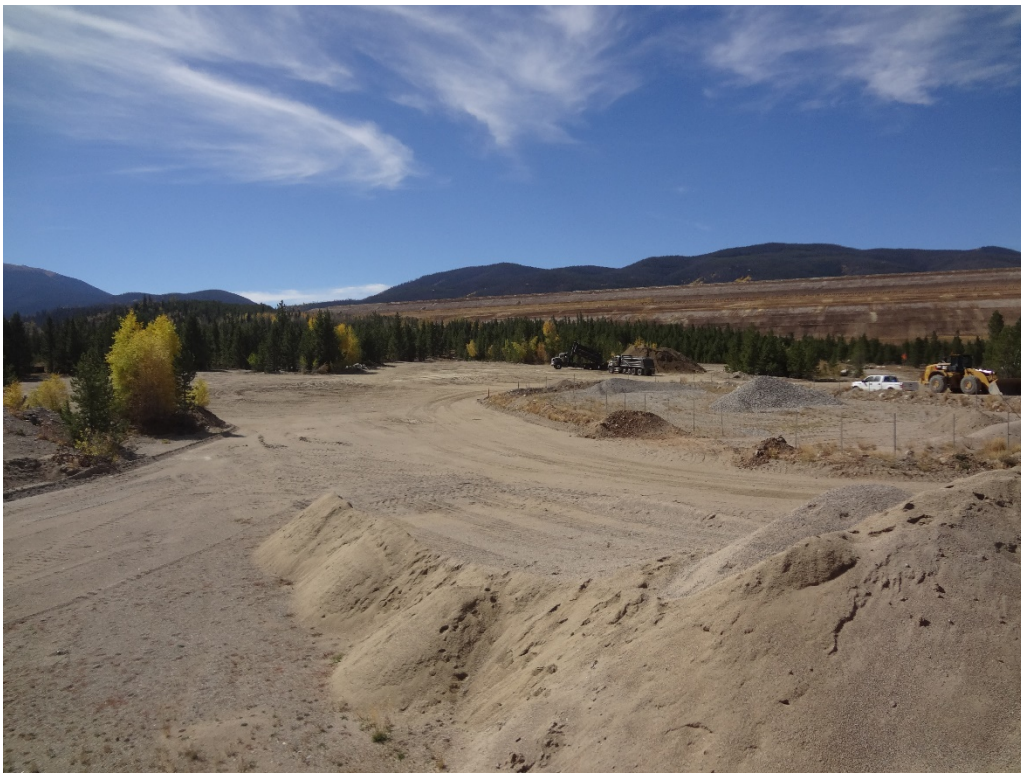
View of the gravel pit from overburden stockpile looking southwest at the filter sand stockpile area
