MINERALS PROGRAM INSPECTION REPORT
PHONE: (303) 866-3567

MINE NAME: Nolte Pit #1	MINE/PROSPECTING ID#: M-2012-016	MINERAL: Borrow material	COUNTY: Garfield
INSPECTION TYPE: Monitoring	INSPECTOR(S): Amy C. Yeldell	INSP. DATE: September 11, 2018	INSP. TIME: 13:00
OPERATOR: Puckett Land Company	OPERATOR REPRESENTATIVE: None	TYPE OF OPERATION: 111 - Construction by Government Agency	
REASON FOR INSPECTION: Normal I&E Program	BOND CALCULATION TYPE: Complete Bond	BOND AMOUNT: \$36,250.00	
DATE OF COMPLAINT: NA	POST INSP. CONTACTS: None	JOINT INSP. AGENCY: None	
WEATHER: Windy	INSPECTOR'S SIGNATURE:

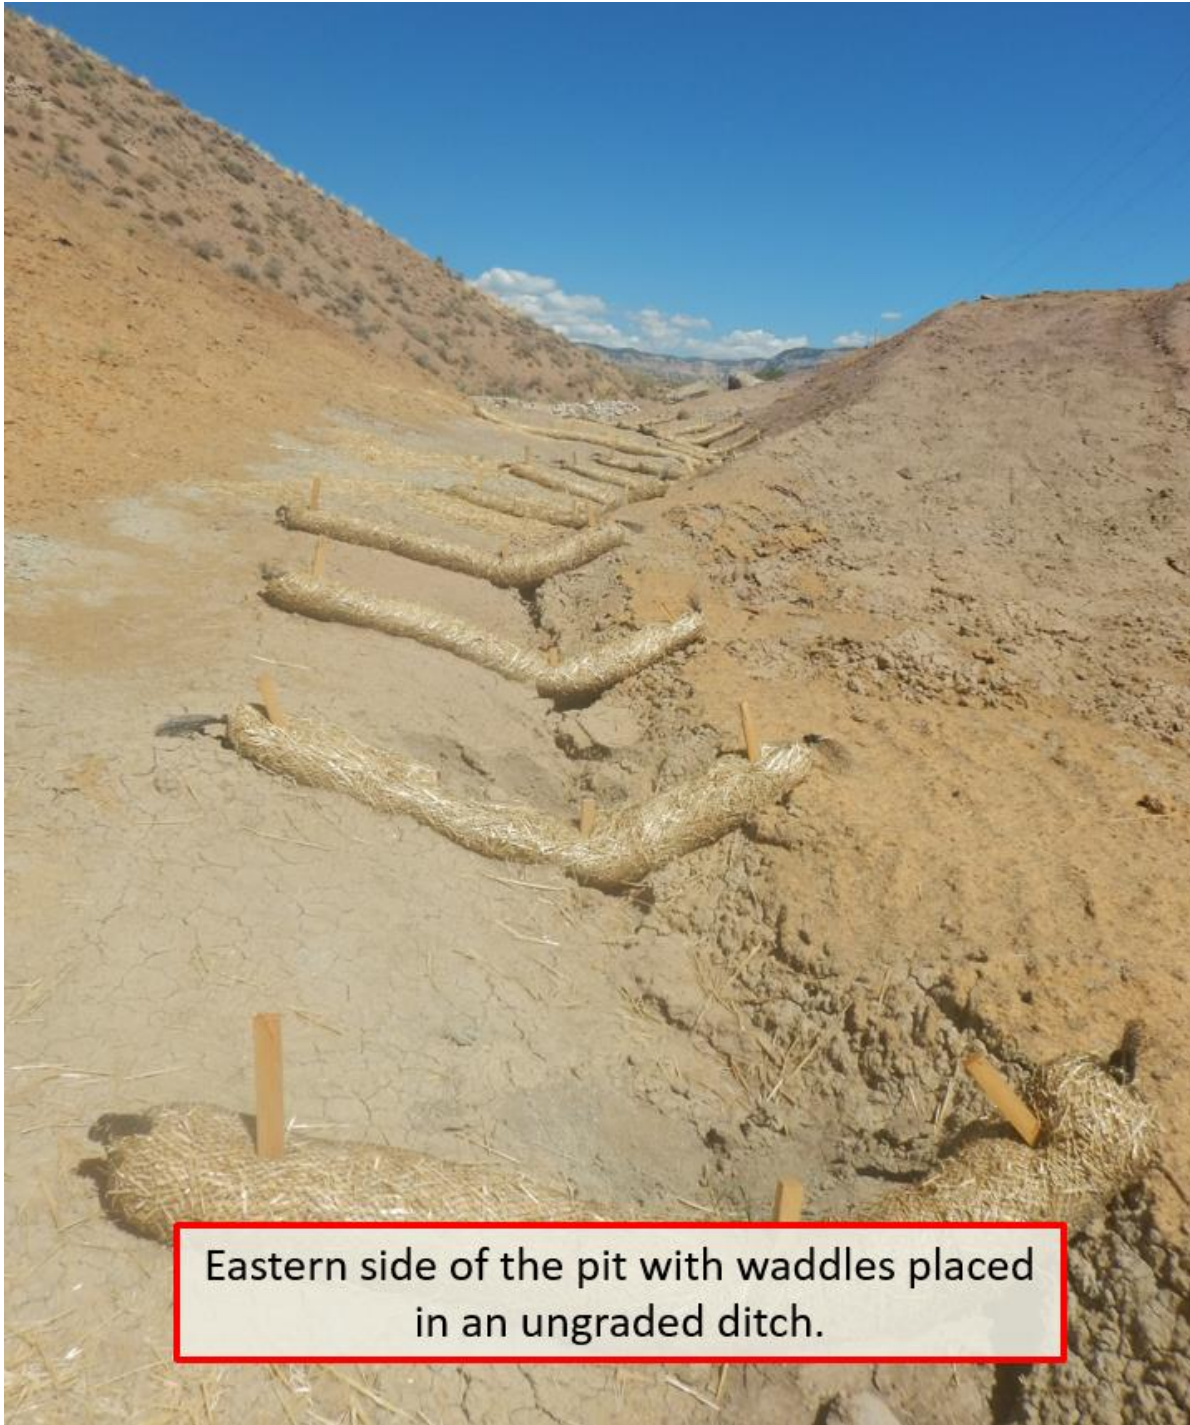
Not all of the waddles to be used as check dams were correctly installed. Waddles need to be partially buried then backfilled/packed in with good soil contact in addition to staking. The straw waddles placed in the channel on the north area between rip-rap sections 5 and 6 the ditch was not graded out prior to placement. Waddles were placed in the eroded ditch then backfilled on the eastern side where water will first be intercepted. It is likely that these waddles will get undercut quite quickly and will continue to erode under the waddle. Previous eroded channels left in place foster new and continued erosion.

Eastern side of the pit with waddles placed
in an ungraded ditch.

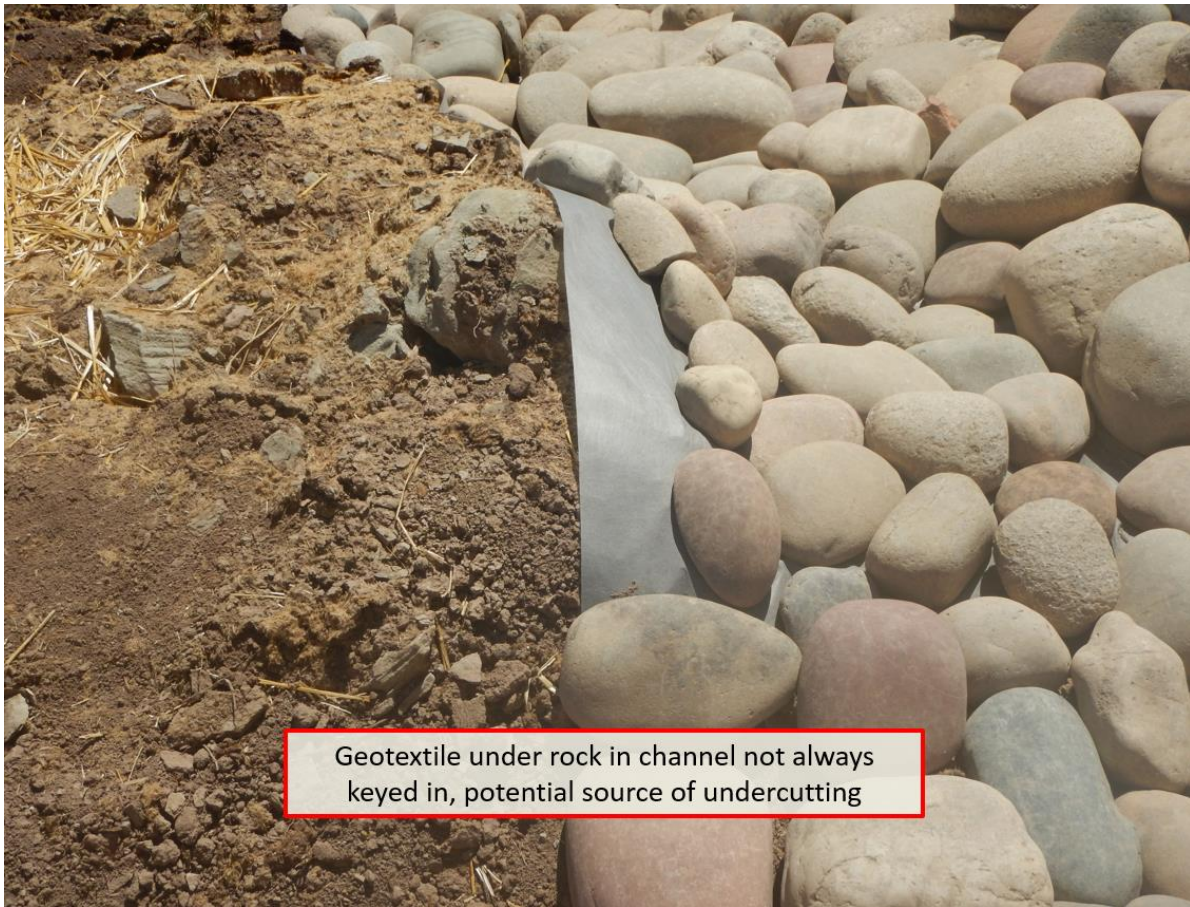
Staff was able to see the geotech liner that was installed prior to placement of the rip-rap. In most cases it appears that the geotech liner was keyed into place and should withstand undercutting at the top of the slope. There were some areas where the geotextile was observed improperly installed. Straw waddles were installed at the top of the slopes and used to direct run-on water into the rip-rap channels.

Geotextile under rock in channel not always keyed in, potential source of undercutting

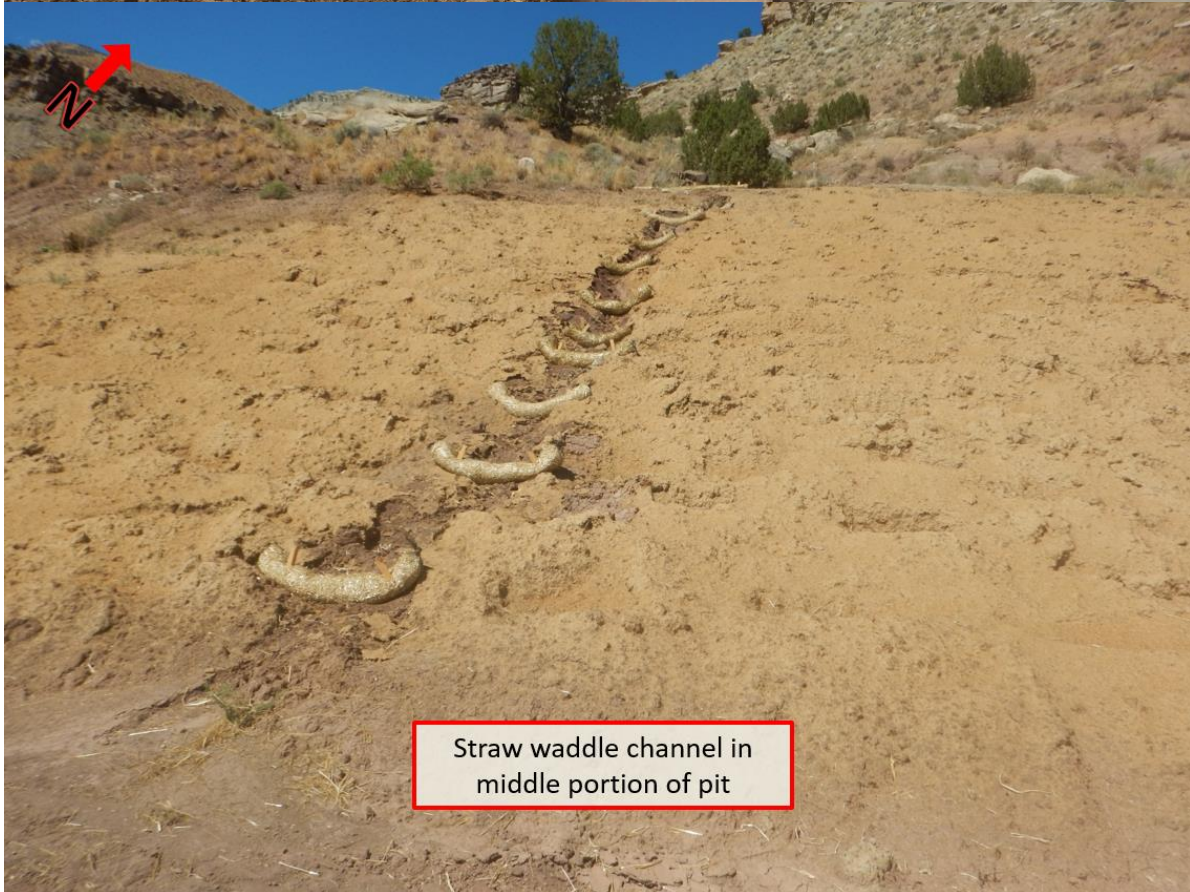
Straw waddle channel in middle portion of pit
