Re: King II Mine
Pond Quarterly Inspection
3rd Quarter 2018

Re: King Coal II - Annual Water Quality Improvements Inspection (Amended)

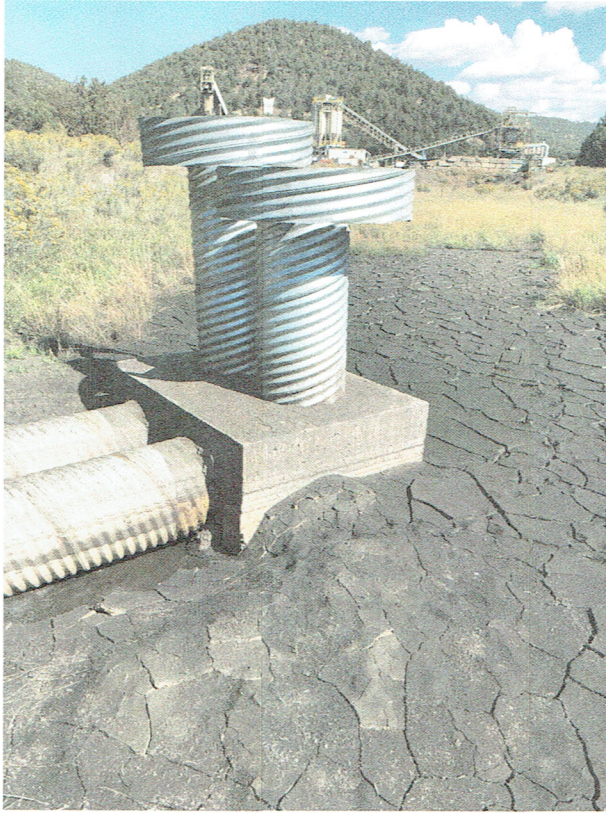
The vegetation established both inside and out of the pond is well established to minimize the erosion impacts of storm runoff. The outlet structure shows no signs of damage and was functioning as designed at the time of the inspection (see Pic. 1). The water quality pond appears to be in generally good condition. There were no signs of weakness or distress to either the outlet structure or the embankment material. The water quality pond has the storage capacity to function as designed.

Pic. 1 – Detention Pond outlet structure, dry.

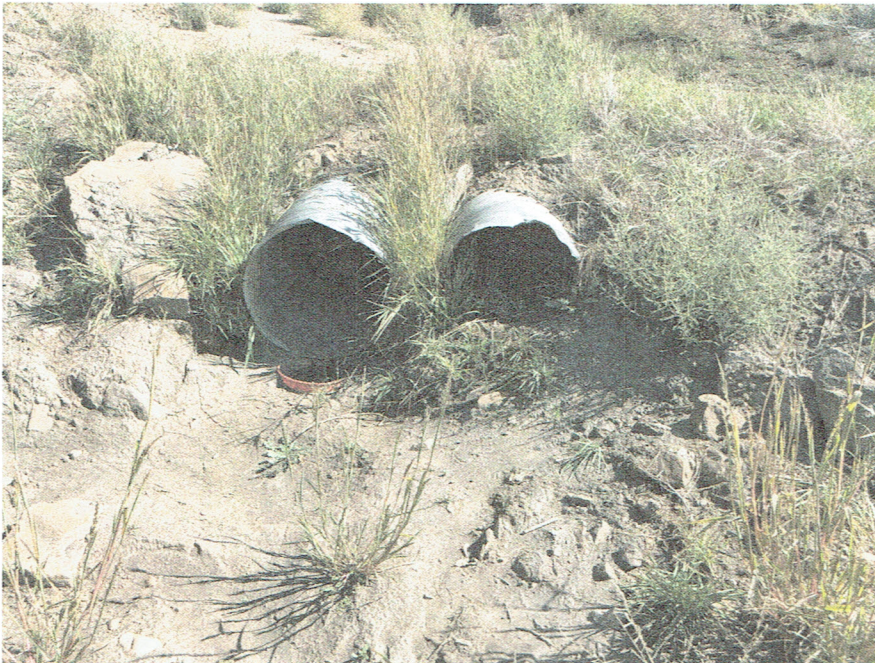
The drainage ditches were found to be in generally good condition and clean of debris (see Pic. 2 & 3). All ditches should be inspected and repaired as necessary, especially after storm events.

Pic. 2 – Dual culverts from outlet structure in good condition.

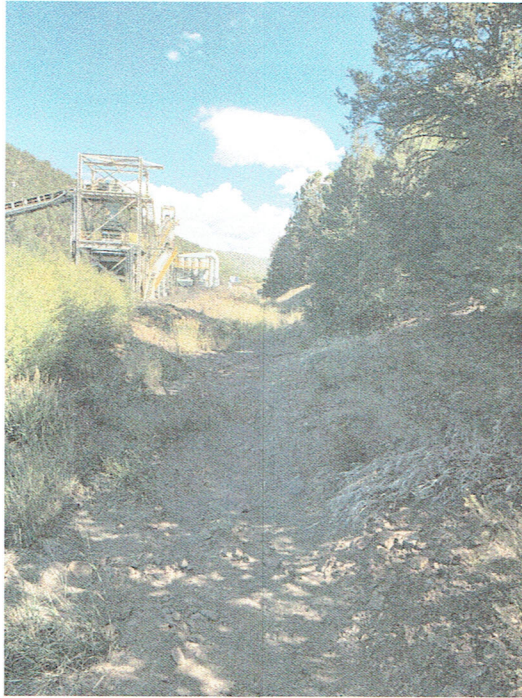
Pic. 3 East clean water ditch.

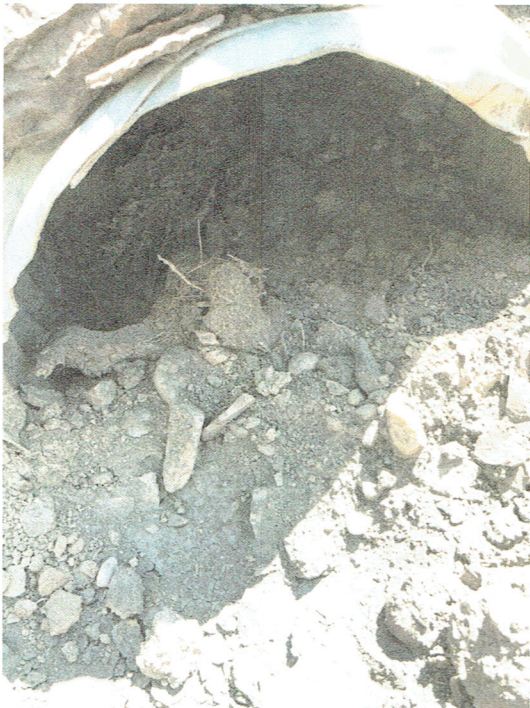
The culvert pipes on the site were in good condition overall. The treated water culvert located to the west of the truck loading/scale area (see Pic. 4) which runs under the driveway should be cleaned out to ensure excess runoff is not allowed to bypass the culvert and create erosion related issues downstream. The west clear water ditch at this location should also be cleaned out at this location. The lower ditch slope has resulted in sedimentation of the channel at this location (see Pic. 5).

Pic. 4 –Culvert inlet west of the loading/scale area west side of driveway.

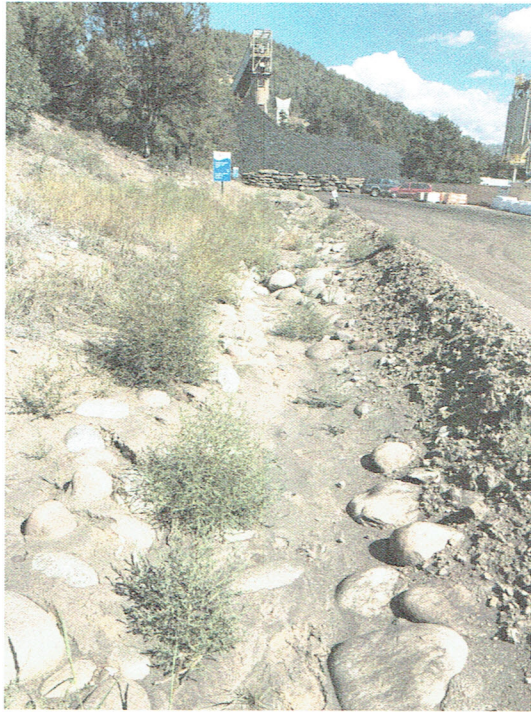
Pic. 4 –Sedimentation clean water ditch west of the loading/scale area west side of driveway.
