Re: King I Mine, C-1981-035  
Stoner Engineering: Quarterly Inspection: Refuse Pile  
3rd Quarter 2018

Date: September 24, 2018

Re: King Coal I – Quarterly Waste Pile/Embankment Inspection

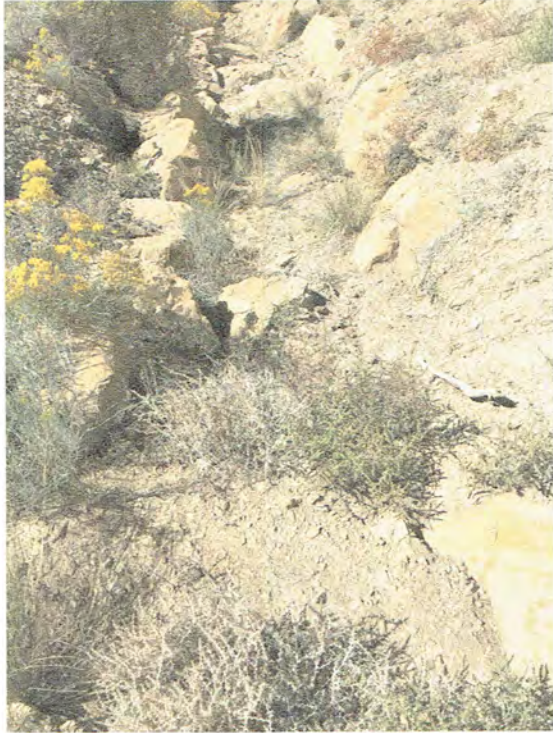
The condition of the perimeter ditches located along the north and south sides of the property were generally in good condition. The north clean water ditch has experienced additional sedimentation from the previous inspection and needs to be cleaned out (see Pic. 1). The south ditch was found to be in good conditions with little to no sedimentation issues. The pipe sections were found to be clear of debris and functioning as designed (see Pic. 2).

Pic. 1 – North channel sedimentation needs to be removed.

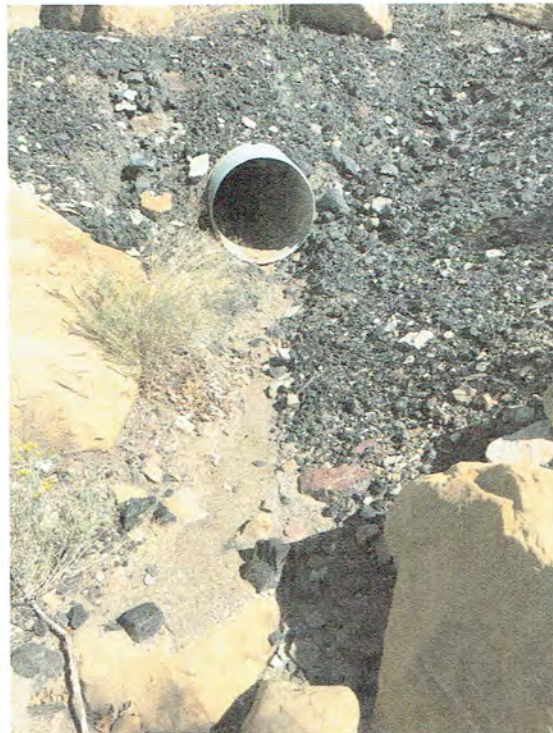
Pic. 2 – Culvert under haul road for south ditch.

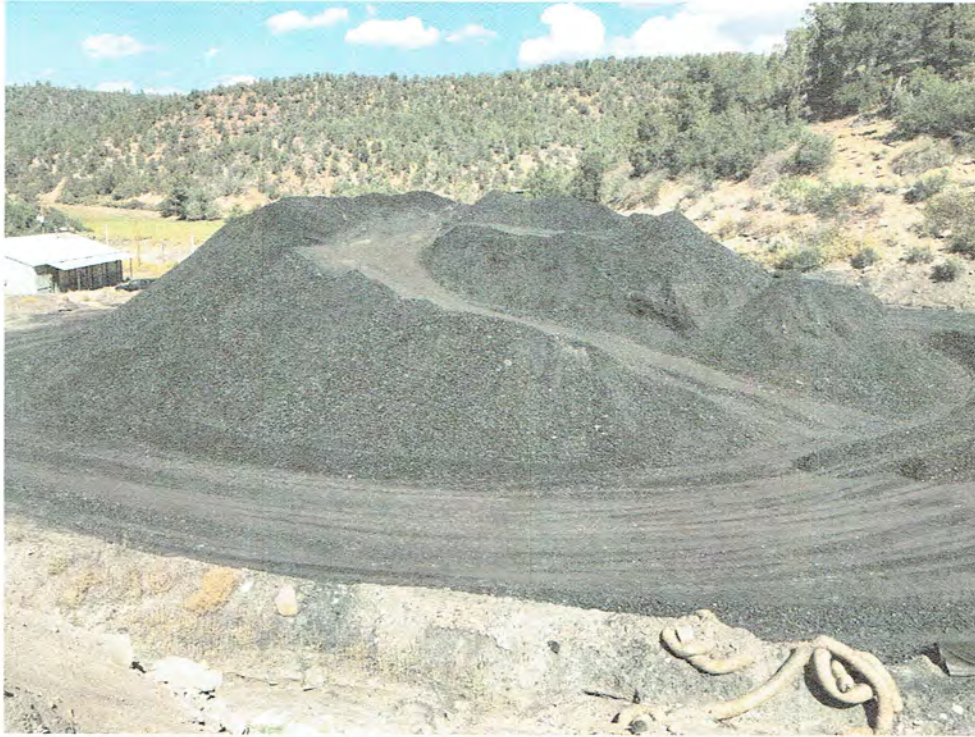
Embankment fill is being stockpiled in larger quantities and placed at the base of the waste pile/embankment (see Pic. 3). The outlet pipe area of the under drain has been cleaned out but, should be monitored and maintained regularly given the proximity of the tie-in location of Reach 10 and the potential for sedimentation to inhibit flows from the under drain. The pipe that drains into Reach 10 is clear of debris/sediment and appears to be functioning as designed (see Pic. 4). There was no visible staining at the outlet at the time of the inspection.

Pic. 3 – Material at base of embankment/waste pile.

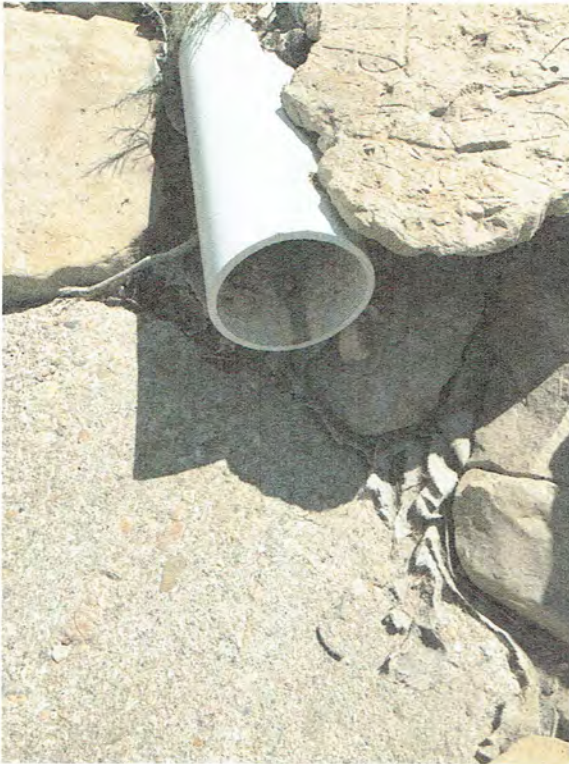
Pic. 4 – Pipe drain into Reach 10.

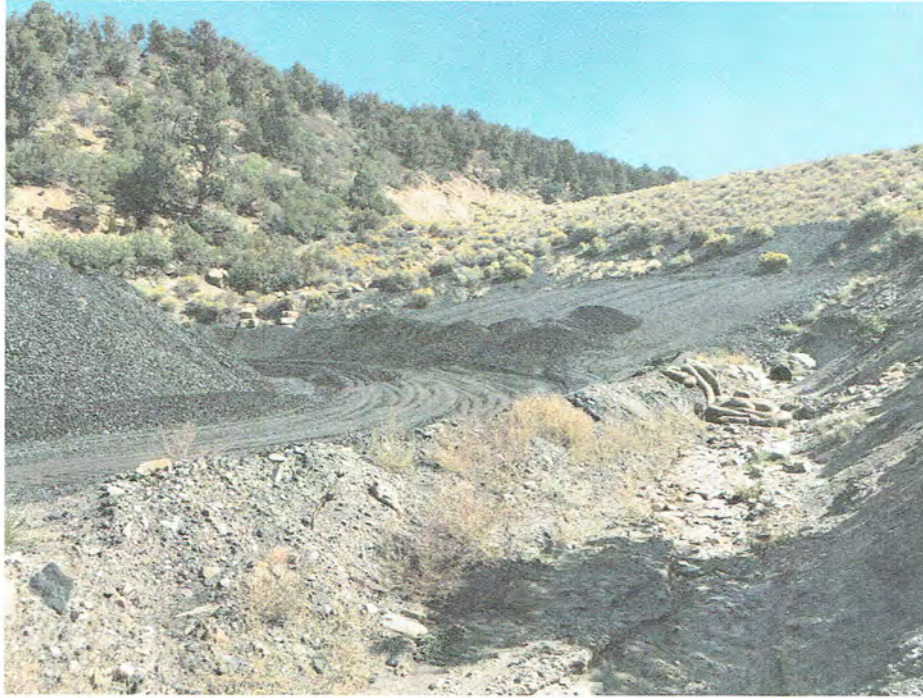
The rate of waste material being generated at the King II site has increased and is actively being placed at the top of the embankment; there has been some additional waste material installed at the base of the waste pile/embankment (see Pic. 5). The face of the embankment was in good condition and does not show any signs of excessive erosion, instability or weakness (see Pic. 6).

Pic. 5 – Additional material placed at base of embankment.

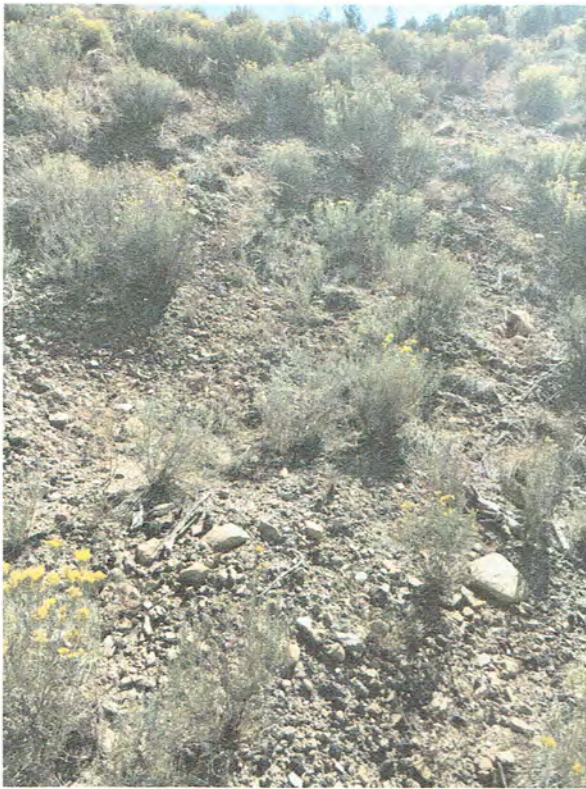
Pic. 6 – Waste pile/embankment face in good condition.
