Re: King I Mine, C-1981-035
Stoner Engineering: Quarterly Inspection: Water Quality Improvements
3rd Quarter 2018

Re: King Coal I – Quarterly Water Quality Improvements Inspection

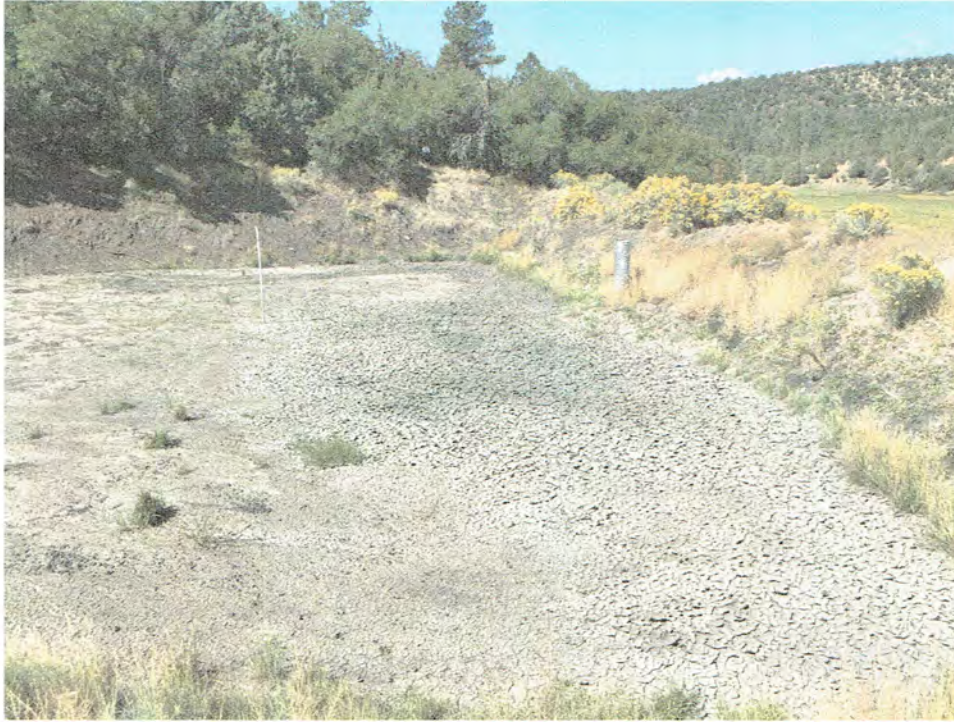
Both ponds were dry at the time of the inspection (see Pic. 1). The ponds are both in generally good condition. The required storage volume appears to be adequate at this time based upon the sedimentation gages installed (see Pic. 2). The ponds should continue to be monitored after storm events to ensure that excess sediment does not reduce the required storage capacity available for storm water runoff.

Pic. 1 – West pond.

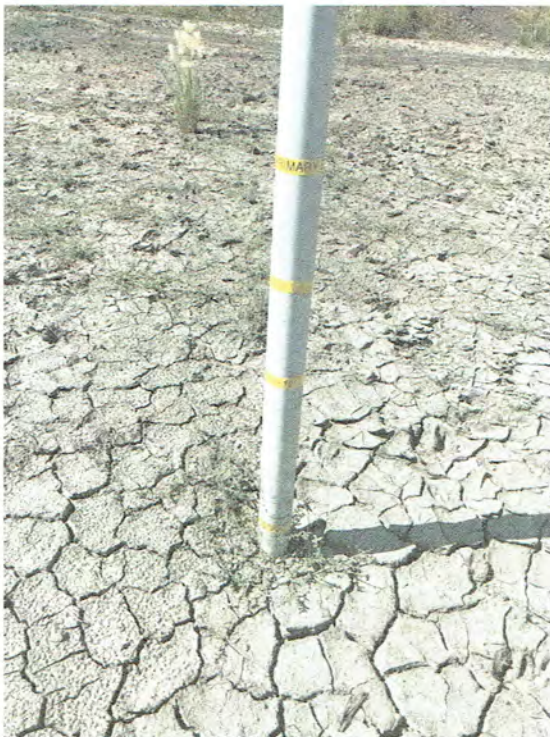
Pic. 2 – West pond sedimentation gage.

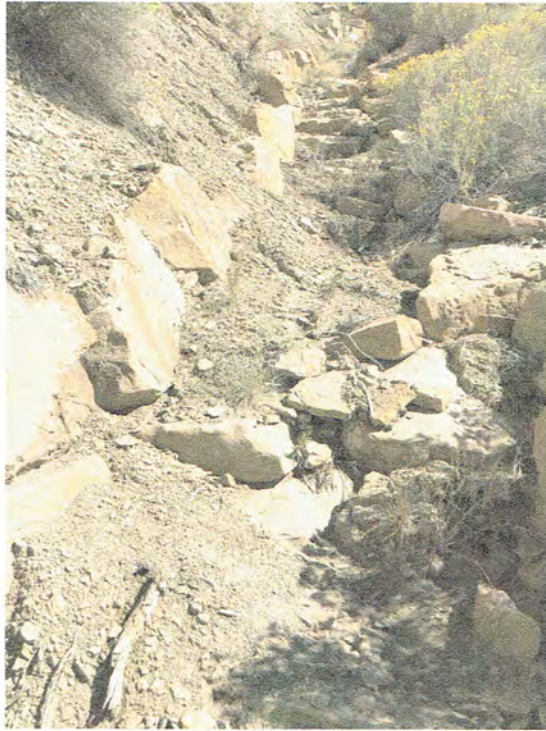
The drainage ditches and pipes were generally in good condition based upon a visual inspection from the inlet and outlet locations. The north clean water ditch has experienced additional sedimentation in portions of the ditch and needs to be cleaned out (see Pic. 3). The south treated water ditch was still in good condition at the time of the inspection (see Pic. 4). All pipes, ditches and sediment traps should be inspected and repaired as necessary, especially after storm events.

Pic. 3 – Sediment buildup north, clean water ditch.

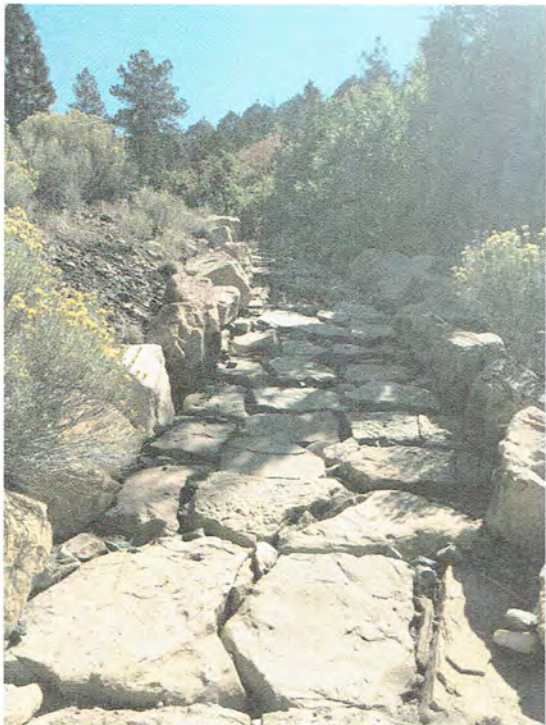
Pic. 4 – South ditch free from sedimentation.
