MINERALS PROGRAM INSPECTION REPORT
PHONE: (303) 866-3567

MINE NAME: Blue Valley Pit	MINE/PROSPECTING ID#: M-2015-008	MINERAL: Sand and gravel	COUNTY: Grand
INSPECTION TYPE: Monitoring	INSPECTOR(S): Peter S. Hays	INSP. DATE: October 3, 2018	INSP. TIME: 13:30
OPERATOR: Kirkland Construction, L.L.L.P.	OPERATOR REPRESENTATIVE: David King	TYPE OF OPERATION: 111 - Construction by Government Agency	
REASON FOR INSPECTION: Normal I&E Program	BOND CALCULATION TYPE: Complete Bond	BOND AMOUNT: \$18,078.00	
DATE OF COMPLAINT: NA	POST INSP. CONTACTS: None	JOINT INSP. AGENCY: None	
WEATHER: Clear	INSPECTOR'S SIGNATURE:

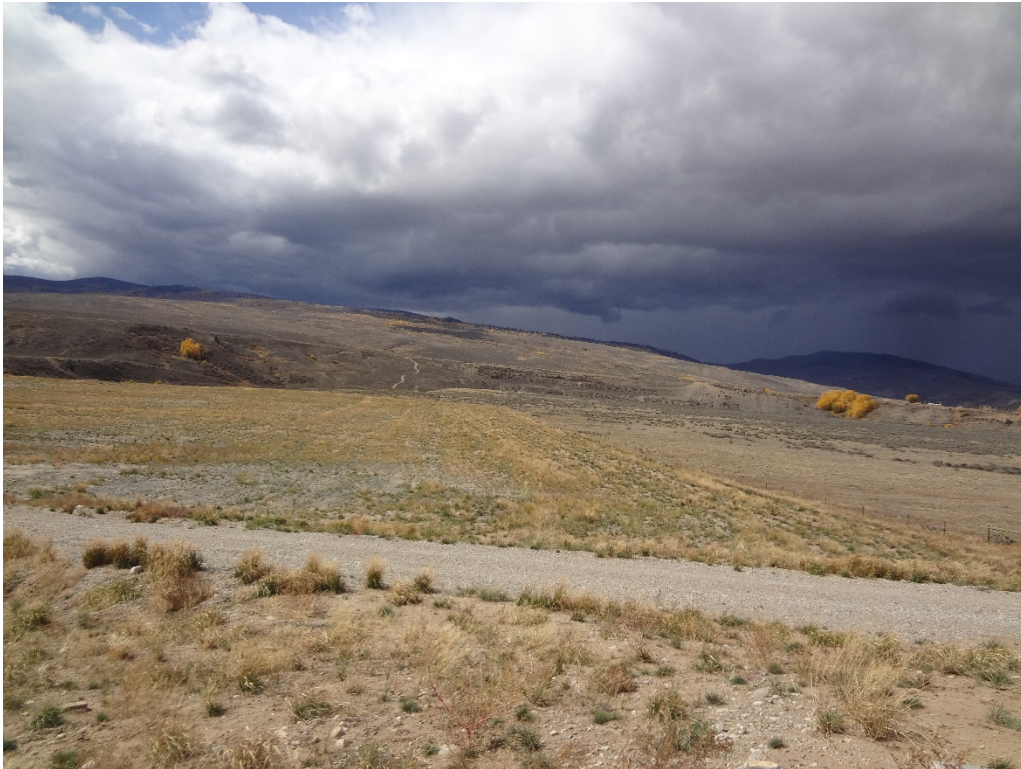
View of site from the northeast corner looking west

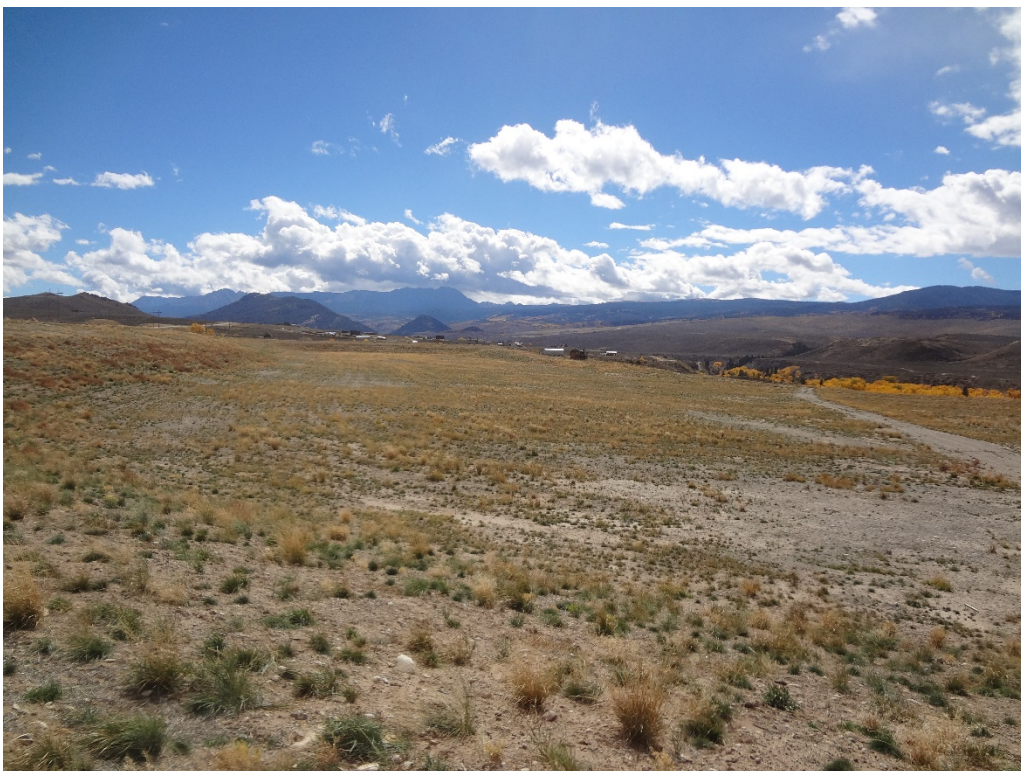
View of site from the northeast corner looking south

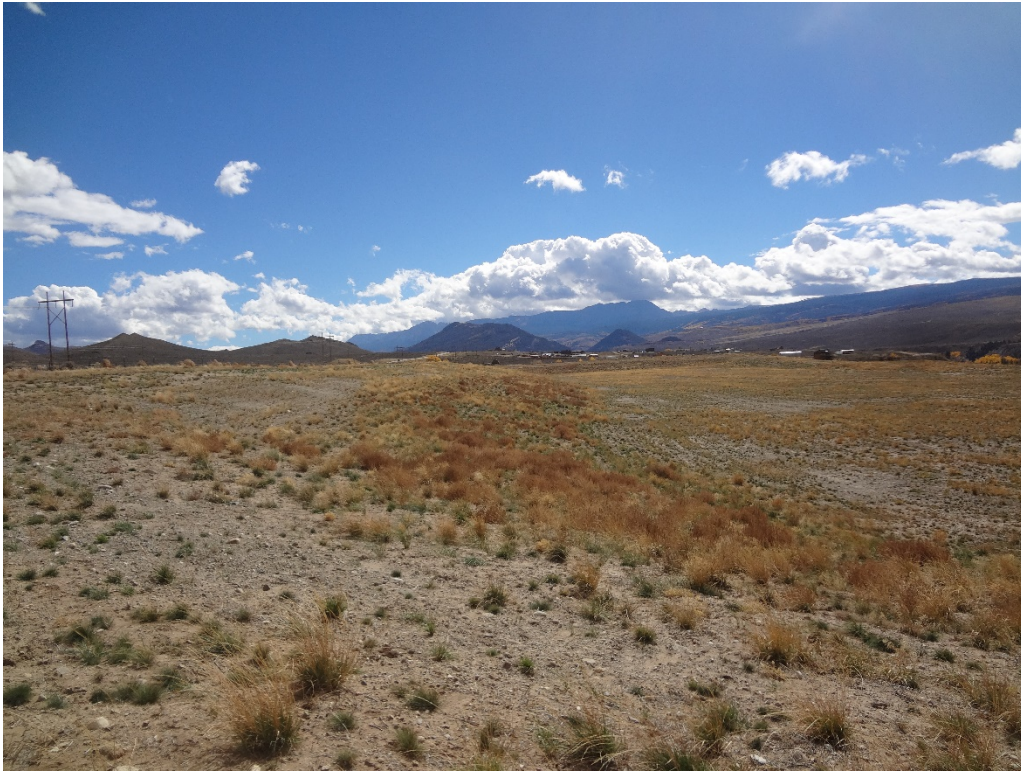
All observed slopes appeared to be graded to the required 3H:1V slope. The site was seeded with the approved reclamation seed mixture in June 2017. The site vegetation consisted of reclamation grasses and weeds. Russian knapweed, a list Class B noxious weed with the Colorado Weed Management Association was observed during the inspection. The Operator collected a sample of the weed to confirm the field identification. If the identification of the noxious weed is confirmed, the Operator must implement the approved noxious weed management plan for the site to control the weeds. The Division estimated 75 percent of the site contained vegetation, with areas of lacking vegetation and areas of bare ground. The site vegetation has improved since the last inspection. The Division recommends the bare areas are inter-seeded to achieve adequate vegetative cover for final release.

View of bare area on the northeast slope looking south

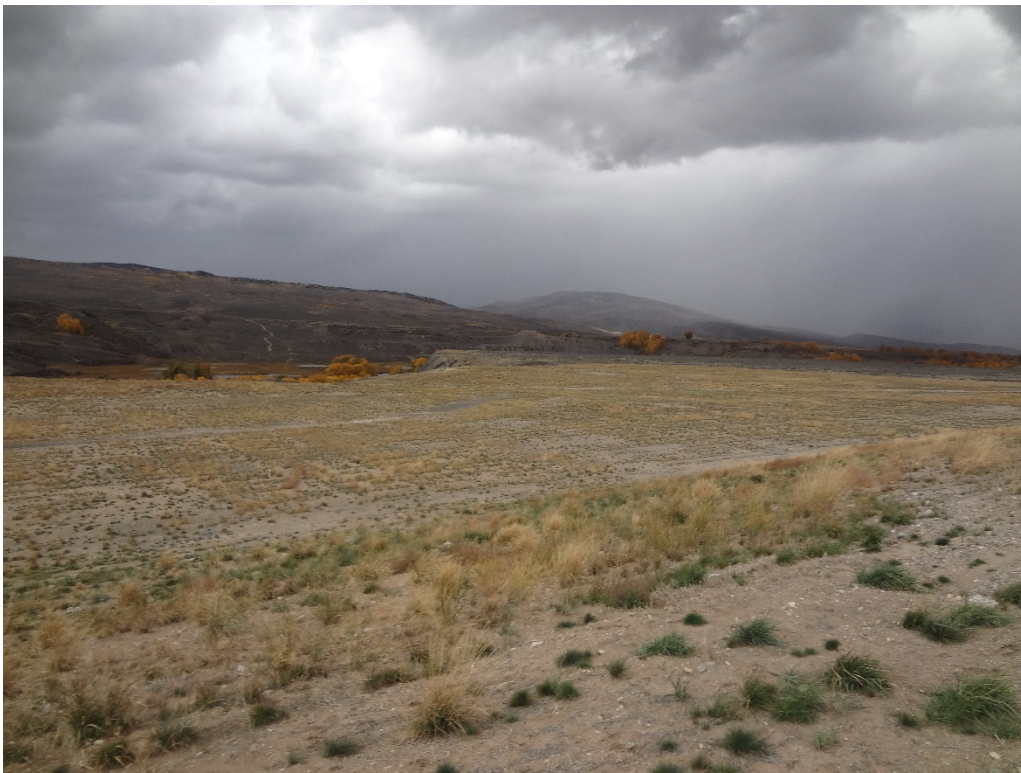
View of site from the former office pad looking northwest

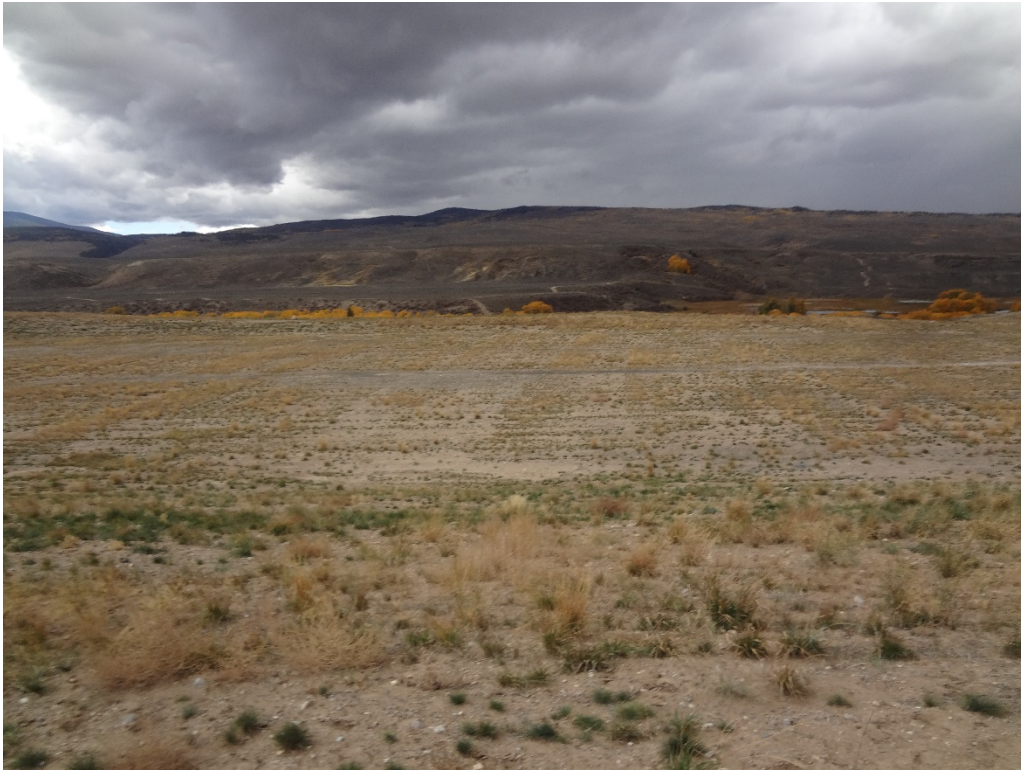
View of site from the former office pad looking west

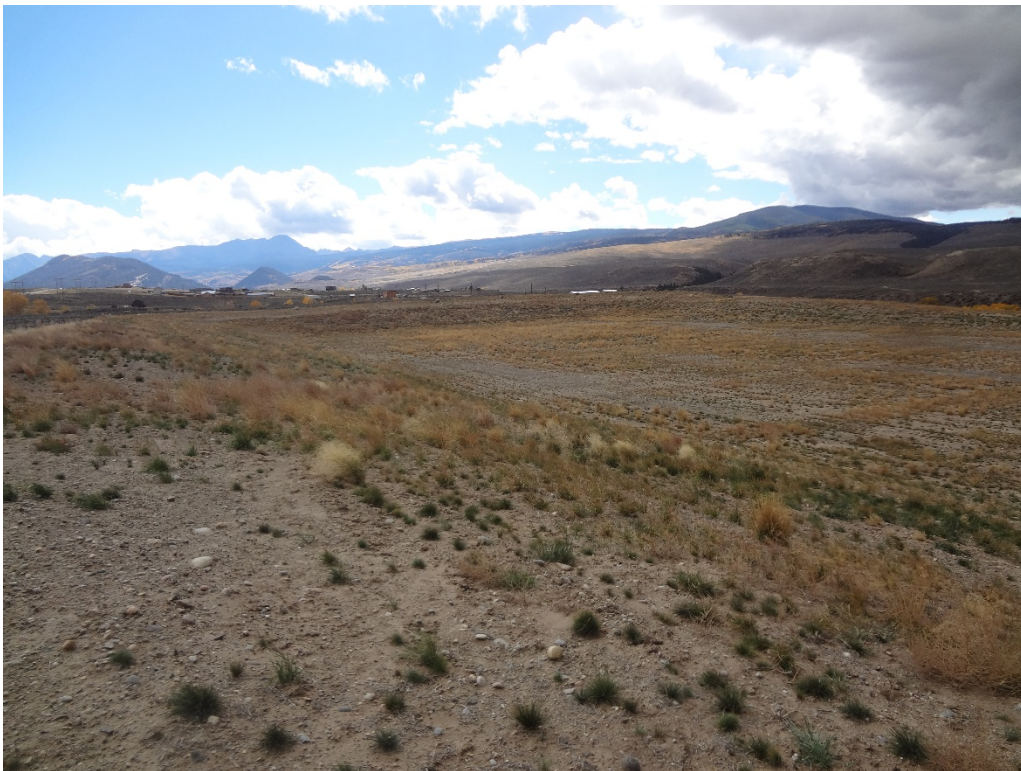
View of site from the former office pad looking southwest
