Reclamation Permit - Site Visit

MINERALS PROGRAM INSPECTION REPORT
PHONE: (303) 866-3567

MINE NAME: Henderson Development	MINE/PROSPECTING ID#: M-1980-110	MINERAL: Sand and gravel	COUNTY: Adams
INSPECTION TYPE: Monitoring	INSPECTOR(S): Jared L. Ebert	INSP. DATE: December 21, 2017	INSP. TIME: 10:30
OPERATOR: E-470 Public Highway Authority	OPERATOR REPRESENTATIVE: Derek Slack, E-470	TYPE OF OPERATION: 112c - Construction Regular Operation	
REASON FOR INSPECTION: Normal I&E Program	BOND CALCULATION TYPE: NA	BOND AMOUNT: \$0.00	
DATE OF COMPLAINT: NA	POST INSP. CONTACTS: None	JOINT INSP. AGENCY: None	
WEATHER: Clear	INSPECTOR'S SIGNATURE:

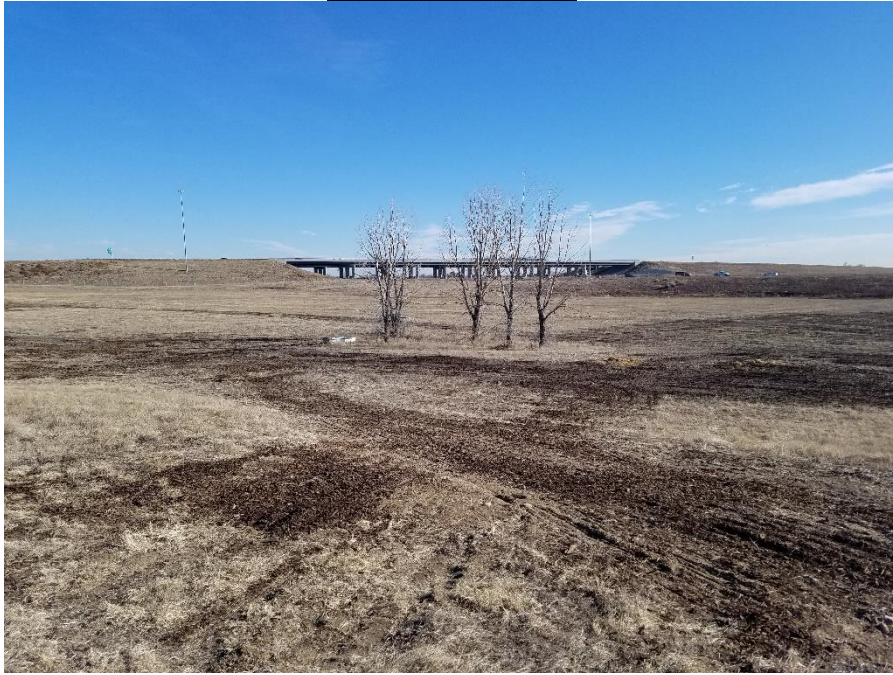
Figure 1. From the entrance of the mine site looking northeast.

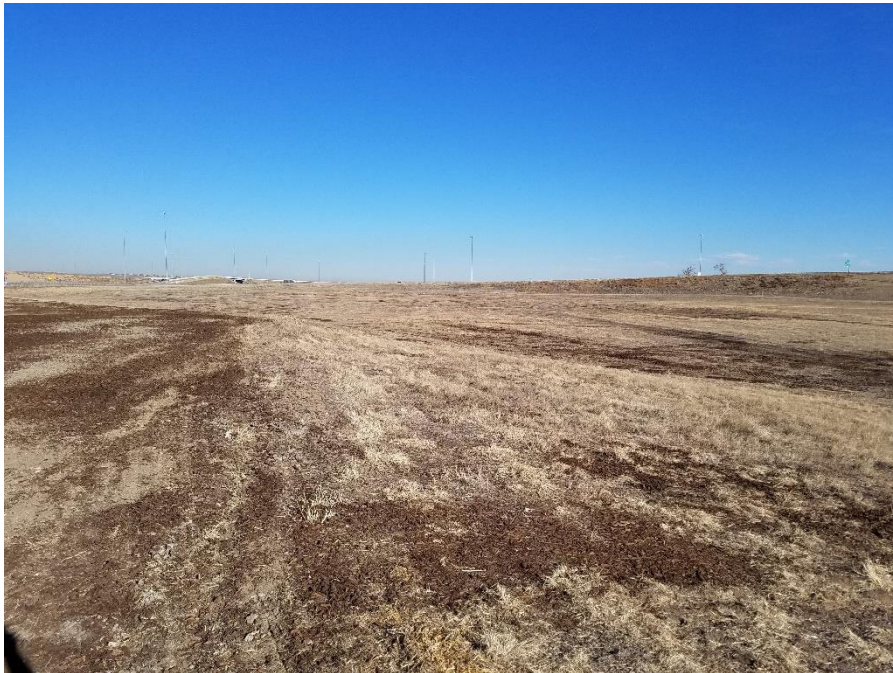
Figure 2. From the entrance of the mine site looking north.

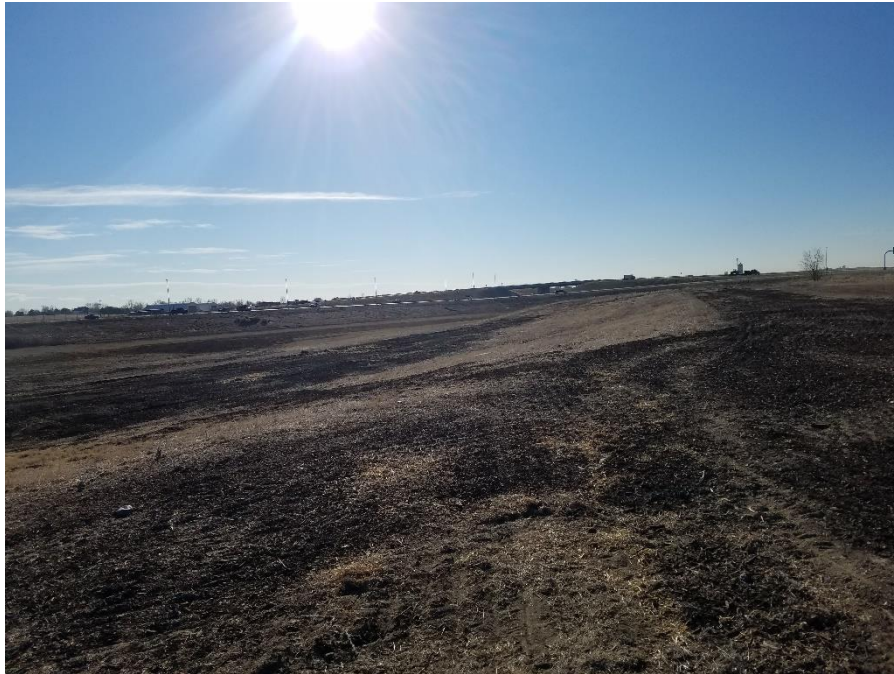
Figure 3. From the entrance of the mine site looking south.

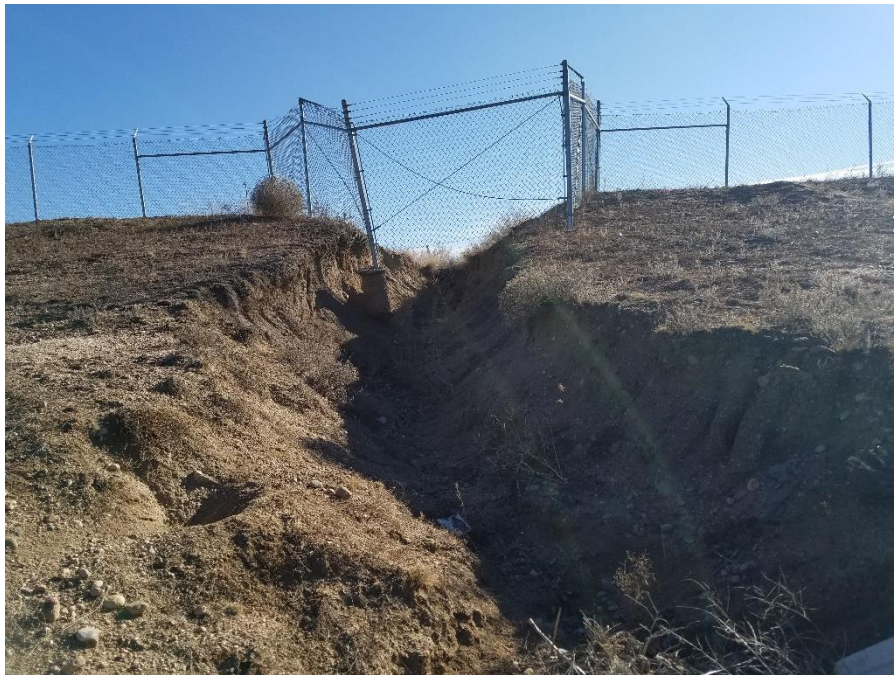
Mining is complete at the site and the pit used to be an open groundwater lake. The reclamation plan for the site called for backfilling the former lake area with inert material. The backfilling operation is complete and the exposed groundwater at the site has been covered up. The area now consists of a graded basin with gentle side slopes that appear to be set at a 3H:1V ratio or less. The majority of the pit slopes appear stable with the exception of a few erosion rills and gullies. One erosion gully on the east-central side of the former pit area near Highway 85 is fairly large, about 4 to 5 feet deep. At the top of this gully a culvert under the highway was observed allowing stormwater discharge into the pit. Mr. Slack indicated they intend to repair the gully and stabilize the area, likely with rip-rap. A few other erosion gullies were observed that will also need to be stabilized.

Figure 4. Large erosion gully on the east-central pit slope.

As indicated above, the Operator will need to stabilize several erosion gullies observed along the pit slopes.

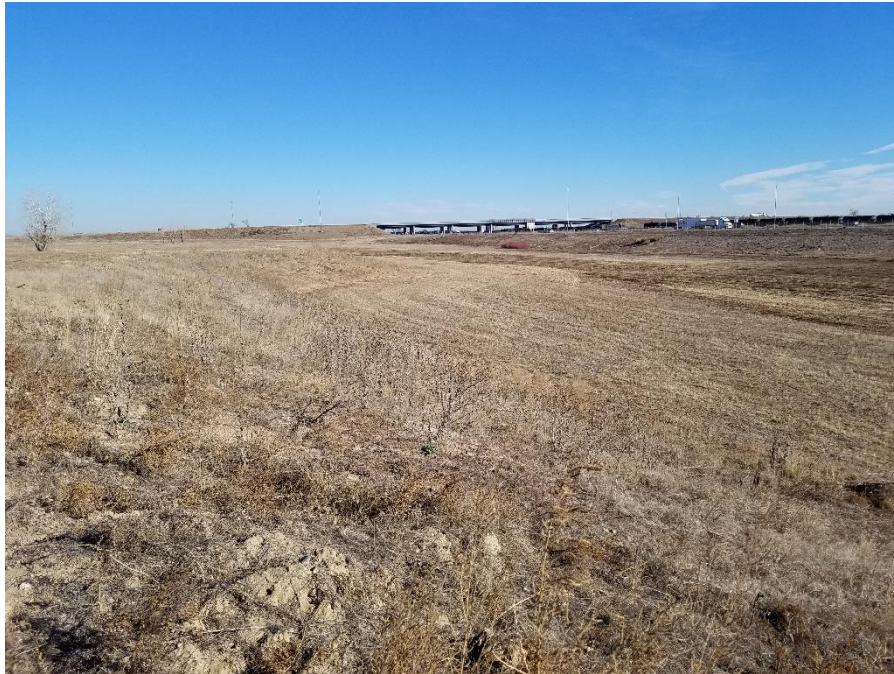
Figure 5. From the south end of the site looking north.
