Re: Cripple Creek & Victor Mining, Co., Cresson Project, M-1980-244; Review of Record of Construction Report, VLF2 Recertification Report, Subgrade and Geomembrane 9750 – 9900' Elevations.

Review of Record of Construction Report, VLF2 Recertification Report,
Subgrade and Geomembrane 9750-9900' Elevations
Response to Comments

October 5, 2018
NewFields Job 475.0106.026

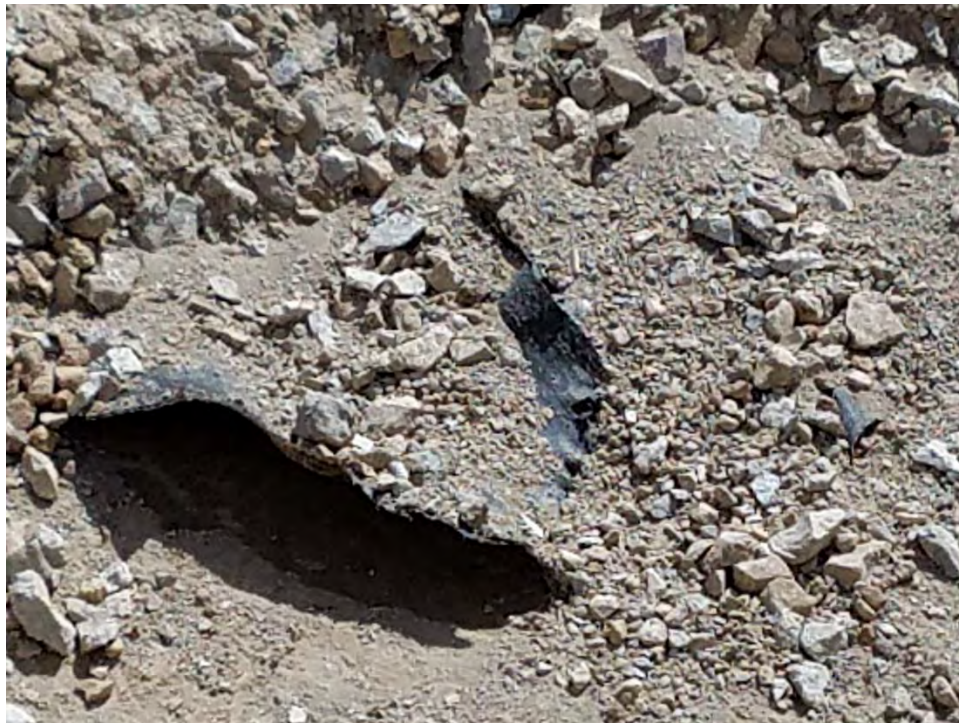
The mini excavator was used to excavate test pits to locate the geomembrane along the 9720' elevation. Seventeen test pits were excavated at an interval of approximately ten-feet. A damaged area of geomembrane was discovered. The excavation continued with a D6T LGP dozer and a mini excavator to identify the extent of the geomembrane damage. The damage is currently found to be approximately 200' wide running along the 9720' elevation and extends into the existing ore stockpile. Ore removal continued in the area between the 9720' and 9650' benches pushing downhill and stockpiling the material near the 9650' bench to allow for further investigation. All equipment worked on at least 2' of geomembrane cover at all times.

Damaged Geomembrane

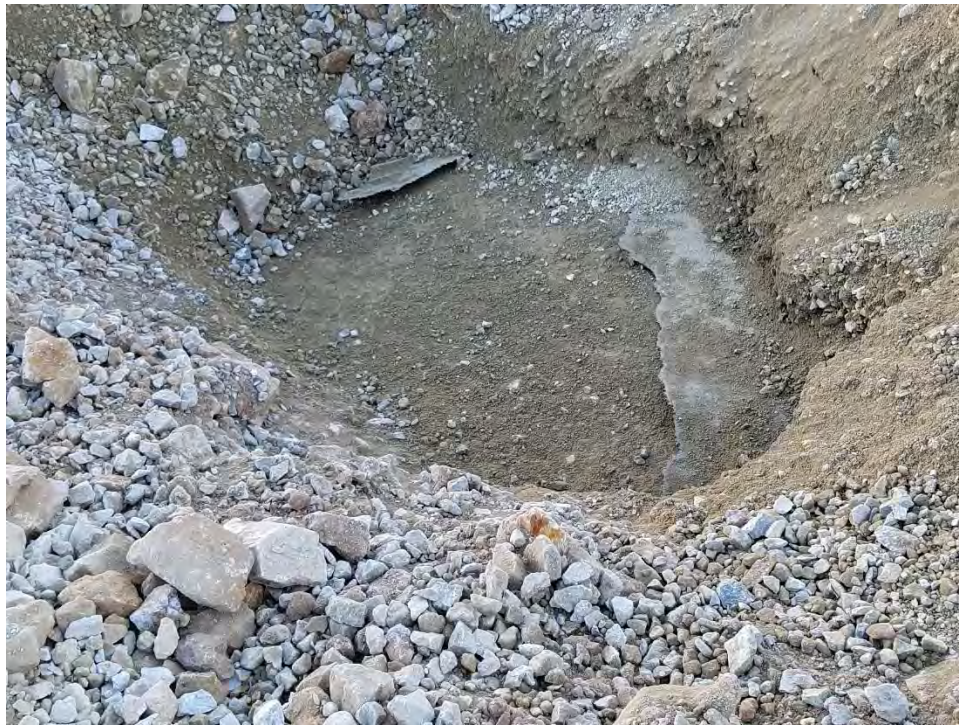
Damaged Geomembrane

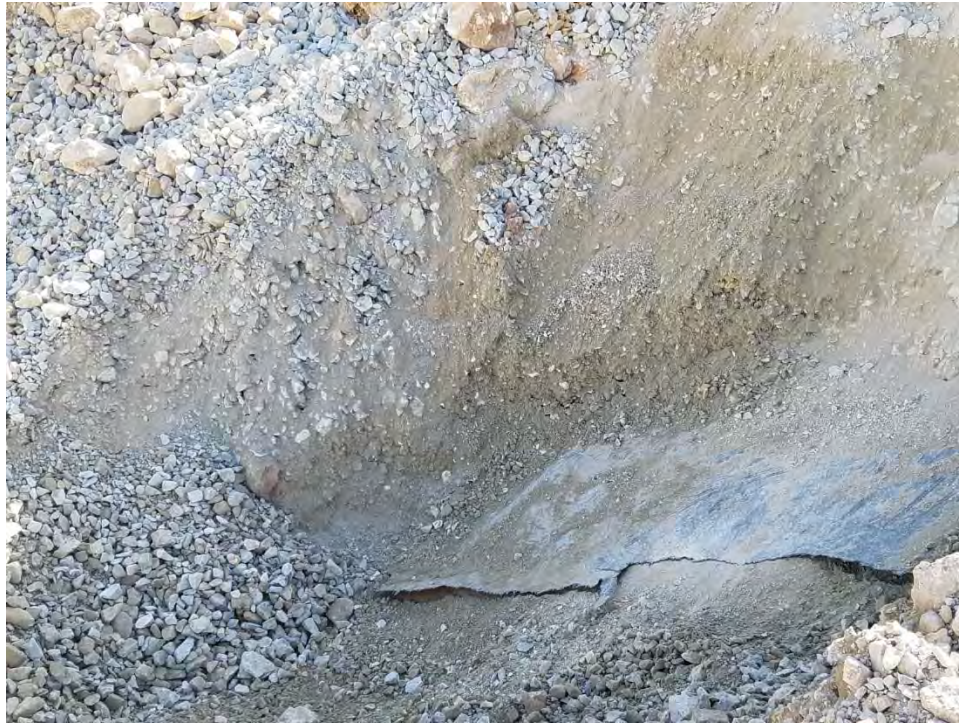
The mini excavator was used to excavate test pits to locate the geomembrane along the 9710' elevation. Five test pits were excavated at an approximate interval of ten feet. The damaged geomembrane was exposed to the toe of stockpile on the north side. Exposure of damaged geomembrane will continue on the south side tomorrow.

Exposed Damage at North Side

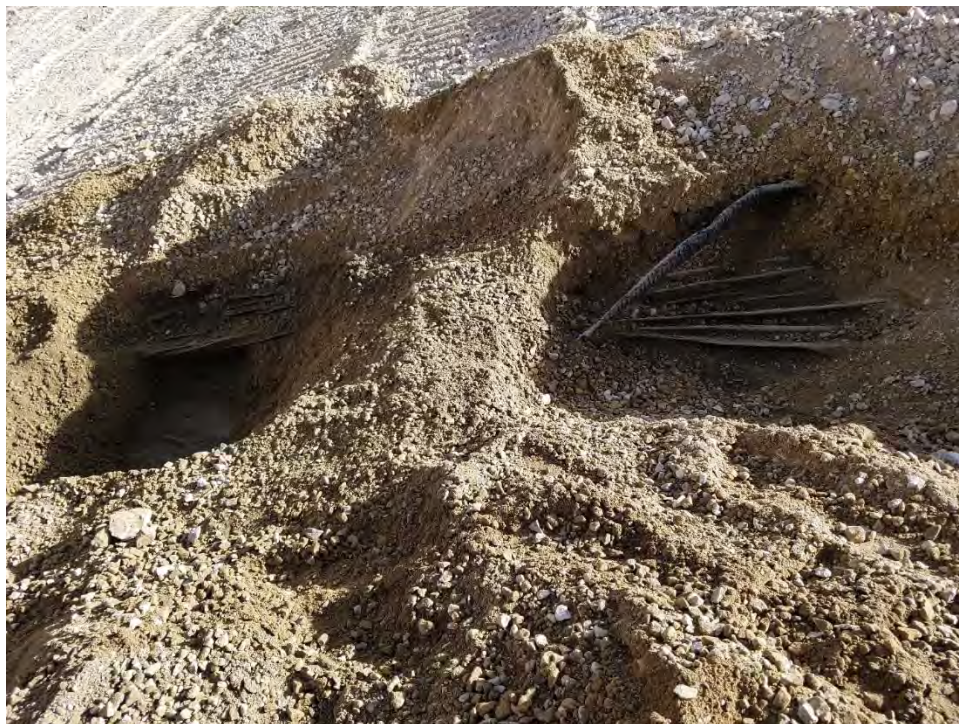
Damaged Geomembrane at South Side

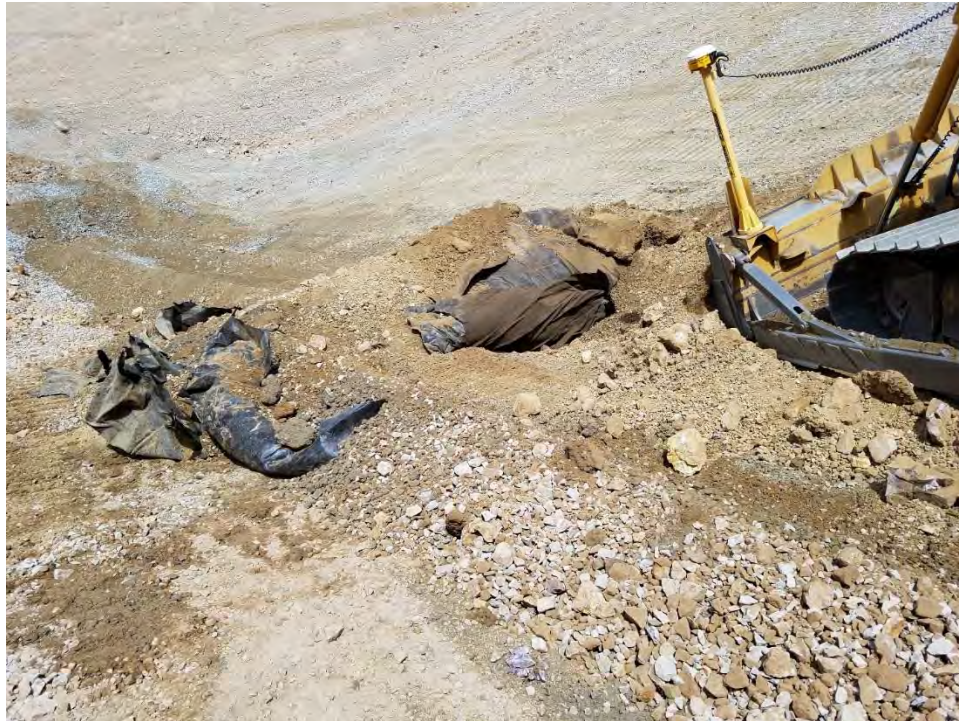
Damaged Geomembrane Removal

Damaged geomembrane was removed between 9650' and 9670' elevation.

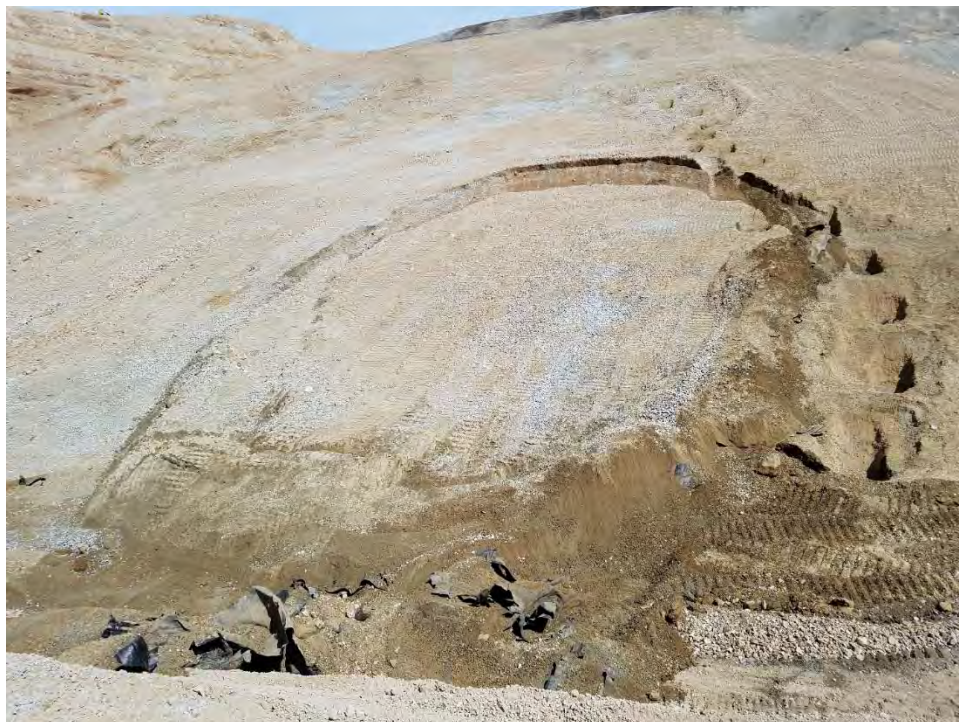
DCF Slide Area

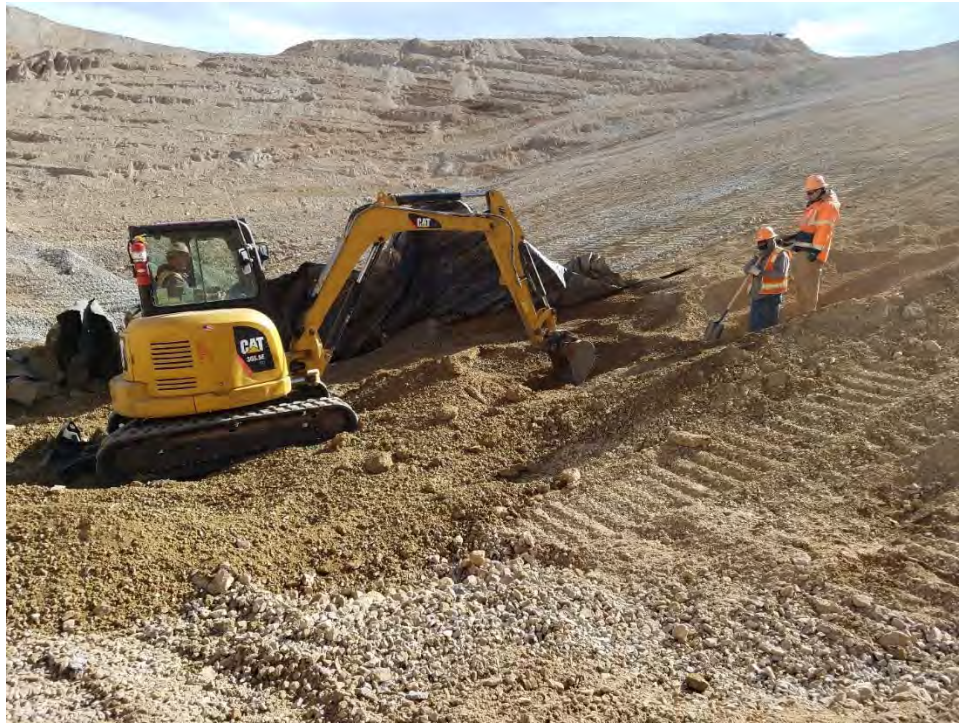
Damaged Geomembrane Exposure

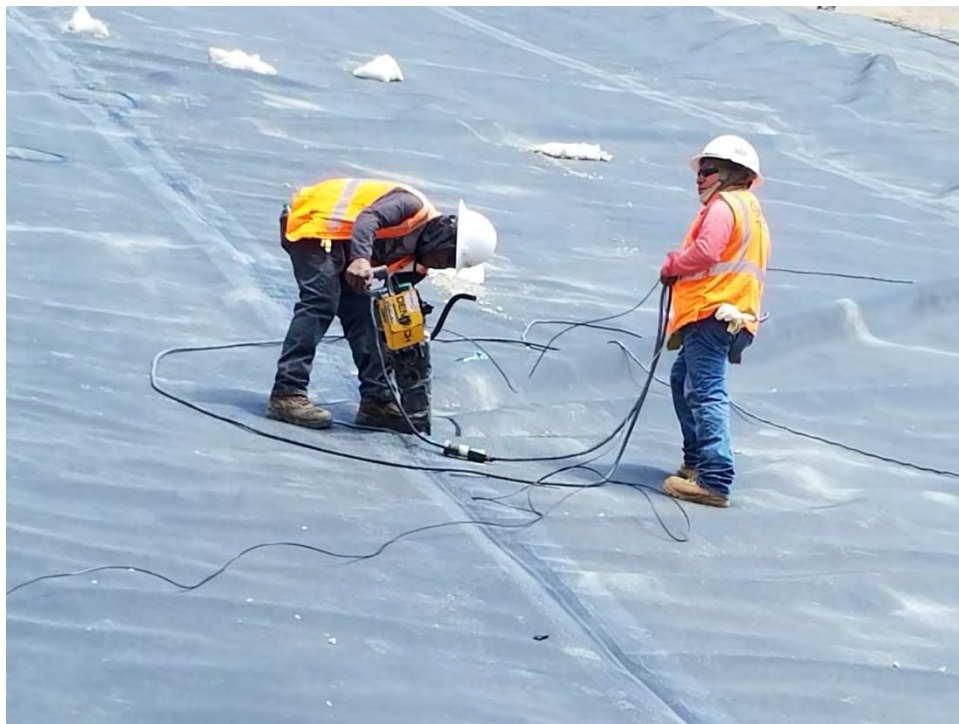
Performing Repairs

Approximately 322 linear feet of extrusion seaming was performed using one extrusion welding machine/operator method. One destructive testing sample was marked during extrusion seaming for future testing. Repairs were performed using the extrusion welding method for most marked defects.

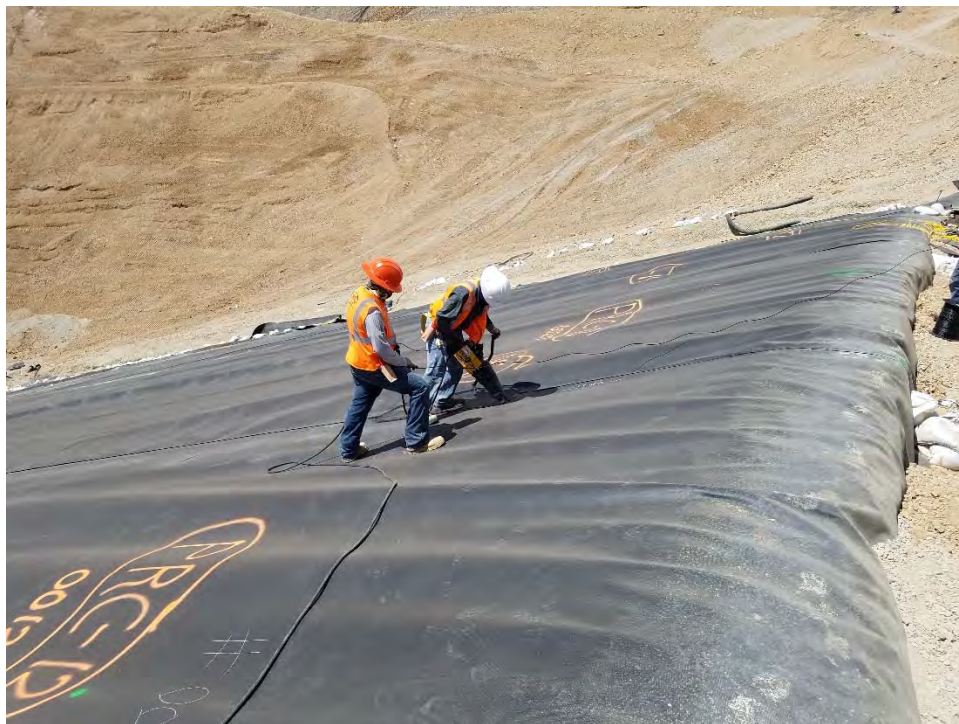
Performing Repairs

All the marked defects were repaired using the extrusion welding method. No vacuum testing was performed.

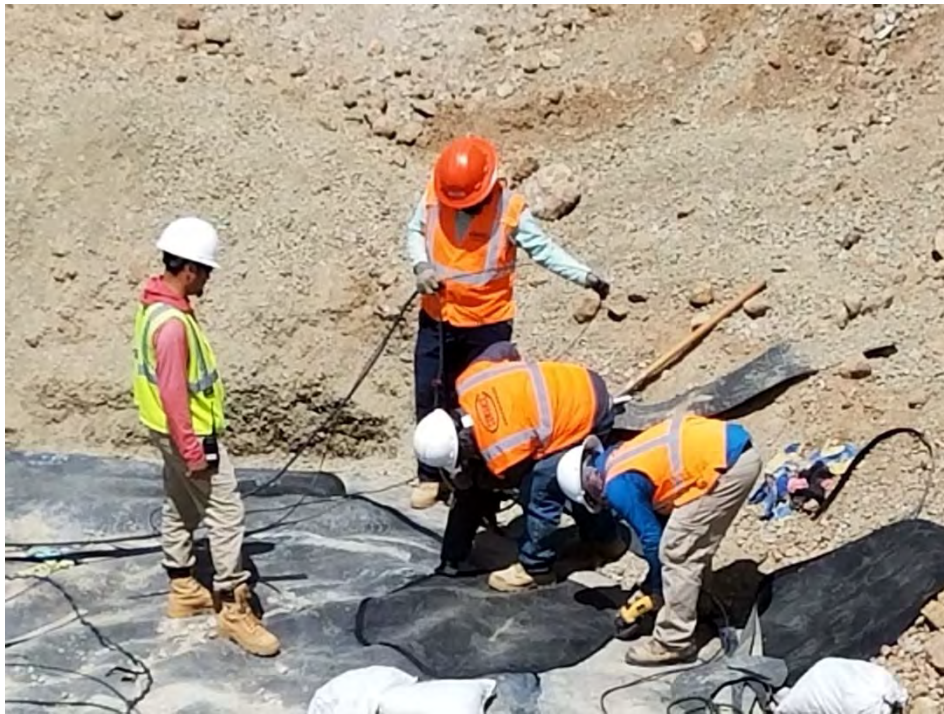
Repair Activities

Repair activities and non-destructive testing were performed throughout the shift. RCDF-9 was backtracked and the limits of the failing seam were identified. The identified area was repaired and tested also. All repairs and testing results met project specifications. Sand bags were filled and staged preparing for subsequent work activities.
