MINERALS PROGRAM INSPECTION REPORT
PHONE: (303) 866-3567

MINE NAME: Argo Gravel Pit	MINE/PROSPECTING ID#: M-1978-267	MINERAL: Sand and gravel	COUNTY: Otero
INSPECTION TYPE: Monitoring	INSPECTOR(S): Amy Eschberger	INSP. DATE: September 13, 2018	INSP. TIME: 10:20
OPERATOR: Otero County	OPERATOR REPRESENTATIVE: Lex Nichols	TYPE OF OPERATION: 112c - Construction Regular Operation	
REASON FOR INSPECTION: Normal I&E Program	BOND CALCULATION TYPE: None	BOND AMOUNT: \$0.00	
DATE OF COMPLAINT: NA	POST INSP. CONTACTS: None	JOINT INSP. AGENCY: None	
WEATHER: Clear	INSPECTOR'S SIGNATURE:

M1978-267 / Argo Gravel Pit / Otero County

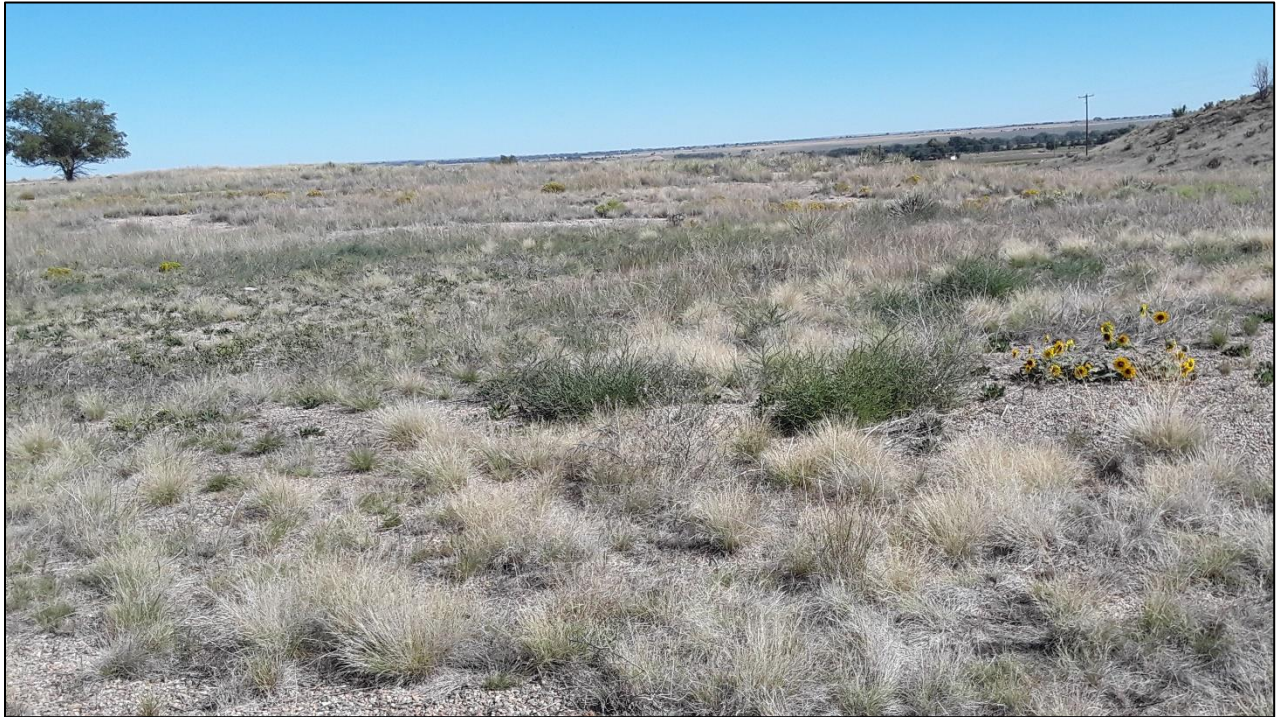
During the current inspection, the Division observed the west ridge to have much better vegetative cover than observed three years ago (**Photos 1-6**). Vegetation in this area consists of native grasses, forbs, shrubs, a few trees, and some annual weeds. The majority of the west ridge has been successfully reclaimed. However, the Division observed an area approximately 0.3 acre in size located near the central portion of the west ridge to have very little to no vegetative cover (**Photos 7 and 8**). Mr. Nichols indicated they will scarify the soil, add more topsoil if needed, and reseed and mulch this area, potentially this fall.

Photo 1. View looking northwest across southeastern portion of west ridge, showing vegetative cover present in this area.

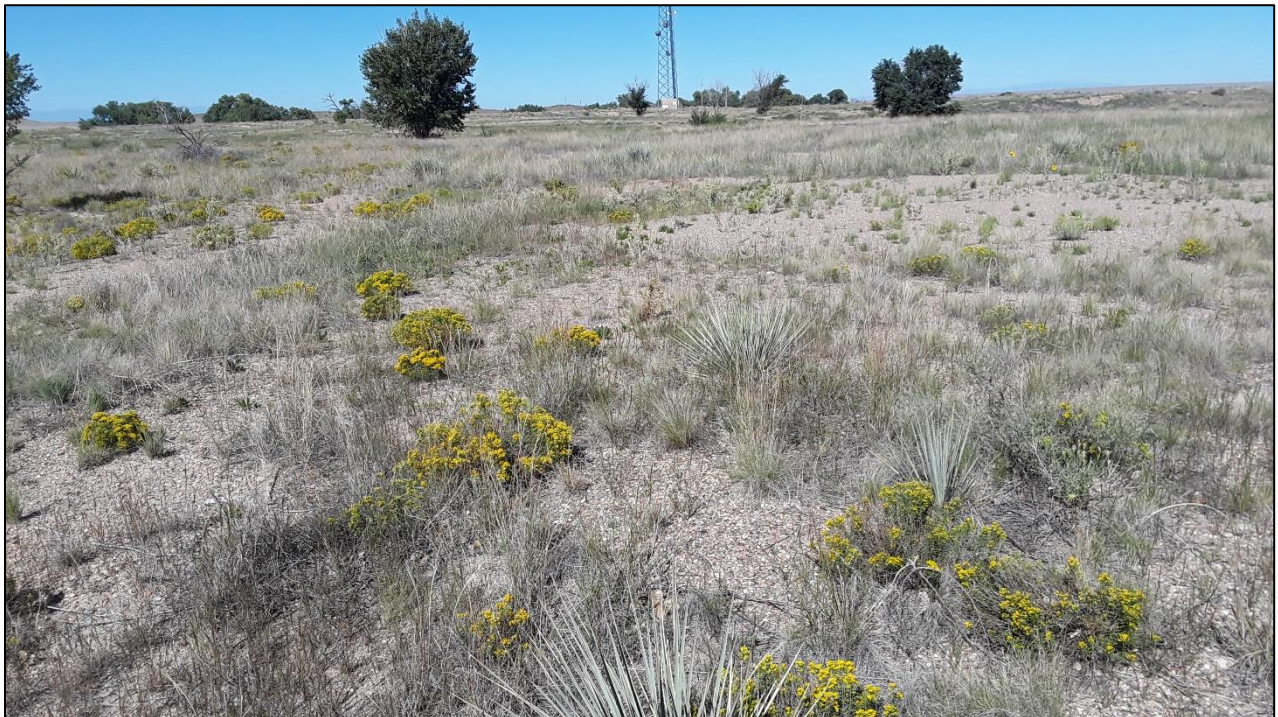
Photo 2. View looking west across southwestern portion of west ridge, showing vegetative cover present in this area.

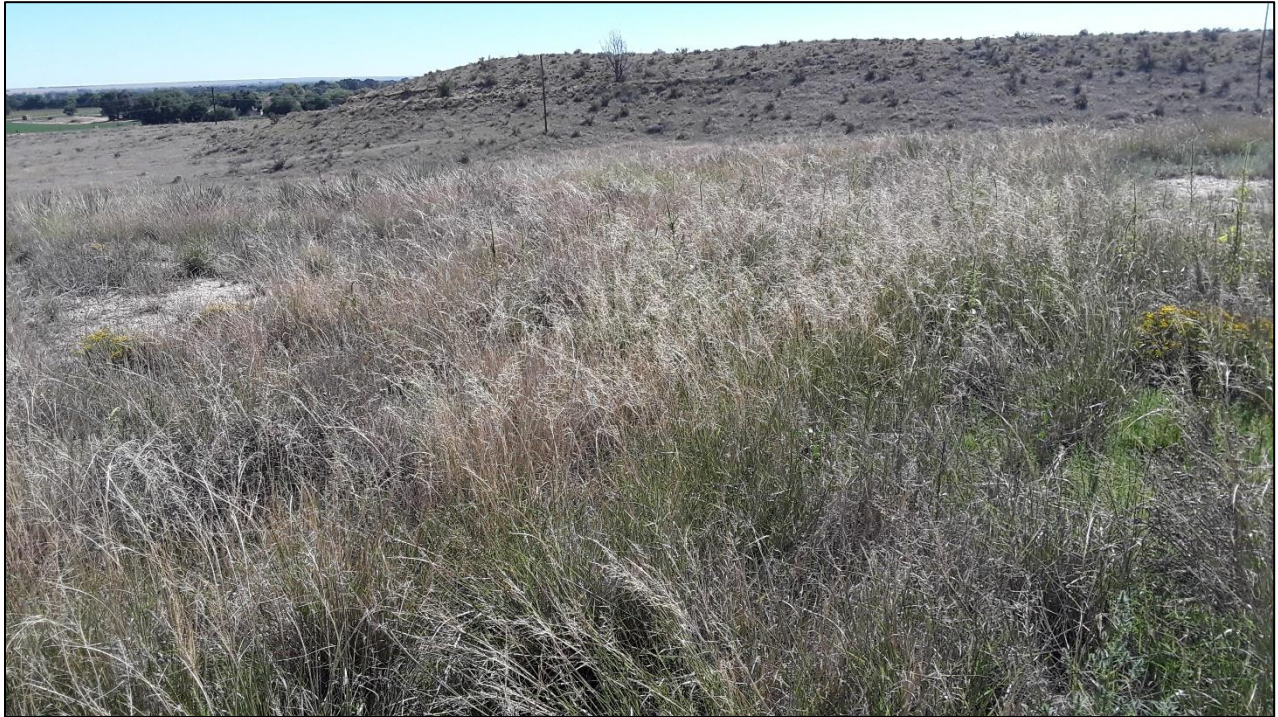
Photo 3. View looking northeast across northern edge of west ridge, showing vegetative cover present in this area.

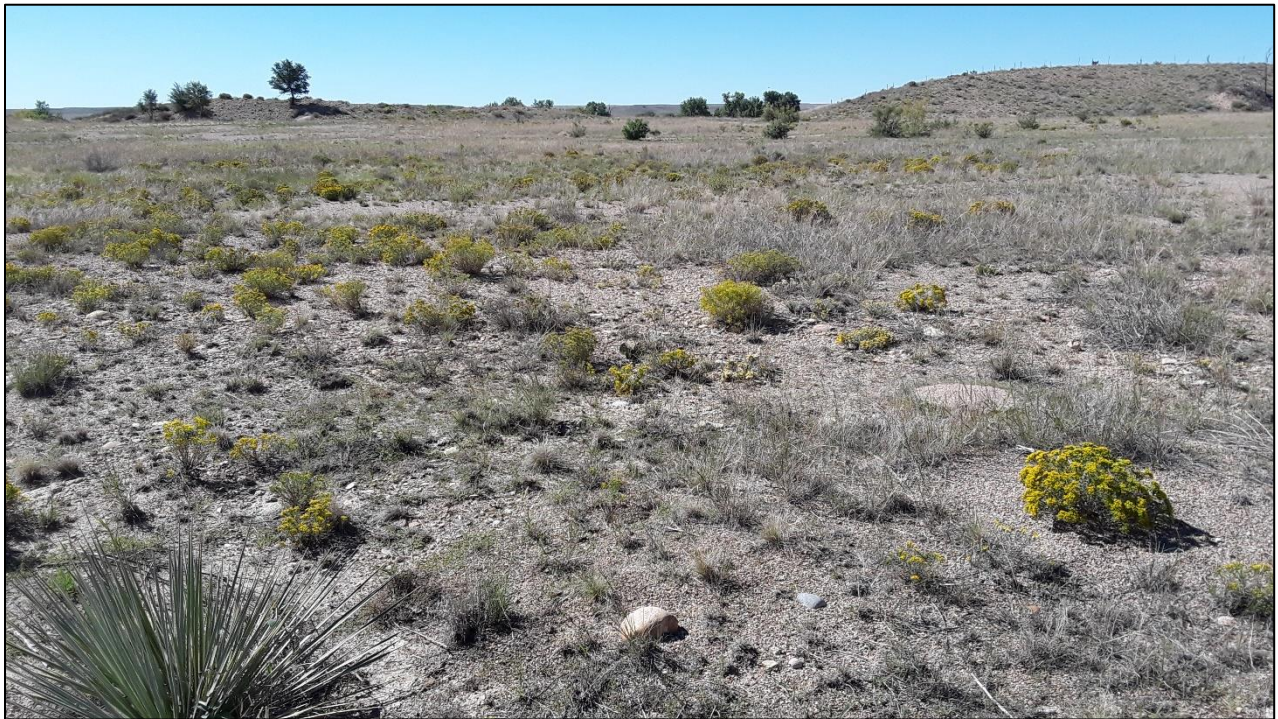
Photo 4. View looking southwest across southwestern portion of west ridge, showing vegetative cover present in this area.

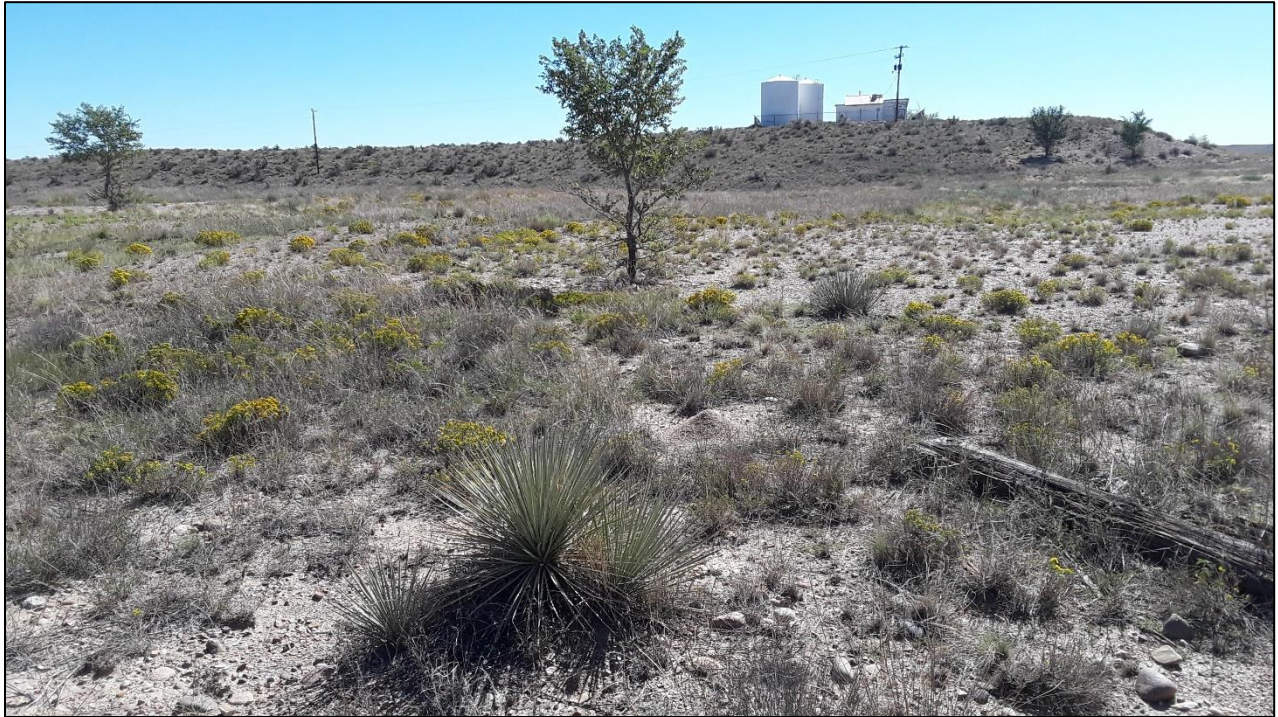
Photo 5. View looking east across southern portion of west ridge, showing vegetative cover present in this area.

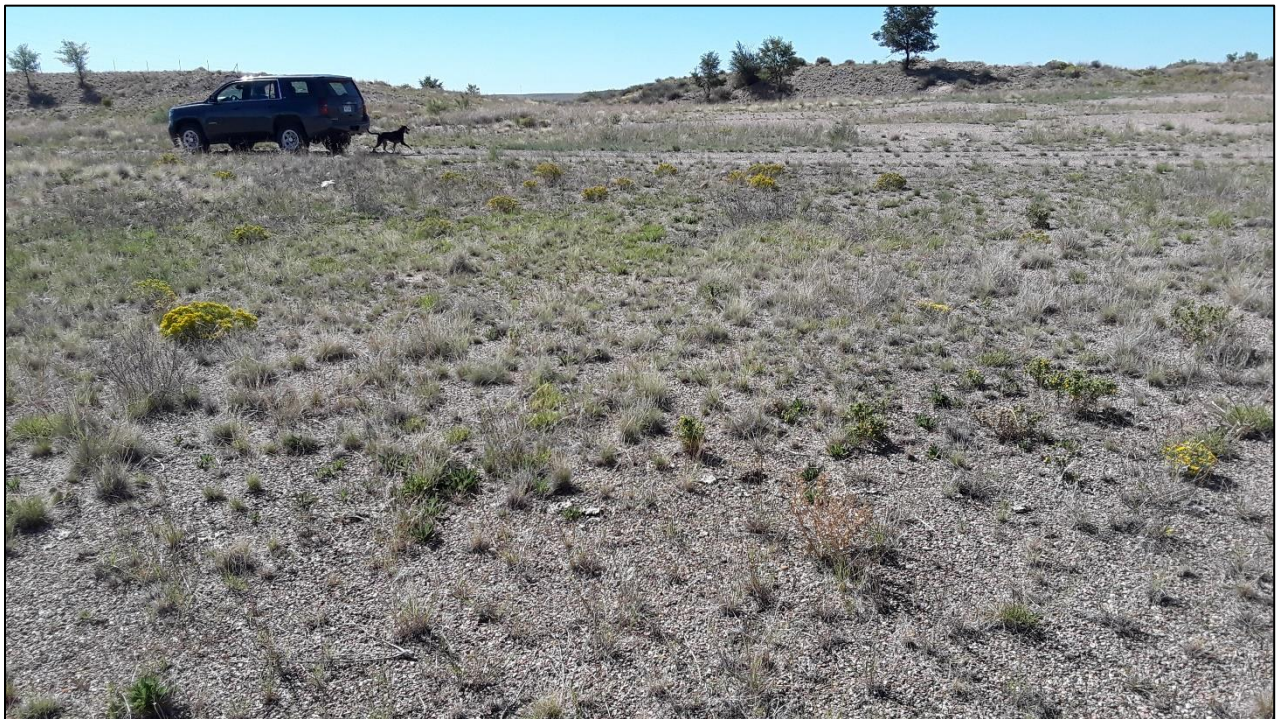
Photo 6. View looking south across area between west ridge and access road, showing vegetative cover present in this area.

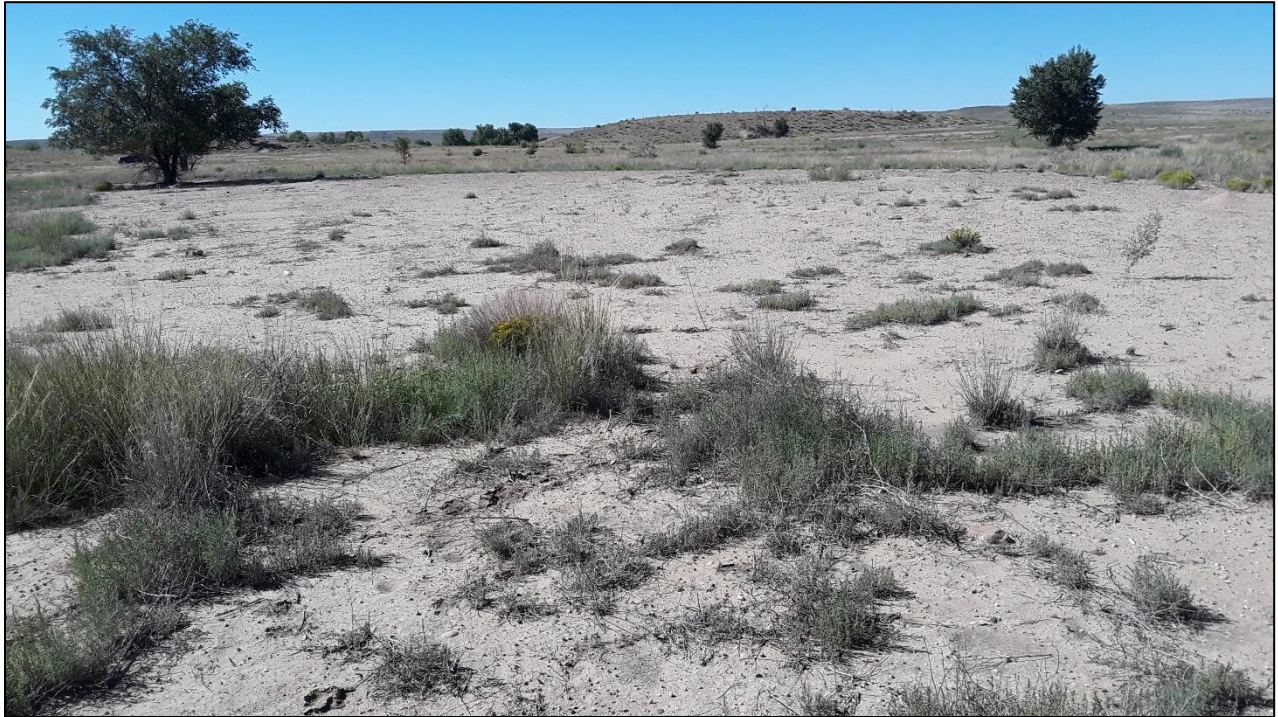
Photo 7. View looking south across central portion of west ridge, showing area with little to no vegetative cover.

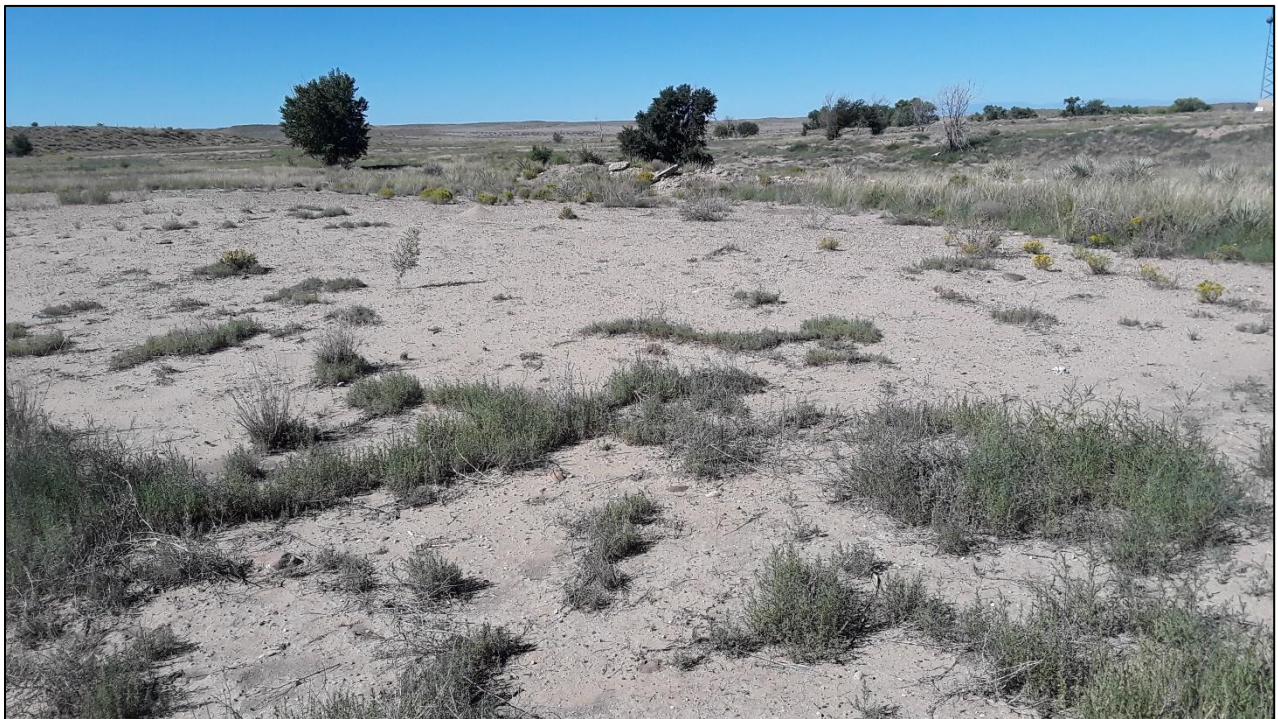
Photo 8. View looking west across central portion of west ridge, showing area with little to no vegetative cover.

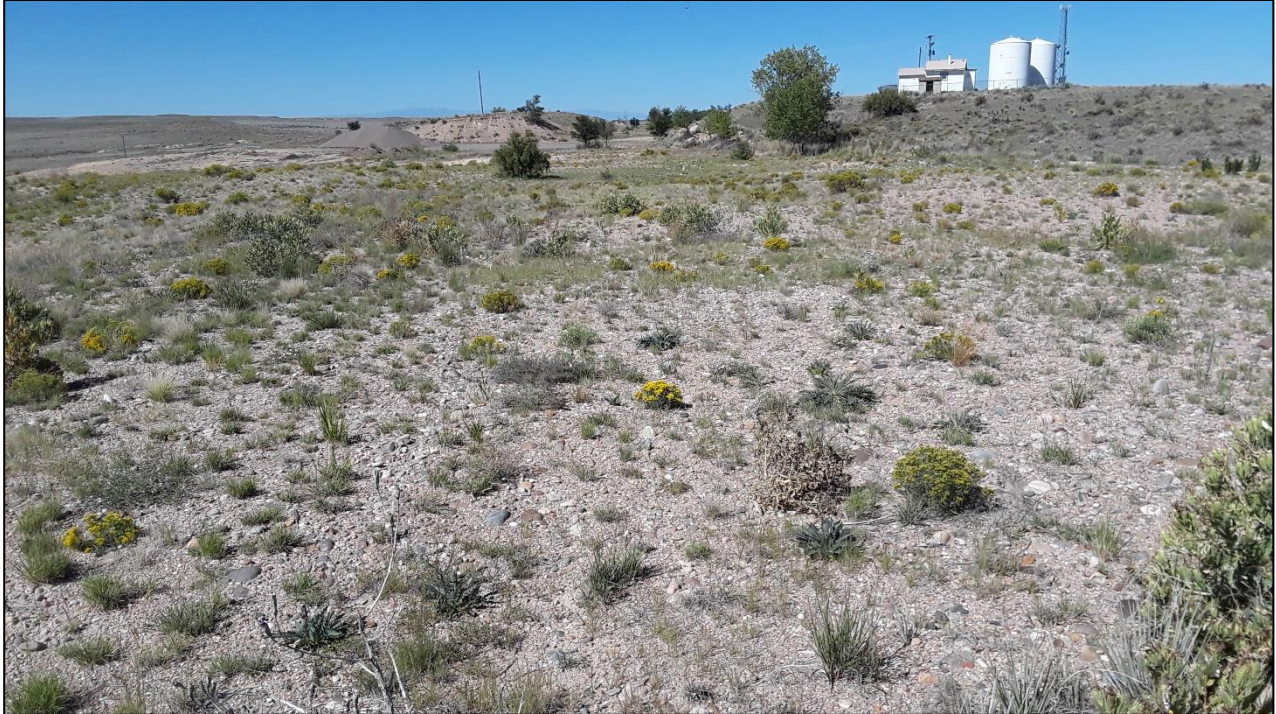
The Division observed the eastern portion of the east ridge to be well vegetated with native grasses, forbs, shrubs, and some annual weeds (**Photos 9 and 10**). The western portion is now utilized as a permanent chip storage area (**Photo 11**), as approved in 2016 with Technical Revision No. 1. This area will not be revegetated for reclamation. The southern slope (just east of the chip storage area), had very little to no vegetative cover (**Photos 12-14**). This slope had some erosional damage in the form of rilling and a few gullies. Mr. Nichols indicated they will repair the erosional damage, add more topsoil if needed, and reseed and mulch (possibly hydroseed) this slope. The operator will work to control erosion on this slope possibly by tracking and placing straw wattles along contour.

Photo 9. View looking west across eastern portion of east ridge, showing vegetative cover present in this area.

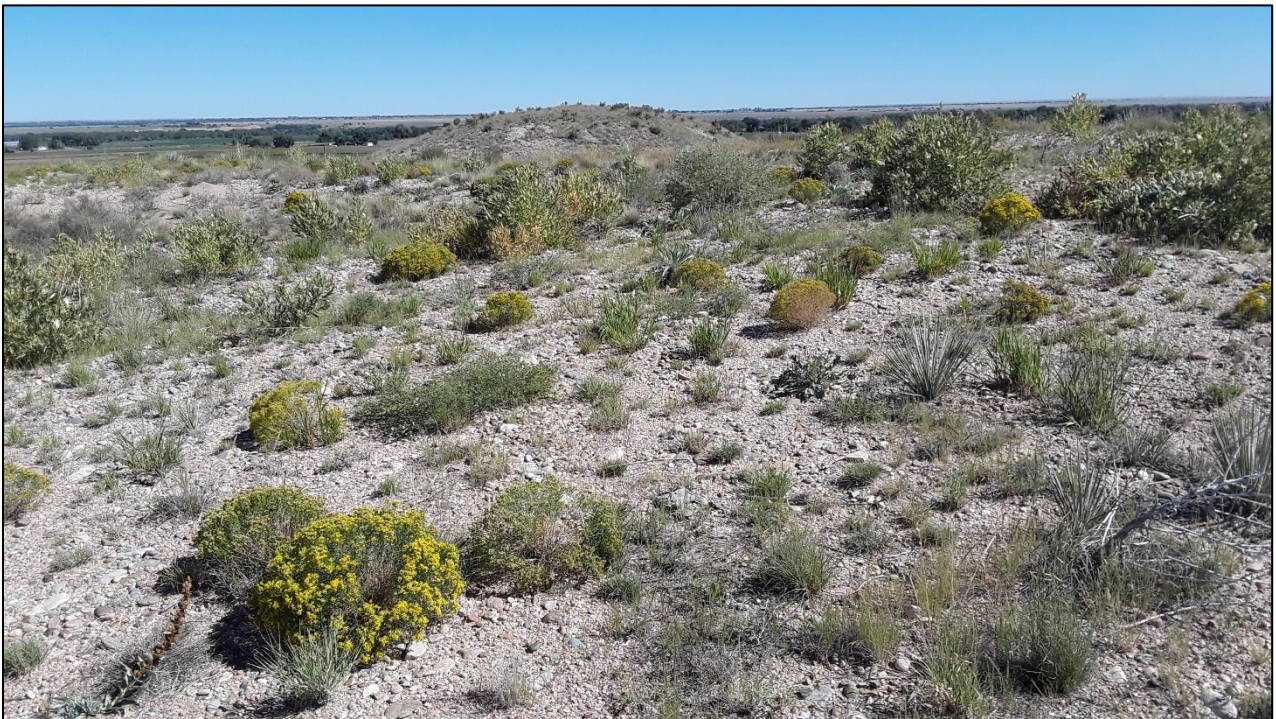
Photo 10. View looking north across eastern portion of east ridge, showing vegetative cover present in this area.

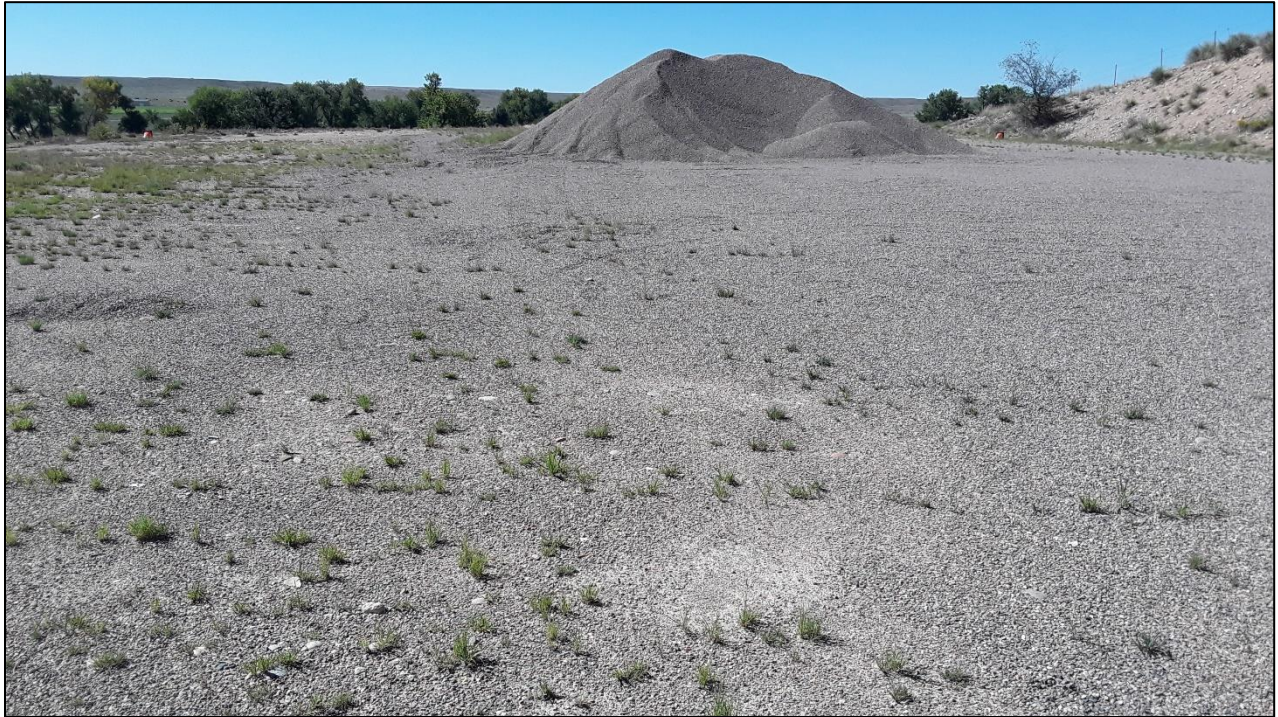
Photo 11. View looking west across chip storage area located in western portion of east ridge. This storage area will remain as-is for county use without revegetation.

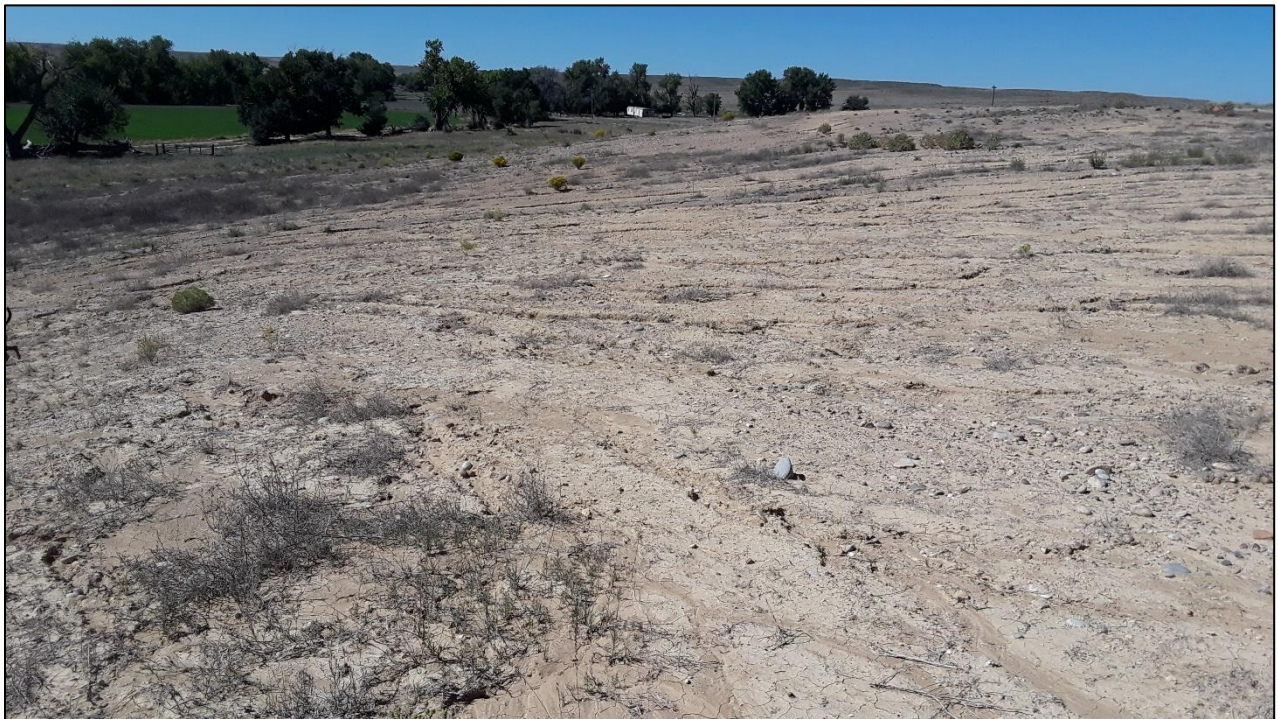
Photo 12. View looking southwest across southern slope of east ridge requiring erosion repair and additional revegetation efforts. The slope is flatter than the required 3H:1V gradient; however, it may require additional measures such as tracking along contour to help control erosion and retain moisture for planted seed.

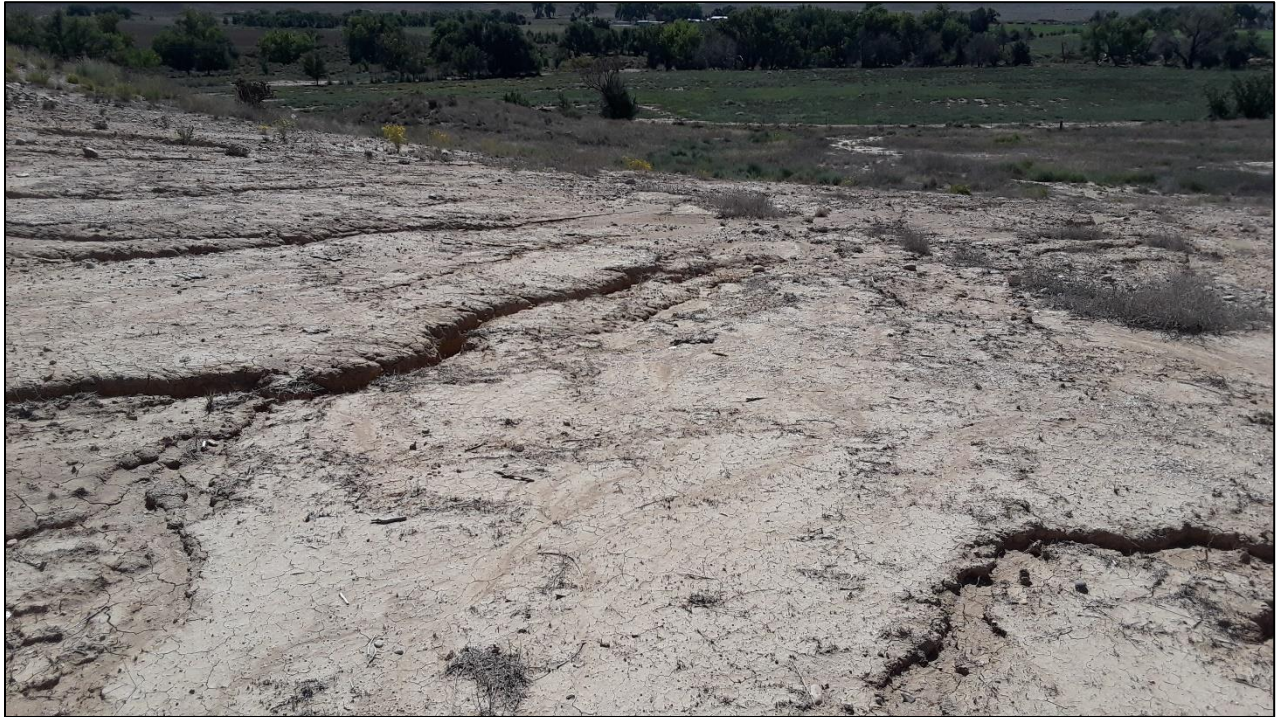
Photo 13. Closer view of southern slope of east ridge requiring erosion repair and additional revegetation efforts.

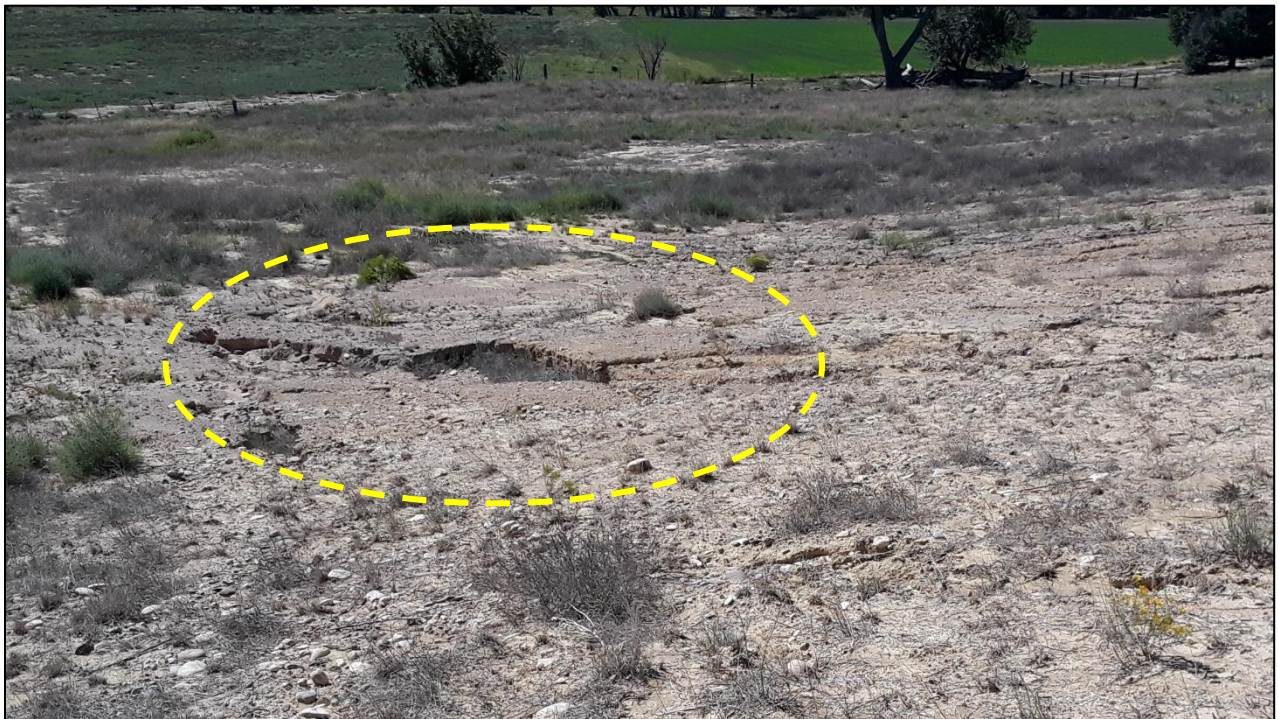
Photo 14. Closer view of southern slope of east ridge requiring erosion repair and additional revegetation efforts, showing erosion gully (indicated) present at approximately mid-slope.
