## MINERALS PROGRAM INSPECTION REPORT

<b>MINE NAME:</b> Shangri La Pit	<b>MINE/PROSPECTING ID#:</b> M-1989-024	<b>MINERAL:</b> Gravel	<b>COUNTY:</b> Custer
<b>INSPECTION TYPE:</b> Monitoring	<b>INSPECTOR(S):</b> Timothy A. Cazier	<b>INSP. DATE:</b> October 2, 2018	<b>INSP. TIME:</b> 15:00
<b>OPERATOR:</b> Edward M. Yaklich	<b>OPERATOR REPRESENTATIVE:</b> Joanie Yaklich and John Houston	<b>TYPE OF OPERATION:</b> 110c - Construction Limited Impact	
<b>REASON FOR INSPECTION:</b> Normal I&E Program	<b>BOND CALCULATION TYPE:</b> None	<b>BOND AMOUNT:</b> \$5,000.00	
<b>DATE OF COMPLAINT:</b> NA	<b>POST INSP. CONTACTS:</b> None	<b>JOINT INSP. AGENCY:</b> None	
<b>WEATHER:</b> Cloudy	<b>INSPECTOR'S SIGNATURE:</b>

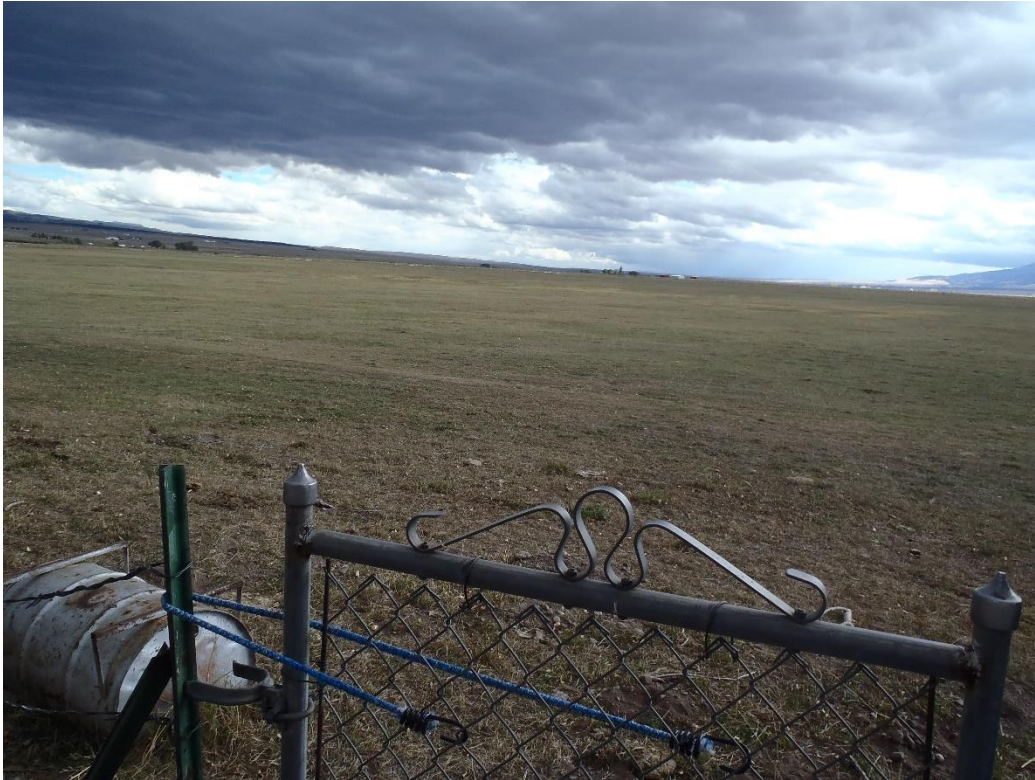
No mining equipment was operating or present at the time of the inspection. The site representatives indicated that the mining project never commenced. No mining disturbance was observed during the inspection. Based on the conditions observed at the site during the inspection (see **Photos 1 and 2**), it appears no mining ever took place on the site. As mining has not been initiated, a permit sign and boundary markers are not required.

Photo 1. Proposed location (looking SE from gate on south side of residence).

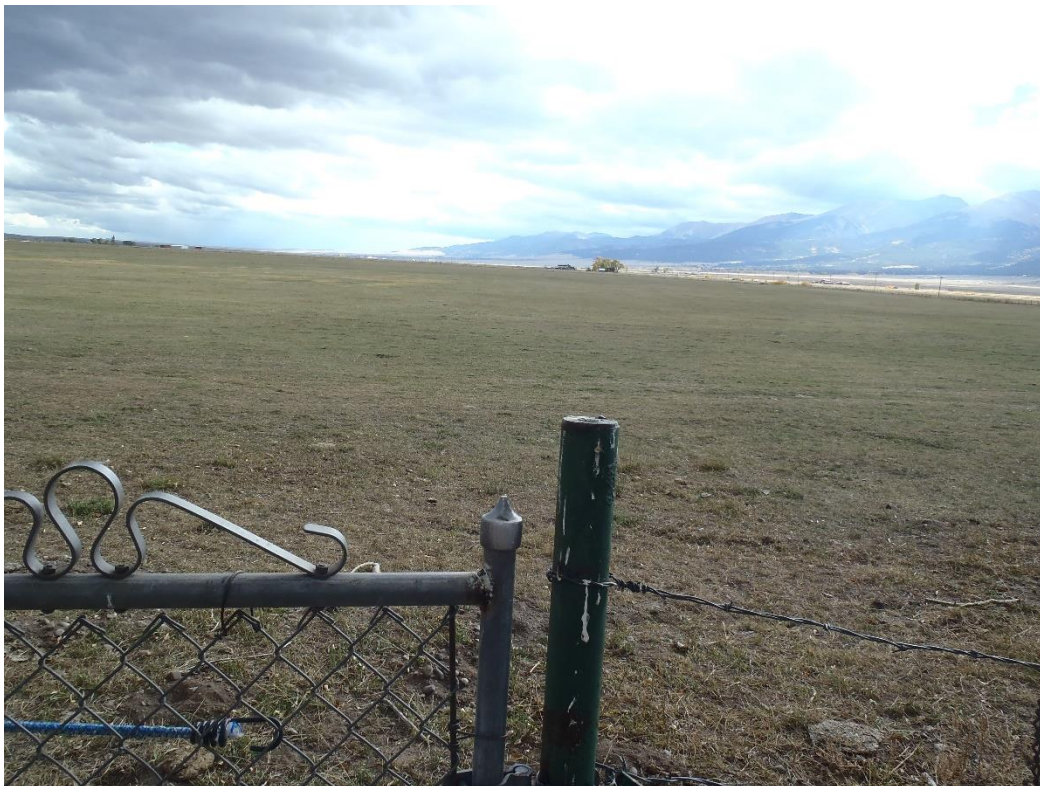
Photo 2. Proposed location (looking SW from gate on south side of residence).
