MINERALS PROGRAM INSPECTION REPORT
PHONE: (303) 866-3567

MINE NAME: AMSO RD&D Project-Phase 1	MINE/PROSPECTING ID#: P-2008-046	MINERAL: Oil shale	COUNTY: Rio Blanco
INSPECTION TYPE: Mineral Prospect Inspection	INSPECTOR(S): Travis H. Marshall	INSP. DATE: September 25, 2018	INSP. TIME: 12:00
OPERATOR: American Shale Oil, LLC	OPERATOR REPRESENTATIVE: Bruce Smith	TYPE OF OPERATION: MP - Mineral Prospecting	
REASON FOR INSPECTION: Normal I&e Program	BOND CALCULATION TYPE: Complete Bond	BOND AMOUNT: \$46,789.00	
DATE OF COMPLAINT: NA	POST INSP. CONTACTS: U.S.BLM	JOINT INSP. AGENCY: None	
WEATHER: Clear	INSPECTOR'S SIGNATURE:

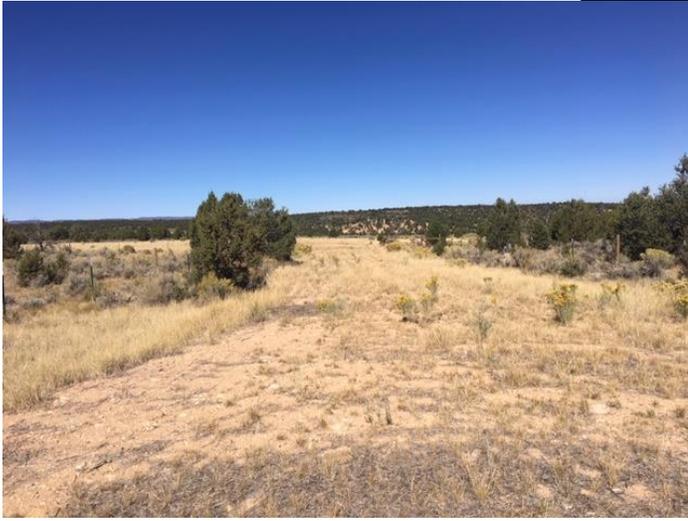
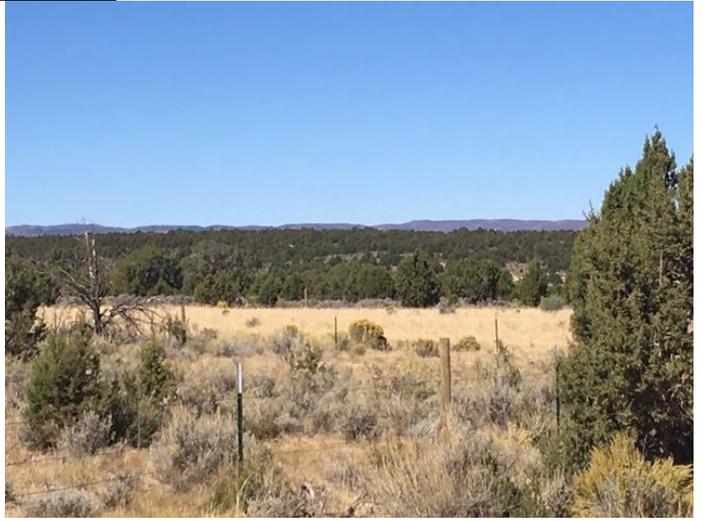
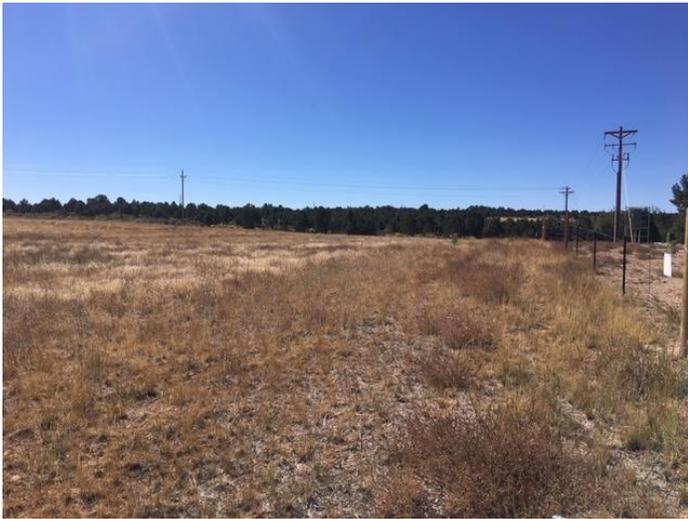
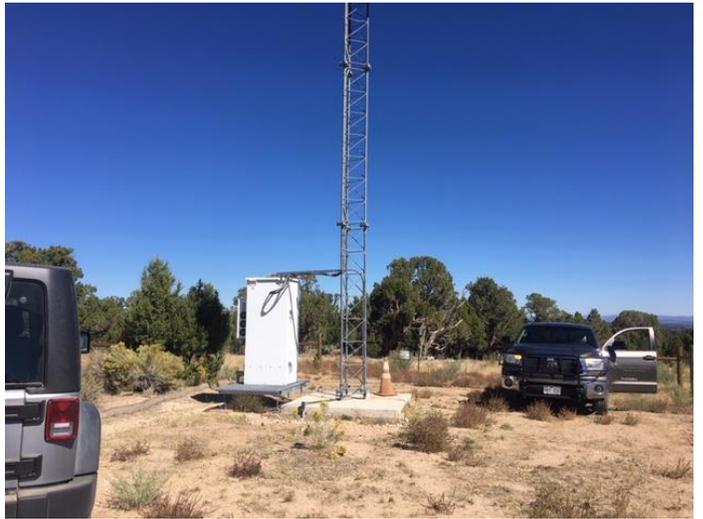
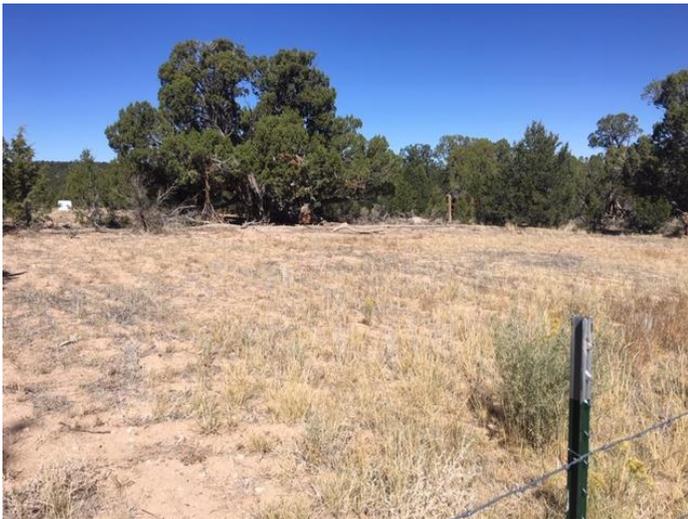
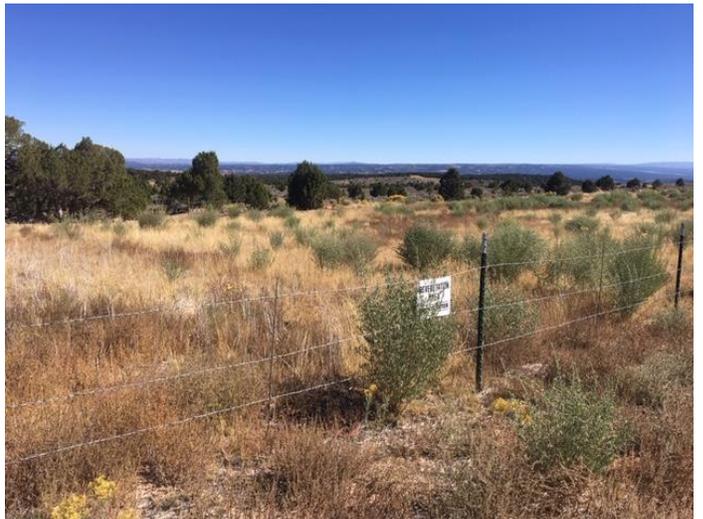
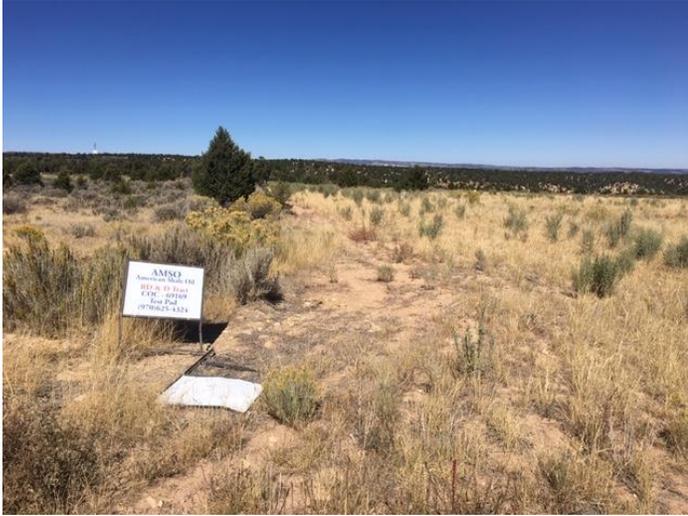
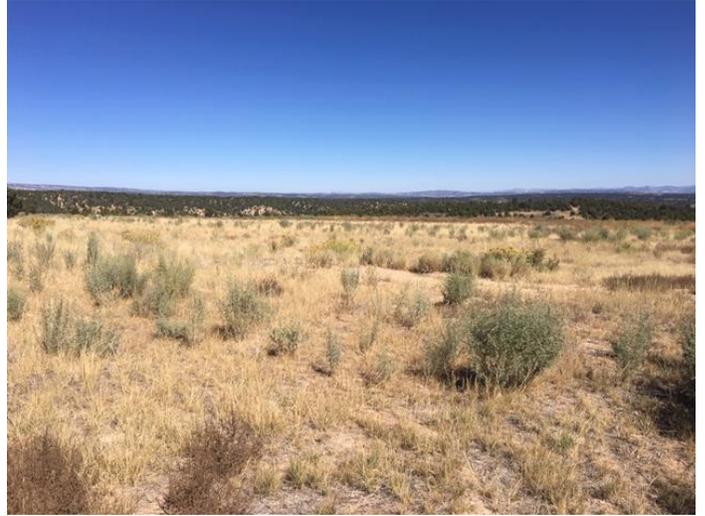
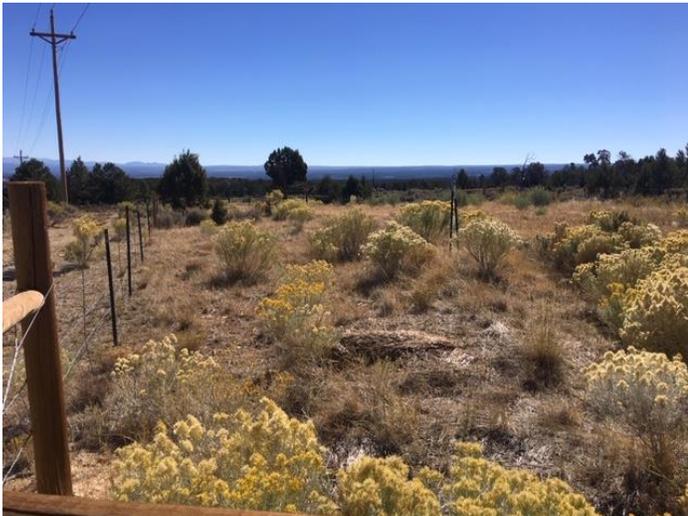
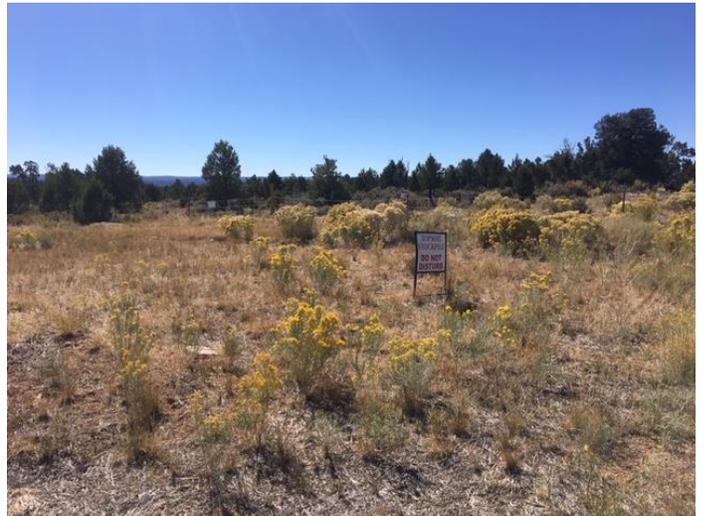
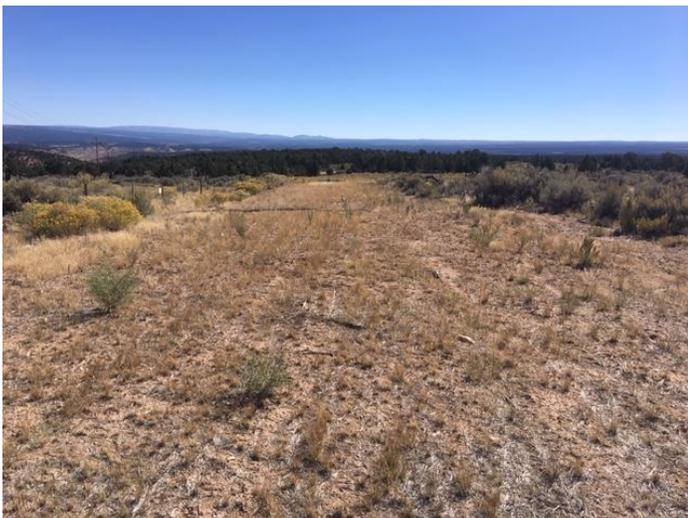
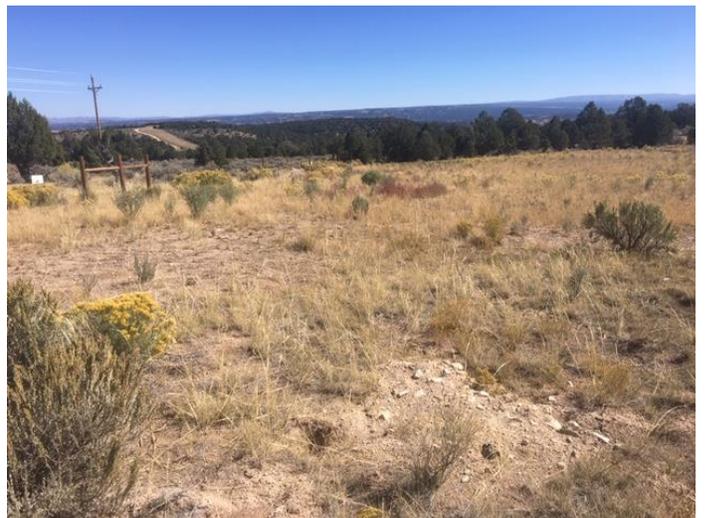
Photos that show the conditions observed during the September 25, 2018 inspection are included at the end of this report.
