## CDRMS Permit C-1981-022 third quarter Pond Inspection and Coal Mine Refuse Pile Inspection Reports

**Re: Oxbow Mining, LLC., CDRMS Permit C-1981-022,**  
**3rd Quarter 2018 Pond Inspection Report and 3rd Quarter 2018 Coal Mine Refuse**  
**Pile Inspection Report.**

## THIRD QUARTER 2018 POND INSPECTION REPORT

THIRD QUARTER 2018 ENGINEERING INSPECTION  
EAST YARD, WEST VALLEY FILL AND II WEST COAL MINE WASTE DISPOSAL PILES

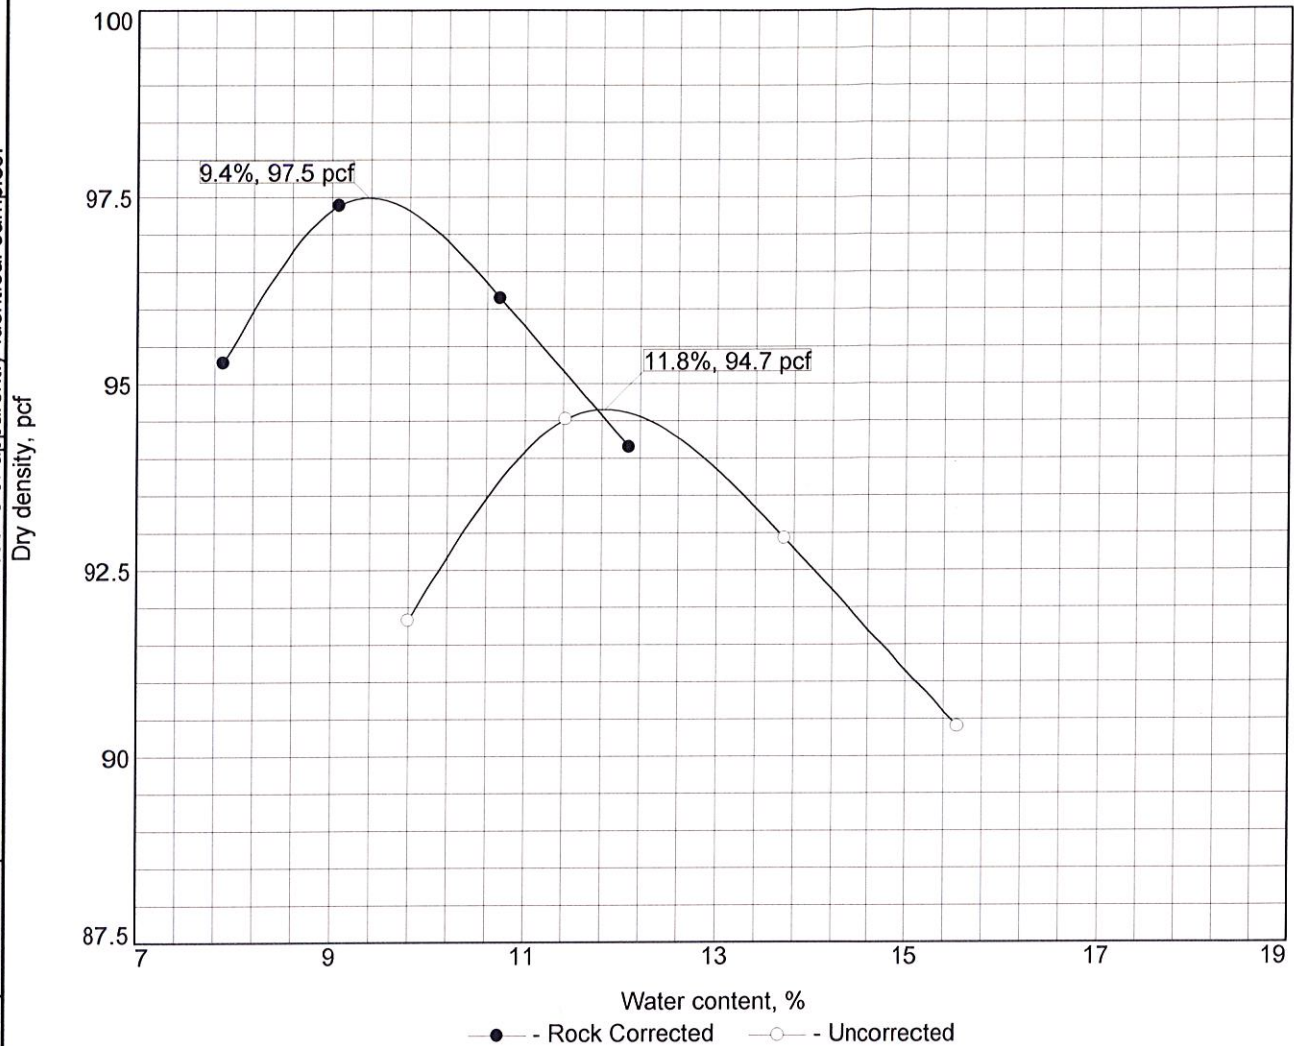
# MOISTURE-DENSITY RELATIONSHIP

Elev/ Depth	Classification		Nat. Moist.	Sp.G.	LL	PI	% > 3/4 in.	% < No.200
	USCS	AASHTO						
northside							26.9	
ROCK CORRECTED TEST RESULTS			UNCORRECTED		MATERIAL DESCRIPTION			
Maximum dry density = 97.5 pcf			94.7 pcf		gray to black clayey COAL TAILINGS with some sand and gravel (ASTM D2488)			
Optimum moisture = 9.4 %			11.8 %					
<b>Project No.</b> 7141.74902.01 <b>Client:</b> Oxbow Mine <b>Project:</b> Oxbow Mine Gob Testing Somerset, CO <b>Source of Sample:</b> West Valley 1 - Top <b>Sample Number:</b> 6						<b>Remarks:</b>

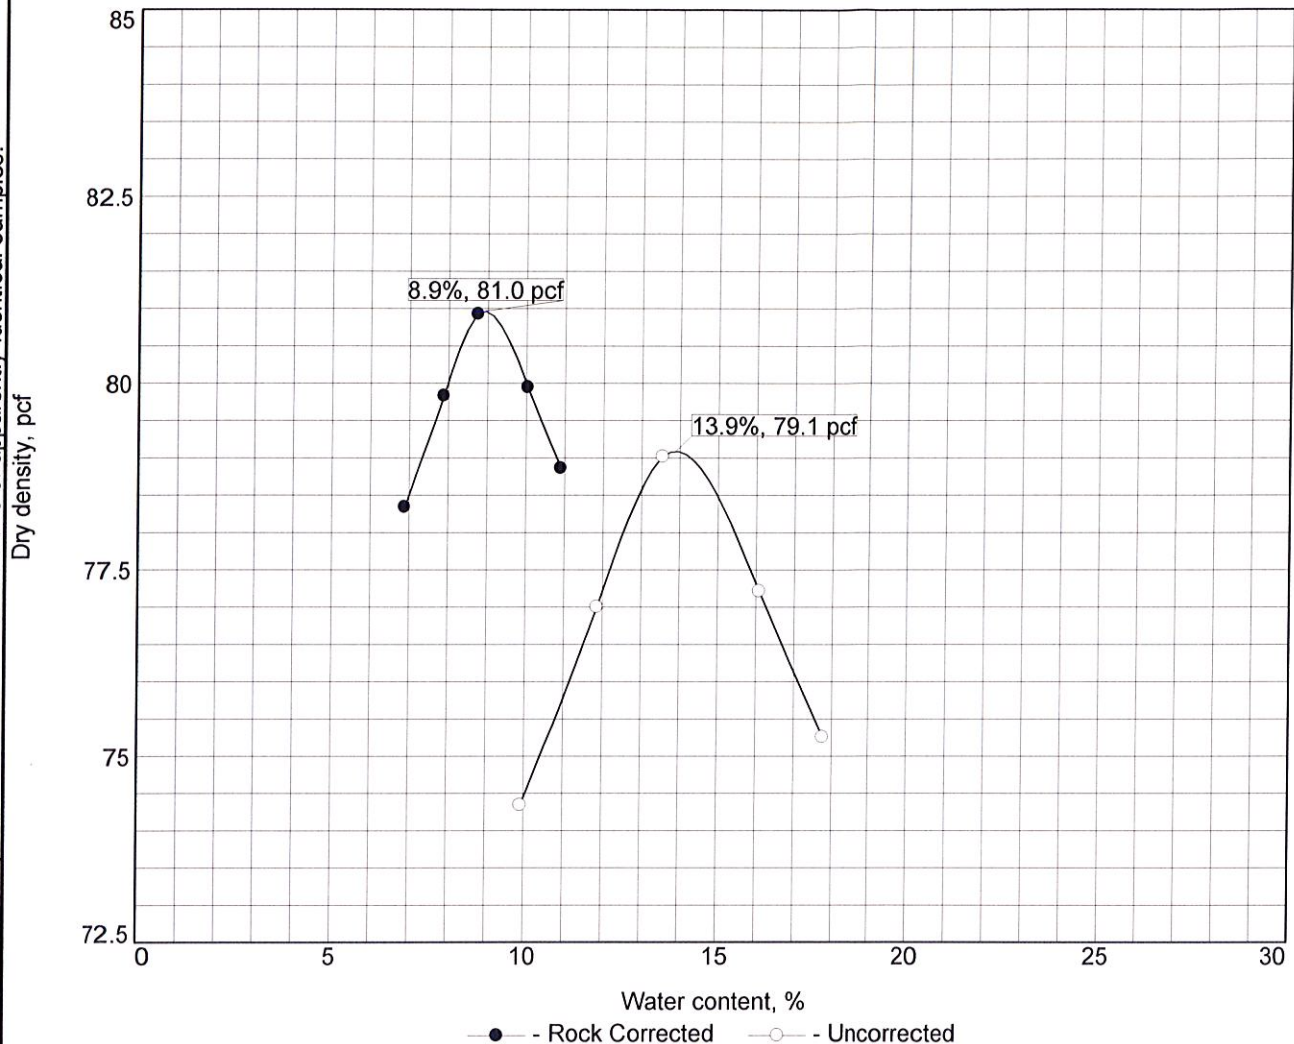
## MOISTURE-DENSITY RELATIONSHIP

ROCK CORRECTED TEST RESULTS	UNCORRECTED	MATERIAL DESCRIPTION
Maximum dry density = 81.0 pcf	79.1 pcf	black sandy COAL TAILINGS with gravel (ASTM D2488)
Optimum moisture = 8.9 %	13.9 %
