PERMIT INFORMATION

Permit Number: C-1983-059 Mine Name: Terror Creek Loadout Operator: Oxbow Mining, LLC Operator Address: Mr. Doug Smith PO Box 535 Paonia, CO 81434	County: Delta Operation Type: Loadout Permit Status: Active Ownership: Private
	Operator Representative Present: Doug Smith
Operator Representative Signature: (Field Issuance Only)

INSPECTION INFORMATION

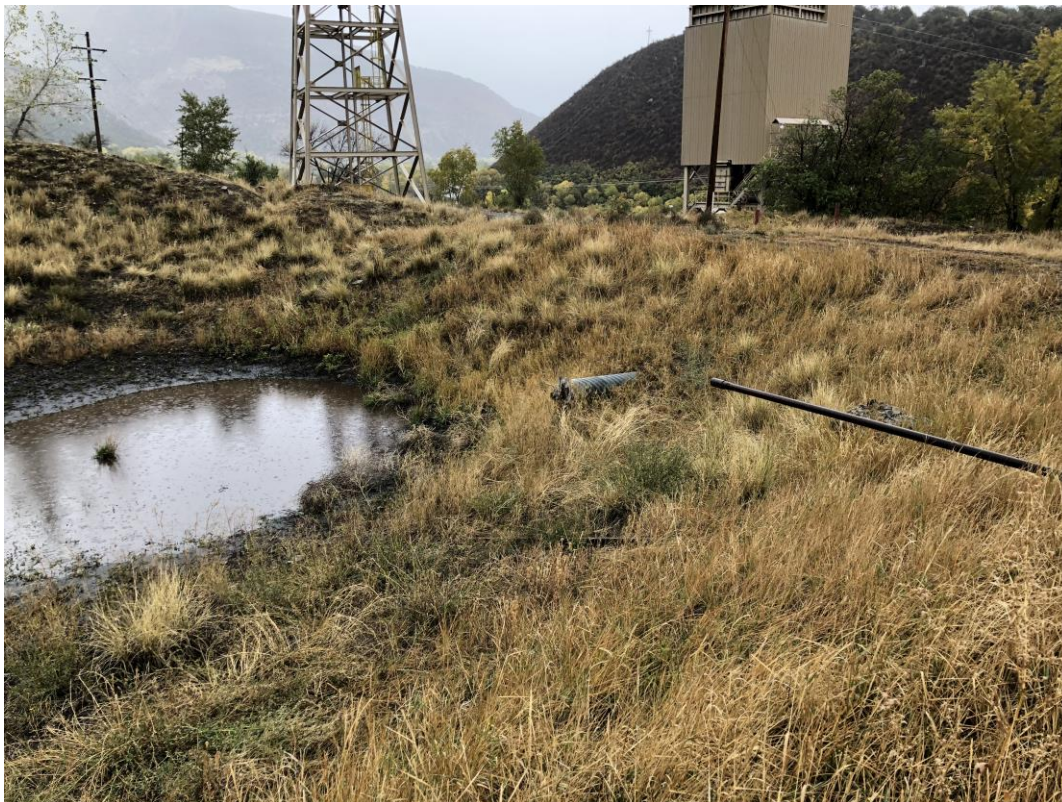
Sediment Pond

The East Yard Pond was not discharging, and no problems were seen with this structure.

The Dugout Pond was empty, and no problems were seen with this structure.

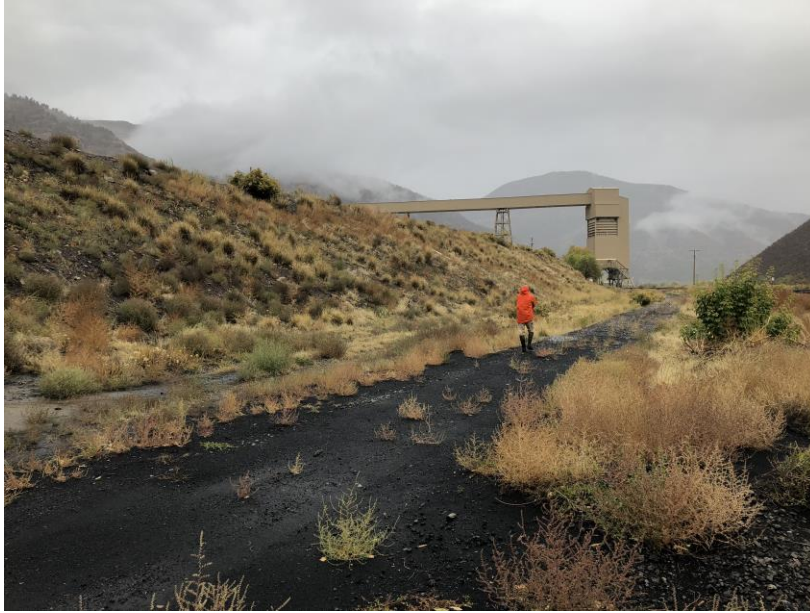
Area 9 and hill below former coal storage area, looking east

No erosion problems were seen around the site, including the steep hill down to the railroad tracks.

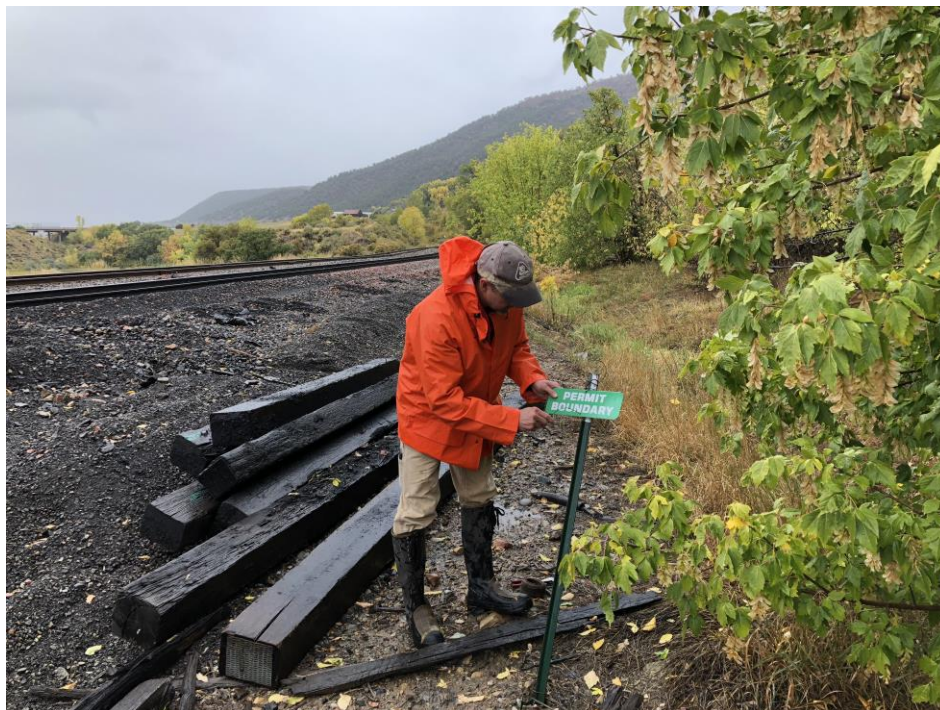
Doug installed two permit boundary signs along the railroad tracks near the west end of the site.

Doug Smith replacing boundary sign
