COLORADO
Division of Reclamation,
Mining and Safety
Department of Natural Resources

PERMIT INFORMATION

Permit Number: C-1983-059 Mine Name: Terror Creek Loadout Operator: Oxbow Mining, LLC Operator Address: Mr. Doug Smith PO Box 535 Paonia, CO 81434	County: Delta Operation Type: Loadout Permit Status: Active Ownership: Private
	Operator Representative Present: Doug Smith
Operator Representative Signature: (Field Issuance Only)

Inspection Start Date: October 11, 2018 Inspection Start Time: 09:45 Inspection End Date: October 11, 2018 Inspection End Time: 10:45		Inspection Type: Coal Partial Inspection Inspection Reason: Normal I&E Program Weather: Raining	
Joint Inspection Agency: None		Joint Inspection Contacts: 	
Post Inspection Agency: None		Post Inspection Contacts: 	
Inspector(s): Robert D. Zuber, P.E.	Inspector's Signature:

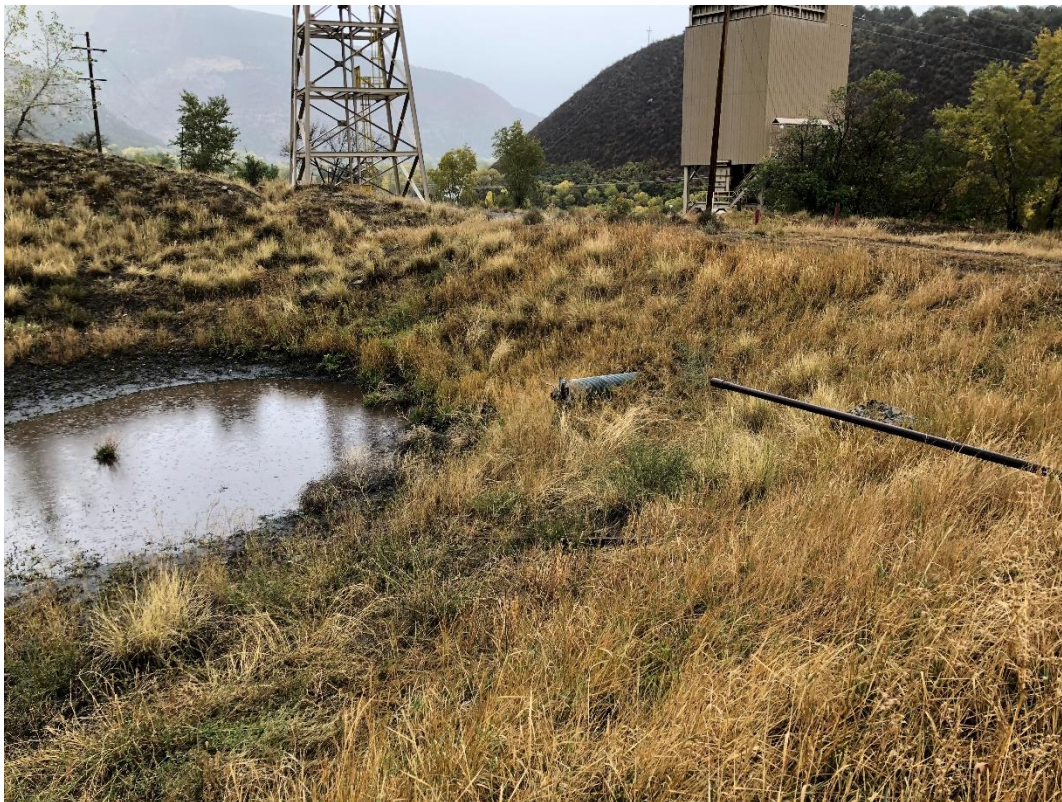
The Sediment Pond was not discharging, and no problems were seen with this structure.

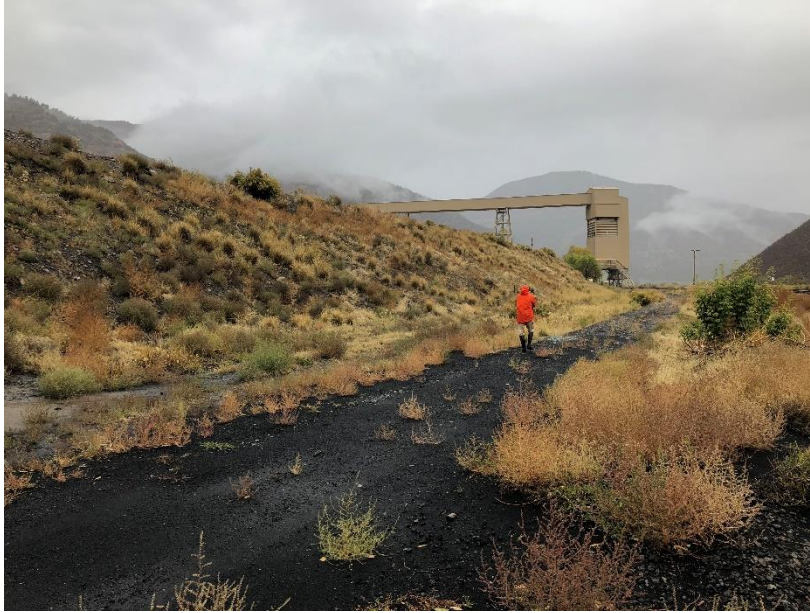
No erosion problems were seen around the site, including the steep hill down to the railroad tracks.

Area 9 and hill below former coal storage area, looking east

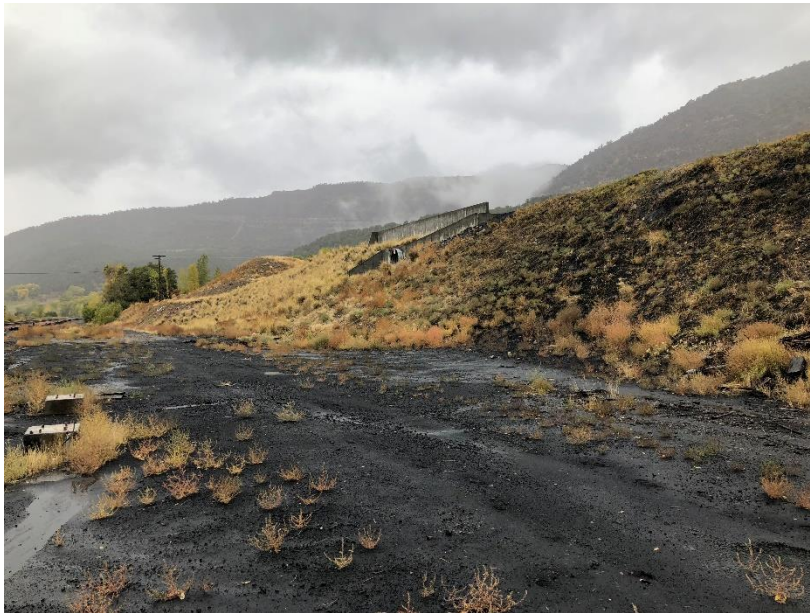
Area 9 and hill below former coal storage area, looking west

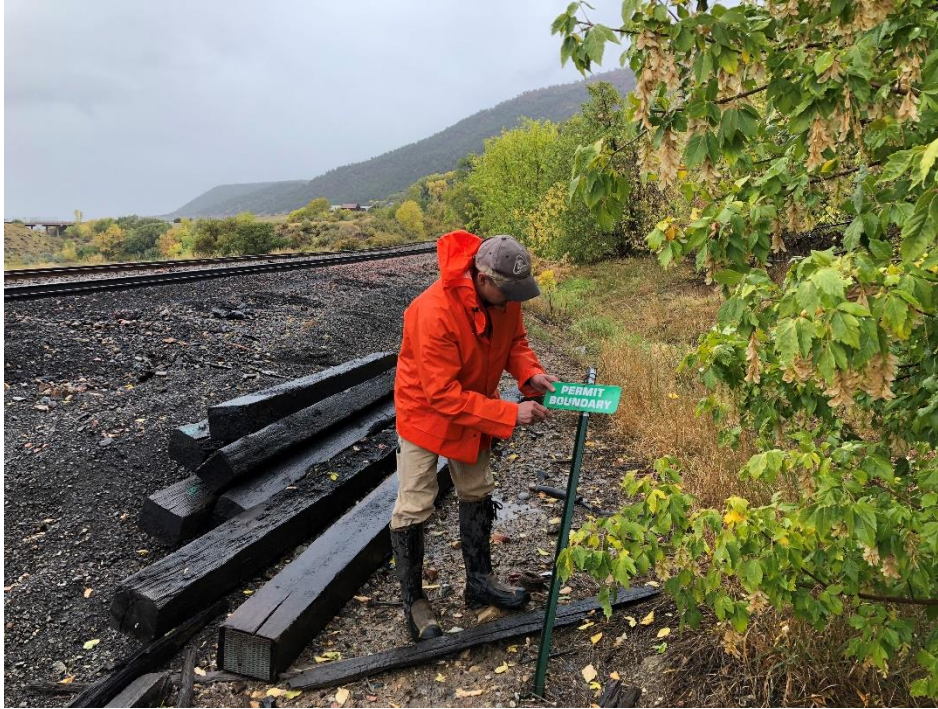
Doug installed two permit boundary signs along the railroad tracks near the west end of the site.

Doug Smith replacing boundary sign
