COLORADO
Division of Reclamation,
Mining and Safety
Department of Natural Resources

Permit Number: C-1981-022 Mine Name: Elk Creek Mine Operator: Oxbow Mining, LLC Operator Address: Mr. Doug Smith 3737 Hwy 133 P. O. Box 535 Somerset, CO 81434	County: Delta, Gunnison Operation Type: Underground Permit Status: Active Ownership: Federal
	Operator Representative Present: Doug Smith
Operator Representative Signature: (Field Issuance Only)

Inspection Start Date: October 10, 2018 Inspection Start Time: 14:00 Inspection End Date: October 11, 2018 Inspection End Time: 08:50		Inspection Type: Coal Partial Inspection Inspection Reason: Normal I&E Program Weather: Cloudy	
Joint Inspection Agency: None		Joint Inspection Contacts: 	
Post Inspection Agency: None		Post Inspection Contacts: 	
Inspector(s): Robert D. Zuber, P.E.	Inspector's Signature:

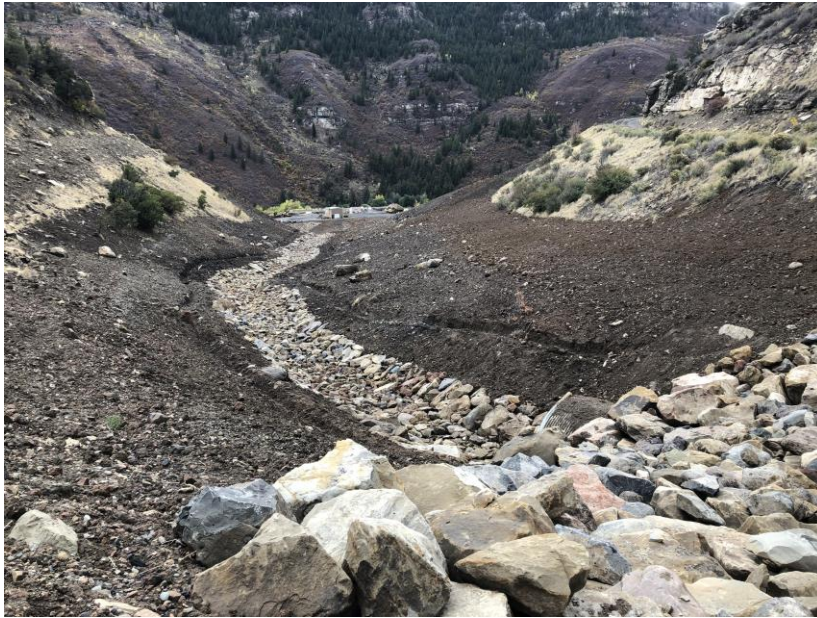
Elk Creek reconstruction

Reconstruction of Elk Creek was apparently done well. The riprap was large enough for the design (D50 greater than 12 inches at steep sections), and smaller rocks were placed in between the larger rocks and boulders, which will reduce the possibility of erosion. The slope near the bottom of the channel (which appears to be the steepest

section of this reconstructed channel) was measured with a clinometer and estimated to be 12 percent; this is within the specification of a maximum of 13 percent. The depth of the channel and bottom width of the channel are greater than the specifications of 1.8 feet and 10 feet, respectively, at all locations inspected (most of the reconstructed channel). This channel will not see runoff from the recently reclaimed areas to the east and the west of the channel, as long as T1 and T2 ditches remain in place.

Check dams may be needed in the future in T1 and T2, especially in the steep portion near the bottom of the Elk Creek reconstruction. These channels should be monitored closely.

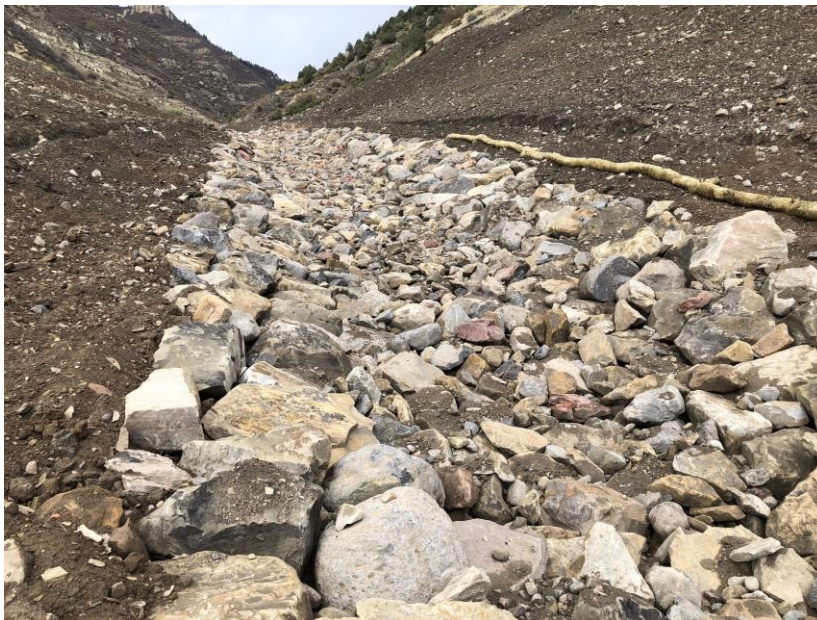
Riprap in Elk Creek channel

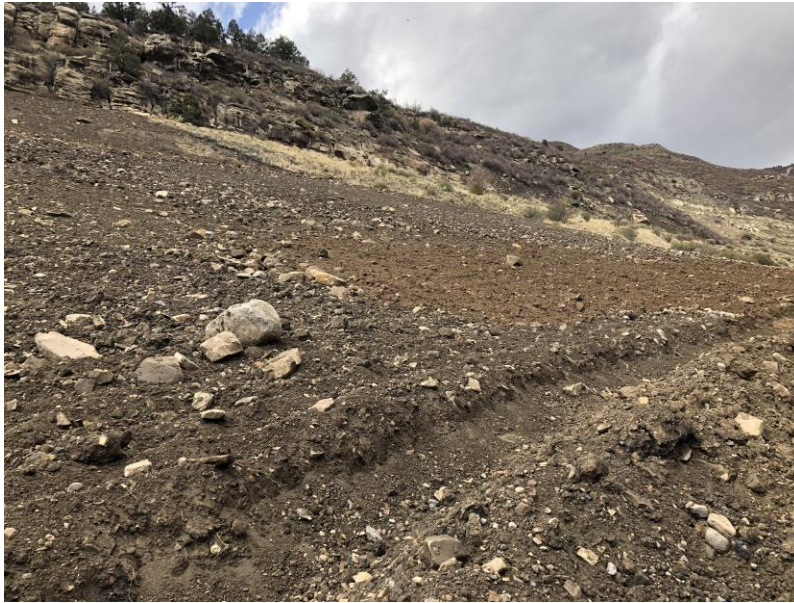
Reclamation beside Elk Creek channel with temporary ditch at lower right

Wattles are needed at several locations on the mine site, including the reclamation above the Elk Creek channel and the bottom of the II West Coal Refuse Facility. All wattles, including those already placed, should be trenched in the ground (approximately four inches) to be effective.

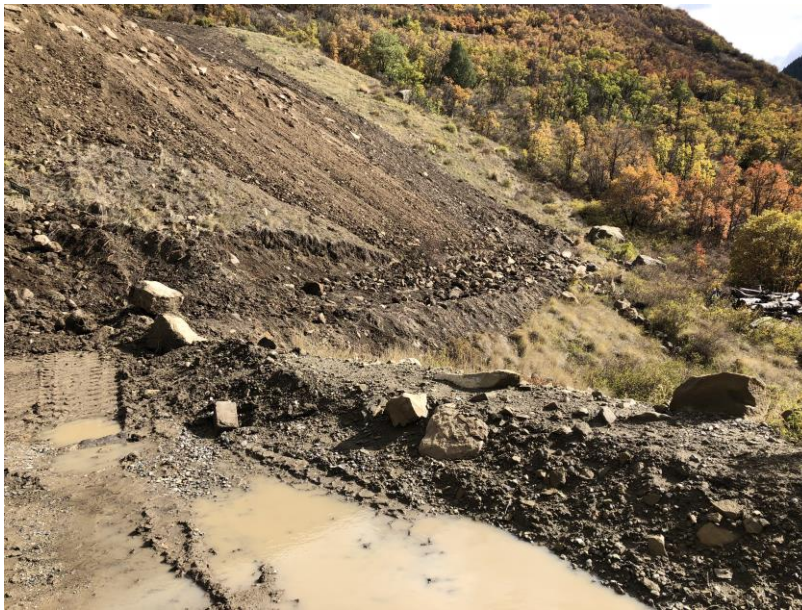
At the Upper Elk Creek Pad, an operator was moving soil on the topsoil stockpile to improve access to it. The soil has filled the ditch below it; this needs to be remedied in near future. Doug Smith said that this would be done this week.

Ditch below topsoil stockpile (at Upper Elk Creek Pad) needs to be cleared of soil

No problems were seen at the Upper Elk Creek Pad other than the need for a ditch below the topsoil stockpile. The hill below the water tanks was stable.

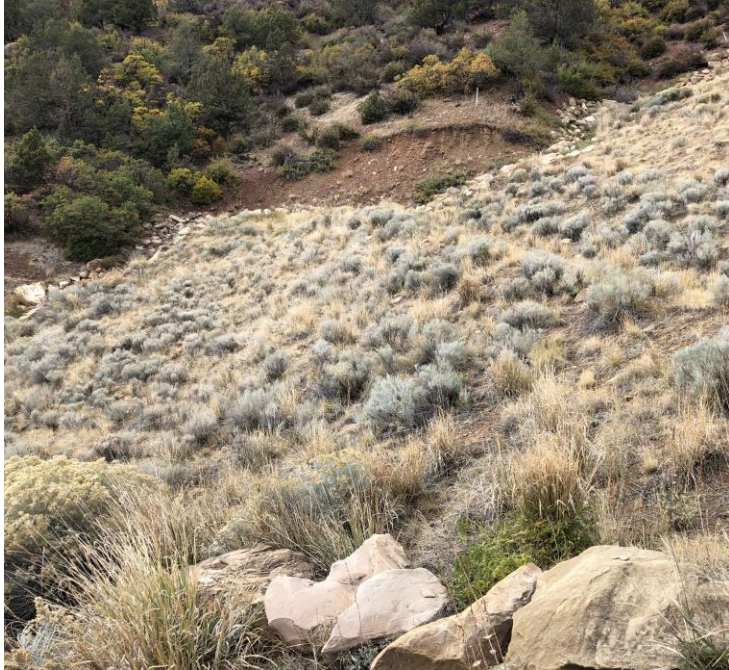
II West Coal Refuse Facility

No erosion or other problems were seen with the recent reclamation of the West Valley Coal Refuse Facility or II West Coal Refuse Facility; they both appeared stable at the time of the inspection.

The side ditches at the II West facility have the following dimensions: the west ditch (larger one receiving runoff from channel above the fill) is 3 – 4 feet deep and approximately 4 feet wide at the bottom. The east ditch is approximately 2 feet deep and approximately 3 feet wide at the bottom.

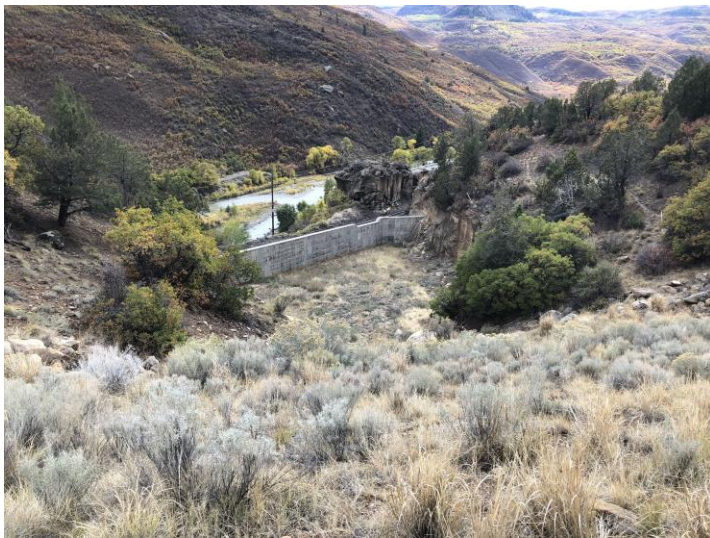
Pond E

Ponds C and E were empty and no problems were seen.

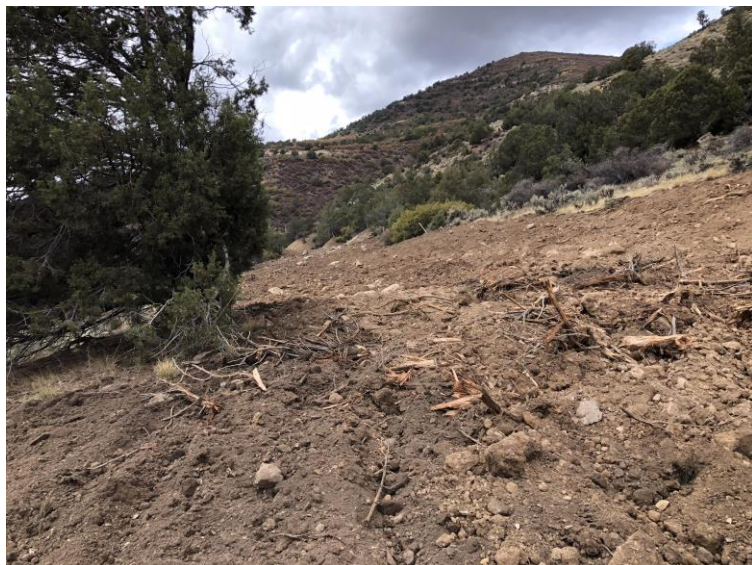
Reclaimed haul road

The II West Haul Road has been reclaimed. Some seeding (east end) had not been completed at the time of the inspection.

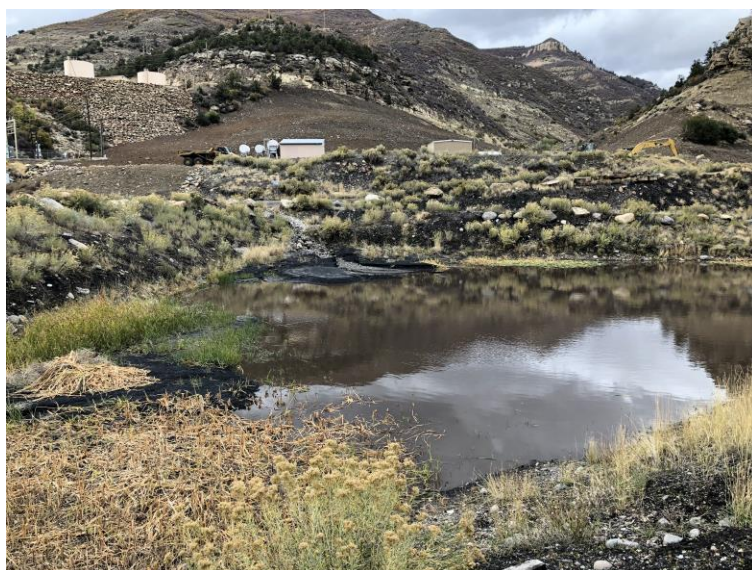
Pond B was holding water but not discharging. The elevations of the water line and emergency spillway invert were estimated with a laser tool (TruPulse 360R), and the difference was 6.5 feet. This value is larger than the elevation difference required for capacity for the 10-year event (4.9 feet per Exhibit 2.05-E3 in the PAP). Given this fact in light of recent rains, the pond is in compliance and may, in fact, be over designed at this time, which is prudent and an acceptable practice to the Division.

The bank below Pond B is very steep and has many coal fines on it. Doug Smith indicated that this area was disturbed pre-SMCRA; he also indicated that Oxbow may be compiling information on such areas in anticipation of bond release applications. This would be beneficial, and should be done in near future, if possible.

Given the change of its function (it no longer receives mine water but now receives runoff that previously went to Pond D), it is uncertain if Pond B is large enough. This should be confirmed by Oxbow.

The culverts below T1 and T2 should be routinely checked and cleared of sediment. One of the culverts between these channels and Pond B included sediment during the inspection and should be cleared.
