**COLORADO**  
Division of Reclamation,  
Mining and Safety  
Department of Natural Resources

<b>Permit Number:</b> C-1980-007 <b>Mine Name:</b> West Elk Mine <b>Operator:</b> Mountain Coal Company, LLC <b>Operator Address:</b> Ms. Kathleen G. Welt 5174 Highway 133 Somerset, CO 81434	<b>County:</b> Delta, Gunnison <b>Operation Type:</b> Underground <b>Permit Status:</b> Active <b>Ownership:</b> Federal
	<b>Operator Representative Present:</b>  Mike Peacock
<b>Operator Representative Signature: (Field Issuance Only)</b>

<b>Inspection Start Date:</b> October 11, 2018 <b>Inspection Start Time:</b> 12:00 <b>Inspection End Date:</b> October 11, 2018 <b>Inspection End Time:</b> 14:30		<b>Inspection Type:</b> Coal Partial Inspection <b>Inspection Reason:</b> Normal I&E Program <b>Weather:</b> Raining	
<b>Joint Inspection Agency:</b>  None		<b>Joint Inspection Contacts:</b>  	
<b>Post Inspection Agency:</b>  None		<b>Post Inspection Contacts:</b>  	
<b>Inspector(s):</b>  Robert D. Zuber, P.E.	<b>Inspector's Signature:</b>

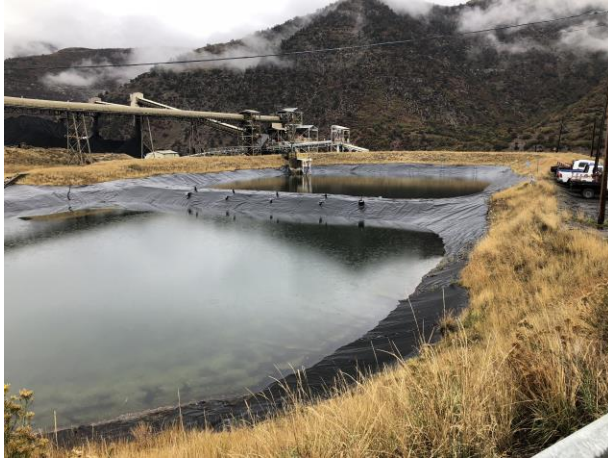
**Fresh Water Pond**

The water in the Fresh Water Pond and FW2 was several feet below the top of the liner, which is several feet below the top of the pond.

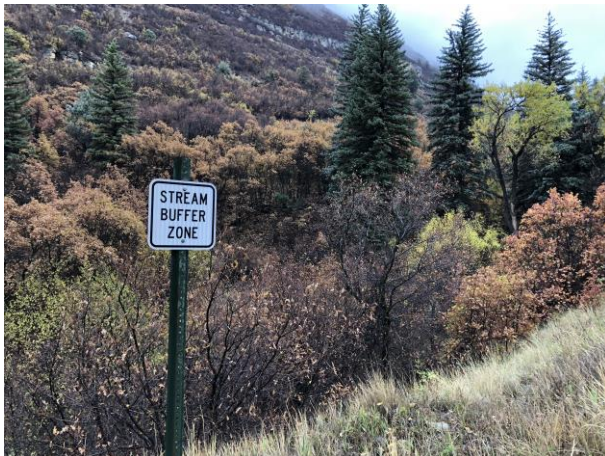
**Stream buffer marker**

Stream buffer markers were found along Sylvester Gulch and by the MB5-E Pond.

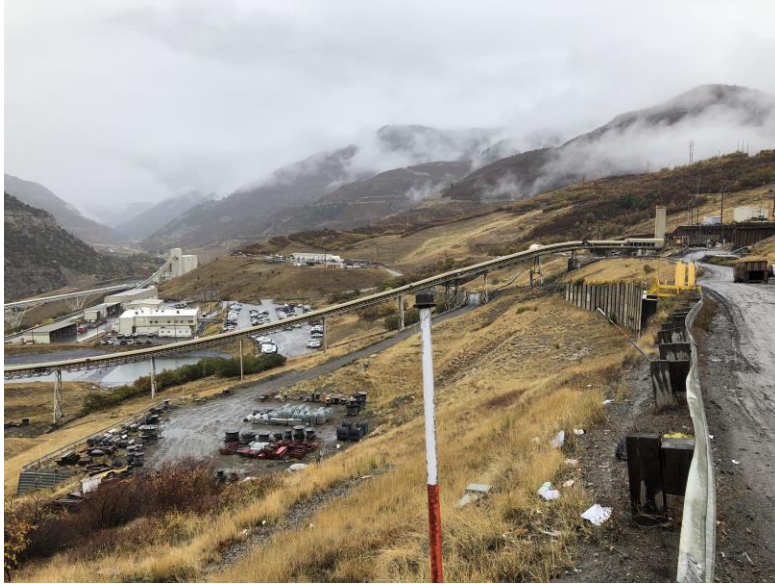
The road to the portal bench was in good shape, and the concrete road-side ditches were functioning well.

**Hillside below road to portal, with main facilities in background**

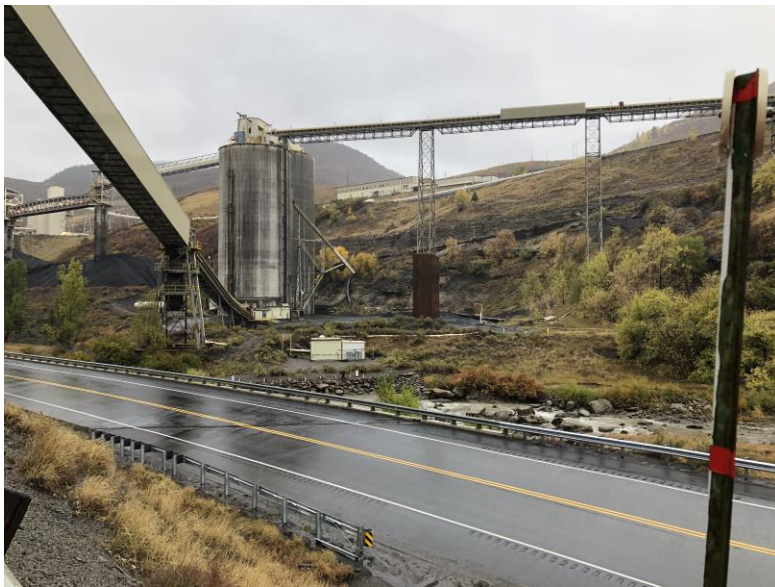
No erosion or other problems were found with any of the facility areas. Besides the main facilities, sites included the dewatering pad, the Shaft 1 Bench, the Shaft 2 Bench, and the Laydown Bench.

**Coal silos and hill below facilities (from loadout)**

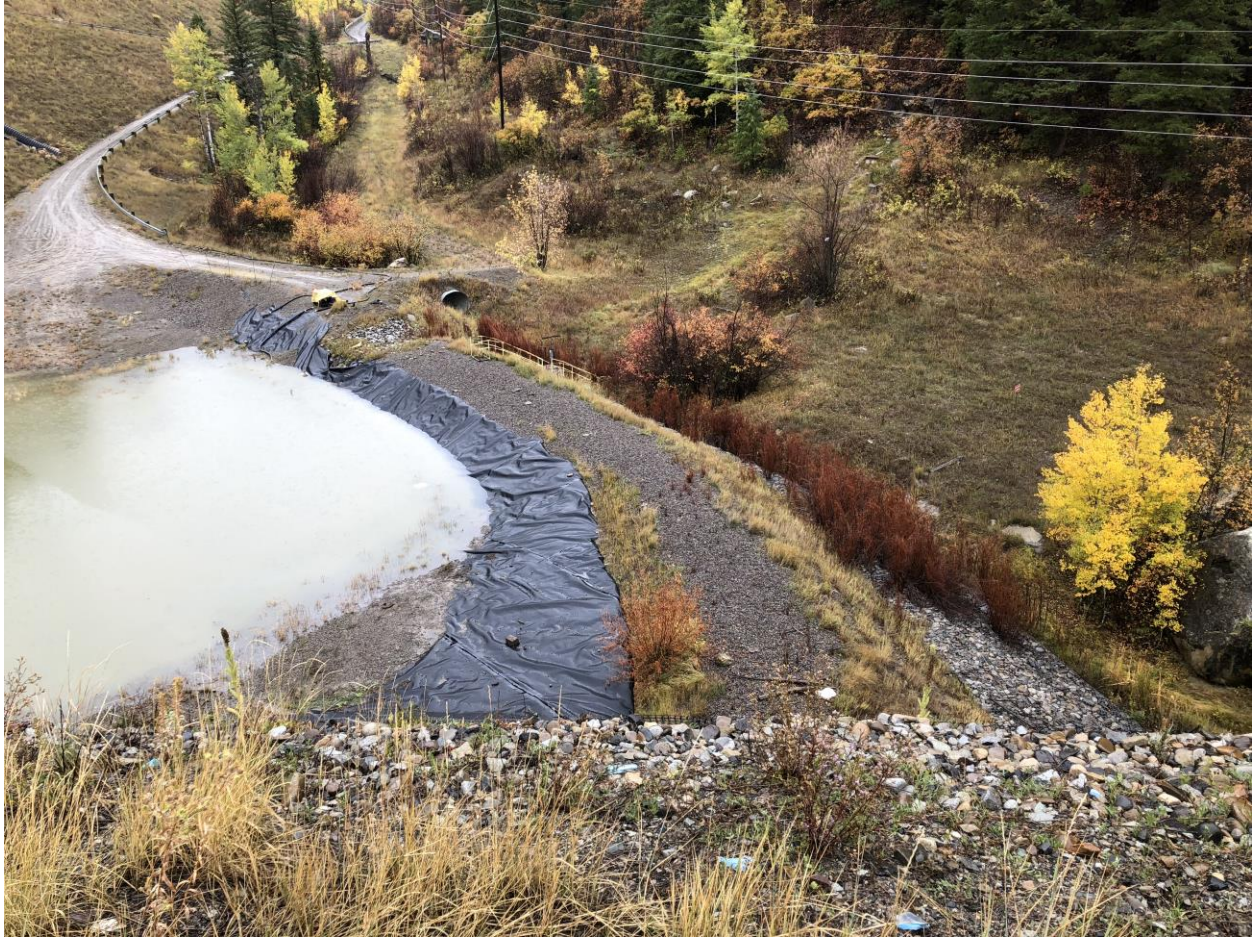
**SG1 Pond along Sylvester Gulch**

No problems were found with the SG1 Pond, although MCC should update the PAP (at next renewal, if not sooner) to indicate that this pond was constructed within the stream buffer zone for Sylvester Gulch. The emergency spillway of this pond is approximately 3.5 feet above the level of water in this pond, as estimated with a laser tool (TruPulse 360R).

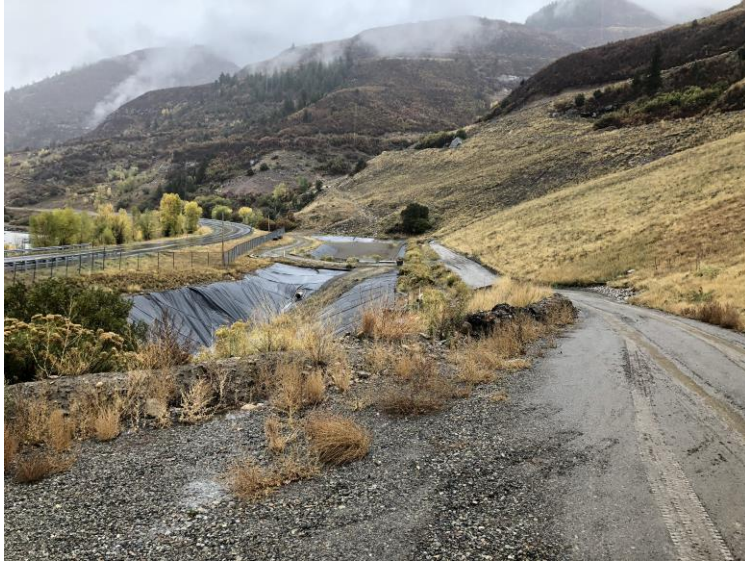
**RPE Sediment Pond**

The RPE was not discharging. The water in the upper cell was approximately five feet below the spillway, even after days of rain. No problems were seen with this pond.

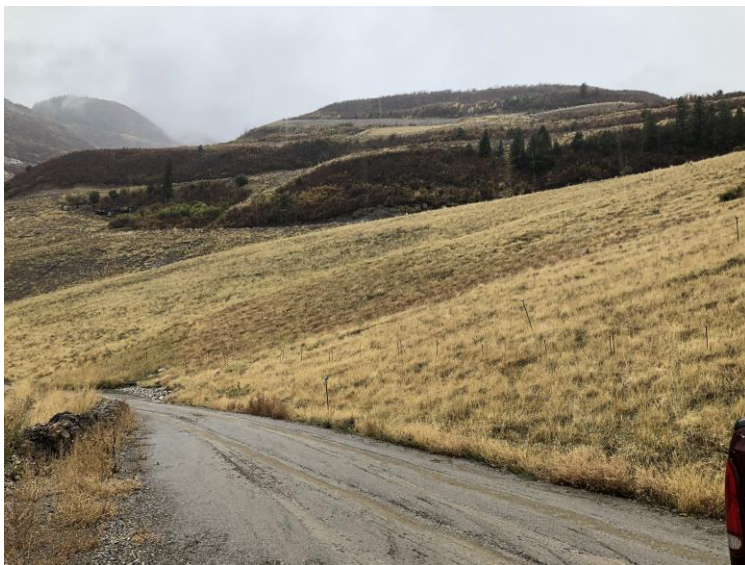
**Lower portion of RPE**

Reclamation of the RPE was viewed from below; no erosion or other problems were seen. The site is well vegetated.
