**COLORADO**Division of Reclamation,  
Mining and Safety

**MINERALS PROGRAM INSPECTION REPORT****PHONE: (303) 866-3567**

| <b>MINE NAME:</b><br>Colorado River Ranch Gravel Pit | <b>MINE/PROSPECTING ID#:</b><br>M-1981-236 | <b>MINERAL:</b><br>Sand and gravel | <b>COUNTY:</b><br>Grand |
| <b>INSPECTION TYPE:</b><br>Monitoring | <b>INSPECTOR(S):</b><br>Peter S. Hays | <b>INSP. DATE:</b><br>October 3, 2018 | <b>INSP. TIME:</b><br>10:00 |

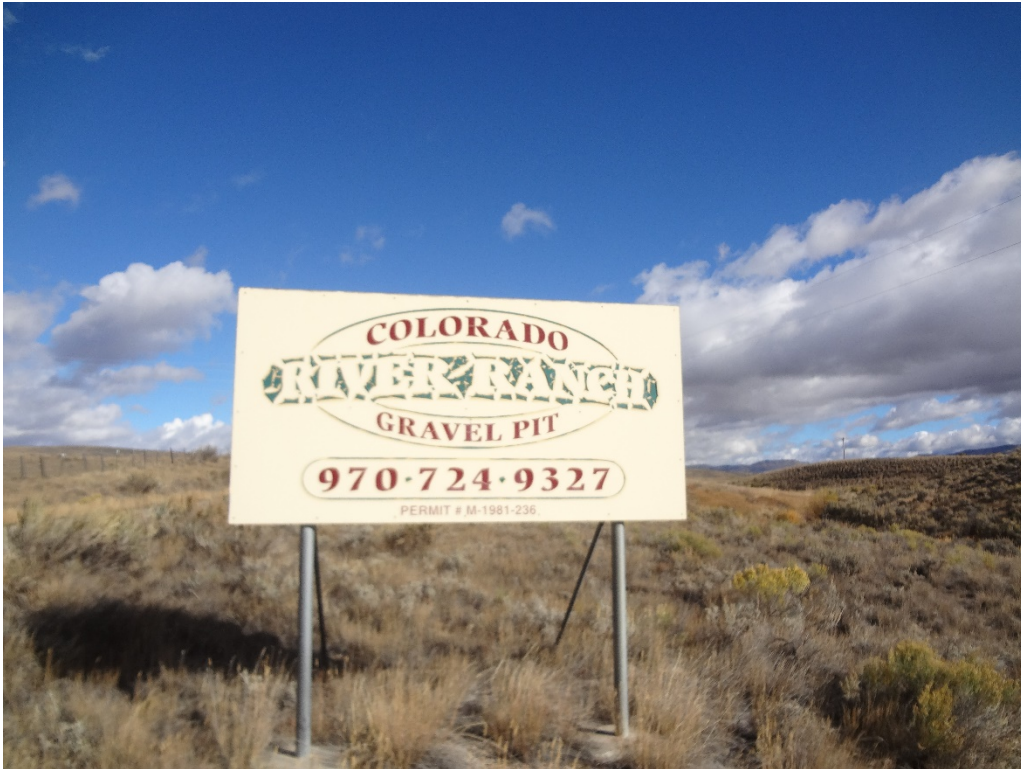
An entrance sign was posted and permit boundary markers were observed as required by Rule 3.1.12. Photographs taken during the inspection are attached.

Colorado River Ranch mine sign

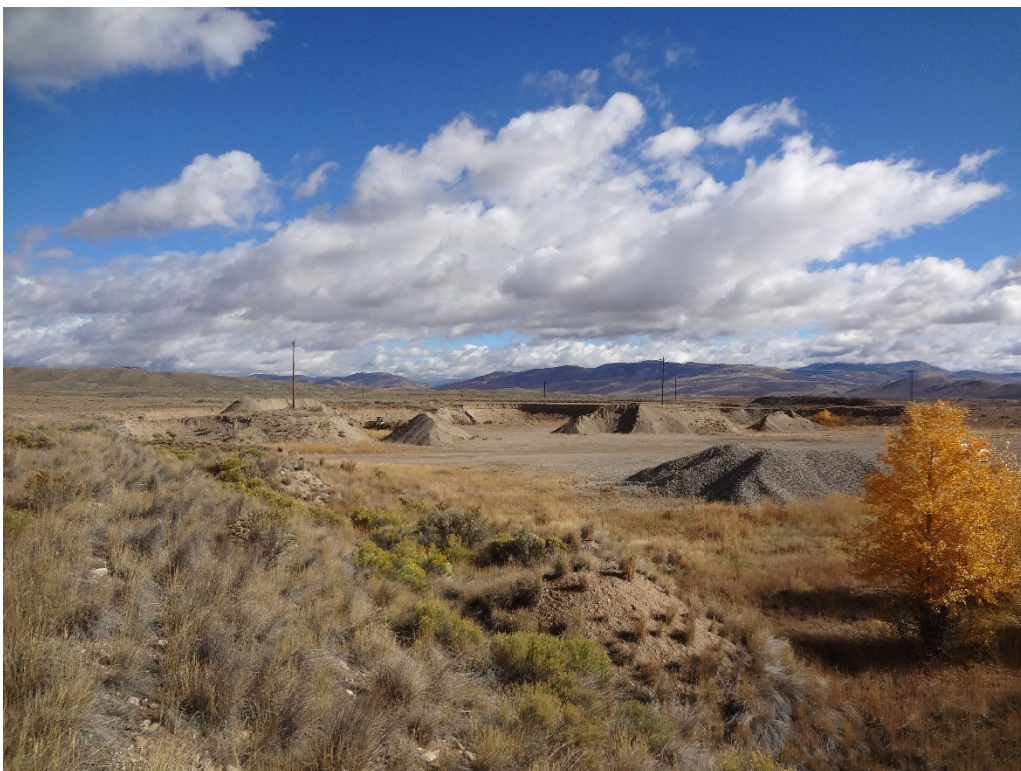
View of north mine area from the south end of the main topsoil stockpile looking northeast

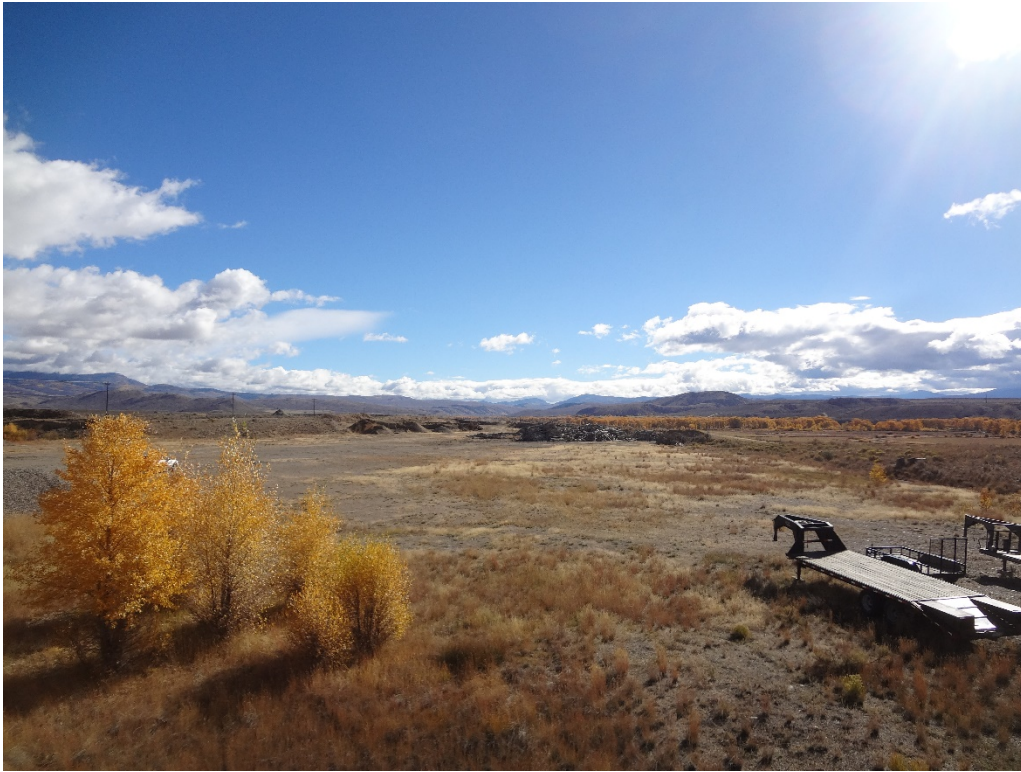
View of south mine area from the south end of the main topsoil stockpile looking east

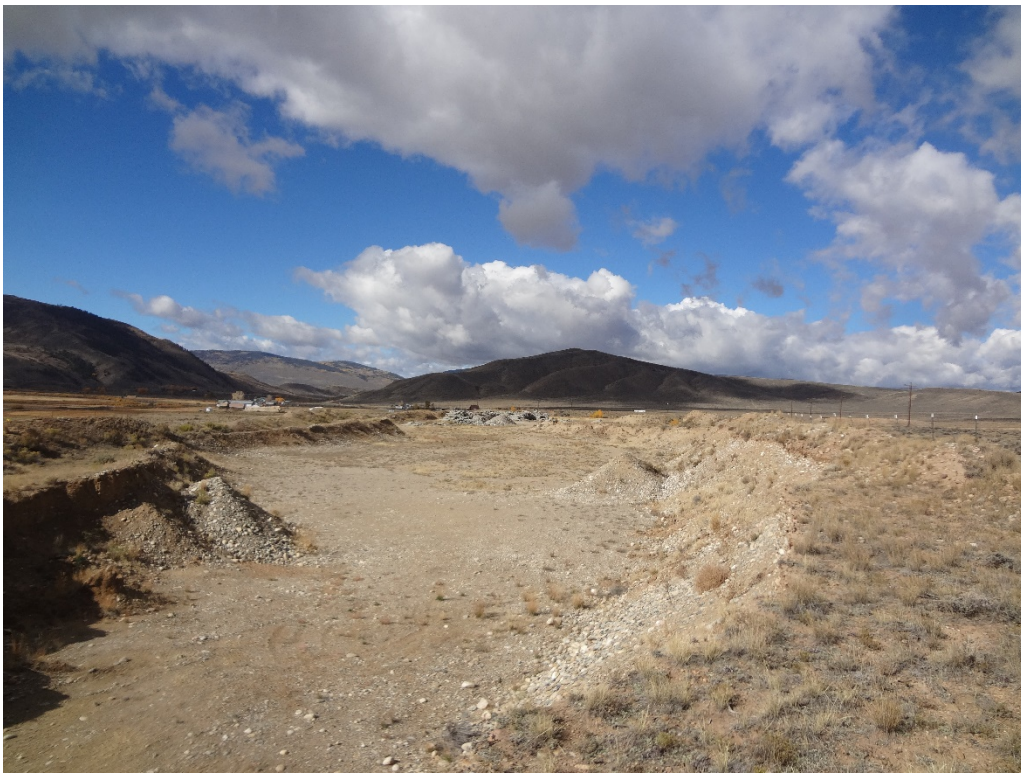
View of south mine area from the east end of the site looking west

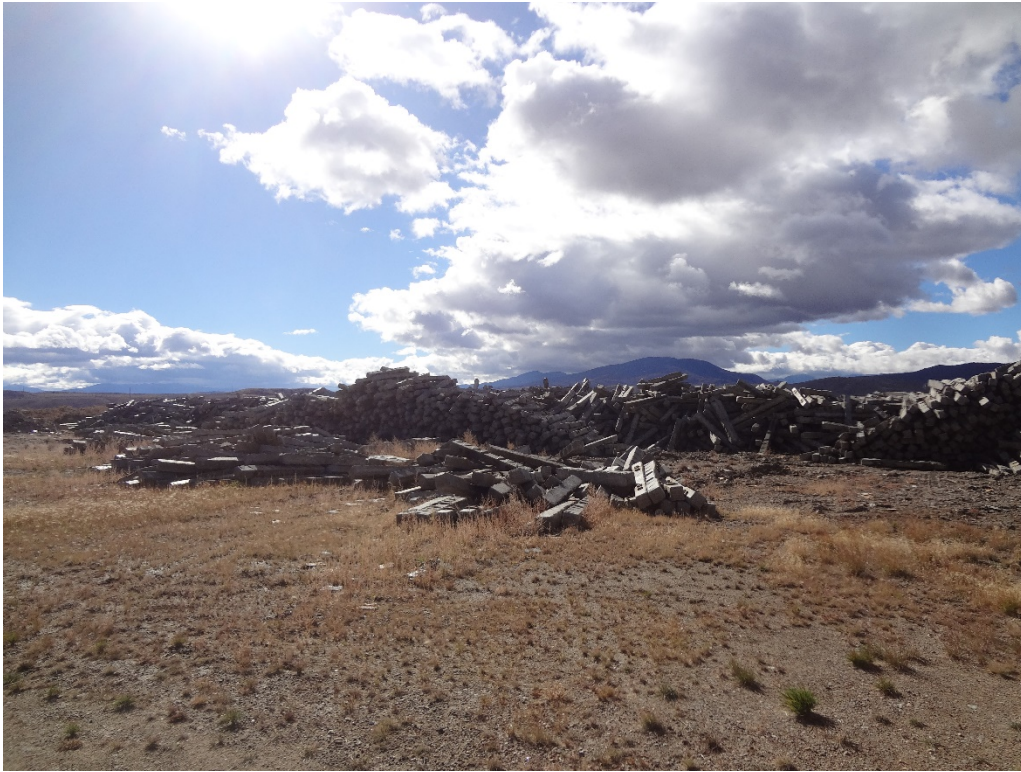
**PROBLEM:** A contractor imported a large stockpile of concrete railroad ties into the south mining area. The Operator allowed the contractor to stockpile the ties temporarily while the contractor processed the ties to separate the metal from the concrete. The presence of off-site material is considered a liability by the Division due to the additional cost required for the Division to remove the stockpile in the event of a permit forfeiture.

View of imported concrete railroad ties stockpile

**CORRECTIVE ACTIONS:** The Operator or contractor must remove or complete the processing of the railroad ties into recycled concrete and clear the site of all scrap metal and debris related to the railroad ties within 120 days from the signature date of this report.

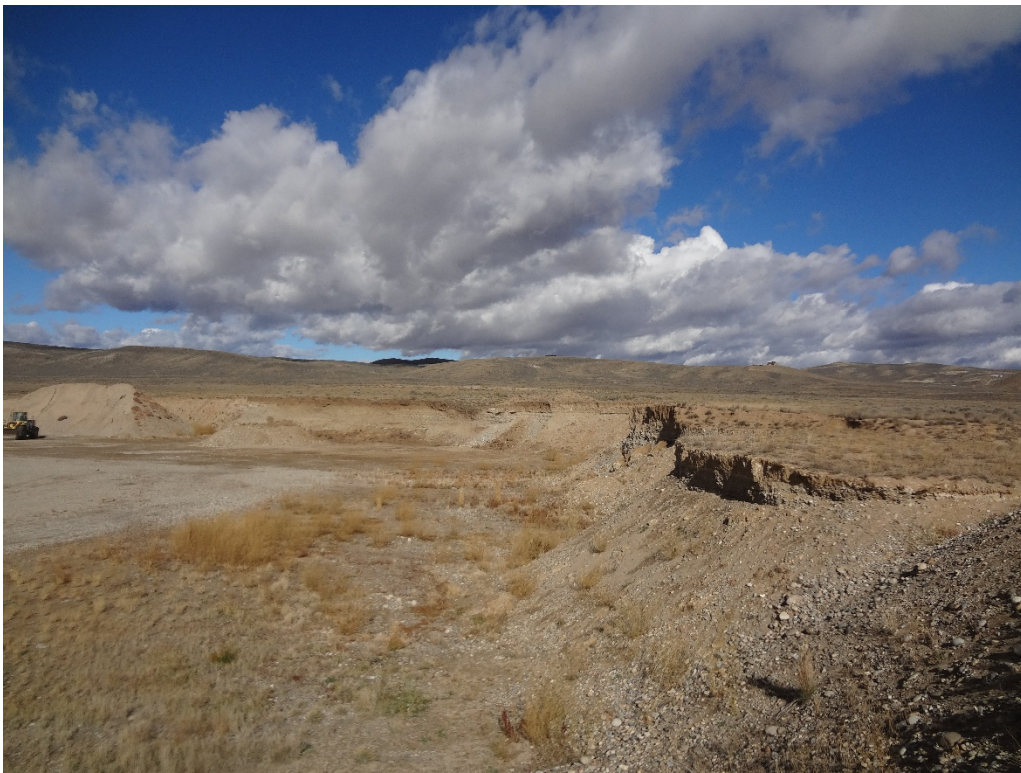
The site was inactive during the inspection. The highwall in the north area was estimated at fifteen (15) in height at a 1H:1V slope. The mining in the eastern half of the north area has reached the stripped topsoil and overburden boundary. The Operator stated mining will continue to the northwest in the west portion of the north area, which has been stripped of topsoil and overburden in advance of mining. Material stockpiles were observed on the pit floor. A large stockpile of concrete railroad ties was located in the south mining area. The Operator allowed a contractor to stockpile the ties temporarily while the contractor processed the ties to separate the metal and concrete. In exchange, the Operator would be left with a recycled concrete stockpile. The contractor would remove the scrap metal from the site. The presence of off-site material is considered a liability by the Division due to the additional cost required for the Division to remove the stockpile in the event of a permit forfeiture. As cited as a problem, the Division will require the railroad ties to be removed from the site or processed into recycled concrete and the site cleared of all metal and debris related to the railroad ties within 120 days from the signature date of this report.

View of the eastern portion of the north highwall from the east end of the highwall
