MINERALS PROGRAM INSPECTION REPORT
PHONE: (303) 866-3567

MINE NAME: Yust Ranch Gravel Pit	MINE/PROSPECTING ID#: M-2000-014	MINERAL: Sand and gravel	COUNTY: Grand
INSPECTION TYPE: Monitoring	INSPECTOR(S): Peter S. Hays	INSP. DATE: October 3, 2018	INSP. TIME: 12:30
OPERATOR: Grand Gravel Pit, LLC	OPERATOR REPRESENTATIVE: Bud Carpenter	TYPE OF OPERATION: 112c - Construction Regular Operation	
REASON FOR INSPECTION: Normal I&E Program	BOND CALCULATION TYPE: Complete Bond	BOND AMOUNT: \$45,600.00	
DATE OF COMPLAINT: NA	POST INSP. CONTACTS: None	JOINT INSP. AGENCY: None	
WEATHER: Clear	INSPECTOR'S SIGNATURE:

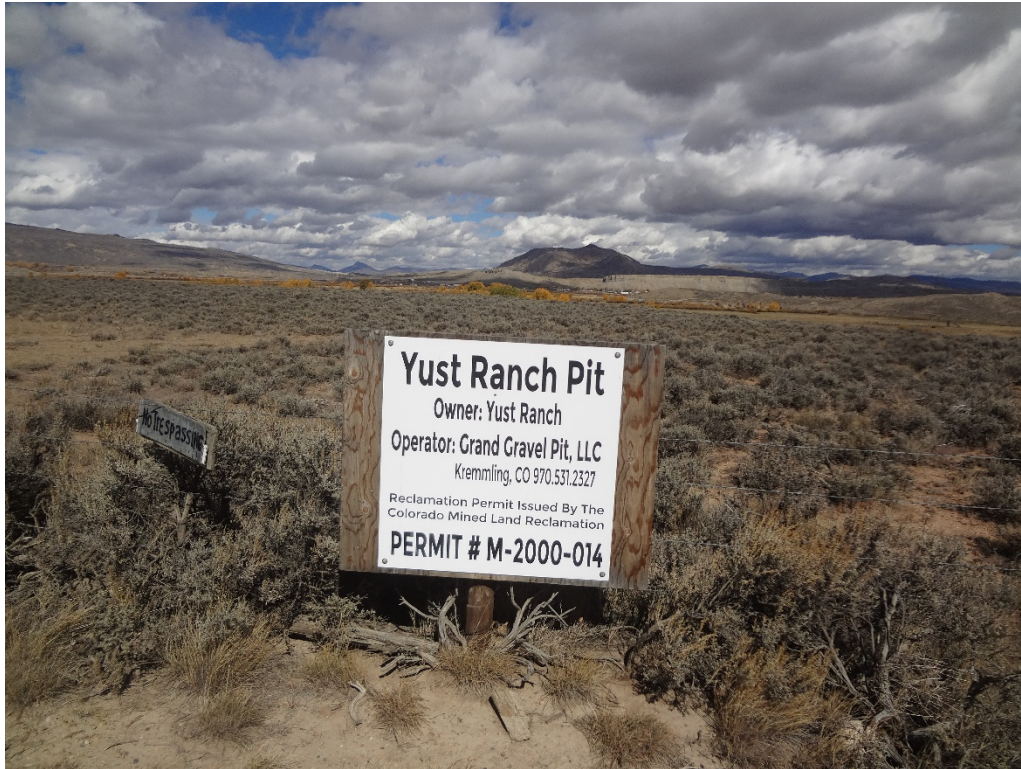
An entrance sign was posted and permit boundary markers were observed as required by Rule 3.1.12. Photographs taken during the inspection are attached.

Yust Ranch Gravel Pit mine sign

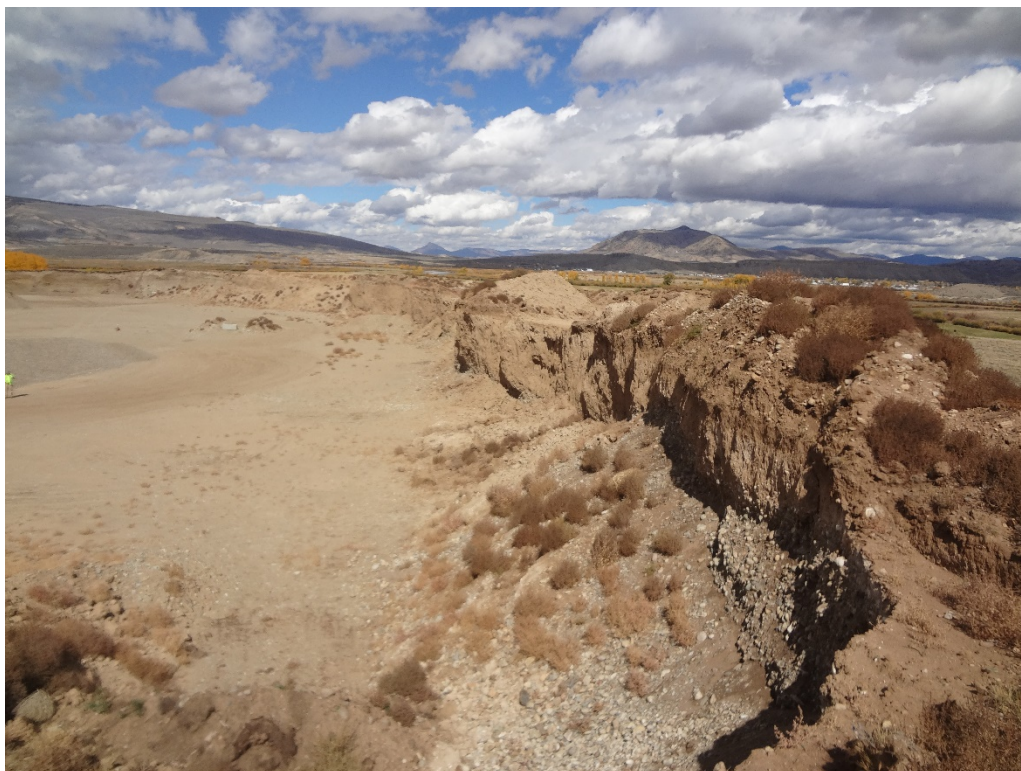
View of the Phase 2 highwall from the south end looking north

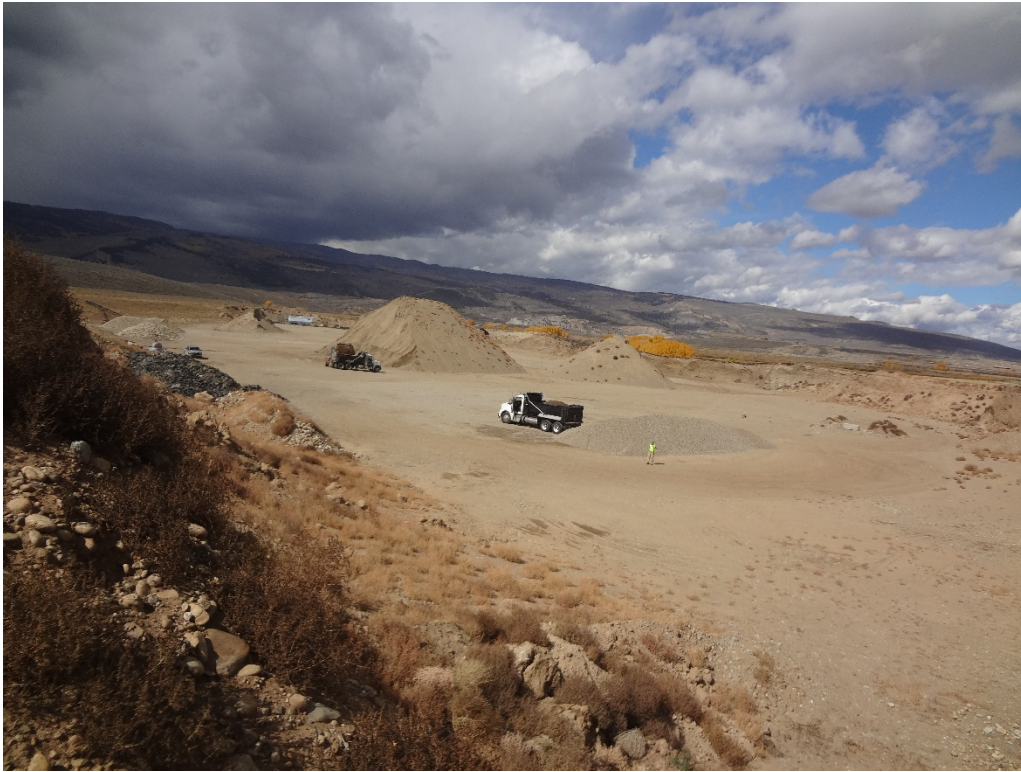
View of pit floor from the southeast corner of Phase 2 looking northwest

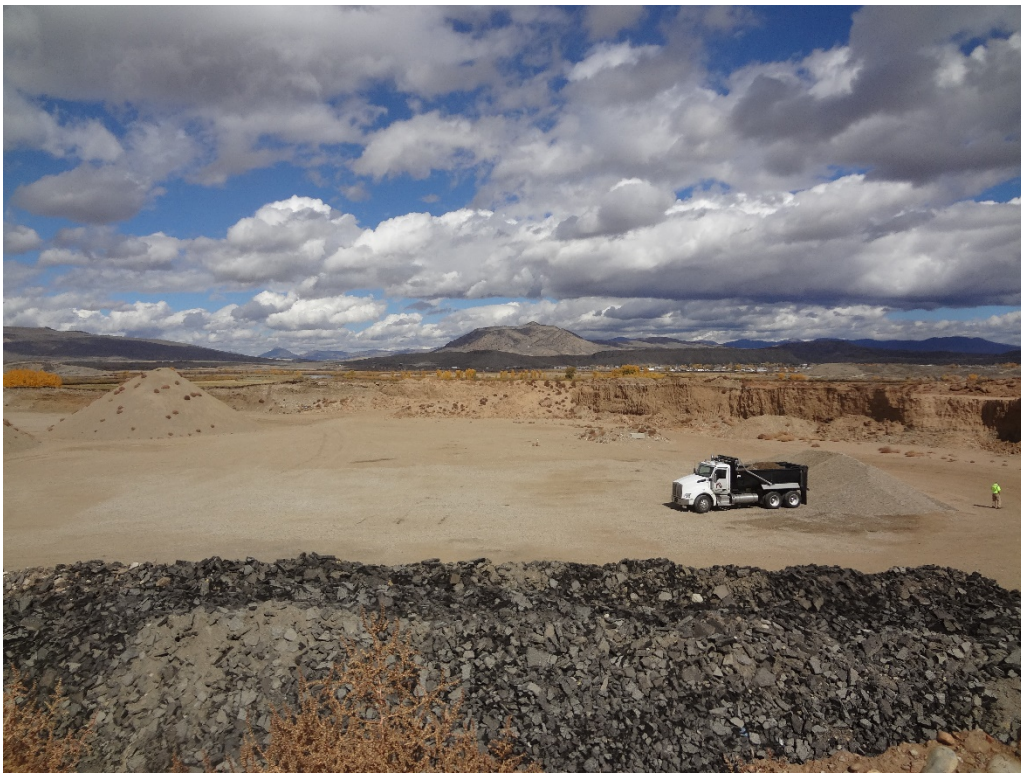
The site was converted from an 110c to an 112c operation under CN-01, which was approved by the Division on October 22, 2014. The conversion application increased the permitted area from 9.9 acres to 46.41 acres. The mining excavation has progress from the original 9.9 acre area to the south into Phase 1 and east into Phase 2. The east highwall and portions of the south highwalls were estimated at twenty (20) feet in height at a 0.5H:1V slope. The Operator stated the plan was to mine down another twenty (20) within the current mining footprint before mining Phase 3 to the west. The site was active during the inspection with stockpiled material being hauled from the site. A stockpile of asphalt was observed in the southeast corner of Phase 1. The Operator is reminded of the requirement to remove the imported asphalt material from the site. The asphalt cannot be used as backfill material for site reclamation.

View of pit floor from the southwest corner of Phase 2 looking north, asphalt stockpile in the foreground

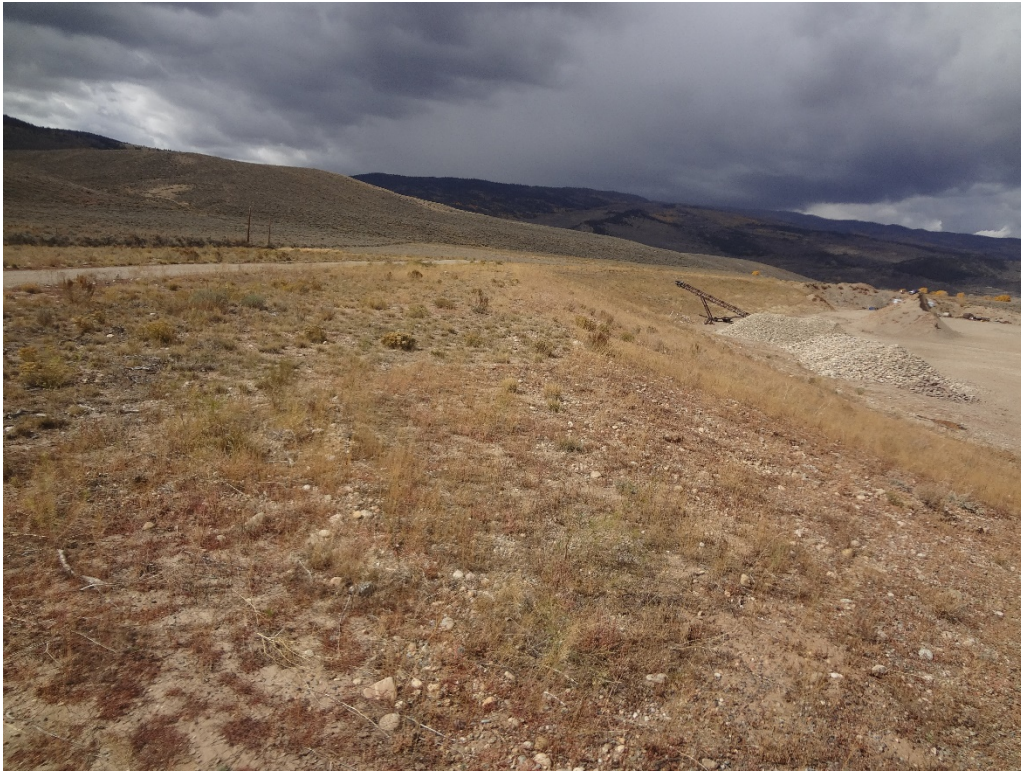
View of reclaimed portion of the Phase 1 western highwall looking west

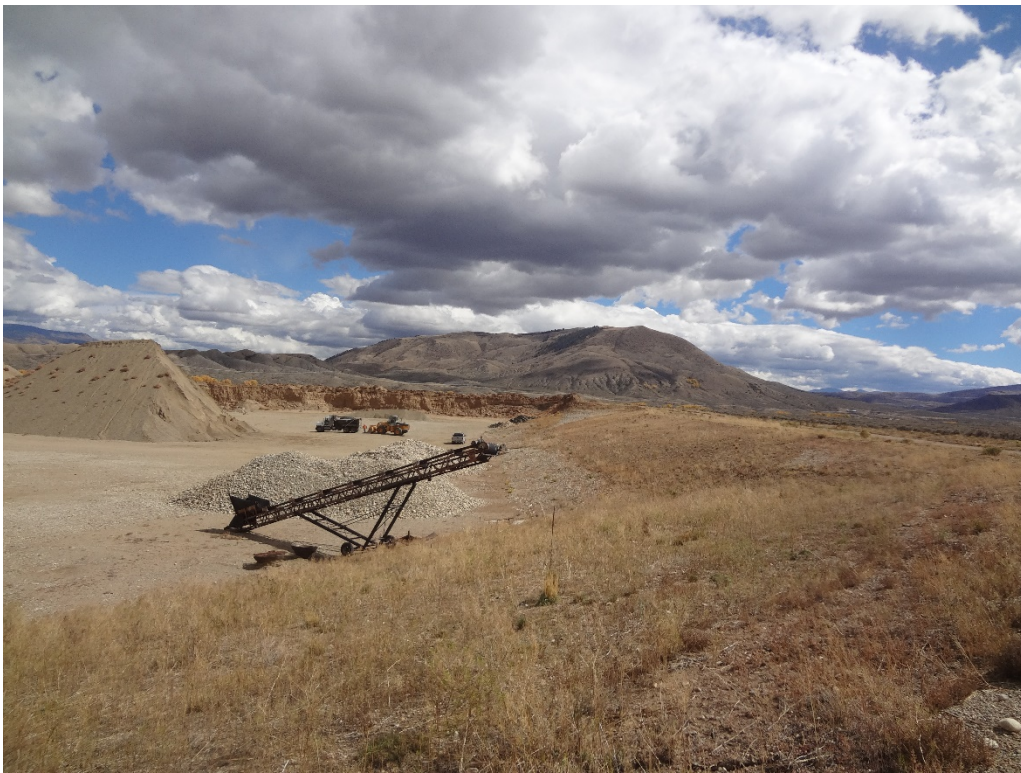
View of reclaimed portion of the Phase 1 western highwall looking east
