**COLORADO**Division of Reclamation,
Mining and Safety

MINERALS PROGRAM INSPECTION REPORT**PHONE: (303) 866-3567**

MINE NAME: Camenish Borrow	MINE/PROSPECTING ID#: M-2006-078	MINERAL: Sand and gravel	COUNTY: Weld
INSPECTION TYPE: Monitoring	INSPECTOR(S): Peter S. Hays	INSP. DATE: October 10, 2018	INSP. TIME: 14:30
OPERATOR: Flatiron Constructors, Inc.	OPERATOR REPRESENTATIVE: None	TYPE OF OPERATION: 111 - Construction by Government Agency

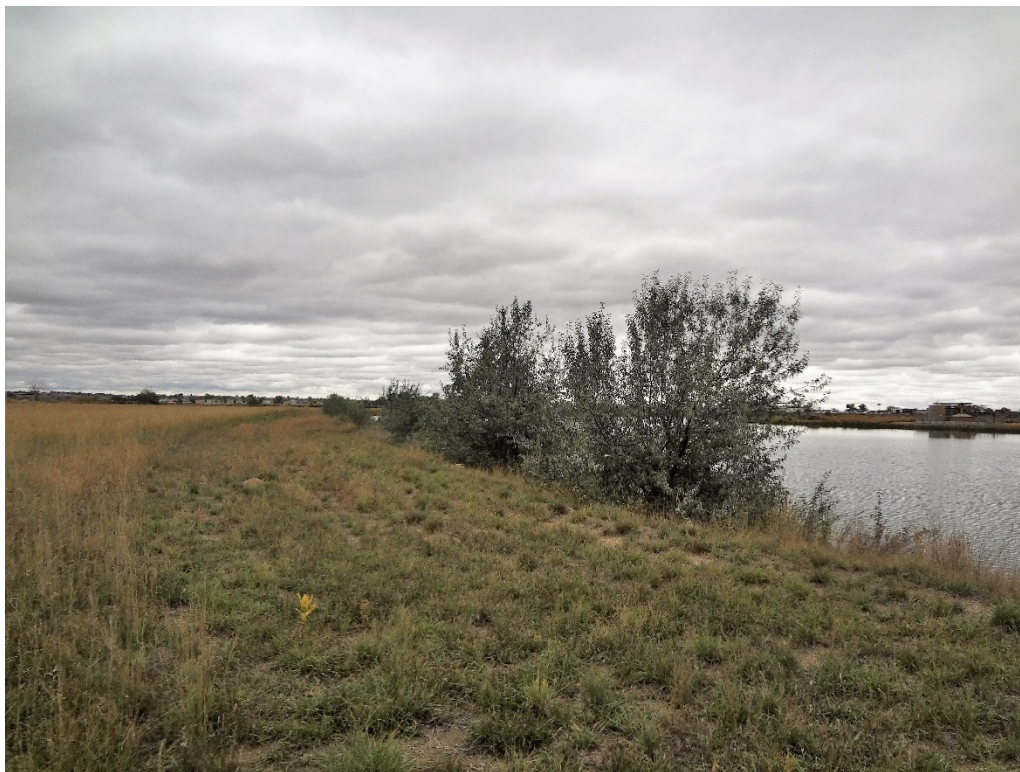
PROBLEM: Russian olive trees and other noxious weeds are present within or have volunteered into the permit area and are becoming established. This is a problem for failure to employ weed control methods for a state listed noxious weed species within the permitted area, and to reduce the spread of weeds to nearby areas as required by Rule 3.1.10(6).

As cited as a problem, noxious weeds including; Russian olive trees, chamomile and Halogeton were observed on-site. The Russian olive trees have volunteered along the perimeter of the shoreline. Patches of chamomile and Halogeton were observed in the northern upland area. The Operator shall either implement the existing weed control plan, or develop a weed control and management plan in accordance with Rule 3.1.10(6). The weed control plan or proof of weed control measures shall be submitted to the Division by the corrective action date.

View of Russian olive trees on the shoreline

CORRECTIVE ACTIONS: The Operator shall either implement the existing weed control plan, or develop a weed control and management plan in accordance with Rule 3.1.10(6). This plan should be developed in consultation with the county extension agency, or weed control district office and should include specific control measures to be applied, a schedule for when control measures will be applied and a post-treatment monitoring plan. This weed control plan shall be submitted to the Division as a Technical Revision to the approved plan with the appropriate Technical Revision fee of \$216.00 by the corrective action date.

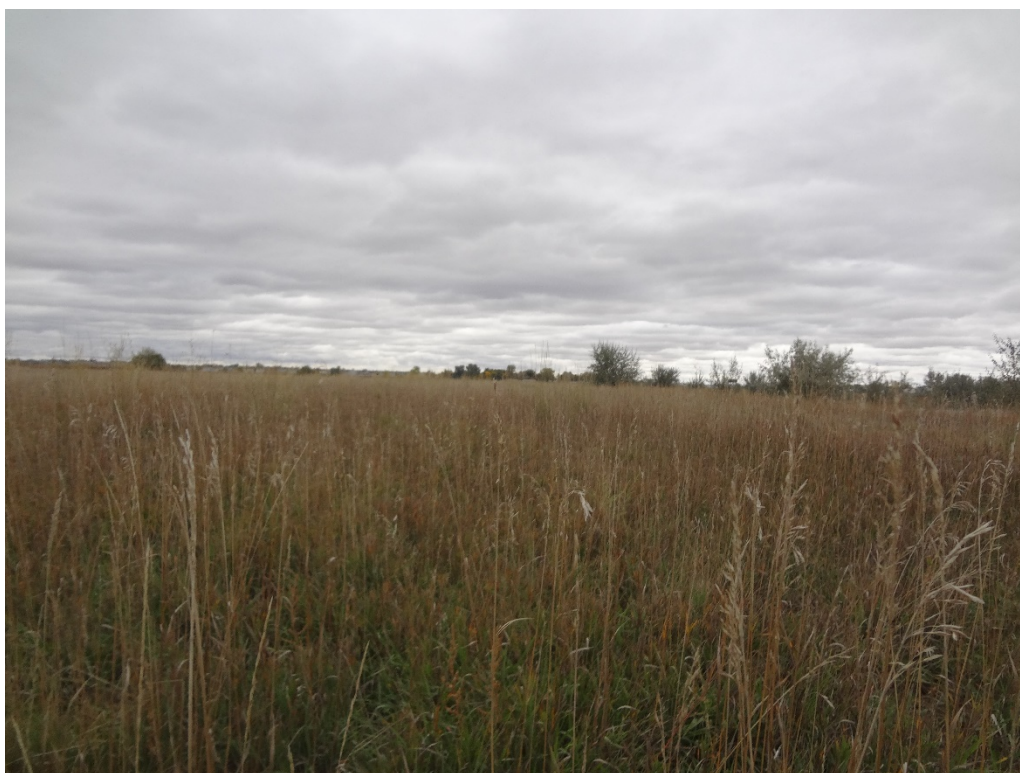
View of typical vegetation in the west upland area

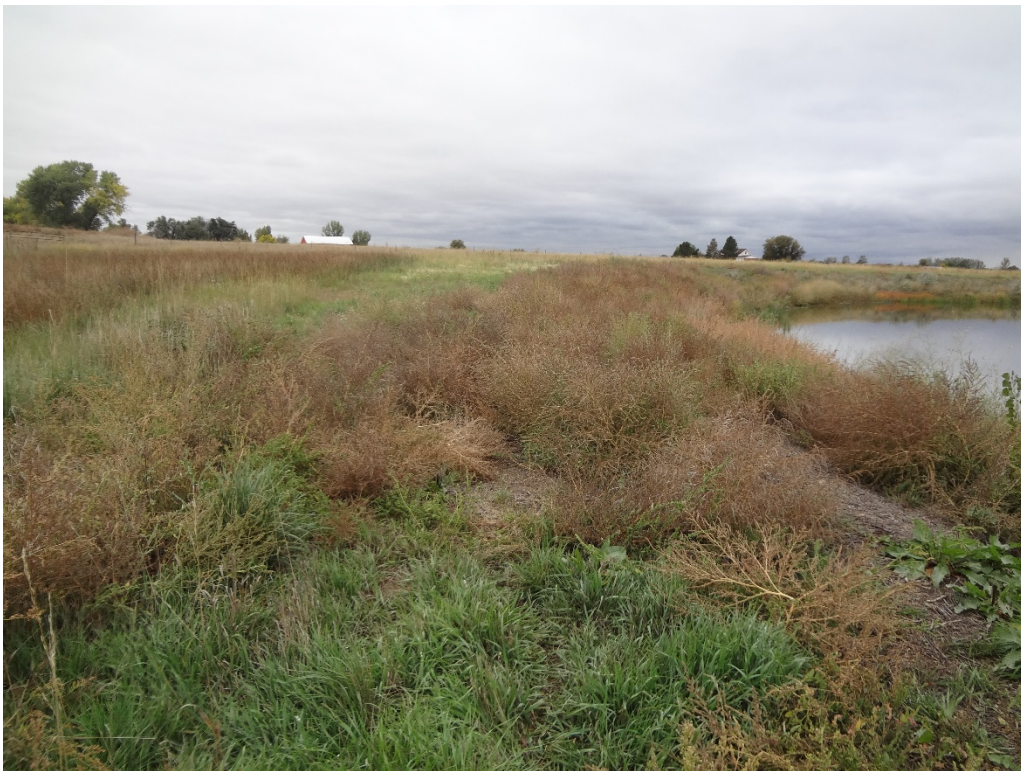
The site vegetation was well-established and consisted of several varieties of wheatgrasses and brome grass. The grasses were mowed around the lake shoreline. The site was stable and no erosion features were observed during the inspection. A patch of Kochia was observed in the southeast corner of the site.

View of kochia in the southeast corner of the site
