**MINERALS PROGRAM INSPECTION REPORT**  
**PHONE: (303) 866-3567**

<b>MINE NAME:</b> Andrews #3 (Mock Pit)	<b>MINE/PROSPECTING ID#:</b> M-1998-075	<b>MINERAL:</b> Sand	<b>COUNTY:</b> Elbert
<b>INSPECTION TYPE:</b> Surety Release Inspection	<b>INSPECTOR(S):</b> Peter S. Hays	<b>INSP. DATE:</b> October 11, 2018	<b>INSP. TIME:</b> 12:00
<b>OPERATOR:</b> Lafarge West, Inc. c/o Lafarge North America	<b>OPERATOR REPRESENTATIVE:</b> Christine Felz	<b>TYPE OF OPERATION:</b> 110c - Construction Limited Impact	
<b>REASON FOR INSPECTION:</b> Surety Release Requested	<b>BOND CALCULATION TYPE:</b> Partial Bond	<b>BOND AMOUNT:</b> \$8,117.00	
<b>DATE OF COMPLAINT:</b> NA	<b>POST INSP. CONTACTS:</b> None	<b>JOINT INSP. AGENCY:</b> None	
<b>WEATHER:</b> Raining	<b>INSPECTOR'S SIGNATURE:</b>

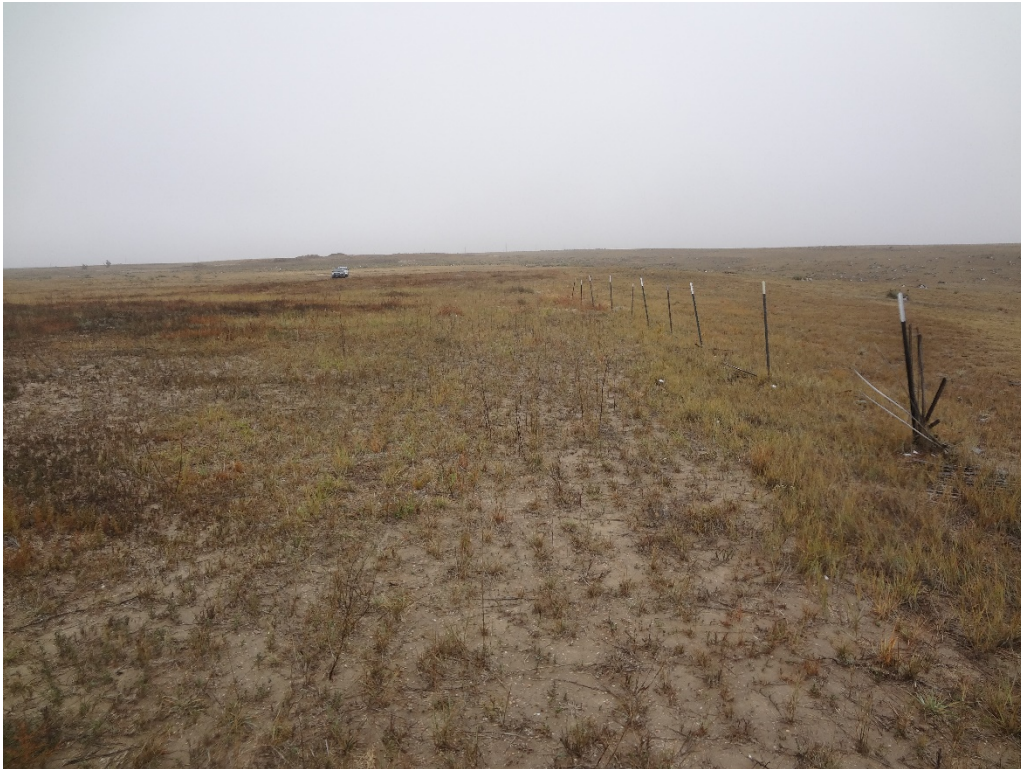
View of the site from the northwest corner looking south

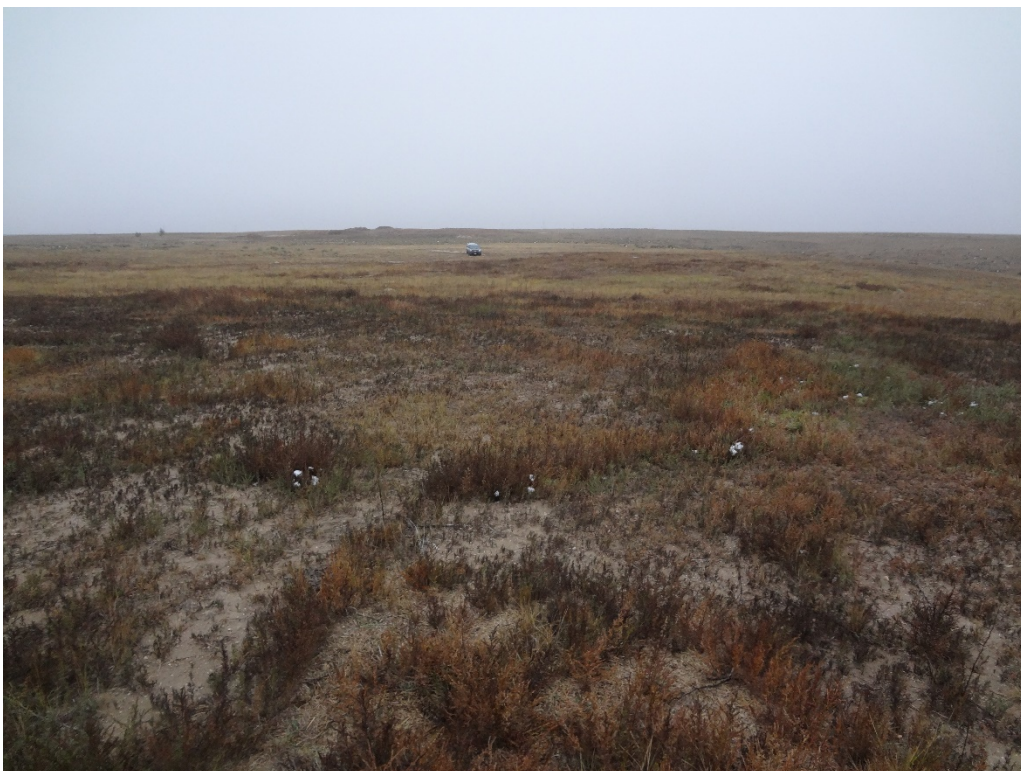
View of the site from the north end looking south

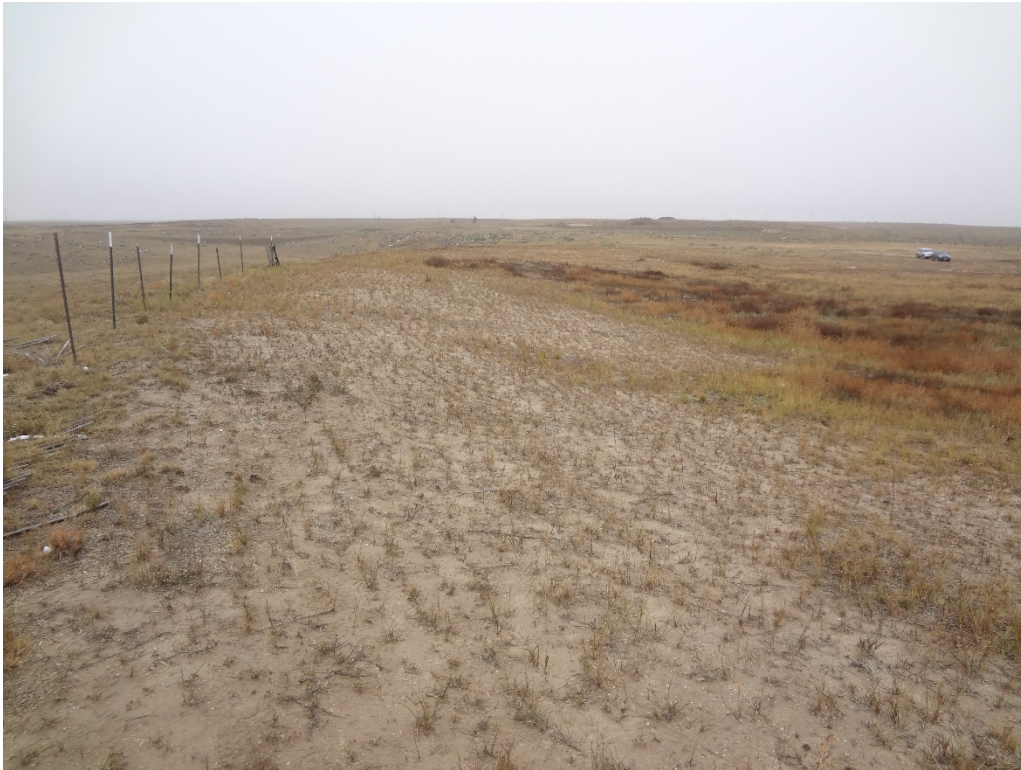
View of the site from the northeast corner looking south

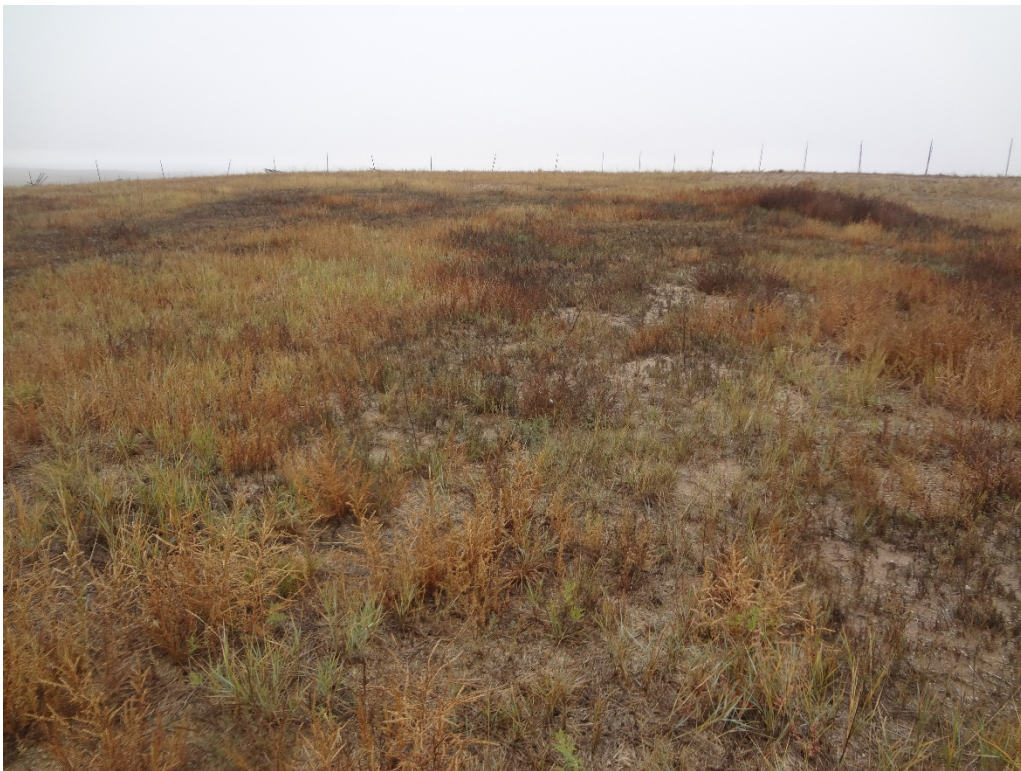
The reclamation vegetation consisted of areas of little to no grasses and contained mostly Kochia. Evidence of drill row seeding and mulching were observed during the inspection. The south end of Pit #1 has self-reclaimed with well-established and diverse volunteer grass species. The Division recommends the reclamation area is reseeded with the approved seed mixture. The Operator stated the use of imprint seeding would be discussed with Arnold's to improve the reclamation success at the site.

View of vegetation from the south end of the site looking north

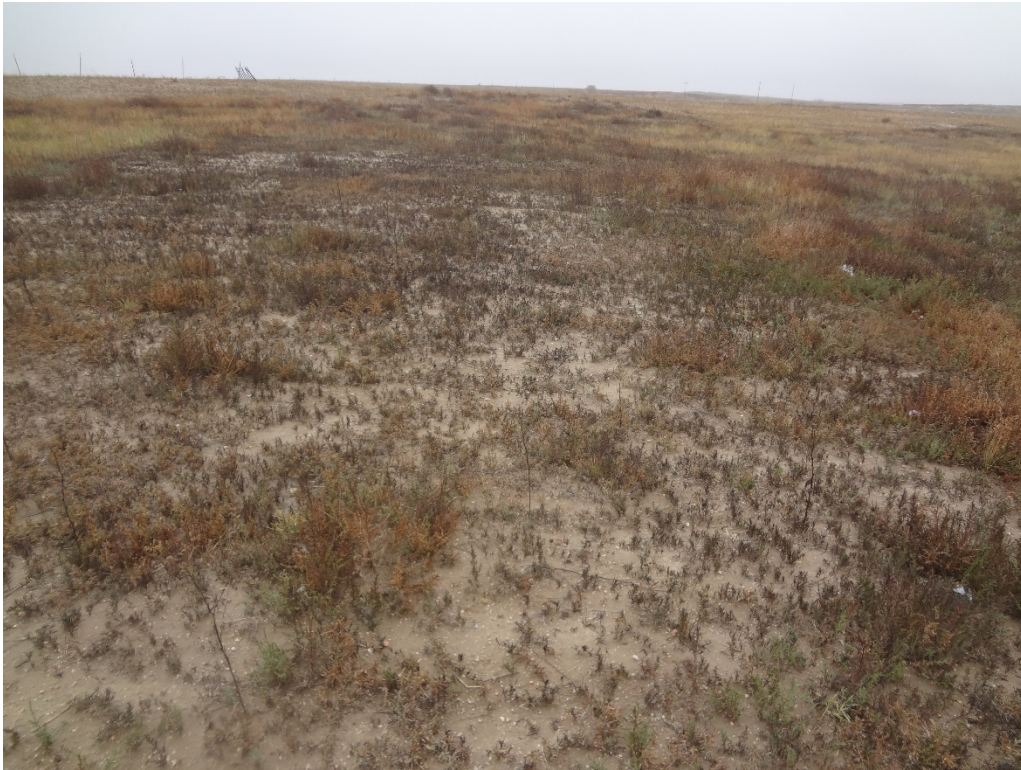
View of the vegetation from the southwest corner looking north

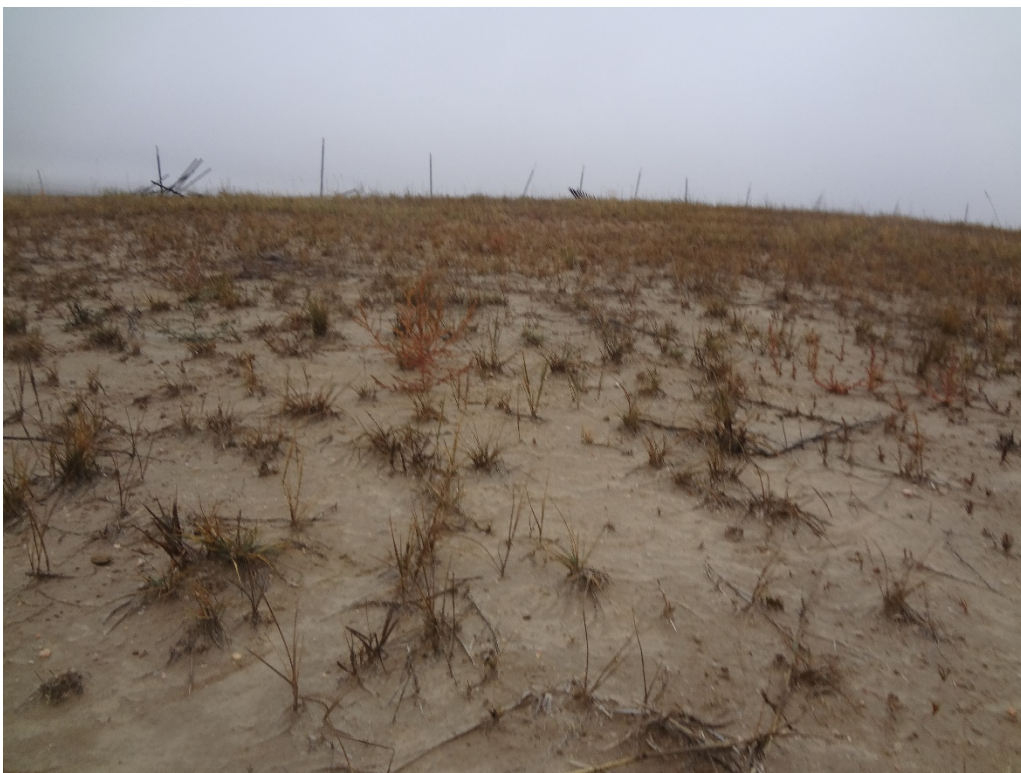
Close-up view of reclamation vegetation in the southwest corner of the site
