MINERALS PROGRAM INSPECTION REPORT
PHONE: (303) 866-3567

| MINE NAME: SH 69 Gravel Pit | MINE/PROSPECTING ID#: M-2018-010 | MINERAL: Sand and gravel | COUNTY: Fremont |
| INSPECTION TYPE: Preoperation Inspection | INSPECTOR(S): Timothy A. Cazier | INSP. DATE: August 7, 2018 | INSP. TIME: 11:15 |

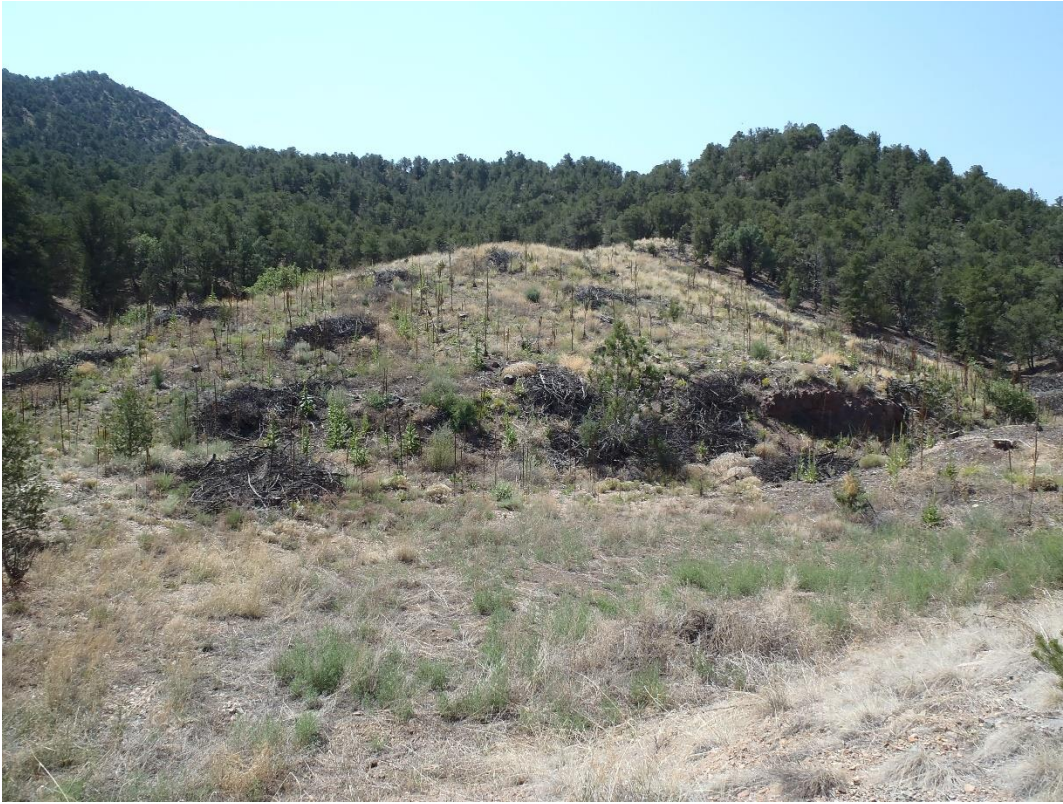
Hydrologic Balance: Mining had not been initiated at the time of the inspection. No standing water was observed on site. (see **Photos 1** and **2**) show the west side of the site to likely be mined first.

Photo 1. West side of future pit (looking south).

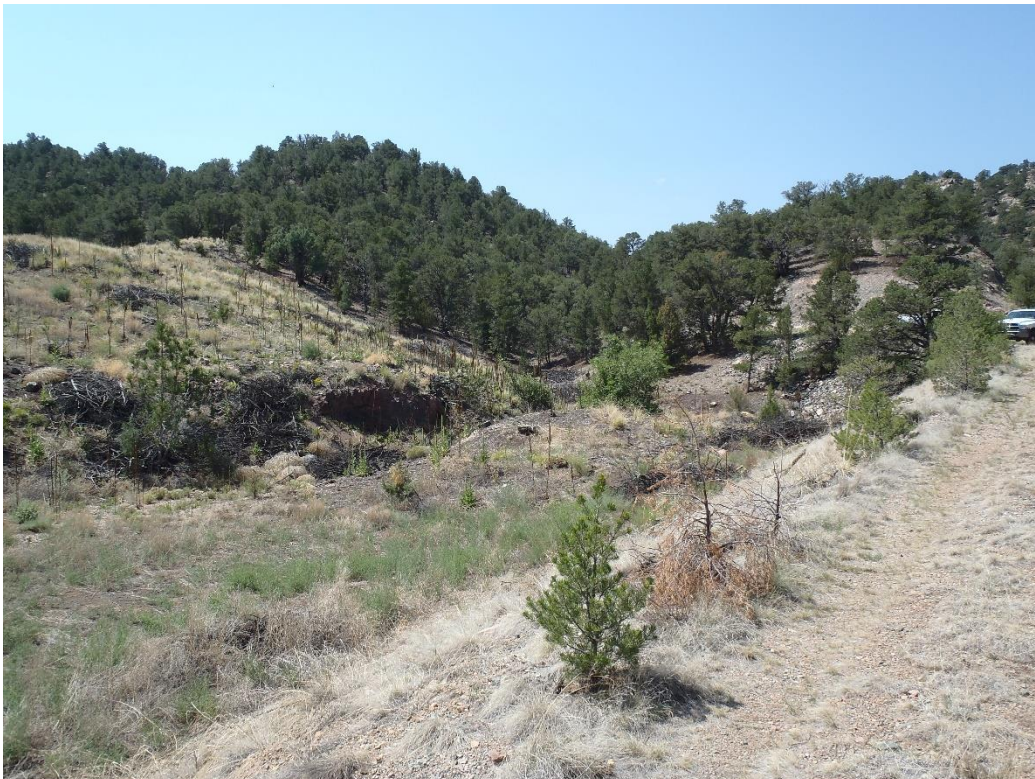
Photo 2. West side of future pit (looking SW).

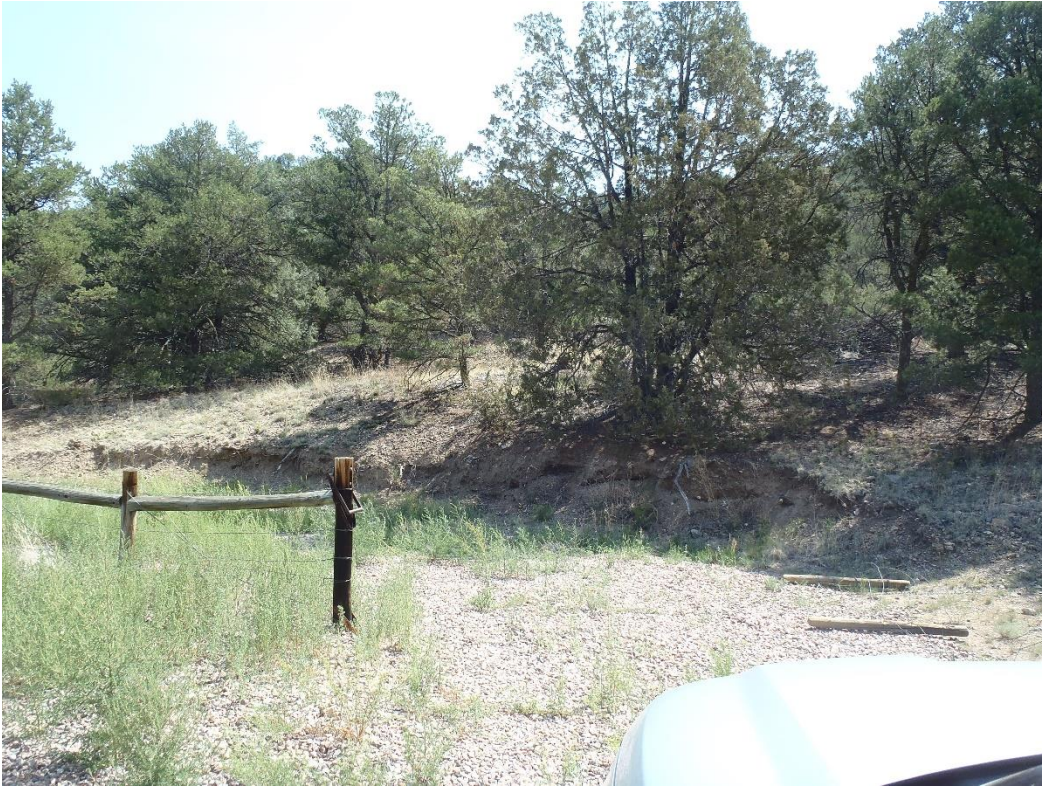
Roads: Haul and access roads did not appear to be a source of sediment that could be tracked offsite as the access road is fairly well graveled (see **Photos 3** and **4**).

Photo 3. Graveled access road at entrance off Hwy 69.

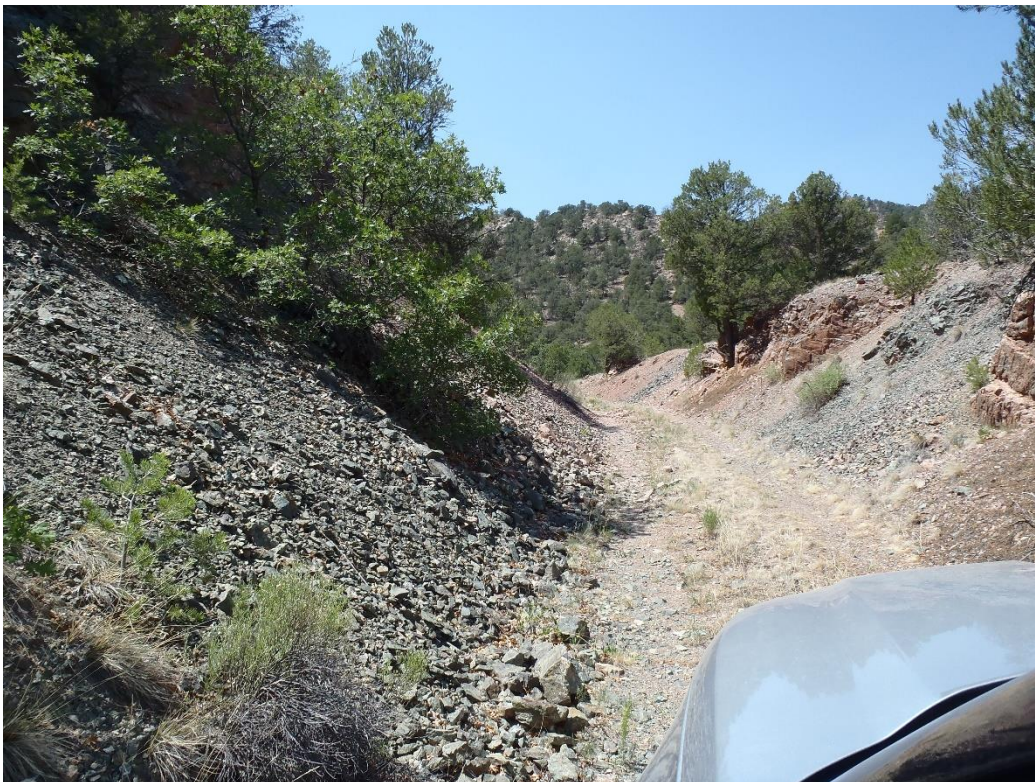
Photo 4. Graveled access road along north side (looking west).

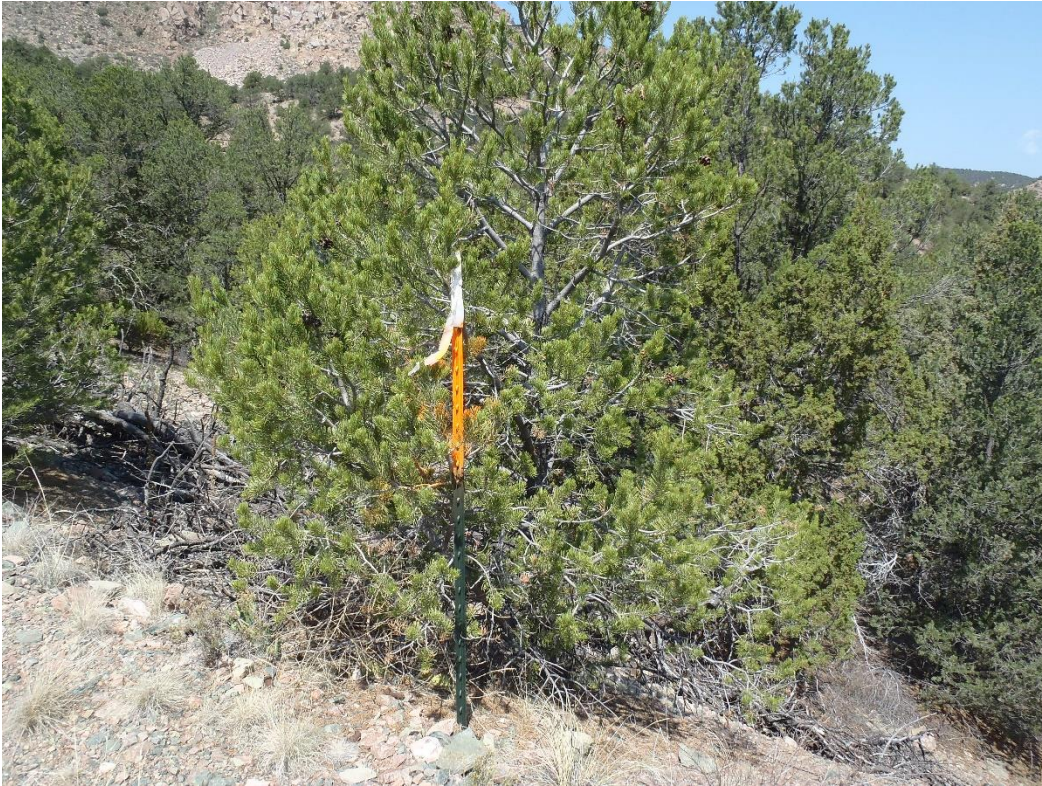
Signs and Markers: The permit sign was not yet posted. **Fremont County representatives were told a permit sign must be posted at the entrance prior to initiating mining.** Two boundary markers (northeast and northwest corners) were observed (see **Photos 5** and **6**). The southeast and southwest corners could not be located during the inspection. Mr. Rife provided coordinates for these corners subsequent to the inspection (see **Figure 1**).

Photo 5. Northwest corner post.

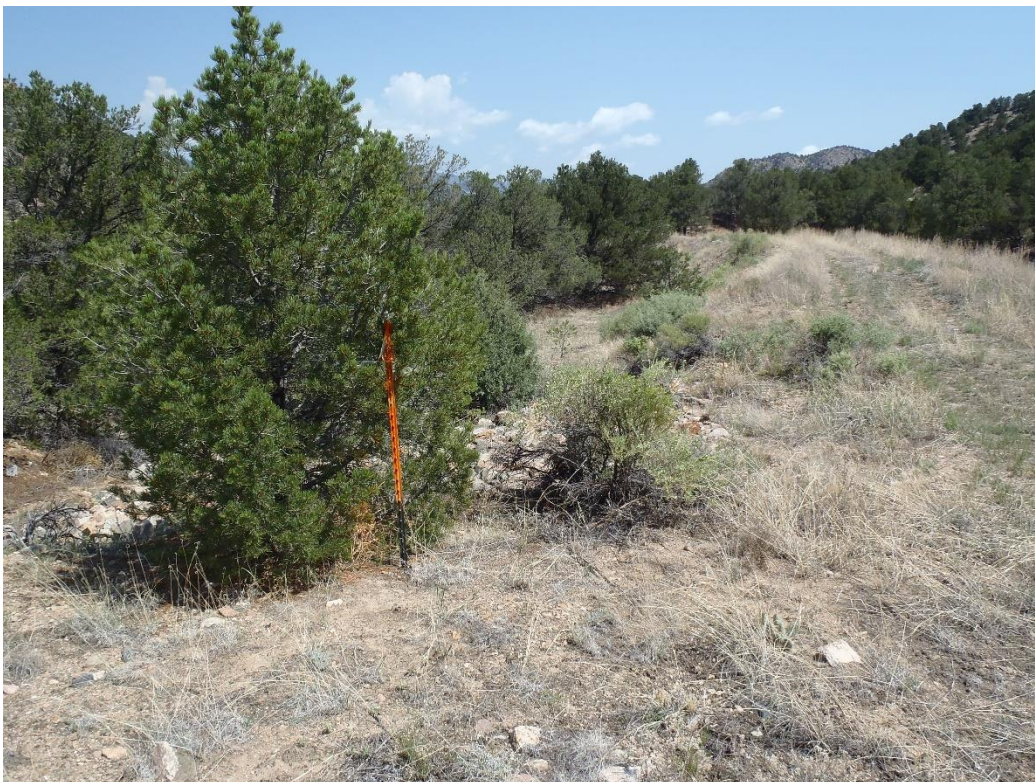
Photo 6. Northeast corner post.
