MINERALS PROGRAM INSPECTION REPORT

MINE NAME: Providence Mine	MINE/PROSPECTING ID#: M-2012-052	MINERAL: Silver and gold	COUNTY: Teller
INSPECTION TYPE: Monitoring	INSPECTOR(S): Elliott R. Russell	INSP. DATE: July 12, 2018	INSP. TIME: 12:00
OPERATOR: Cripple Creek & Victor Gold Mining Company	OPERATOR REPRESENTATIVE: Justin Bills and Erik Munroe	TYPE OF OPERATION: 110d - Designated Limited Impact

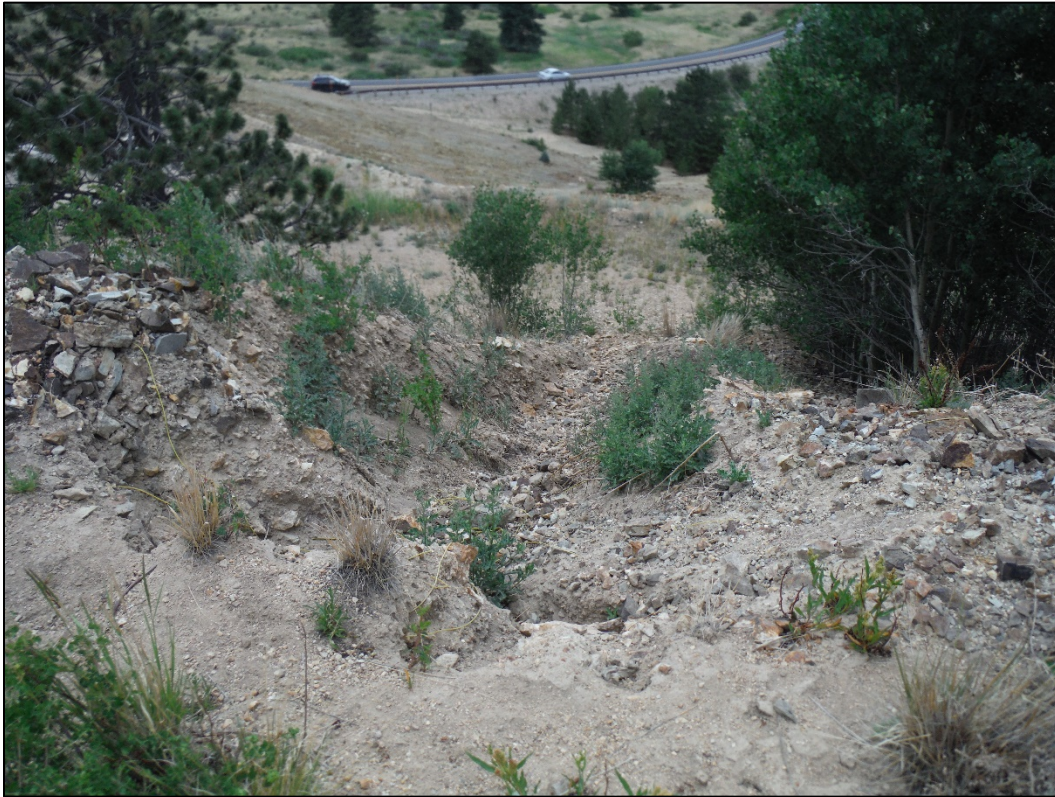
COMPLIANCE PROBLEM #2: Erosion gullies and ruts were observed on-site. This is a problem at this time for failure to protect the affected land from erosion pursuant to C.R.S. 34-32-116(4)(i).

Sediment Control: Portions of the storm water containment berm around the crest of the Sangre de Cristo Tunnel area had eroded and two erosion gullies were observed. The Operator will need to backfill the two erosion gullies and re-establish the berm to ensure all storm water is managed in accordance with the approved permit. This has been cited as Compliance Problem #2 requiring corrective action; please see the second page of this report for more information.

Photo 3. First erosion gully resulting from the washed-out berm; looking west.

CORRECTIVE ACTIONS: The operator shall provide photo documentation to the Division verifying erosion gullies and ruts have been repaired, and that the site has been reconstructed and stabilized to prevent erosion damage by the corrective action date.

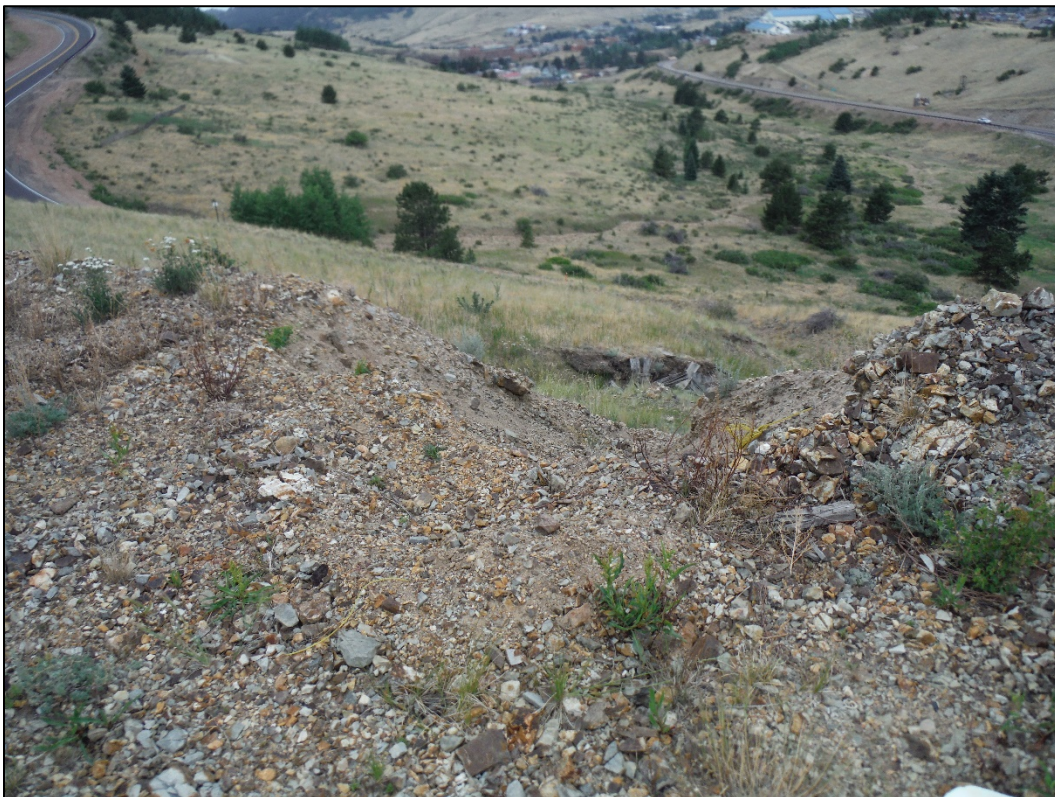
Photo 4. Second erosion gully resulting from the washed-out berm; looking southwest.

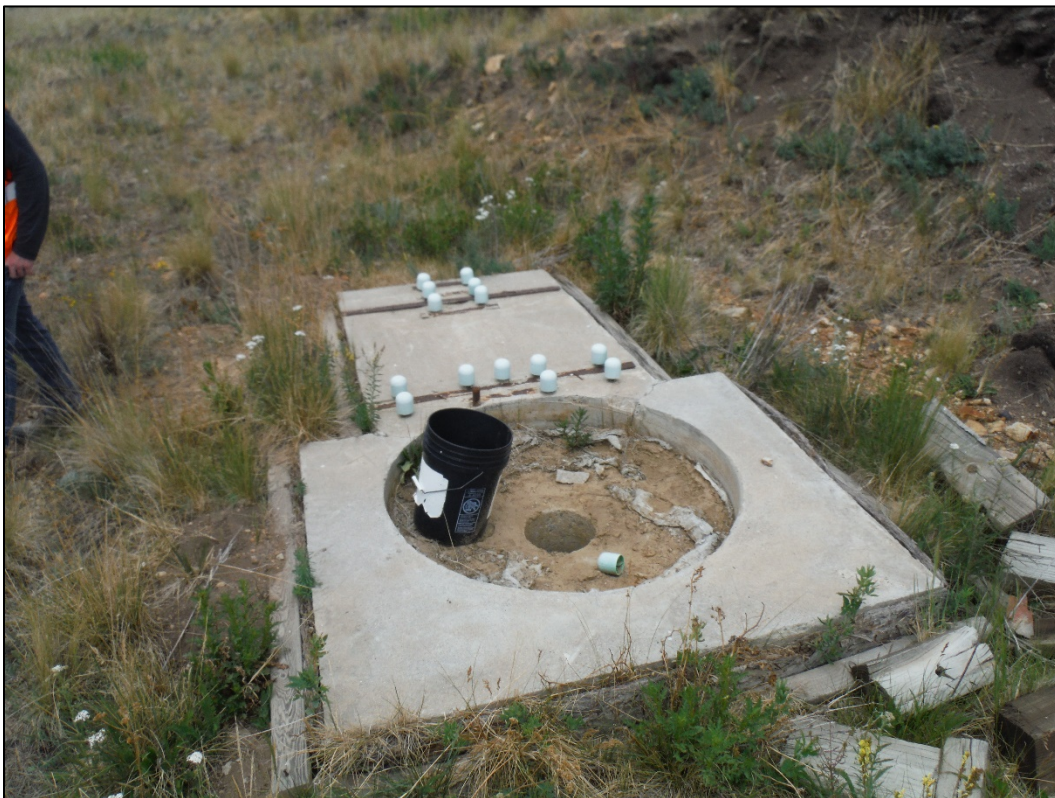
COMPLIANCE PROBLEM #3: There are two open and unsecure boreholes within the Air Raise area.

Other: The Air Raise area, located approximately 1,800 feet east-northeast of the Sangre de Cristo Tunnel area, contains an air ventilation shaft (permitted at a 48" diameter) and two pilot boreholes for future raises for additional ventilation or secondary escape ways. The air ventilation shaft was fenced and locked, however the two pilot holes, approximately 12" diameter, were open and unsecured. As these open boreholes pose a potential safety issue, Compliance Problem #3 has been cited requiring corrective action; please see the second page of this report for more information.

Photo 6. First open 12" borehole in the Air Raise area; looking northwest.

CORRECTIVE ACTIONS: The Operator shall secure the open boreholes or plug and abandon the boreholes in accordance with the approved reclamation plan. The Operator shall provide photo documentation to the Division verifying the open boreholes have been appropriately safeguarded by the corrective action date.

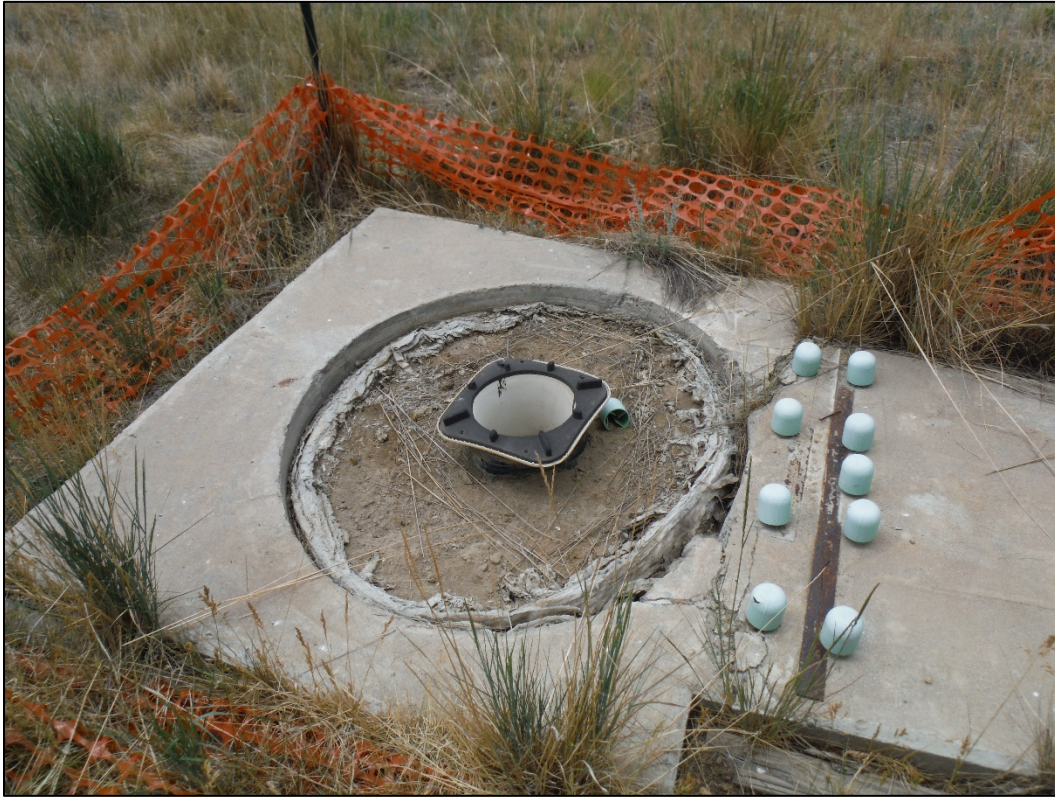
Photo 7. Second open 12" borehole in the Air Raise area; looking west.

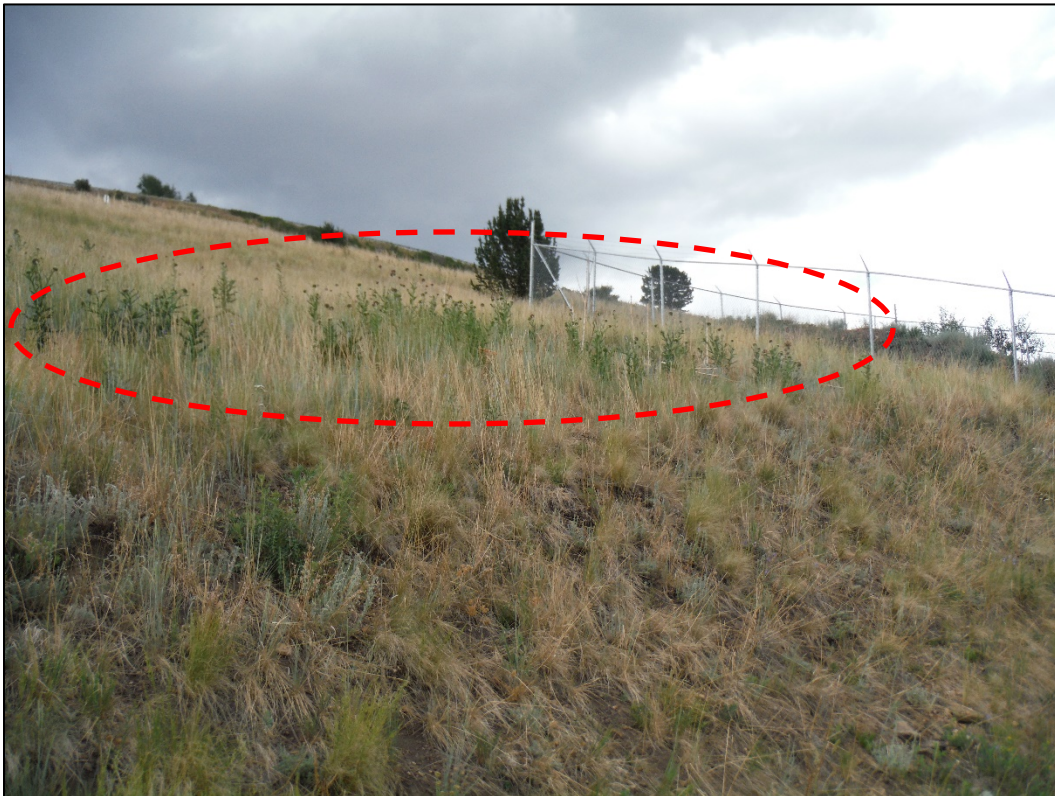
COMPLIANCE PROBLEM #4: There are state-listed noxious weeds present on site. This is a problem for failure to employ weed control methods for state listed noxious weed species within the permitted area, and to reduce the spread of weeds to nearby areas as required by Rule 3.1.10(6)

Revegetation: A large amount of musk thistle, a List B noxious weed, was observed across the mine site. This

Photo 8. Sample photo of musk thistle infestation; looking southeast.

CORRECTIVE ACTIONS: Implement weed control and provide proof to the Division that this has been done by the corrective action date.

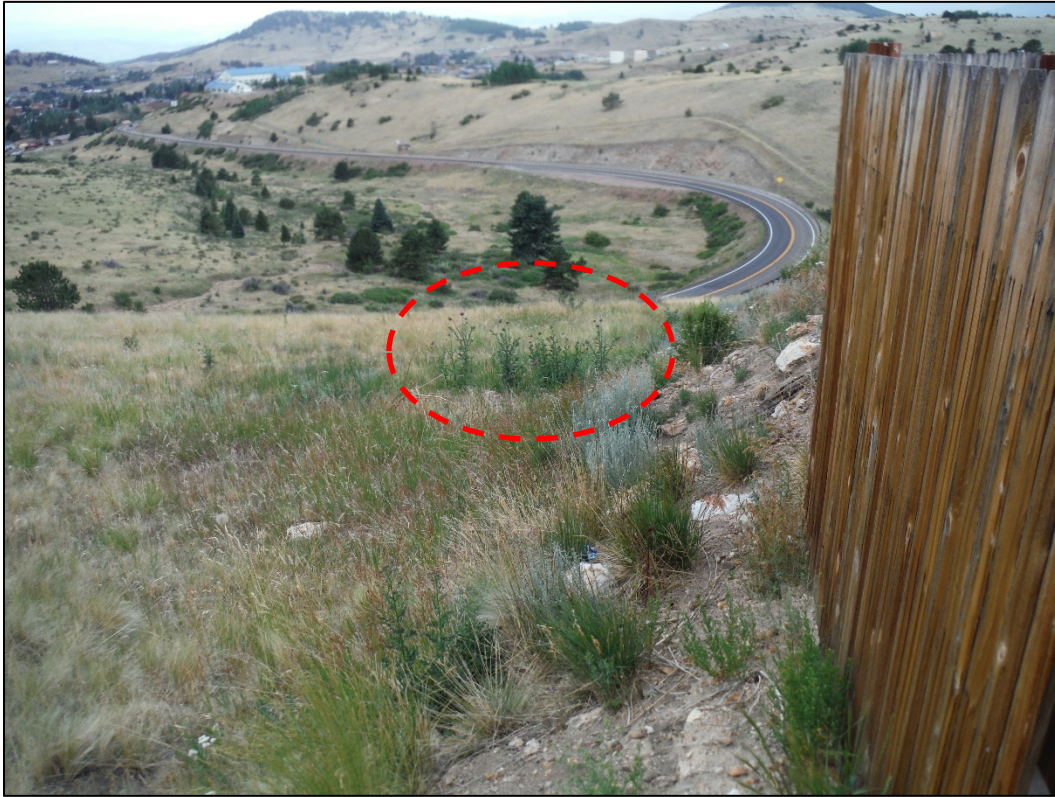
Photo 9. Sample photo of musk thistle infestation; looking southeast.

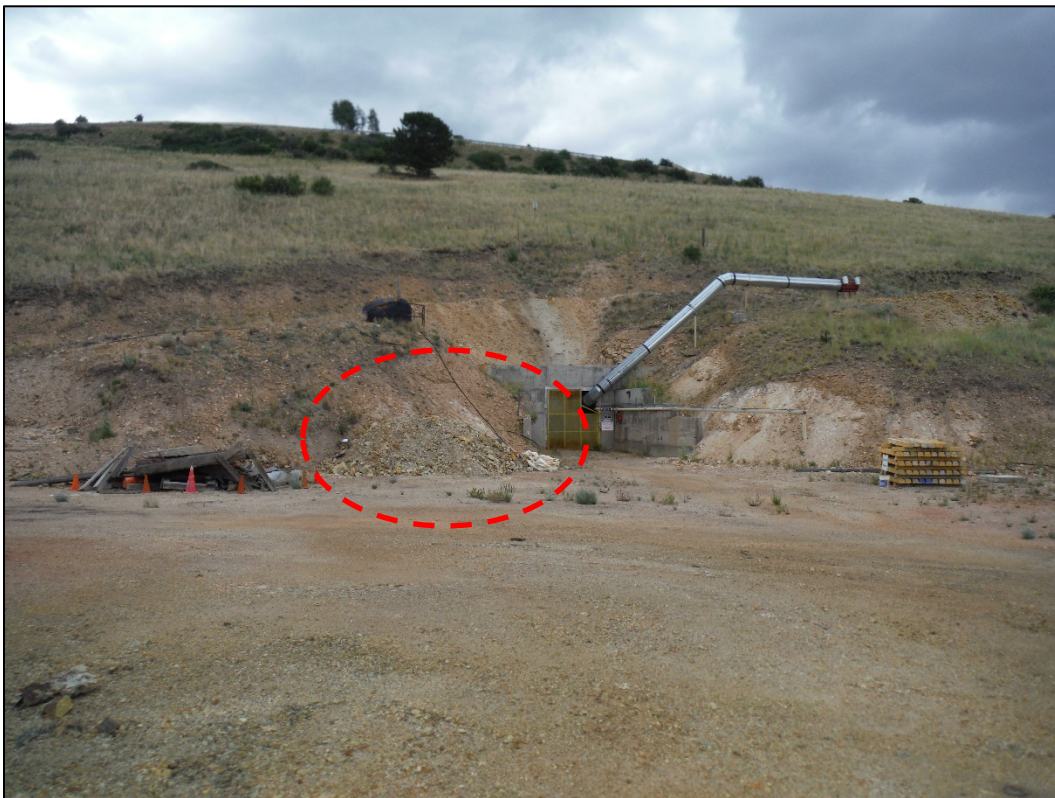
COMPLIANCE PROBLEM #5: A small stockpile of waste rock was observed on the surface of the mine site near the Sangre de Christo Tunnel portal. The Division has no record of a geochemical analysis for this material in accordance with Stipulation No. 1 of the approved permit.

Permit Stipulations: The Division observed a small stockpile, approximately 10 cubic yards, near the entrance to the Sangre de Christo Tunnel portal. The Operator wasn't sure of the origin of this material and believed it was placed there by the previous operator prior to SO-01. Based on the appearance and location, the Division believes this material came from within the mine and is either ore or waste rock. Stipulation No. 1 of the approved permit states: *The permittee will commit to performing annual testing of ore and waste rock if removed to the surface of the permit area. Results to be included with Annual Report.* The permit file doesn't contain any information regarding the results of any Meteoric Water Mobility Procedure (MWMP) characterization of the geochemistry and leaching potential of this stockpiled material. This has been cited as Compliance Problem #5 requiring corrective action; please see the second page of this report for more information. After the inspection, the Division and Operator discussed that in this particular situation, instead of testing the unknown stockpiled material the Operator could haul this material to one of the Valley Leach Facilities of the adjacent Cresson Project and submit appropriate documentation of such action.

Photo 10. Sangre de Cristo Tunnel portal overview, stockpiled ore or waste rock material circled in red; looking east.

CORRECTIVE ACTIONS: The Operator shall conduct testing on the stockpiled material in accordance with the approved permit OR remove this material from the surface of the site and dispose of it appropriately.

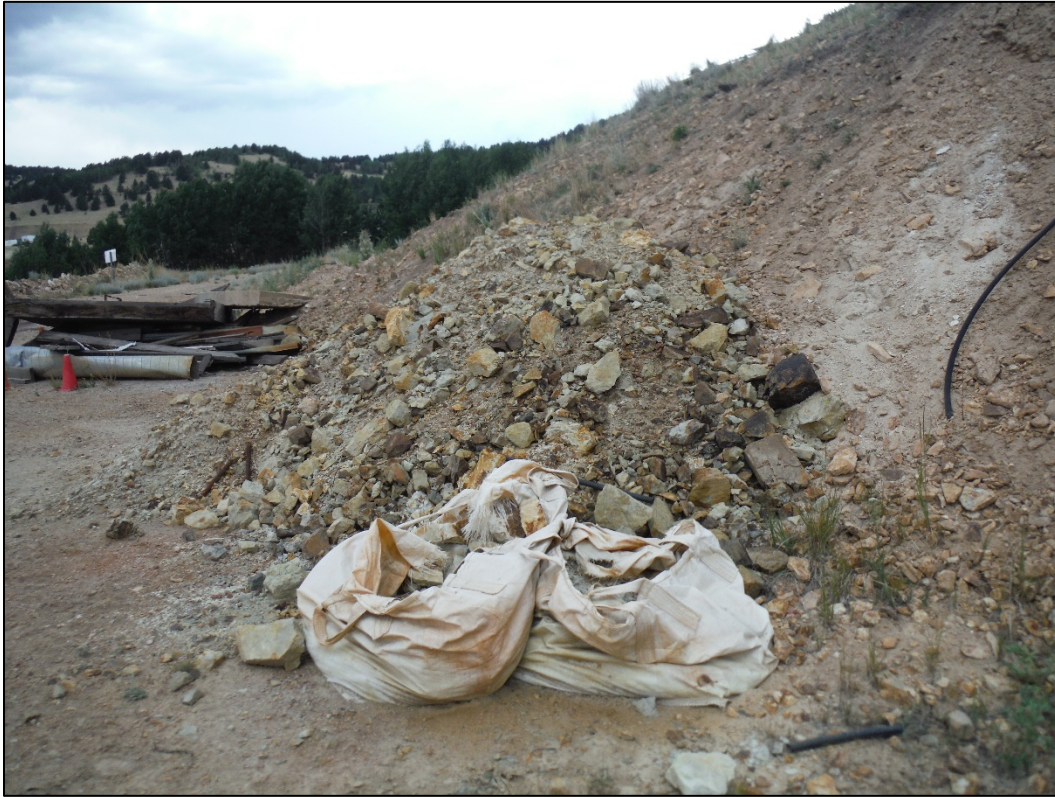
Photo 11. Stockpiled ore or waste rock material; looking north.
