MINERALS PROGRAM INSPECTION REPORT
PHONE: (303) 866-3567

MINE NAME: Yetter Pit	MINE/PROSPECTING ID#: M-1996-050	MINERAL: Sand and gravel	COUNTY: Logan
INSPECTION TYPE: Monitoring	INSPECTOR(S): Patrick Lennberg and Jared L. Ebert	INSP. DATE: October 17, 2018	INSP. TIME: 12:50
OPERATOR: R & J Yetter Sand & Gravel LLC	OPERATOR REPRESENTATIVE: Russ and Jewleie Yetter	TYPE OF OPERATION: 110c - Construction Limited Impact	
REASON FOR INSPECTION: Normal I&E Program	BOND CALCULATION TYPE: Complete Bond Calculation	BOND AMOUNT: \$17,500.00	
DATE OF COMPLAINT: NA	POST INSP. CONTACTS: None	JOINT INSP. AGENCY: None	
WEATHER: Clear	INSPECTOR'S SIGNATURE:

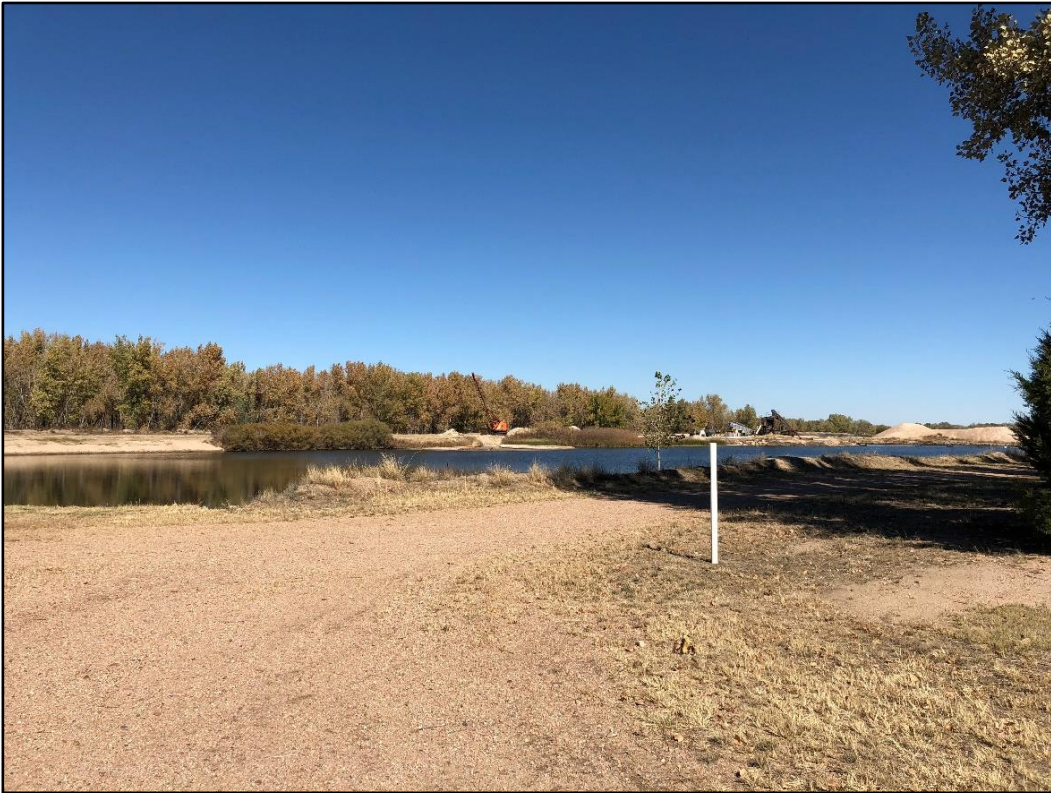
Mining is being conducted within the permit boundary. All permit boundary markers, 2-inch PVC, are clearly visible along perimeter of the site. The mine permit sign is clearly visible at the entrance.

Photo 1: SW corner of site looking to NE with permit boundary with marker in foreground

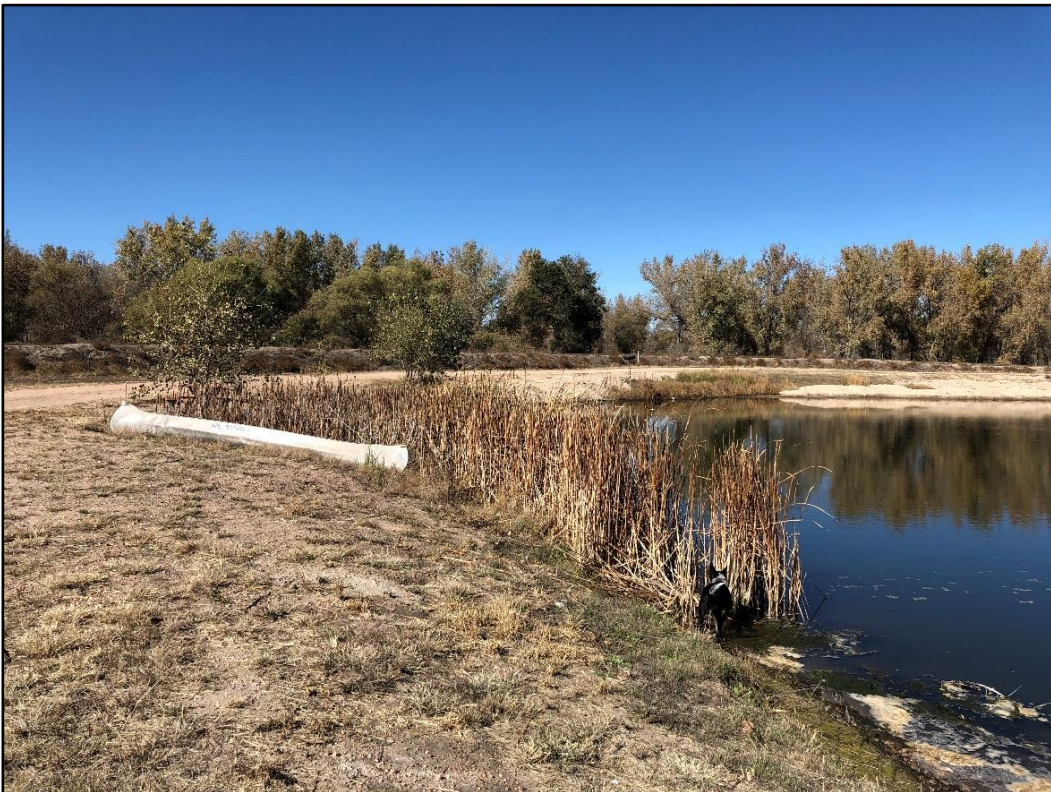
The shoreline around the western portion of the pond has been graded to a minimum of 3H:1V slope and appear to be stable. There are a couple of young cottonwood trees in the area that are trying to become established. Further along the northwest shoreline there is an established stand of willows. The operators are gradually beginning reclamation efforts in the western portion and will move around the lake as time allows. The east bank of the pond were near vertical as a result of undercutting from dredging activities along this area. The operators stated that the banks will be recontoured after winter shut down to minimize hazards and erosion. The banks along the southern portion of the pond were near the angle of repose. The operators mentioned that as reclamation activities progress the banks will be flattened out to the required 3H:1V slope. Currently there is a berm along the banks to minimize the risk of a truck accidentally driving into the pond.

Photo 2: SW corner of pond that has had some reclamation work performed

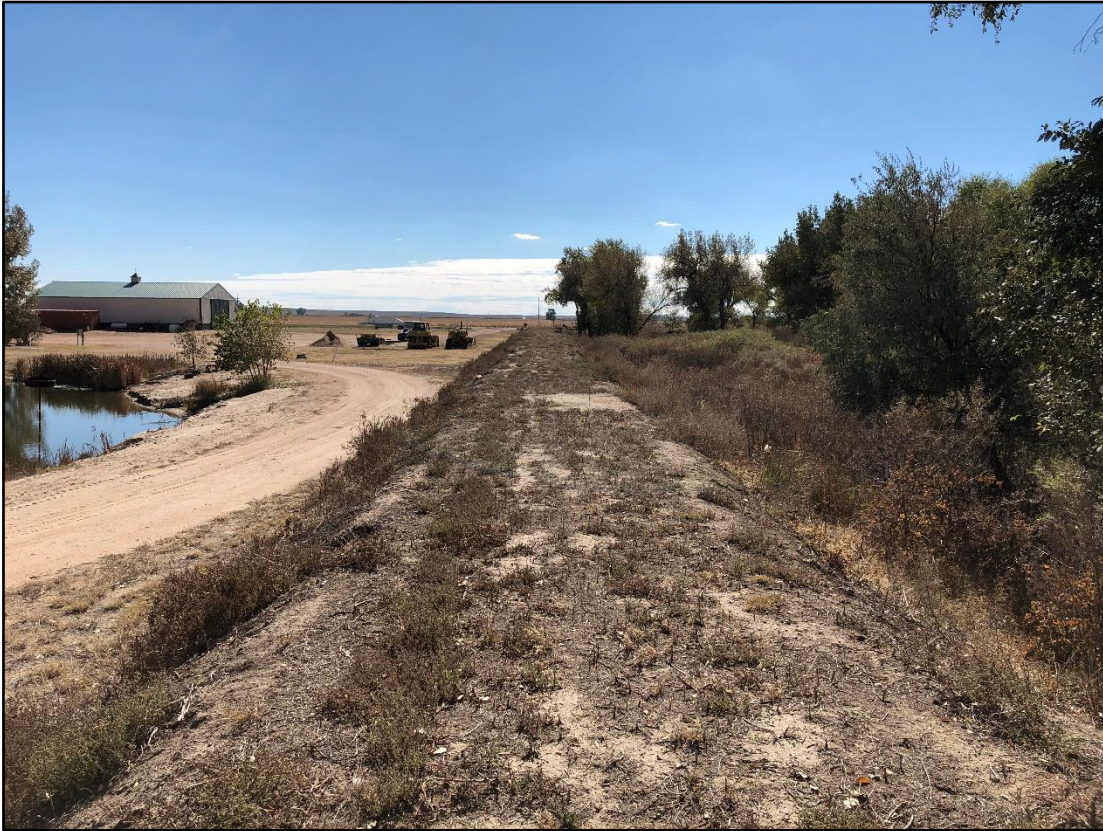
The South Platte River borders the property to the north. A safety berm has been installed by the Operators that runs along the west and wraps around to the north to help mitigate flooding of the property which has occurred a couple of times during flooding in 2013 and 2015. The berm is outside the permit boundary and was constructed using import fill.

Photo 3: Flood control berm on the west side looking south

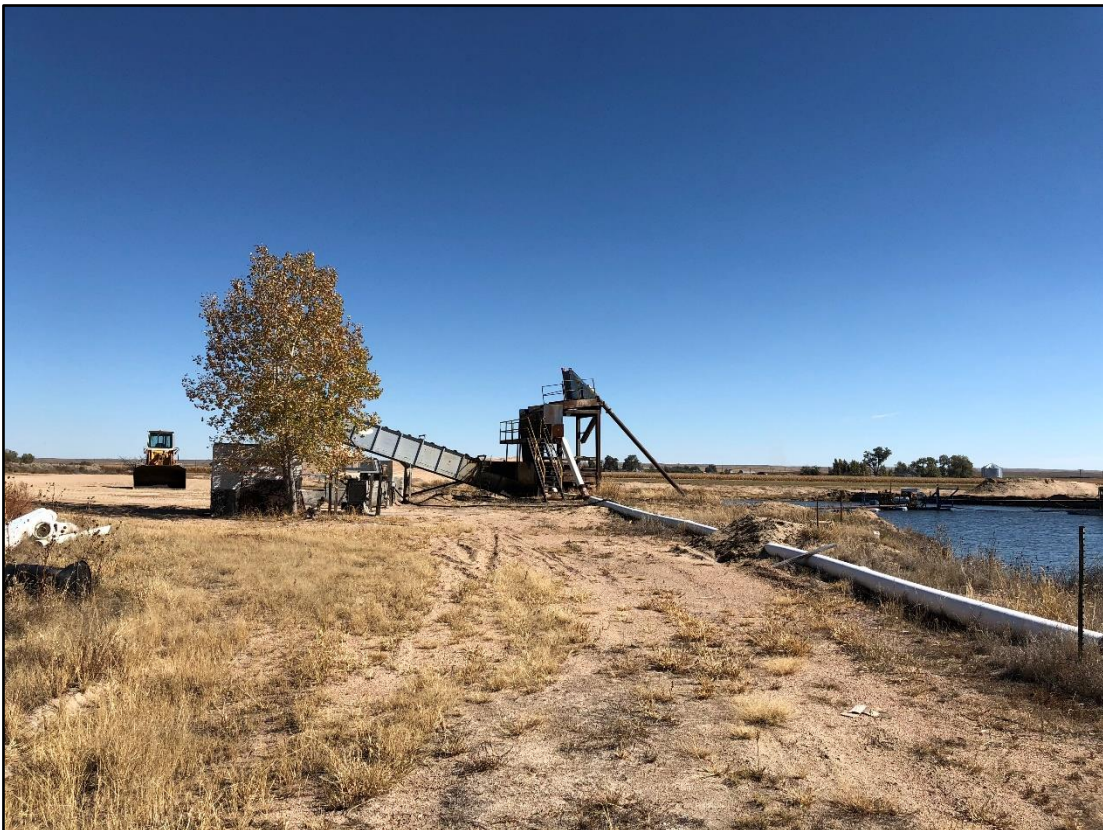
Photo 4: Dredge and processing plant

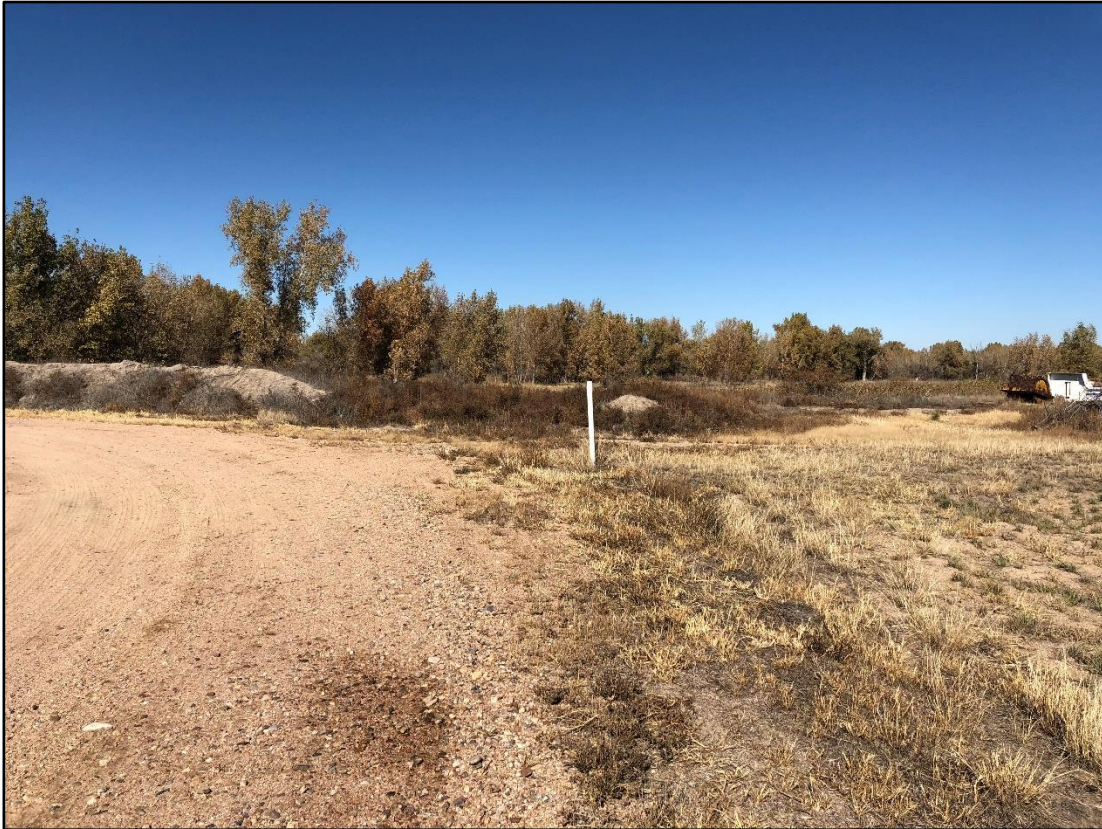
Photo 5: NE permit boundary marker

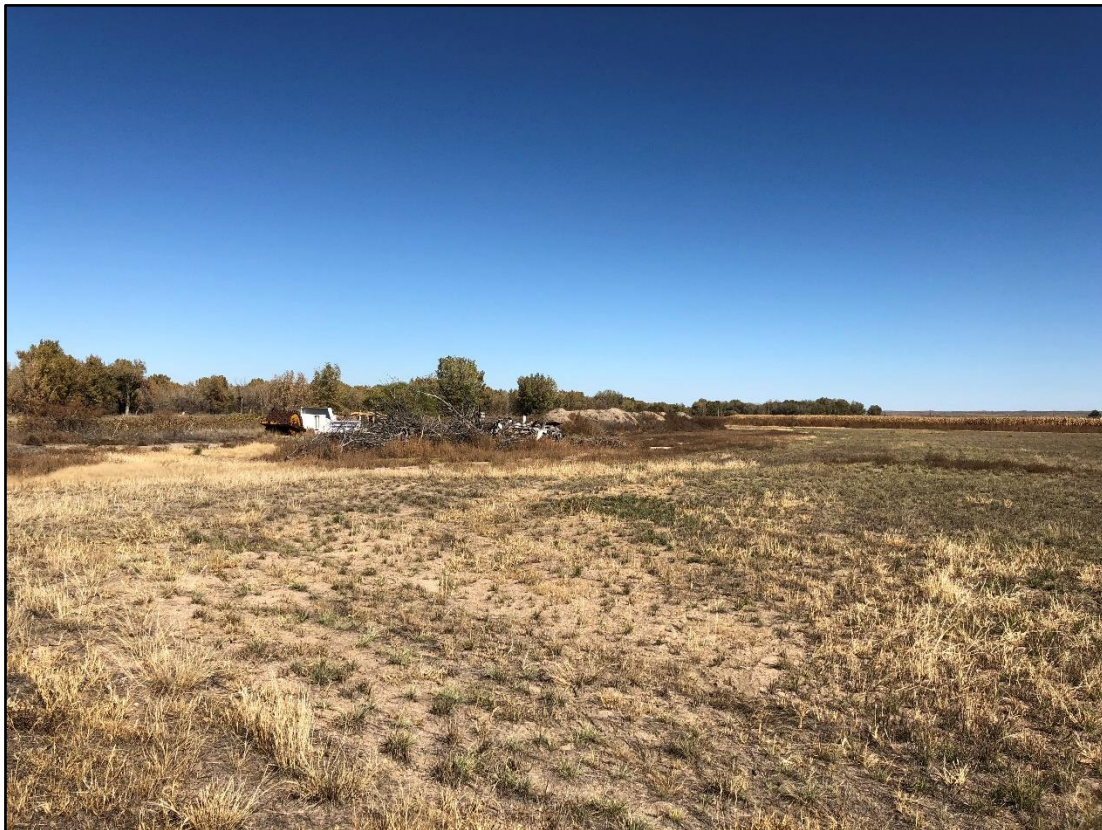
The pond banks, stockpile and processing areas and areas between the access road and permit boundary will have 6-inches of topsoil placed, tilled, seeded and mulched. There is a beet tare pile that is located outside the permit boundary to the northeast that is staged on property owned by the operators. The pile may be used as top soil as needed during reclamation. The operators should be aware that if at any time during reclamation they determine they will need to use the beet tare pile they will have to submit a Technical Revision prior to using the material. Use of beet tare material is not in the approved reclamation plan and will require certification that it is clean and inert material. Additionally a sample will have to determine its agronomic properties for use as top soil. The Technical Revision will need to address the requirements of Rule 3.1.5(9).

Photo 6: Beet tare pile

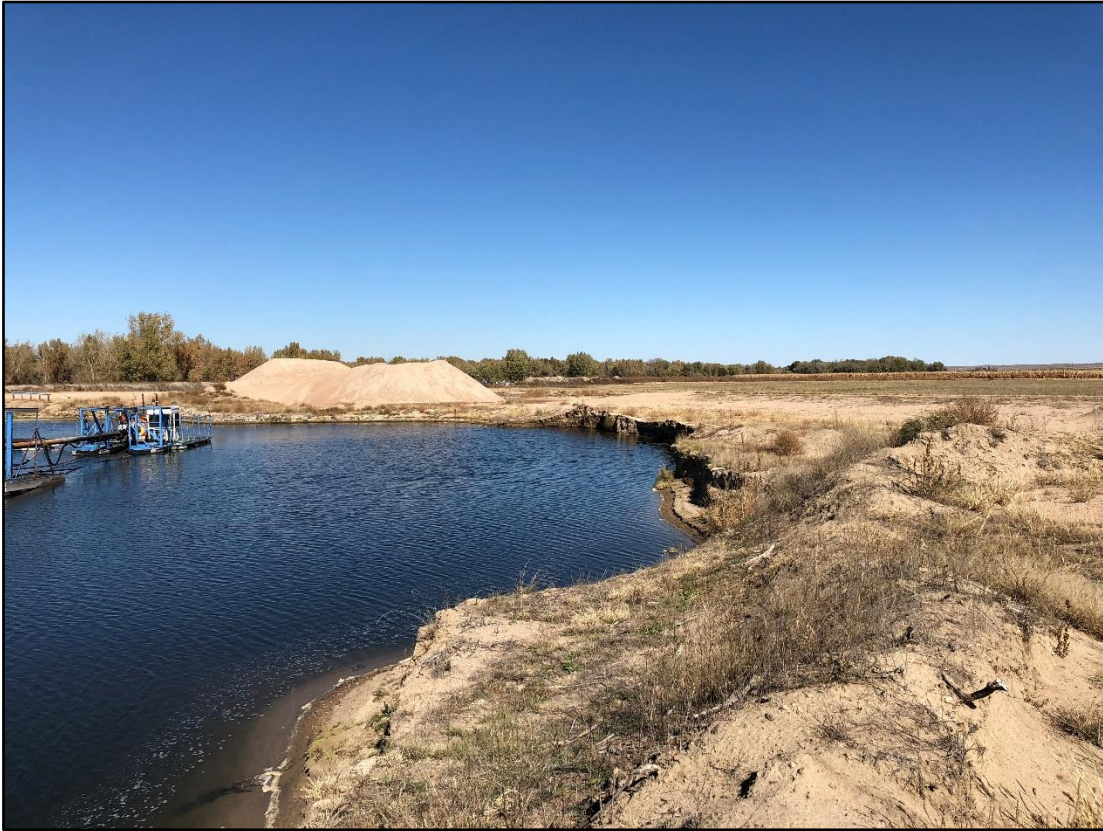
Photo 7: Stockpile of material and current above water face of mining operations

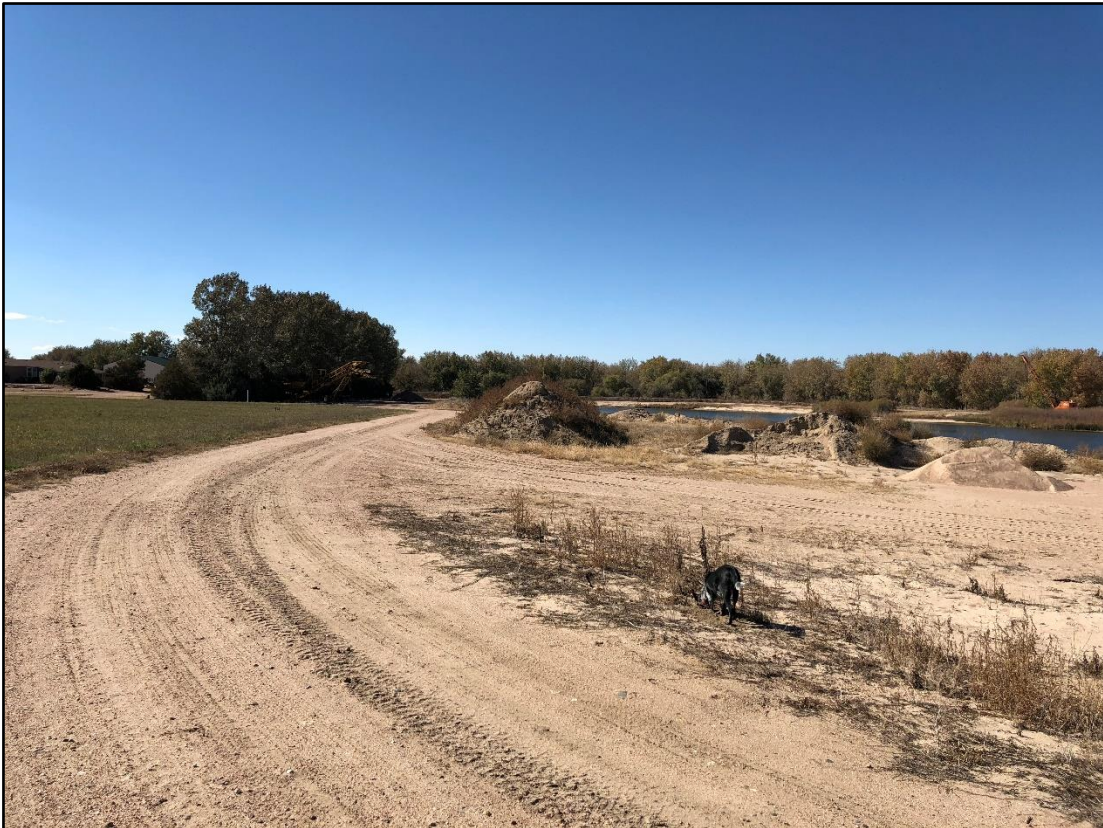
Photo 8: SE corner of permit area looking west with topsoil piles
