## MINERALS PROGRAM INSPECTION REPORT

<b>MINE NAME:</b> Florence South Pit	<b>MINE/PROSPECTING ID#:</b> M-1988-093	<b>MINERAL:</b> Sand and gravel	<b>COUNTY:</b> Fremont
<b>INSPECTION TYPE:</b> Monitoring	<b>INSPECTOR(S):</b> Timothy A. Cazier	<b>INSP. DATE:</b> June 14, 2018	<b>INSP. TIME:</b> 13:45
<b>OPERATOR:</b> Fremont Paving & Redi-Mix, Inc.	<b>OPERATOR REPRESENTATIVE:</b> John Young	<b>TYPE OF OPERATION:</b> 112c - Construction Regular Operation

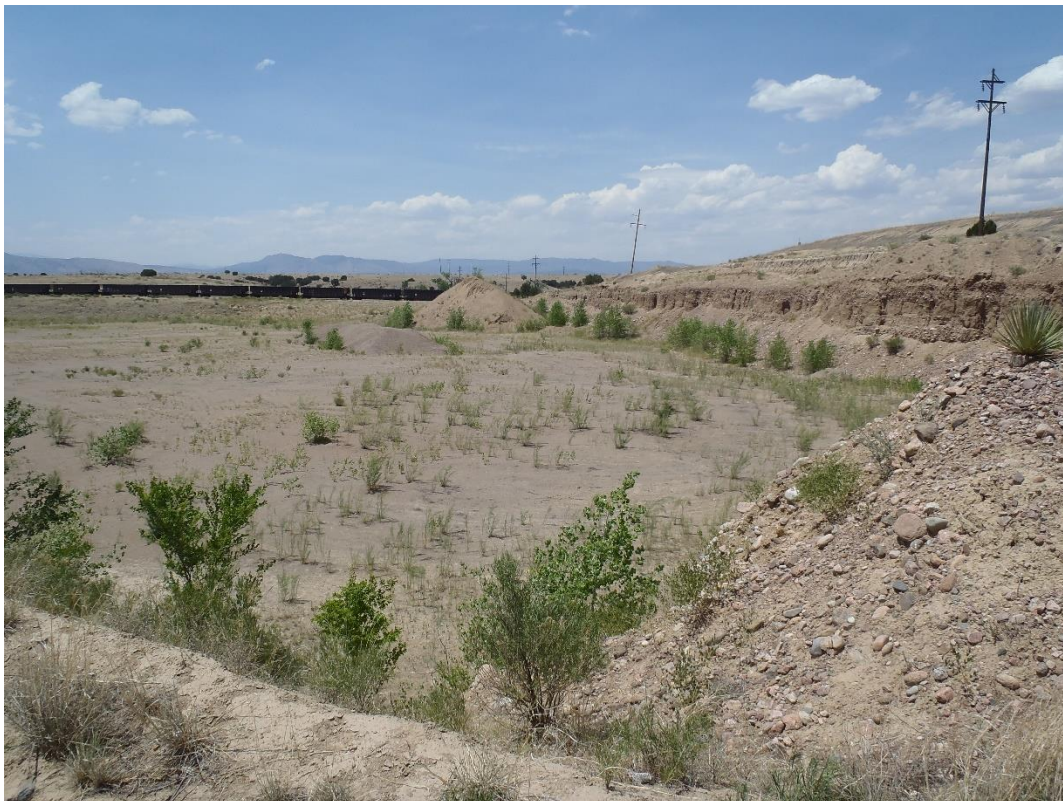
Gen. Compliance with Mine Plan: The operation appeared to be in compliance with the approved mine plan. Mr. Young indicated they are partially between phases 1 and 2. Google Earth was used to measure the disturbed area, which was estimated to be approximately 13.5 acres, based on 2016 imagery. Highwalls were estimated to vary between 30 and 40 feet in height (see **Photo 1**). Some raveling of the highwall was observed (see **Photo 2**).

Photo 1. 30 to 40 foot highwall (looking west, note topsoil stockpile north of powerline).

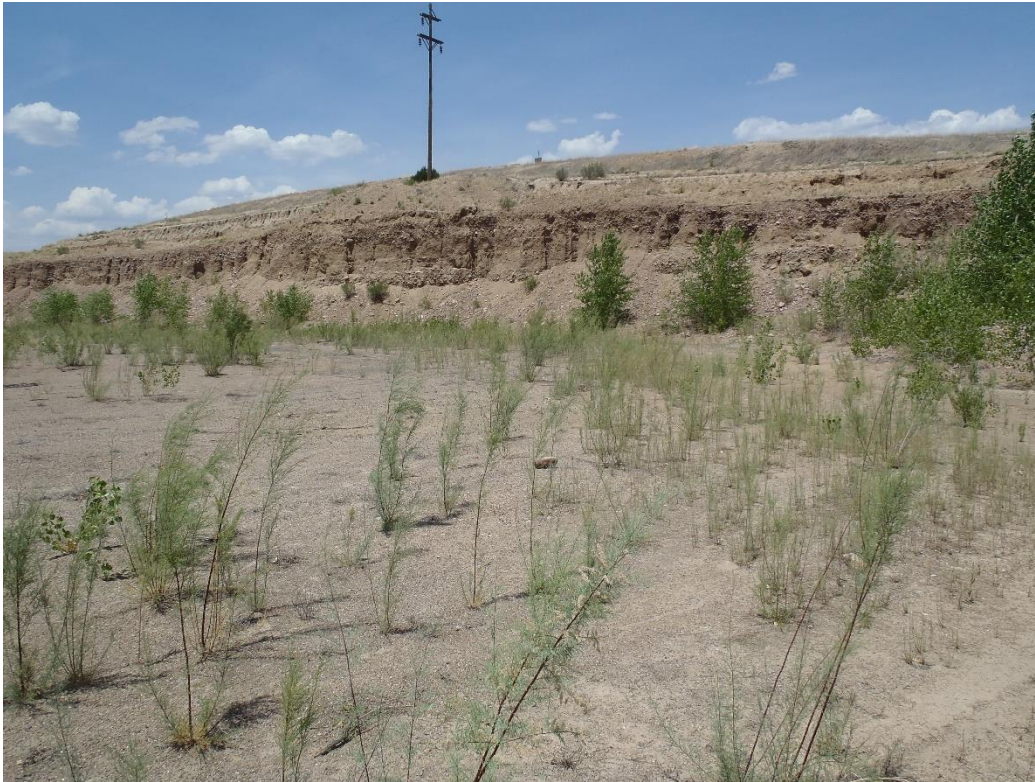
Photo 2. Highwall (looking NW, note raveling on left).

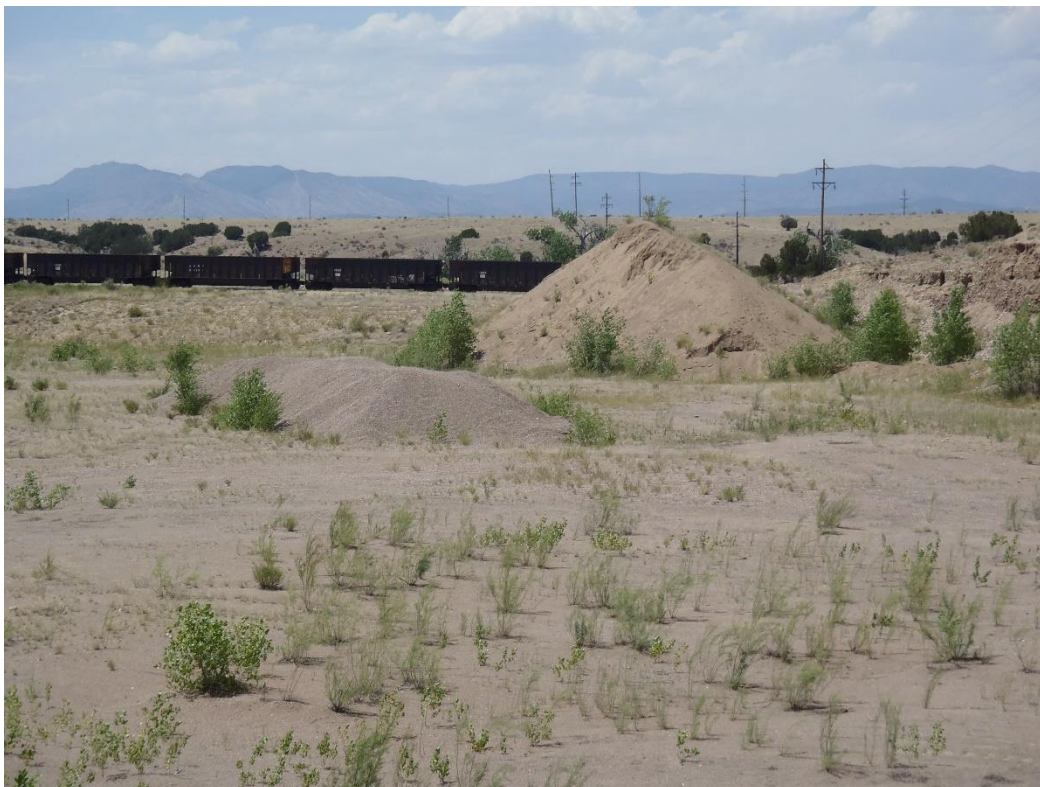
Processing Waste: A stockpile of fines was observed in the northwest corner (see **Photo 3**).

Photo 3. Fines and product stockpiles (northwest pit floor, looking west).

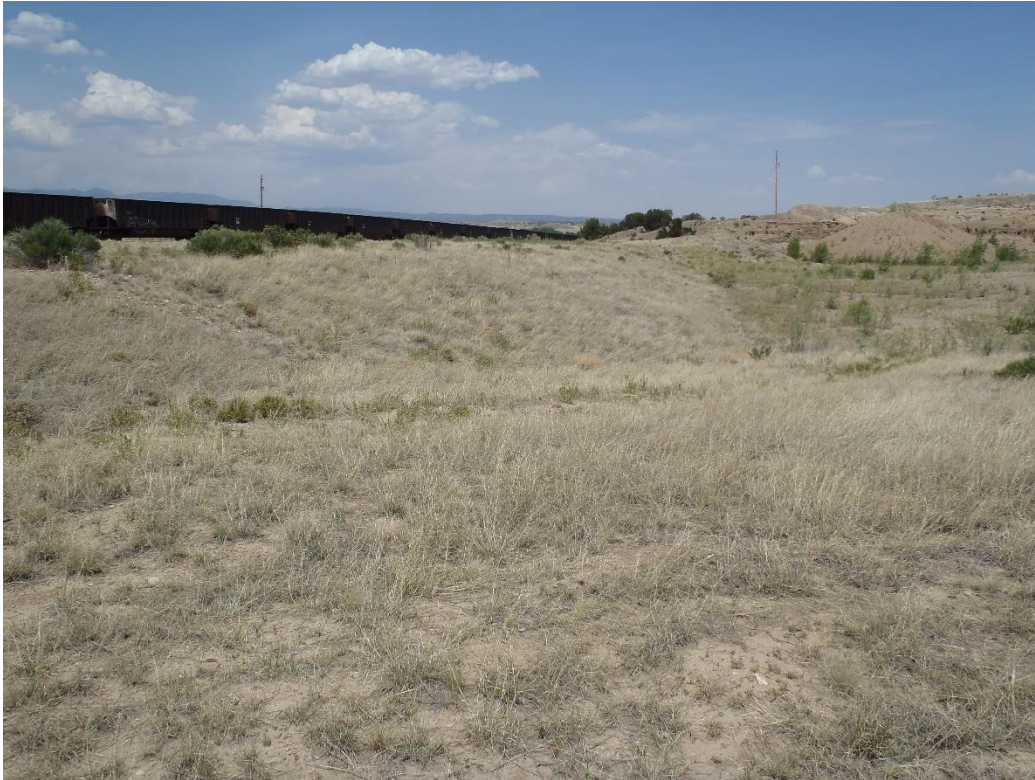
Reclamation Success: The west side appears to have been graded to 3H:1V or flatter (see **Photo 4**).

Photo 4. Graded, revegetated west end pit slope (looking north).

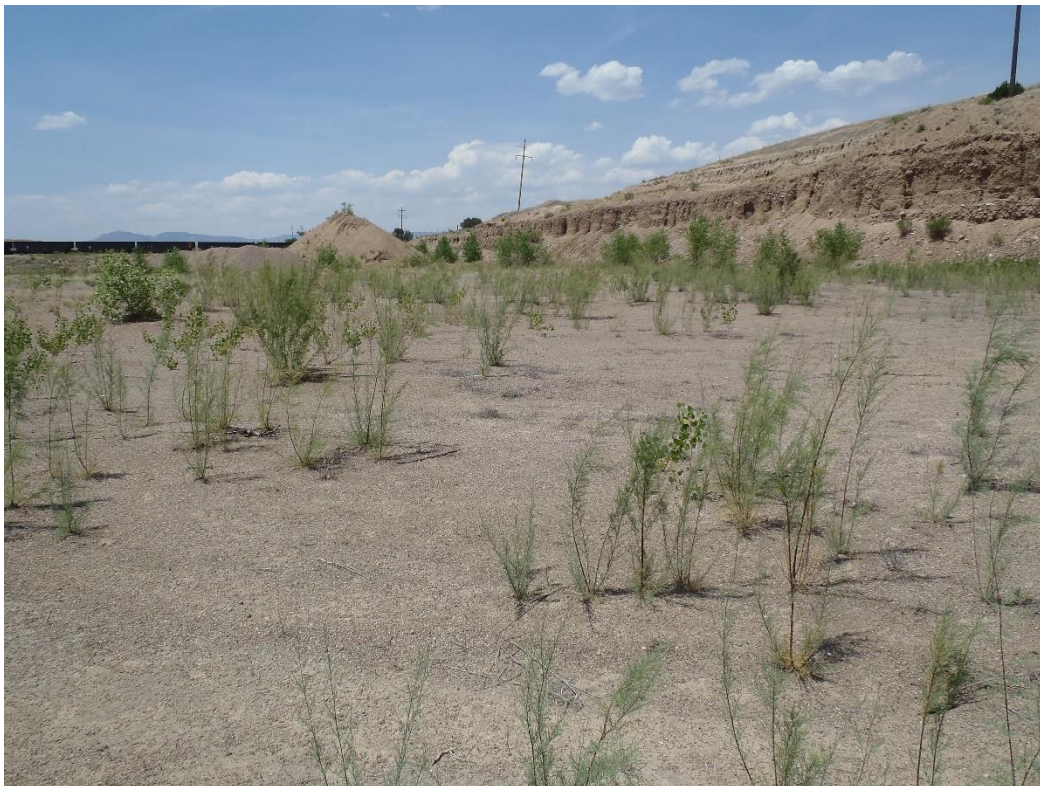
**PROBLEM/POSSIBLE VIOLATION:** Problem 2: Tamarisk (salt cedar) trees are present within or have volunteered into the permit area and are becoming established. This is a problem for failure to employ weed control methods for a state listed noxious weed species within the permitted area, and to reduce the spread of weeds to nearby areas as required by Section 3.1.10 (6) of the rule.

Revegetation: A large amount of tamarisk (salt cedar) was observed on the east end of the pit floor (see **Photo 5**). **The presence of this a noxious weed List B species is cited as Problem 2 on page 1 of this report.** The aforementioned west side graded slopes appear to have been naturally revegetated after sloping.

Photo 5. Tamarisk (salt cedar) on east end of pit floor (looking west).

**CORRECTIVE ACTIONS:** The operator shall implement the existing weed control plan (approved as TR-02 in July 2014) and provide documentation of completing tamarisk control to the DRMS by the corrective action date.

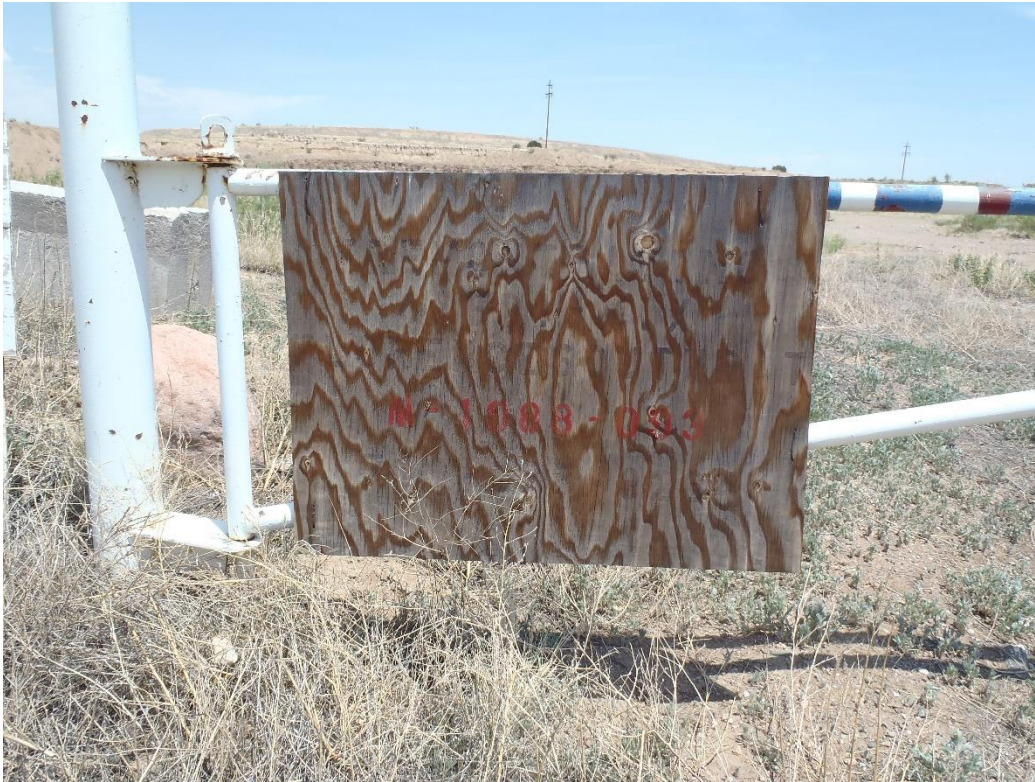
Signs and Markers: The permit sign was posted (see **Photo 6**), but mostly illegible. Only the permit number could be confirmed. The permit sign should be repainted or replaced. Boundary markers were observed to be adequate to delineate the permit boundary in all areas except the two western corners. **The missing boundary markers on the west side are cited as Problem 3 on page 1 of this report.**

Photo 6. Permit sign, showing only the permit number.

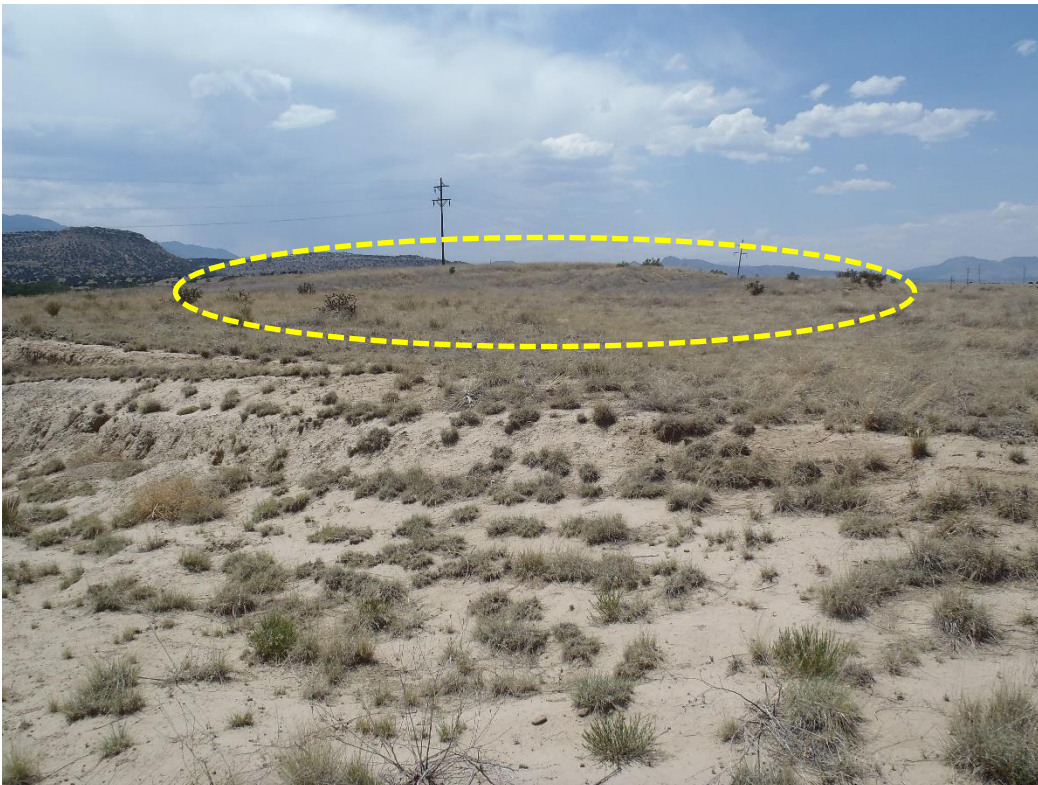
Topsoil: Topsoil has been stripped and is stockpiled on the uphill side of the highwall (see **Photo 7**).

Photo 7. Topsoil stockpile (from phase 2 area, looking SW).
