**MINERALS PROGRAM INSPECTION REPORT**  
**PHONE: (303) 866-3567**

<b>MINE NAME:</b> Cresson Project	<b>MINE/PROSPECTING ID#:</b> M-1980-244	<b>MINERAL:</b> Gold	<b>COUNTY:</b> Teller
<b>INSPECTION TYPE:</b> Aerial Inspection	<b>INSPECTOR(S):</b> Timothy A. Cazier	<b>INSP. DATE:</b> April 27, 2018	<b>INSP. TIME:</b> 14:08
<b>OPERATOR:</b> Cripple Creek & Victor Gold Mining Company	<b>OPERATOR REPRESENTATIVE:</b> N/A	<b>TYPE OF OPERATION:</b> 112d-3 - Designated Mining Operation	
<b>REASON FOR INSPECTION:</b> Normal I&E Program	<b>BOND CALCULATION TYPE:</b> None	<b>BOND AMOUNT:</b> \$208,491,188.00	
<b>DATE OF COMPLAINT:</b> NA	<b>POST INSP. CONTACTS:</b> None	<b>JOINT INSP. AGENCY:</b> None	
<b>WEATHER:</b> Clear	<b>INSPECTOR'S SIGNATURE:</b>

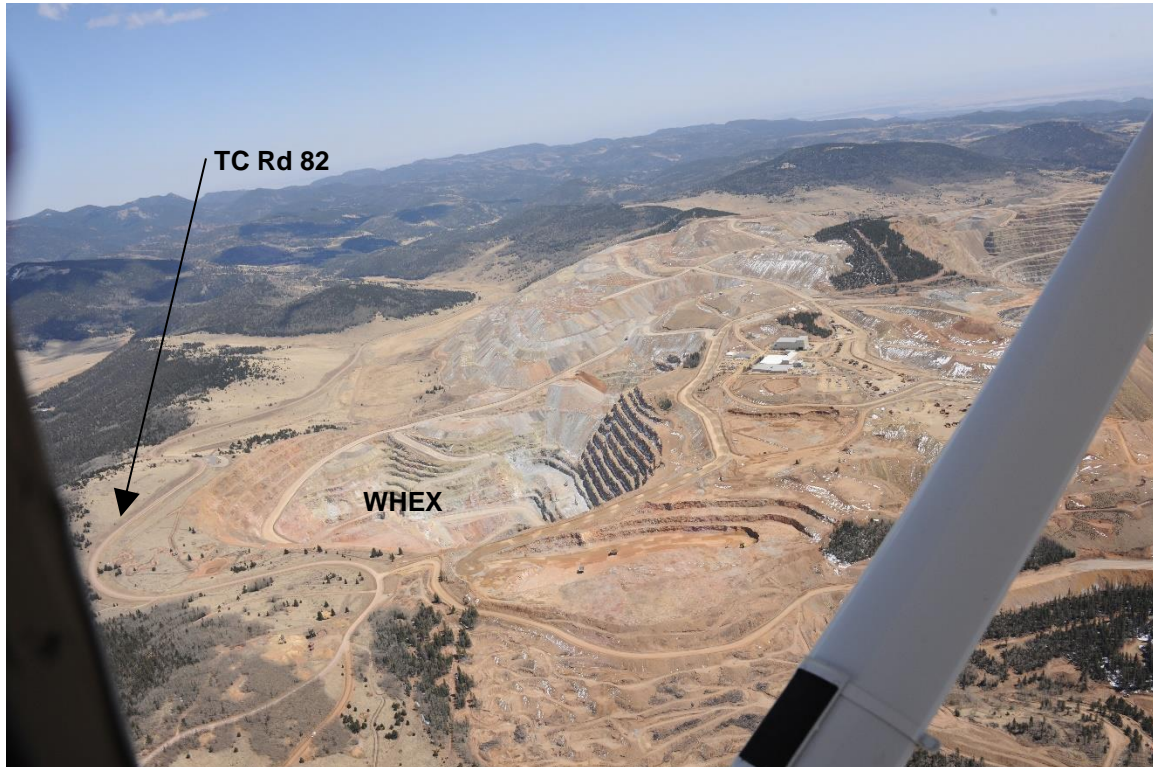
Photo 1. Wildhorse Extension Pit (Looking SE).

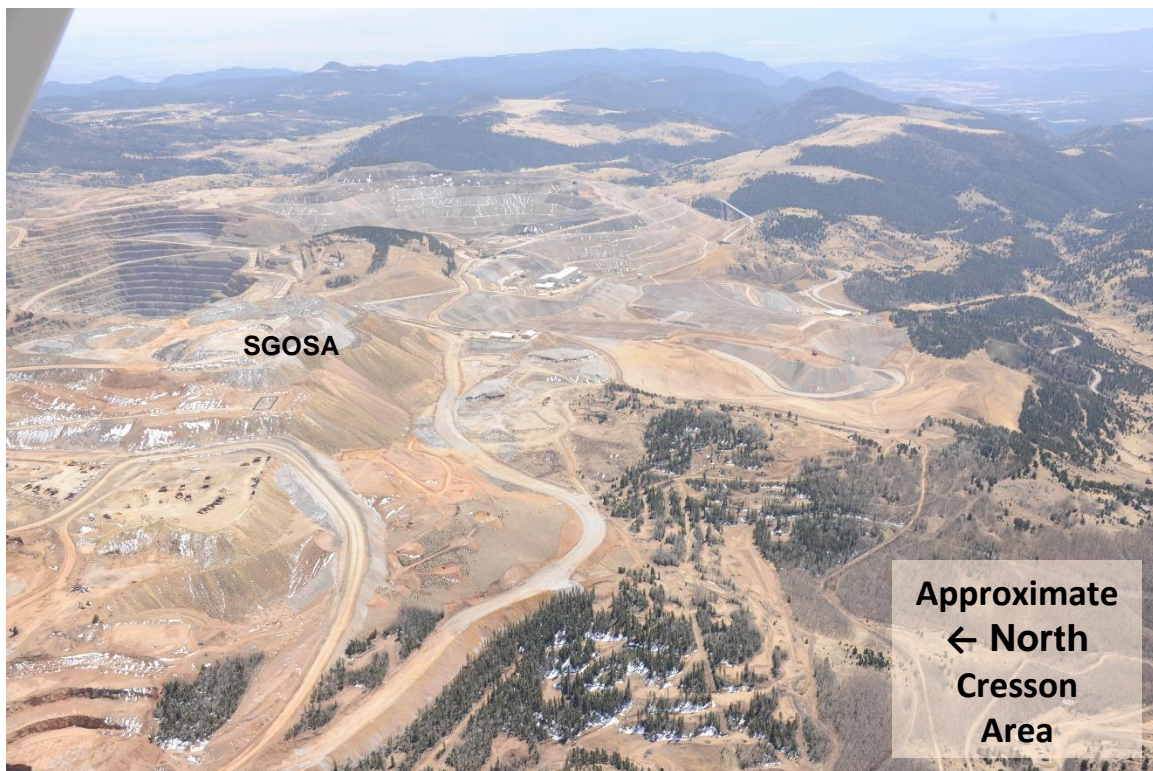
Photo 2. North Cresson (future, looking south).

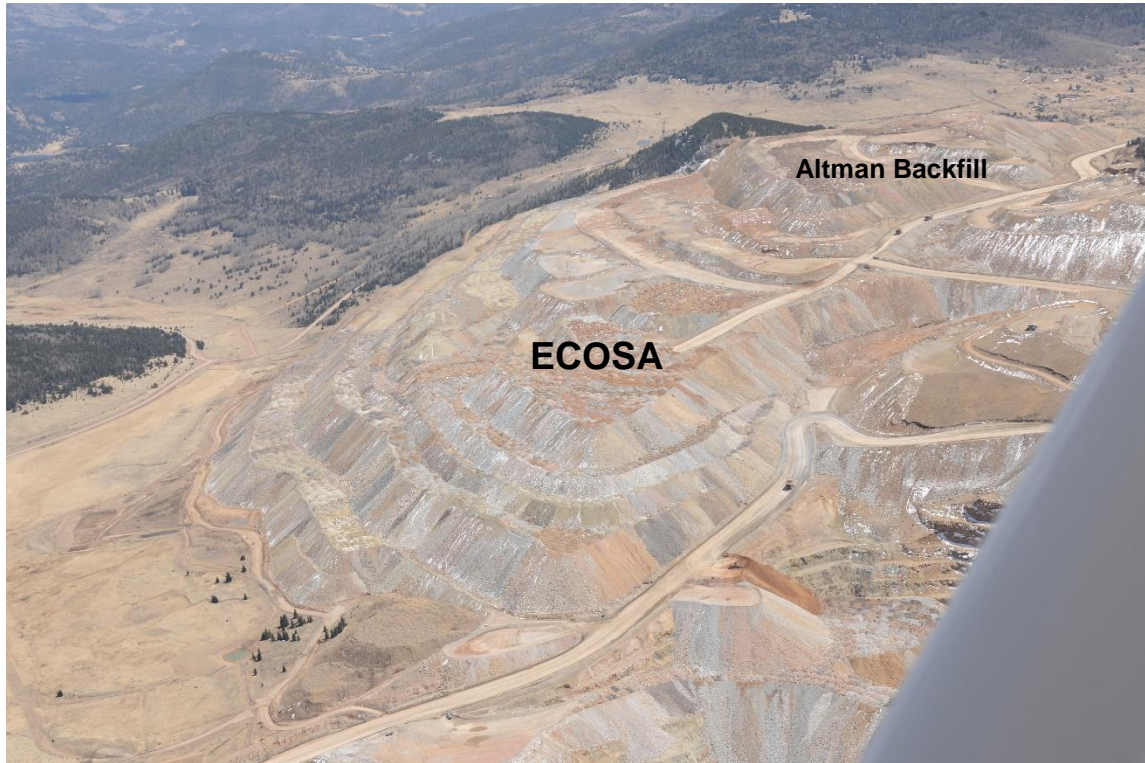
Photo 3. East Cresson OSA (looking SE).

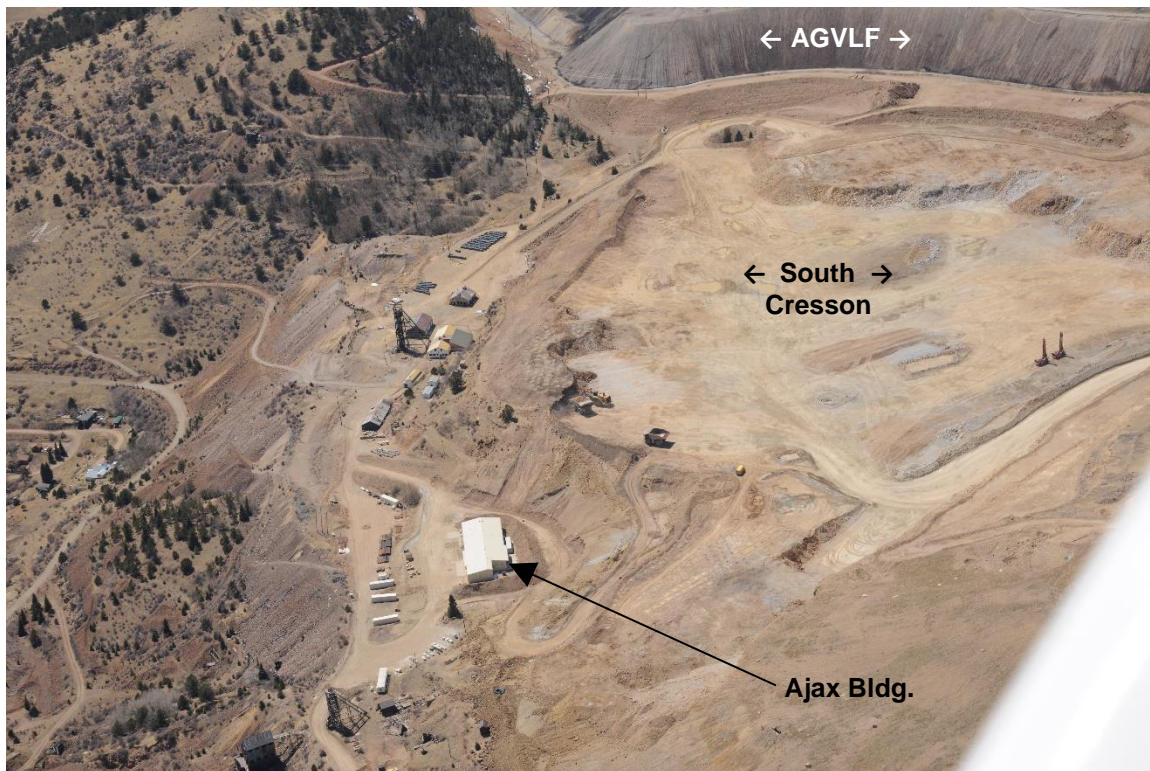
Photo 4. South Cresson (looking west).

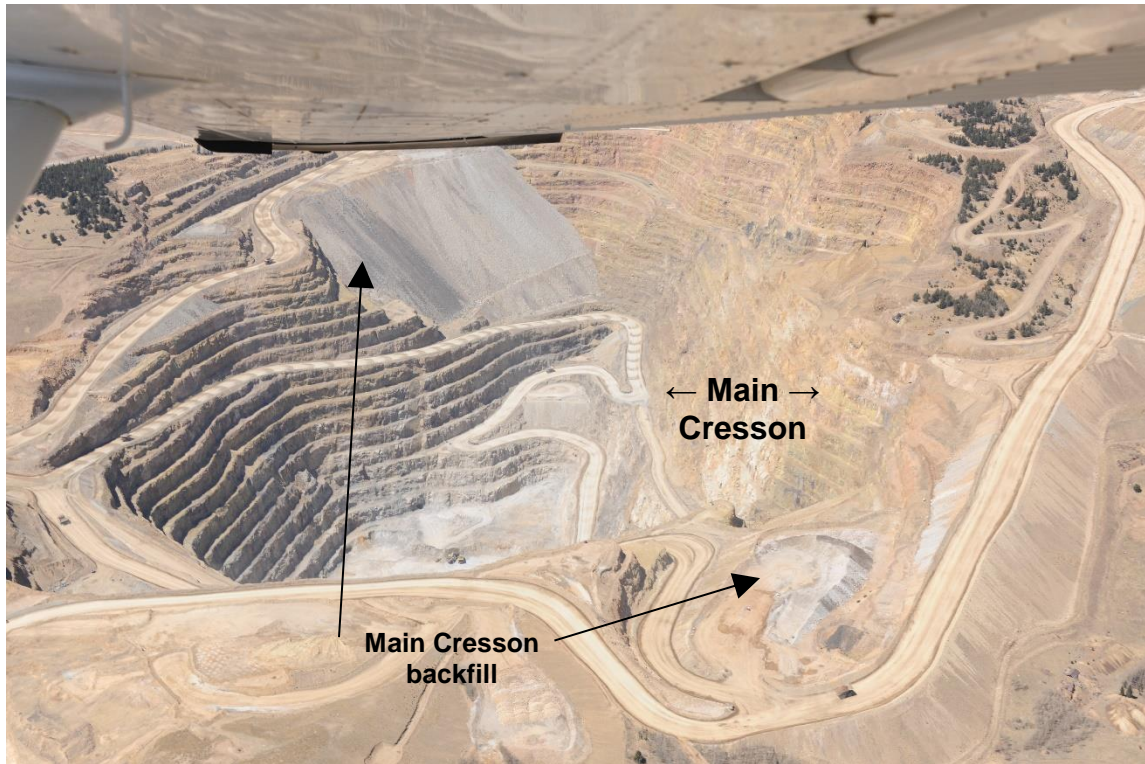
Photo 5. Main Cresson Pit (looking north).

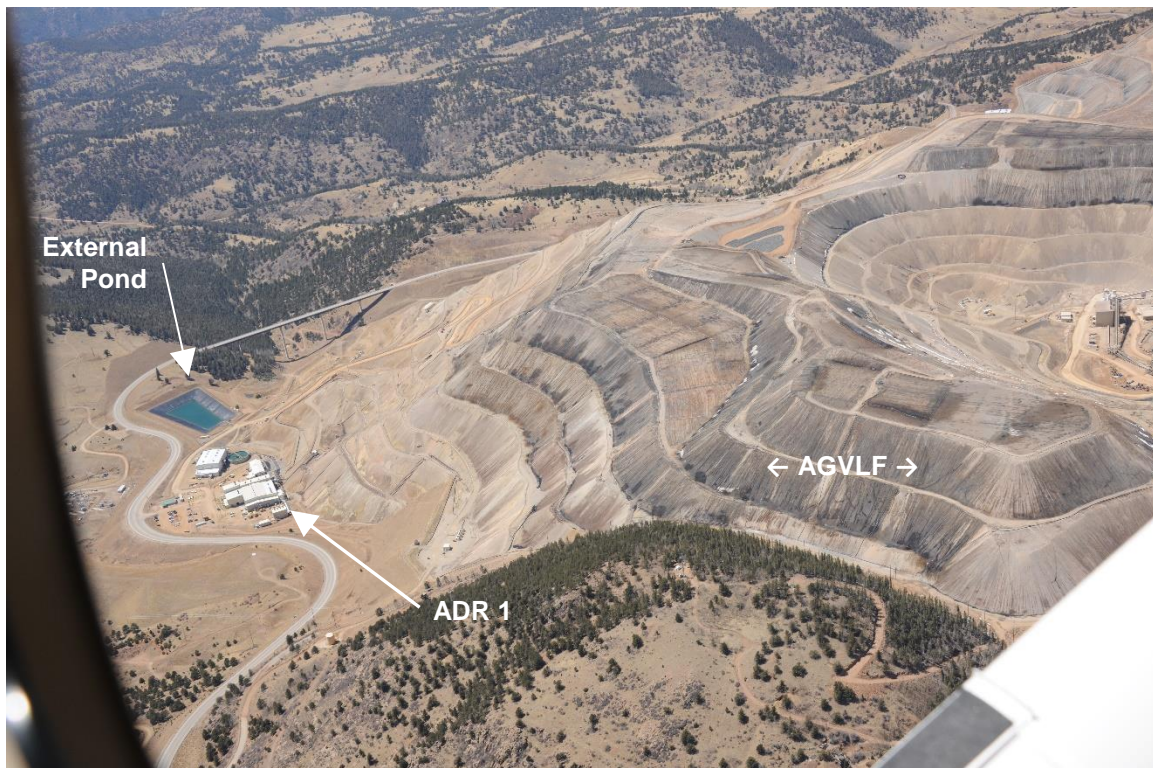
Photo 6. ADR 1 (looking west).

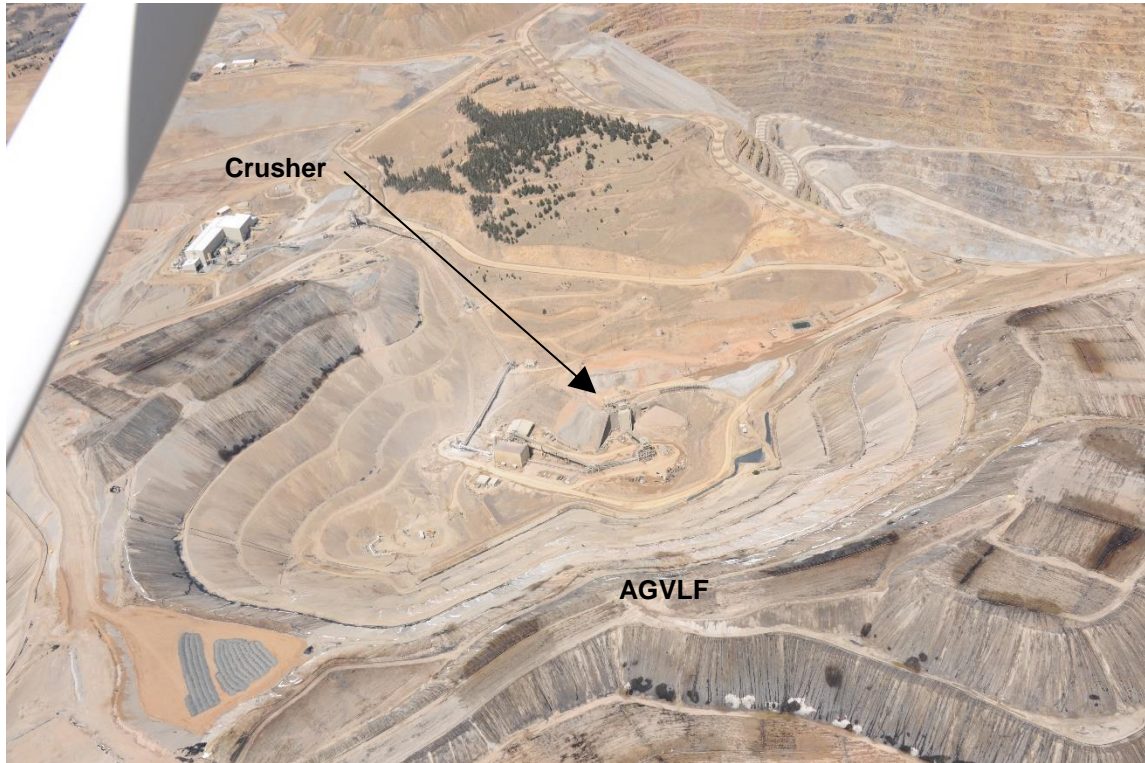
Photo 7. Arequa Gulch VLF (looking north).

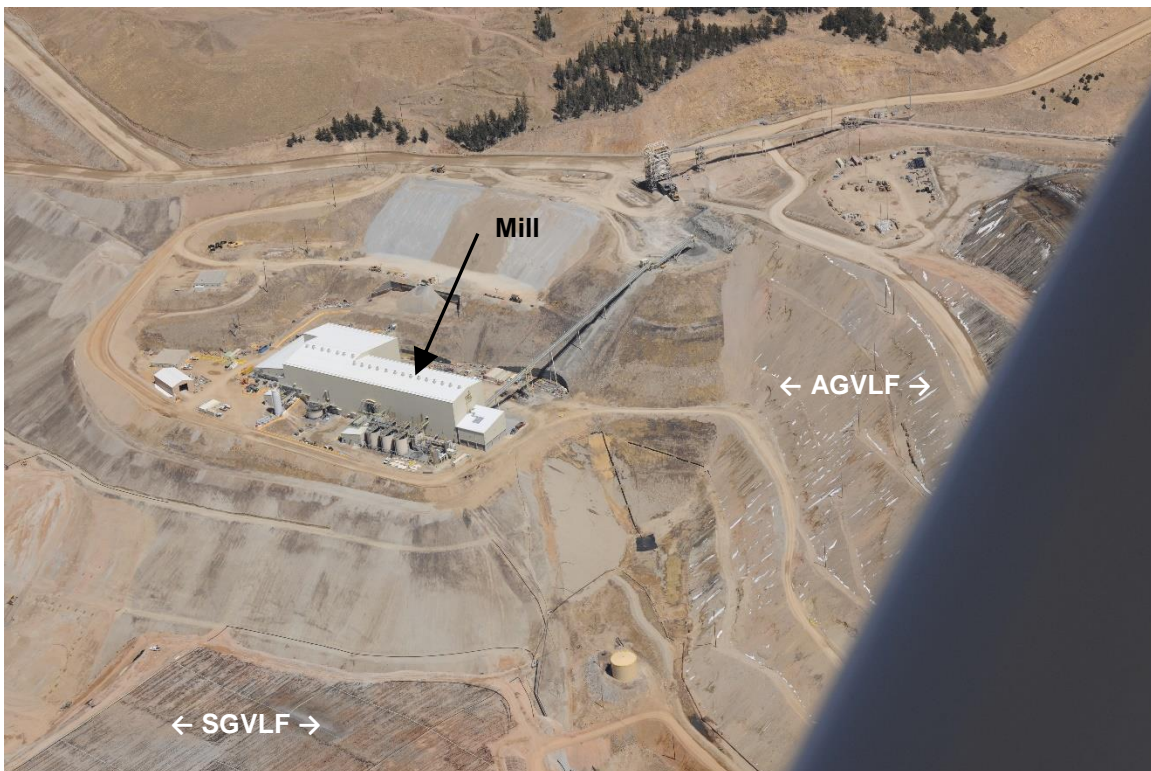
Photo 8. Mill building between SGVLF & AGVLF (Looking east).

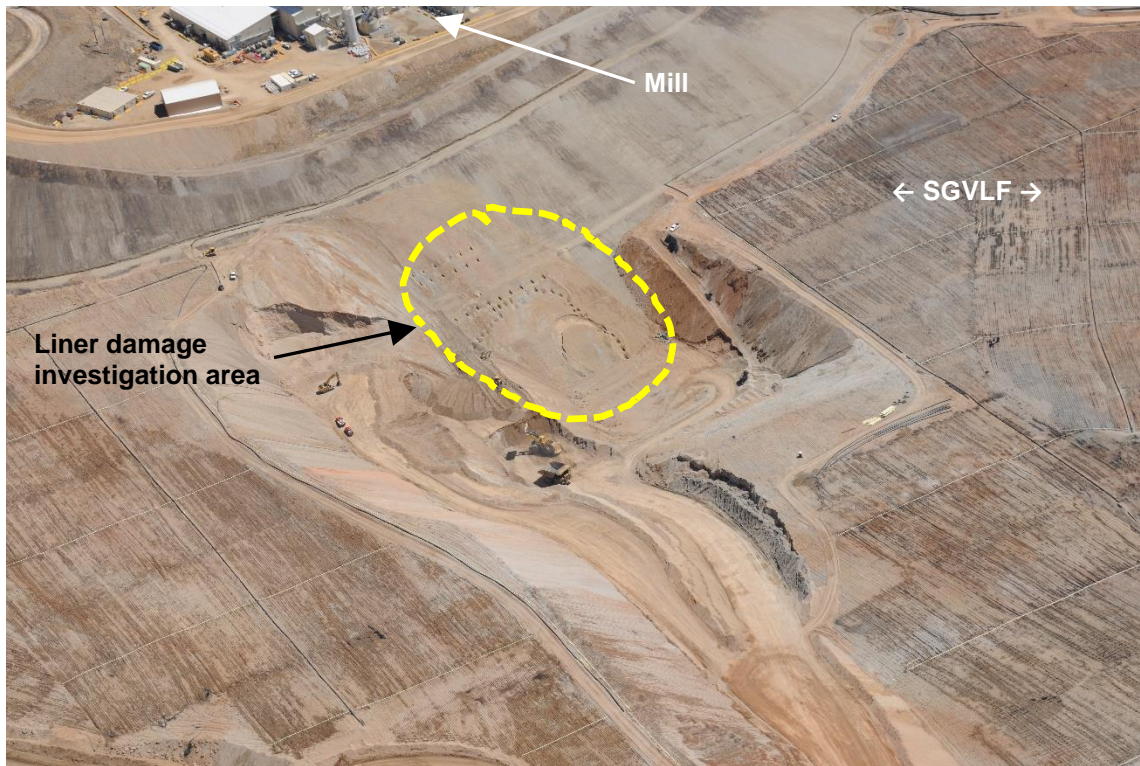
Photo 9. Squaw Gulch VLF (Looking SE).

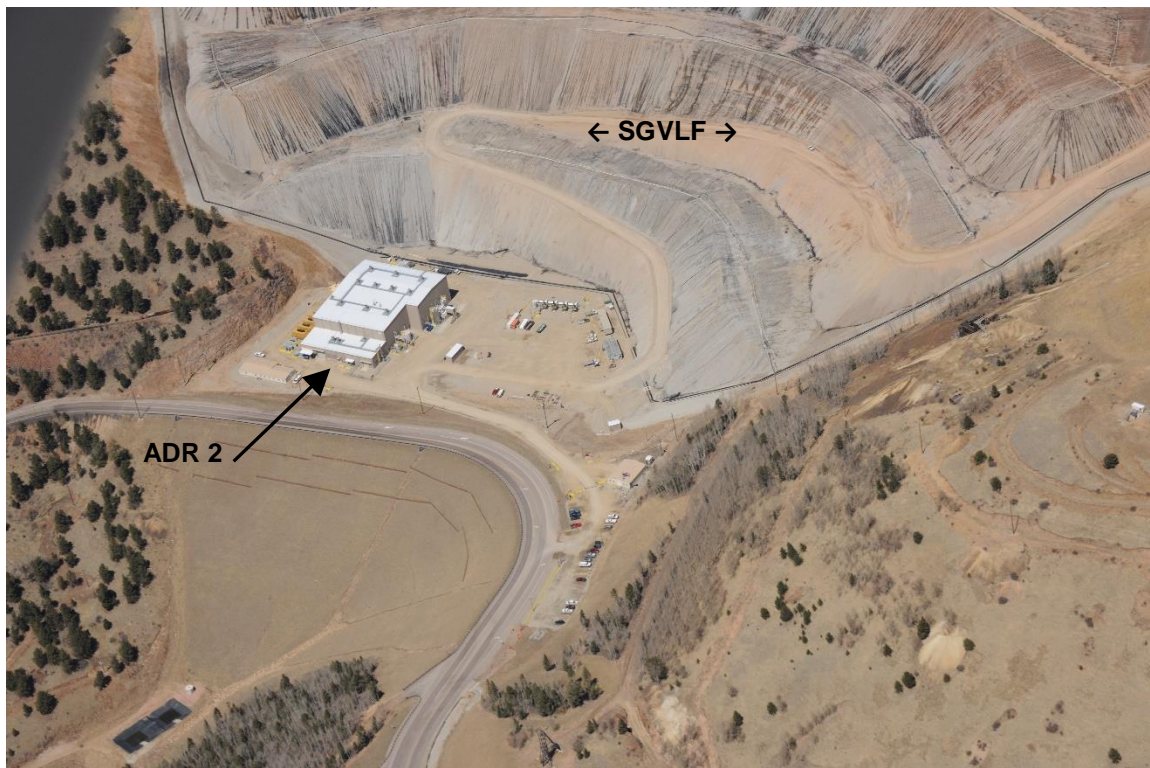
Photo 10. ADR 2 (looking north).
