UNITED STATES ENVIRONMENTAL PROTECTION AGENCY  
REGION 8

Re: Inspection Report for the Golden Wonder Mine, NPDES Permit Nos. CO0048119 and  
COR040226

## NPDES Stormwater Inspection Report - Industrial

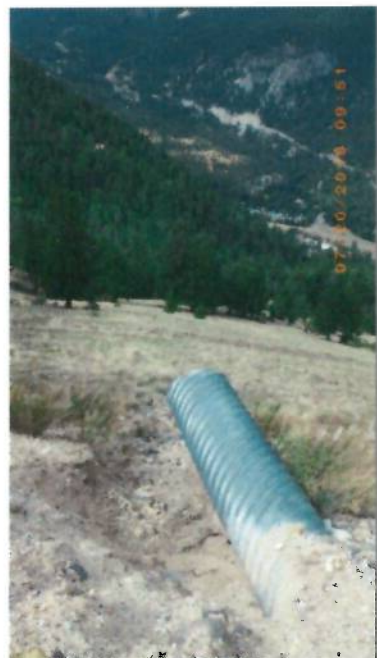
Photo number 1676 taken by D. Gwisdalla on 7/20/2018.

Culvert outlet directing stormwater runoff underneath the mine haul road for Pad 6, looking down gradient. Located at (lat/long): 38° 0'19.62"N / 107°17'4.39"W. Note that the culvert's outlet had rills at and below the fall pad and was in need of maintenance and improved armoring.

- A rock check dam along the haul and access roads serving Pad 6 need to be refreshed (photograph 1680);
- Rock armoring at two culvert outlets serving the haul and access roads serving Pad 6 need repair (photographs 1676 and 1679);
- Berming adjacent to the rock crusher and tram on Pad 6 needs to be regraded (photographs 1689 and 1690); and
- Covers for the ore storage need to be replaced on Pads 3 and 6 (photographs 1682 and 1711);

**Provide the EPA and CDPHE with photographs showing the above BMP deficiencies were corrected.**

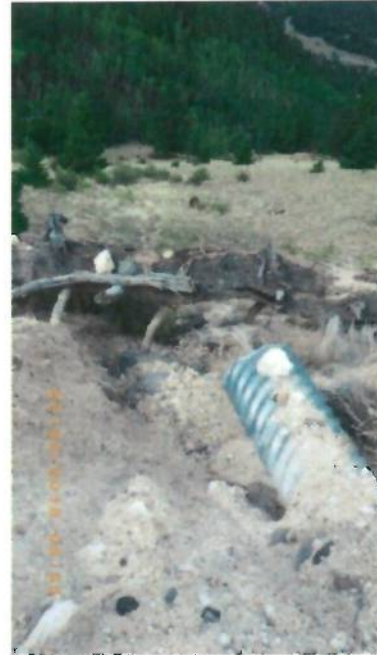
Culvert outlet directing stormwater runoff underneath the mine haul road for Pad 6, looking down gradient. Located at (lat/long): 38° 0'19.62"N / 107°17'4.39"W. Note that the culvert's outlet had significant erosion at and below the fall pad and was in need of maintenance and improved armoring.

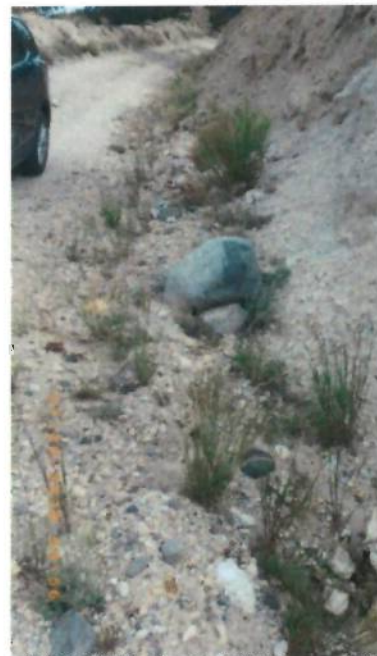
Photo number 1680 taken by D. Gwisdalla on 7/20/2018.

Looking up-gradient along the mine haul road. Photograph taken at the location of the inlet of the culvert shown in photograph 1679. Note rock check dam needs sediment removal and erosion.

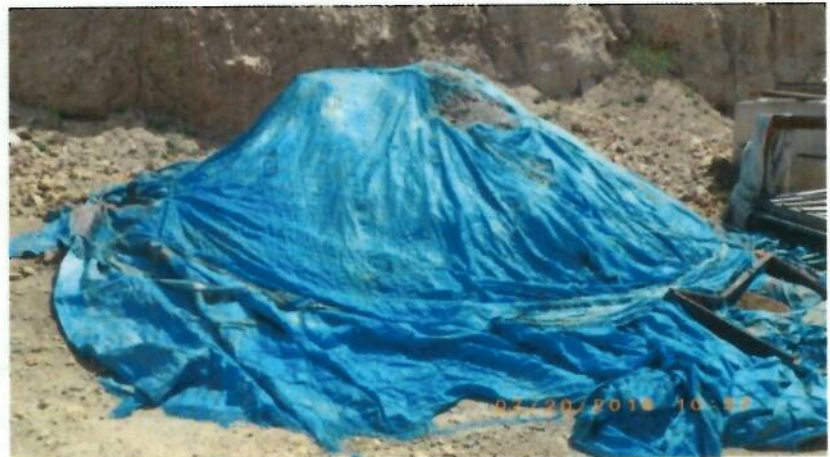
Photo number 1682 taken by D. Gwisdalla on 7/20/2018.

Ore storage. Note the cover has a tear in it.

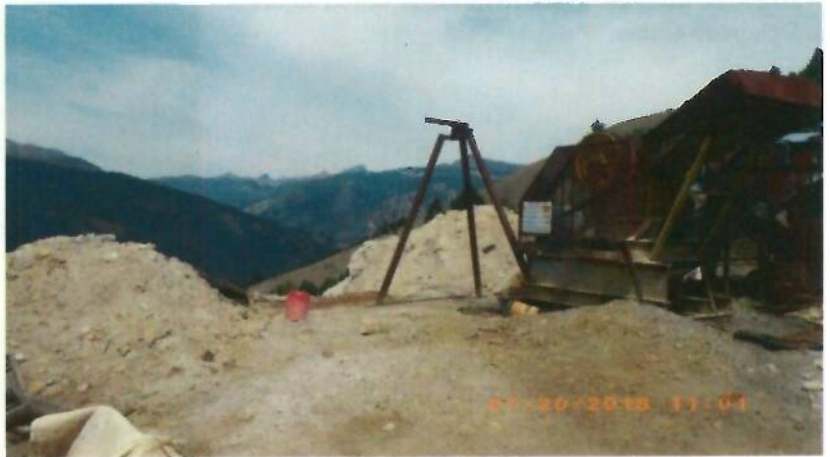
Crusher and the tram used to convey slag and limestone to Outfall 001 for treatment. Note the break in the berm.

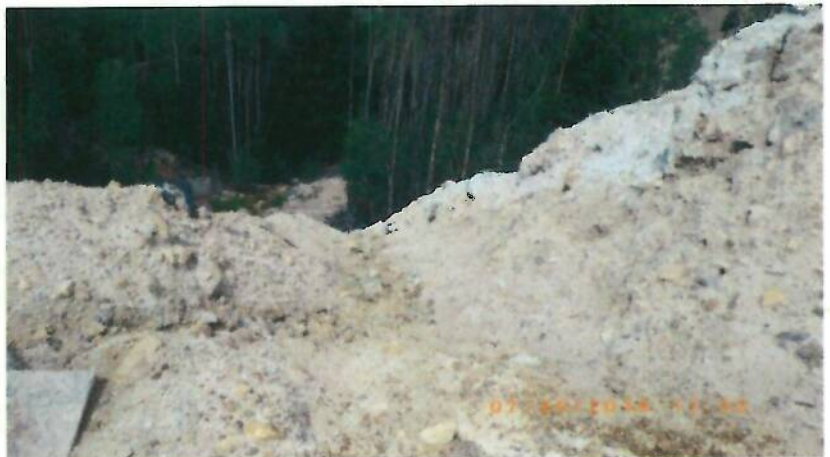
Photo number 1690 taken by D. Gwisdalla on 7/20/2018.

Located at the break in the berm at the tram. Note the erosion rill.

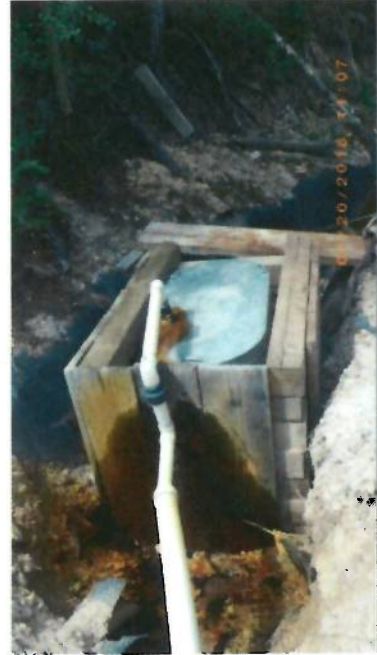
During the inspection of the mine water passive slag filter treatment unit prior to Outfall 001A, it was noted that the slag filter was overflowing at the elbow prior to, and also at, the inlet to the slag filter treatment unit (photographs 1699 and 1700). There appeared to be some sort of obstruction that prevented the mine water from flowing out of the treatment unit's discharge piping causing the mine water to back up and flow from the two connections. This is believed to be the case because when another valve on the treatment unit was opened, water discharged through the discharge pipe freely. The inspector also observed that the inlet pipe flowing into the settling basin was not secured (photographs 1702 and 1703). Kye Abraham stated that the settling basin's connection was disconnected prior to the winter season (Fall 2017). This was affirmed by the fact that the inspector heard a "gurgling" sound and saw air bubbles discharging from the connection prior to the discharge pipe in the settling basin. After Kye Abraham opened the valve from the slag filter after it was closed to assist in flushing the slag filter's outlet. While the mine water was by-passing the slag filter and the settling filter, no discharge was observed at the time of the inspection at Outfall 001A.

Mine water passive treatment unit, note the mine drainage water that leaking from the treatment unit prior to treatment as shown in photograph 1700.

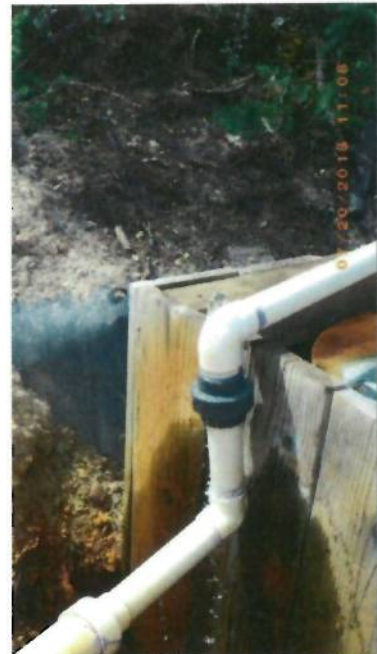
Photo number 1700 taken by D. Gwisdalla on 7/20/2018.

Leak at the head of the treatment unit. Note the water flowing from the pipe.

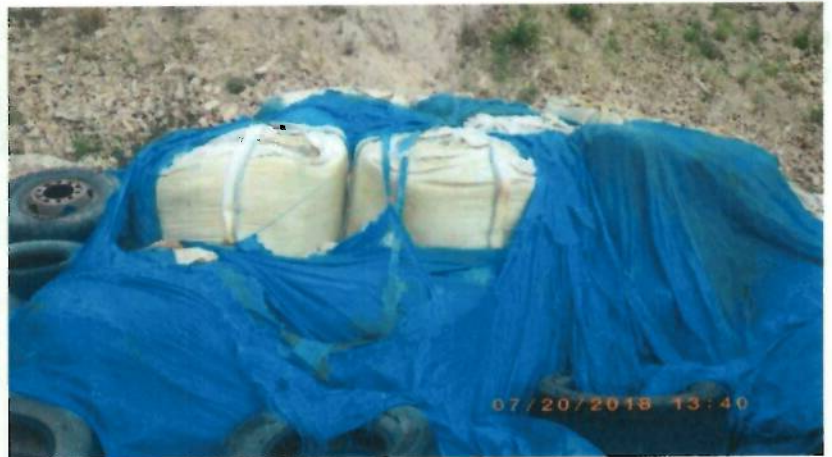
Ore storage. Note the cover has a tear in it.

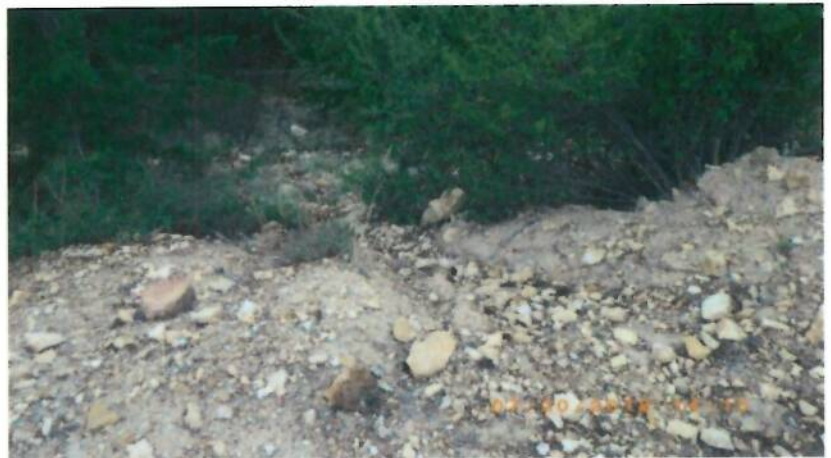
Point where the runoff from the mine haul road, shown in photograph 1721, flows from the haul road down the side of the embankment. Note the minor erosion rill at this location the water flows down the embankment.
