MINERALS PROGRAM INSPECTION REPORT

MINE NAME: Golden Wonder Mine	MINE/PROSPECTING ID#: M-1978-091-UG	MINERAL: Gold	COUNTY: Hinsdale
INSPECTION TYPE: Monitoring	INSPECTOR(S): Travis H. Marshall	INSP. DATE: October 3, 2018	INSP. TIME: 10:30
OPERATOR: LKA International Inc.	OPERATOR REPRESENTATIVE: Kye Abraham	TYPE OF OPERATION: 110d - Designated Limited Impact	
REASON FOR INSPECTION: Normal I&E Program		BOND CALCULATION TYPE: None	
DATE OF COMPLAINT: NA		BOND AMOUNT: \$134,388.10	
POST INSP. CONTACTS: U.S. BLM		JOINT INSP. AGENCY: None	
WEATHER: Clear	INSPECTOR'S SIGNATURE:

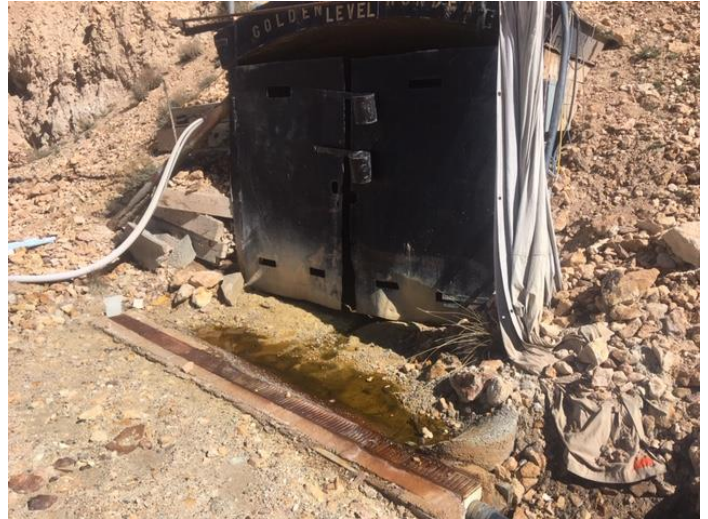
The mine discharge water treatment system appeared to be properly functioning during the inspection. Mr. Abraham stated that the system was recently maintained. Red stained "spent slag" was observed on the concrete pad immediately east of the mine entrance. Mine water was observed discharging from a PVC pipe that discharges directly into Deadman Gulch. The treatment system discharge point is a limestone lined channel that leads to the NPDES individual Permit No. CO0048119 Outfall 001A. In order to determine to effectiveness of the discharge water treatment system the Division requests that the Operator submit water quality samples from the point where water discharges from the mine opening and the point where the water discharges from the PVC pipe into Deadman Gulch. The analyses must include potentially dissolved copper, lead, selenium, zinc, total copper, total recoverable iron, TSS, pH and flow at the time of sampling. **Samples must be collected using standard sampling methods, sample handling and employ proper chain of custody protocol. Sample results must be provided to the Division no later than November 30, 2018 to avoid potential enforcement action for failure to protect the hydrologic balance.**

Mine water discharge collection point.

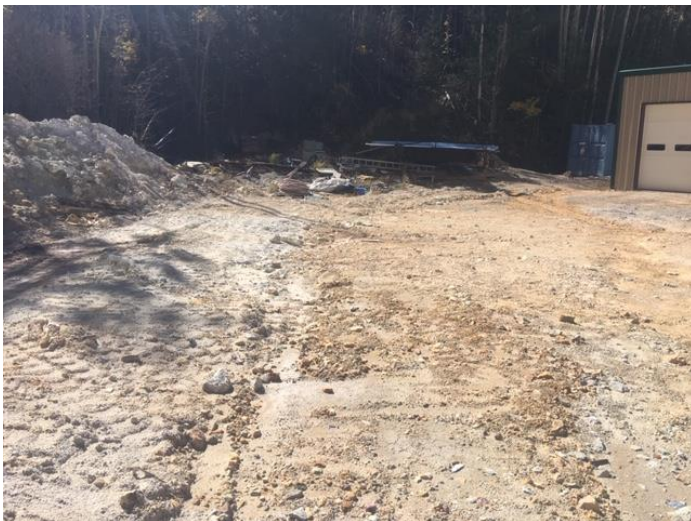
Mine bench, discharge pipe buried.

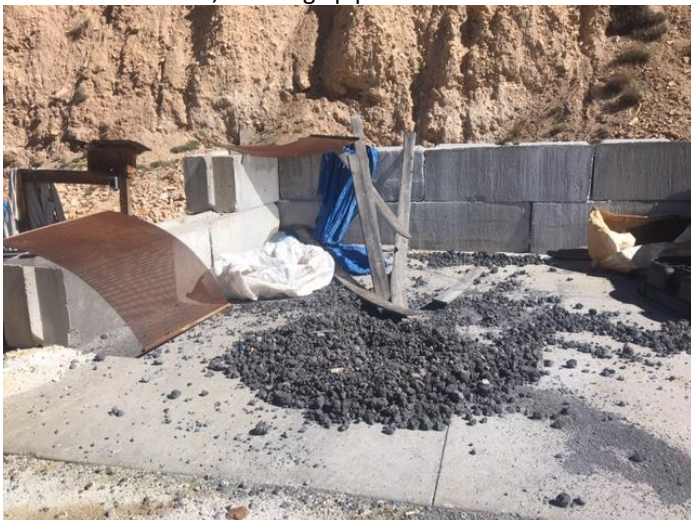
New unused slag.

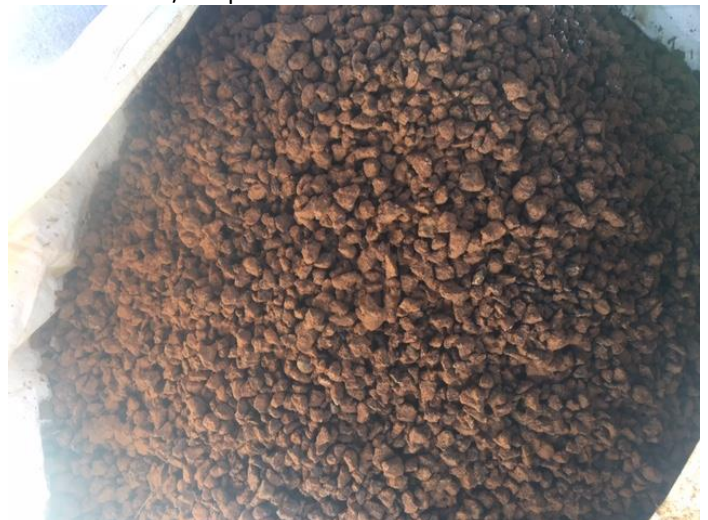
Used slag, note red coloration.

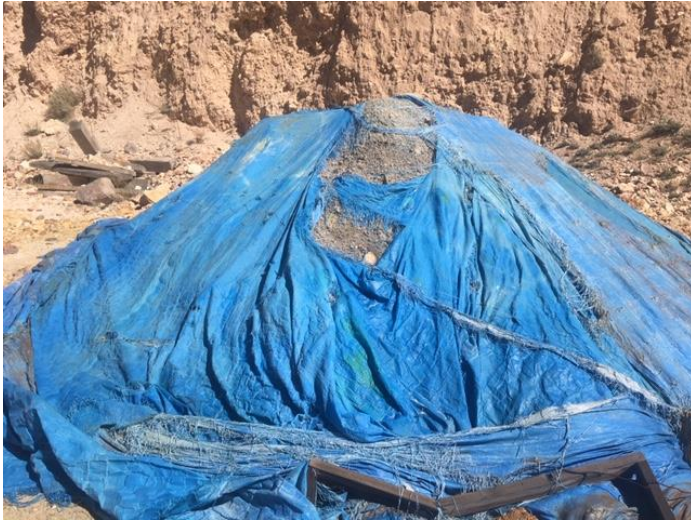
The purpose of the inspection was to observe the site conditions and the mine discharge water treatment system. The site conditions appeared to be in an orderly condition. An ore stockpile was observed on the mine bench covered by a compromised blue tarp partially covering it. **This is noted as a problem and the operator must replace the tarp or remove the ore pile no later than November 30, 2018 and provide photo-documentation demonstrating that the corrective action has been completed.**

Ore pile with compromised tarp.

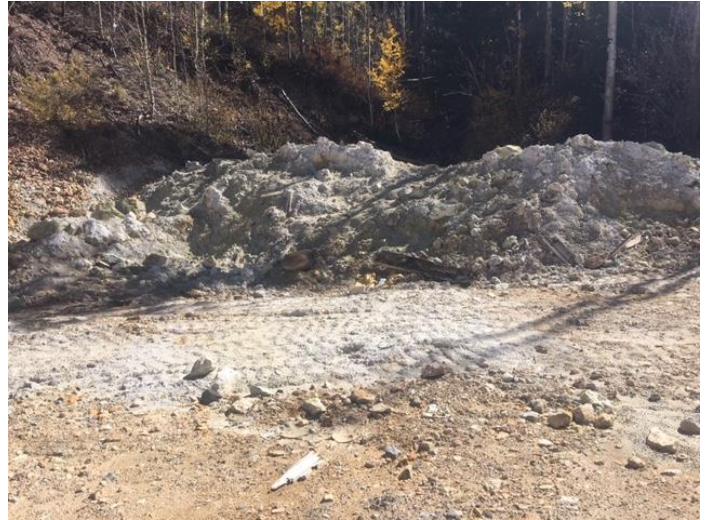
Rhyolitic waste rock pile on mine bench.

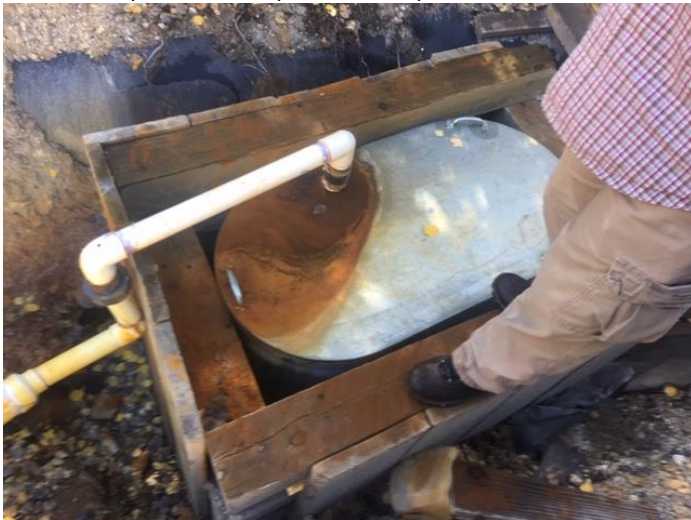
Slag treatment system inlet.

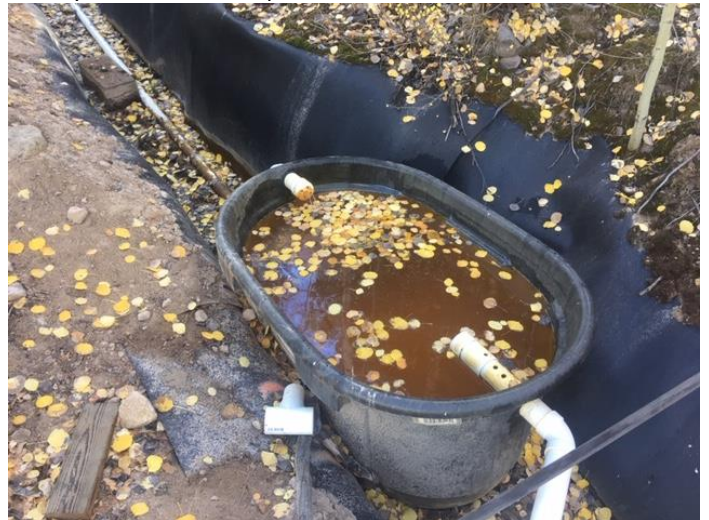
Treatment system settling point.

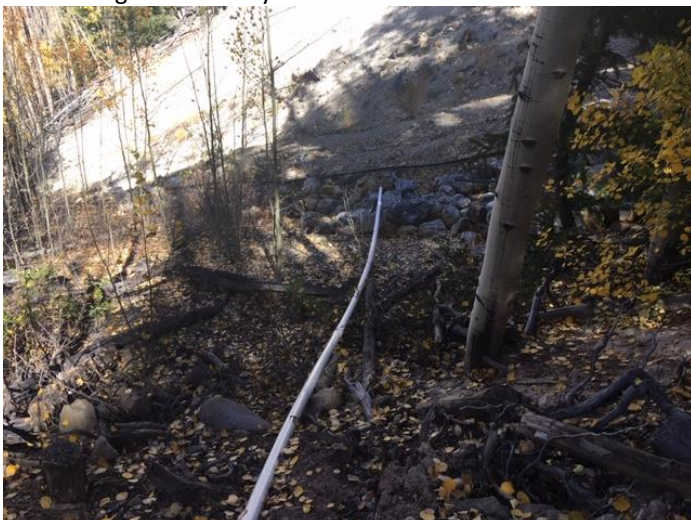
Treatment system outlet into limestone channel.

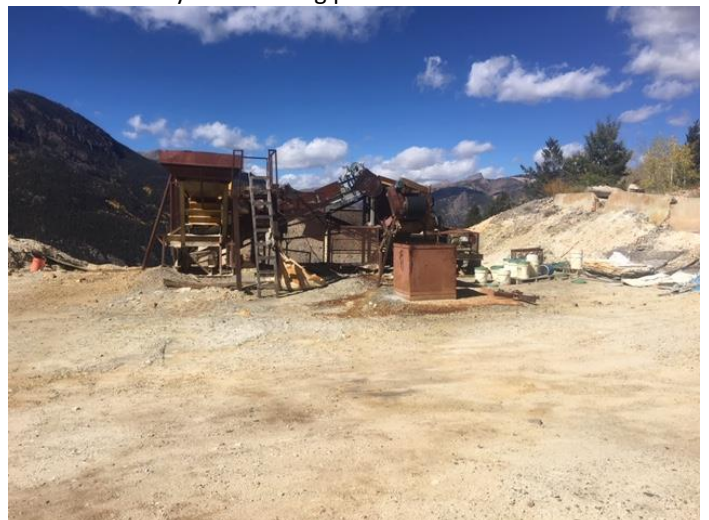
Material processing system located on mine bench.
