MINERALS PROGRAM INSPECTION REPORT
PHONE: (303) 866-3567

MINE NAME: Cooley Reservoir & Fulton Wildlife Area	MINE/PROSPECTING ID#: M-1999-034	MINERAL: Sand and gravel	COUNTY: Adams
INSPECTION TYPE: Monitoring	INSPECTOR(S): Jared L. Ebert	INSP. DATE: October 10, 2018	INSP. TIME: 10:00
OPERATOR: Aggregate Industries - WCR, Inc.	OPERATOR REPRESENTATIVE: Connie Davis and Joel Bolduc	TYPE OF OPERATION: 112c - Construction Regular Operation	
REASON FOR INSPECTION: Normal I&E Program	BOND CALCULATION TYPE: Partial Bond	BOND AMOUNT: \$1,510,800.00	
DATE OF COMPLAINT: NA	POST INSP. CONTACTS: None	JOINT INSP. AGENCY: None	
WEATHER: Cloudy	INSPECTOR'S SIGNATURE:

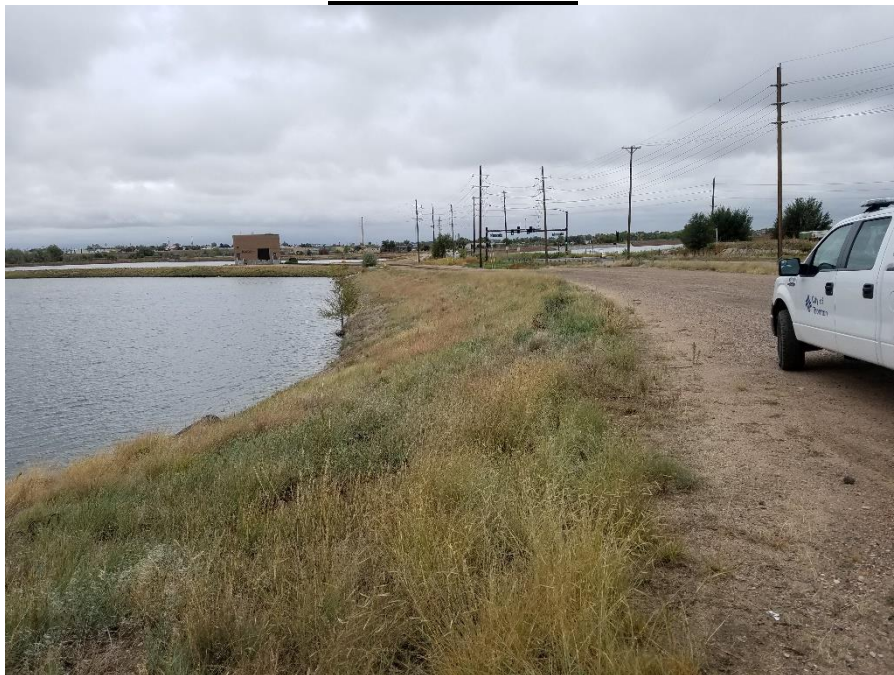
Figure 1. From the west side of the Phase 3 reservoir looking south.

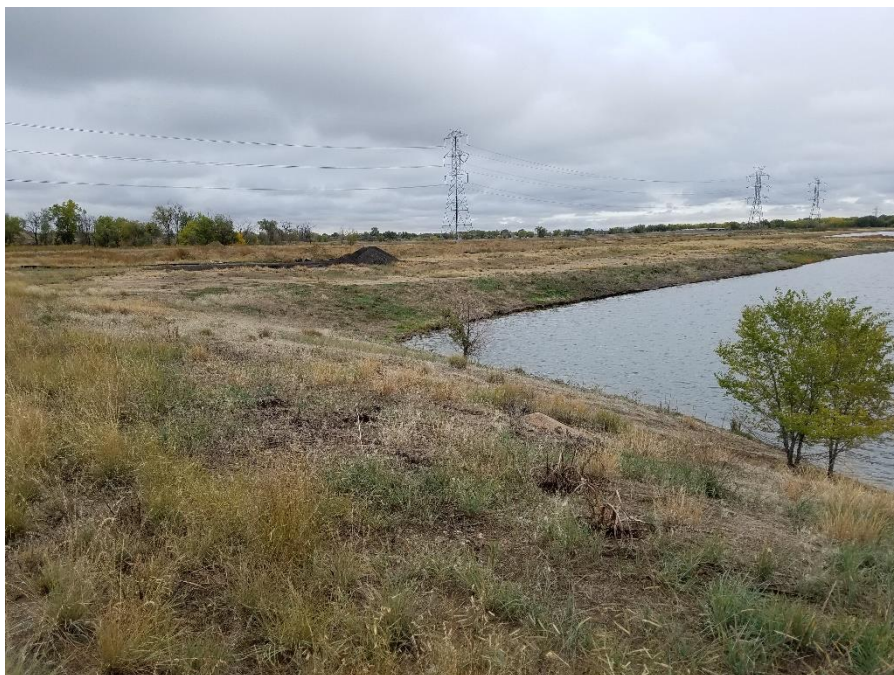
Figure 2. From the northwest corner of the Phase 3 reservoir looking northeast.

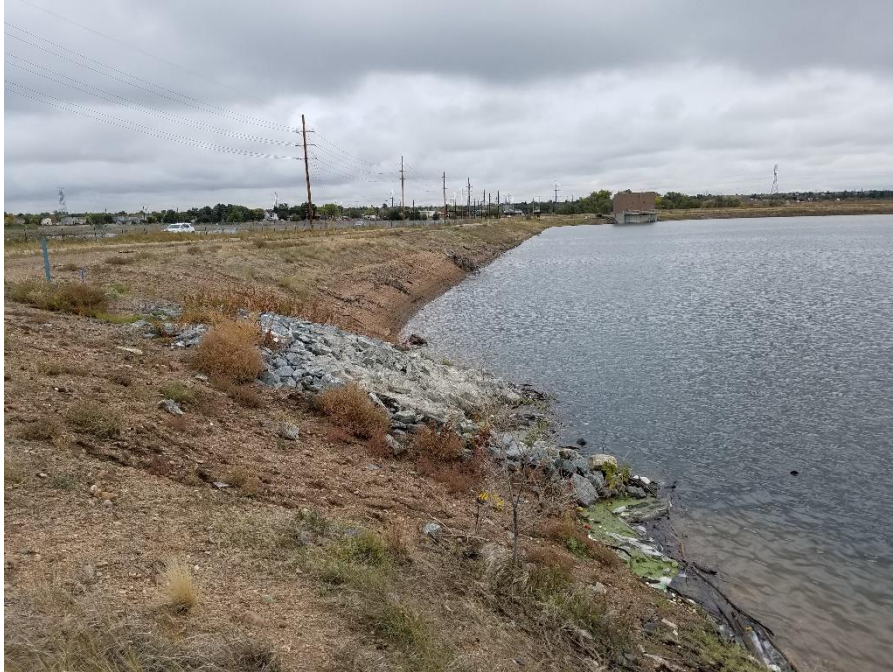
The Phase 2 reservoir area was observed. It appears an area near the southeast corner of this reservoir has been recently affected as very little vegetation has established. Some rilling was noted and this area will need to be stabilized with vegetation.

Figure 3. View of the southwest corner of the Phase 2 reservoir area where sparse vegetation has established.

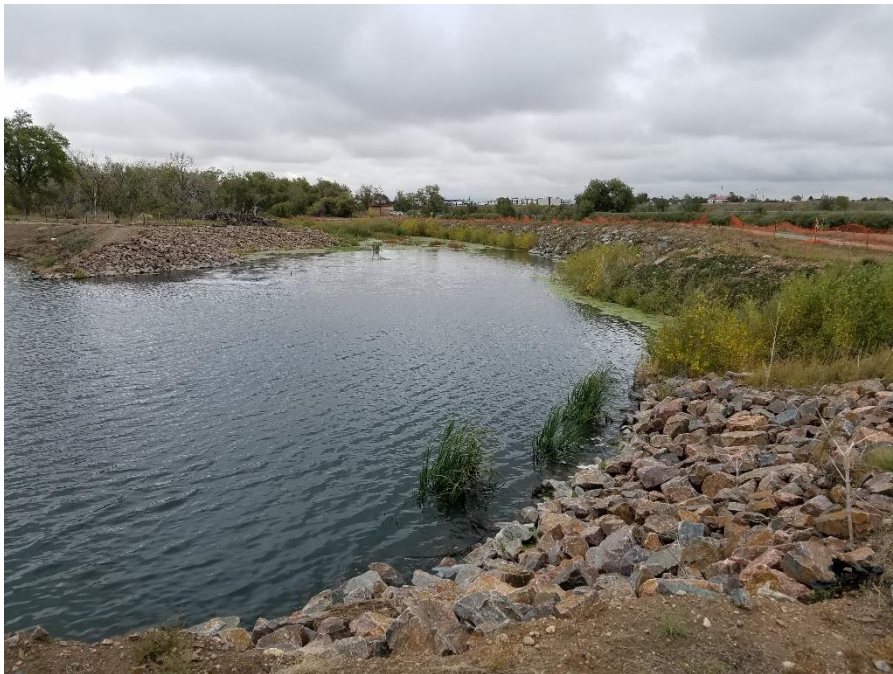
The temporary breach repair that occurred on the southeast portion of the Phase 2 reservoir was observed. Overall, the temporary measures appear to be functioning. The breach between the Phase 2 and Phase 3 cells has not been repaired.

Figure 4. Southwest breach area of the Phase 2 reservoir.

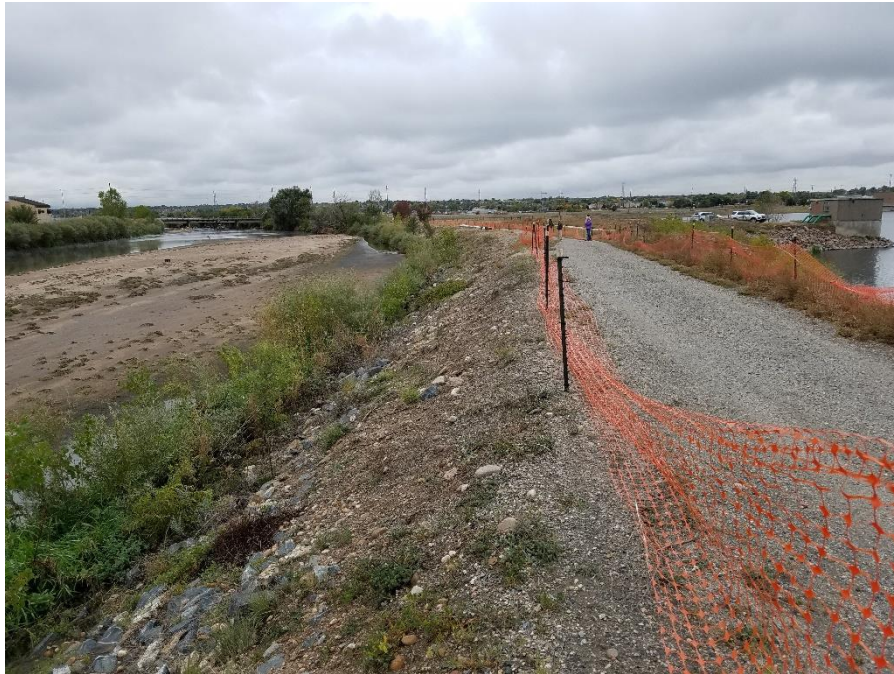
Figure 5. Riverside view of the Phase 2 breach area.

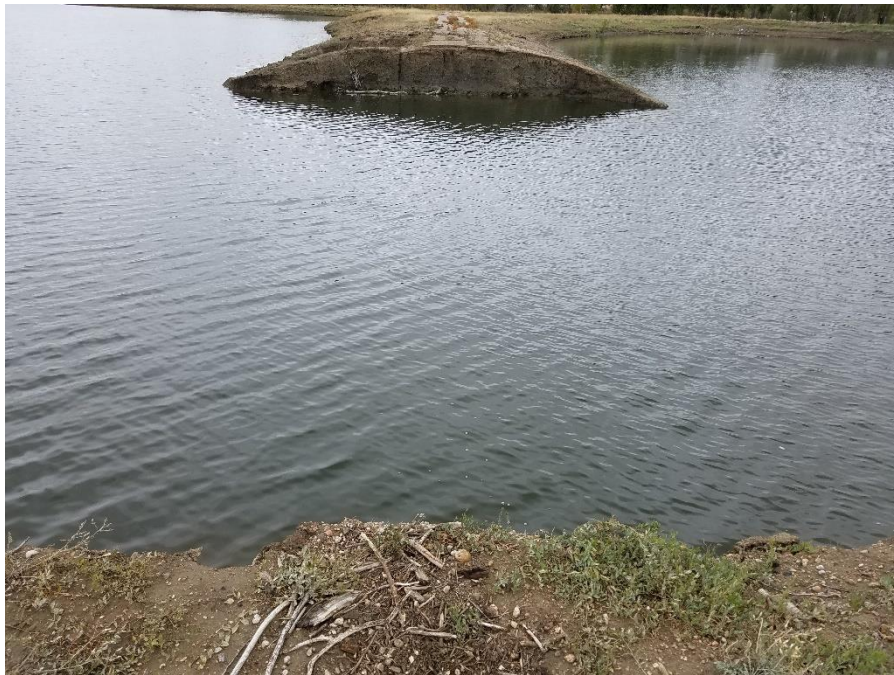
The embankment between the Phase 2 and Phase 3 reservoir cell was breached during the 2015 flood event. This area has not been repaired. The Phase 3 reservoir cell was observed. Shoreline cutting and erosion was observed in the southwest corner of the reservoir cell and along the eastern shoreline. These areas will need to be stabilized.

Figure 6. Berm breach between the Phase 2 reservoir and Phase 3 reservoir.

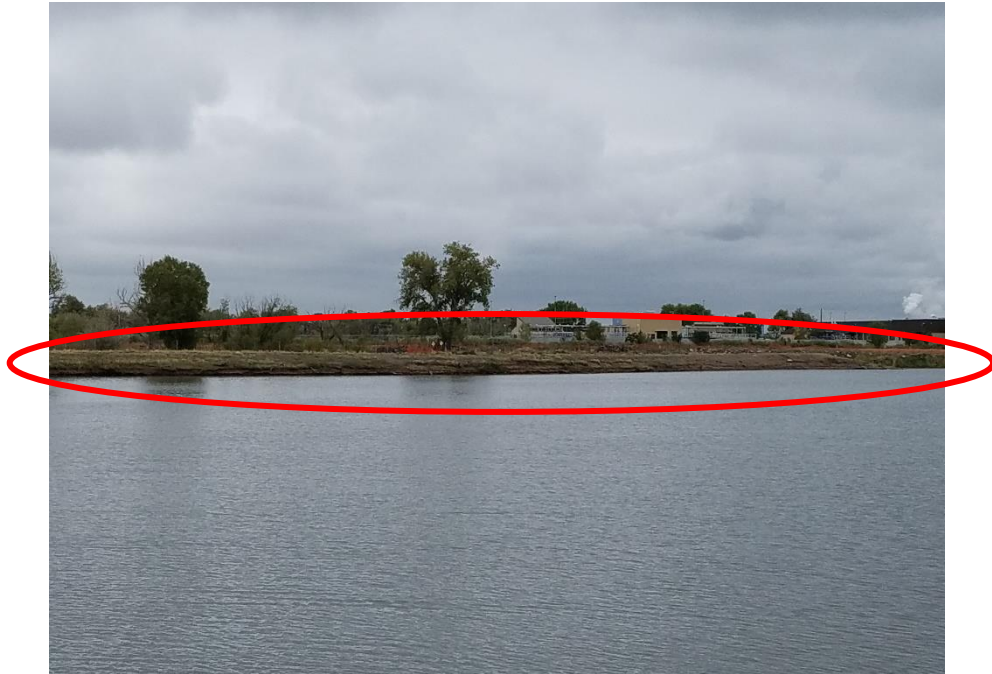
Figure 7. Shoreline cutting along the eastern slope of the Phase 2 reservoir.

AI requested that the Division observe the Cooley Reservoir areas to assess the vegetation established around the reservoirs. Other than in the areas discussed in this report where shoreline cutting was observed and areas that have been recently affected like the southwest corner of the Phase 2 cell, desired grassy vegetation has established around the reservoirs. The eastern shoreline of the Phase 2 and 3 cells are cutting near the water line. Mr. Redman indicate the City may install rip-rap along these shorelines. If this is not done, AI will need to stabilize the shoreline from cutting.

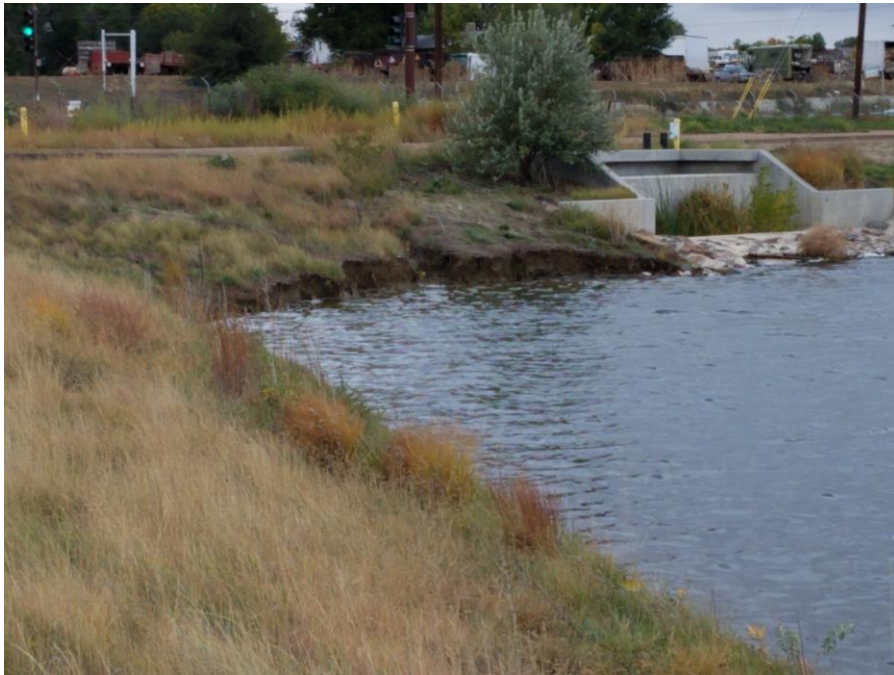
Figure 8. Shoreline cutting in the southwest corner of the Phase 3 reservoir.

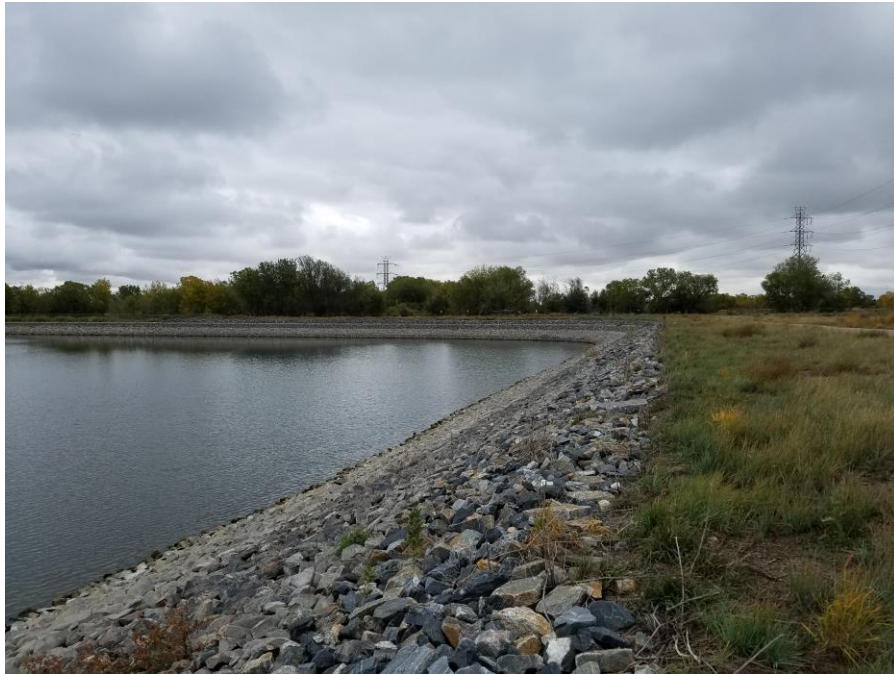
The Phase 4 reservoir cell was observed. The slopes were stable and vegetated. The eastern shore was rip-rapped and appeared stable.

Figure 9. Rip-rap lined shoreline on the south and east corner of the Phase 4 reservoir area.

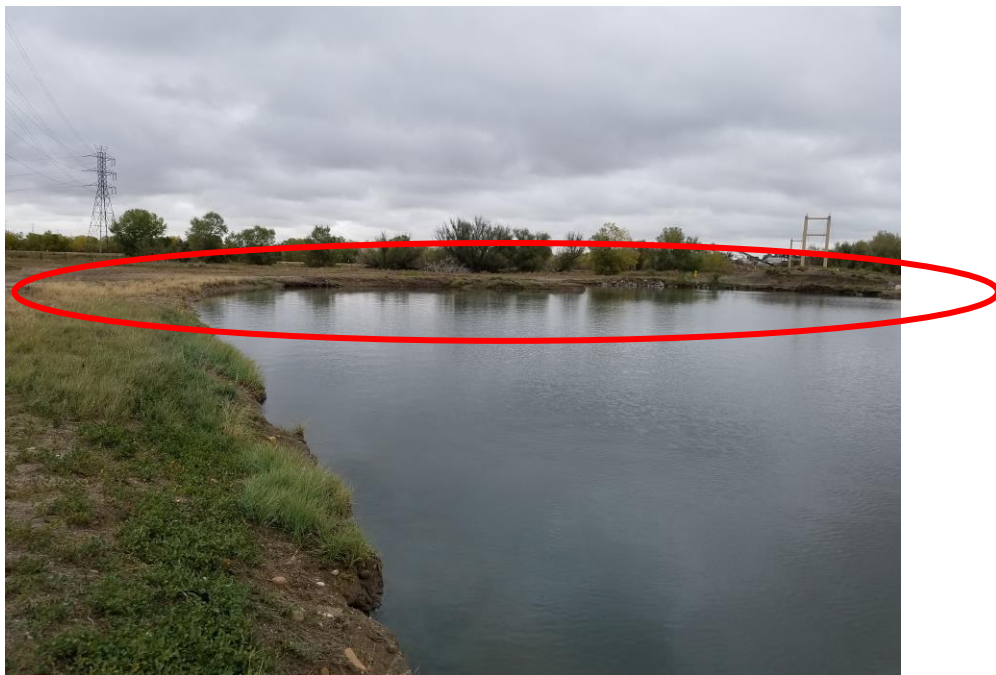
Figure 10. Slope cutting on the east slope of the Phase 3 reservoir area.

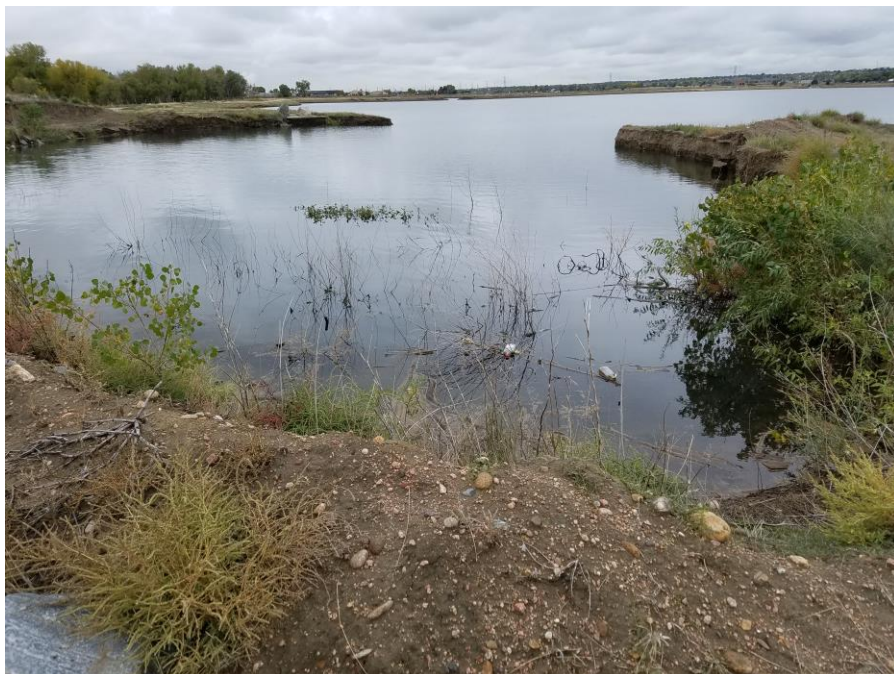
The damage that occurred on the northeast corner of the Phase 3 reservoir appears to have partially repaired, as the riverside breach appears to have been backfilled and stabilized. However, the pit-side failure in the Phase 3 reservoir area has not been repaired. The side slopes at this location are steep and eroded.

Figure 11. Pit side flood damaged area on northeast corner of the Phase 3 reservoir.

The slopes damaged by the 2013 and 2015 flood event will need to be repaired and stabilized prior to release of the site.

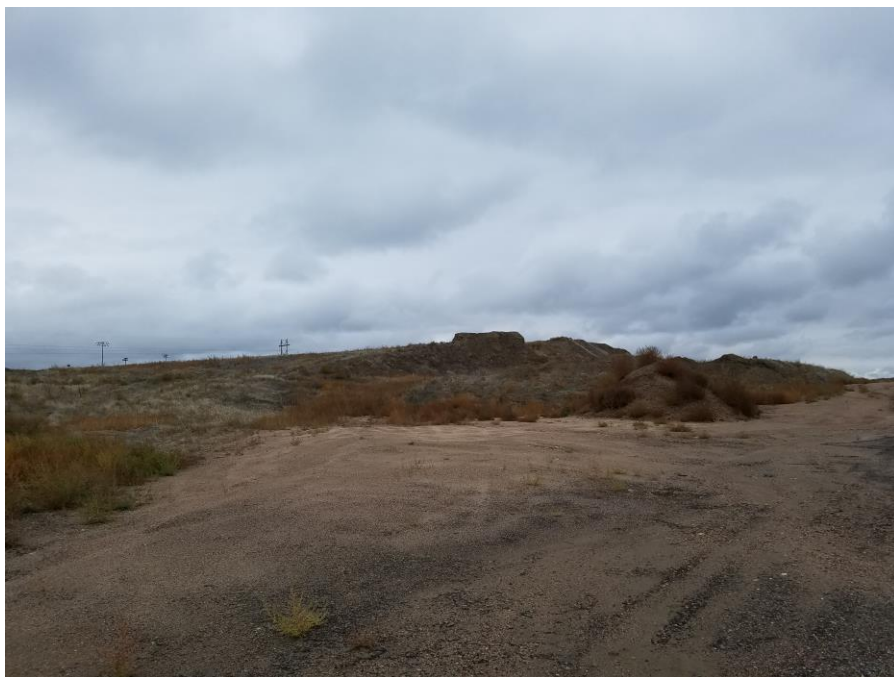
Figure 12. Large stockpile on the west side of the Phase 4 reservoir area.

A large stockpile of material is located on the west side of the Phase 4 reservoir. This area will not be eligible for release until the stockpile has been removed and the area reclaimed in accordance with the reclamation plan.

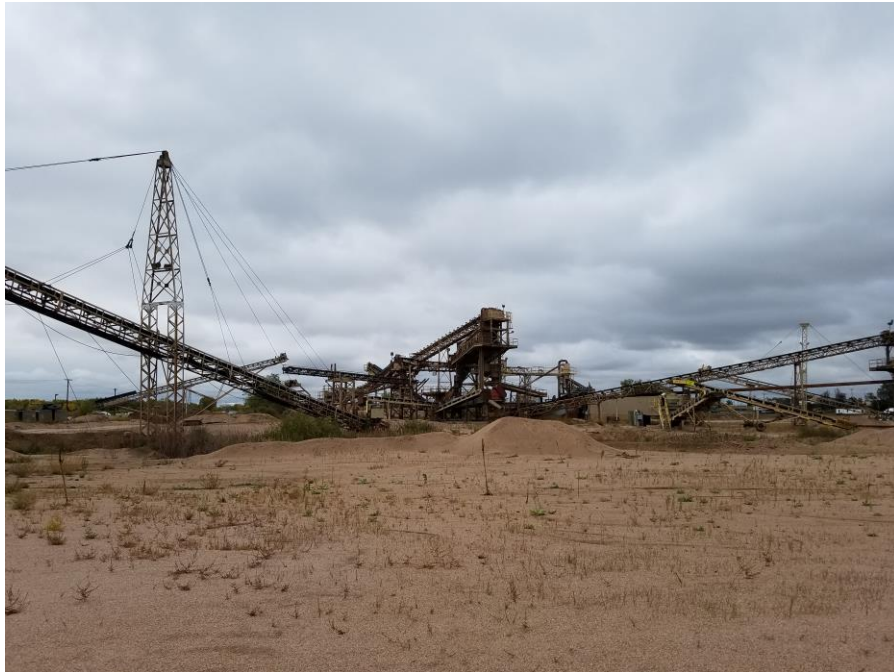
The processing equipment was still in place within the processing area in the southeast portion of the site. Several small ponds were observed in the processing area and there were several large stockpiles of material that appear to have been in place for many years. The small ponds will need to be backfilled and the area will need to be graded. According to the reclamation plan, the processing area is required to be covered with six to twelve inches of topsoil and revegetated with the non-irrigated grass seed mixture approved.

Figure 13. Processing facilities.

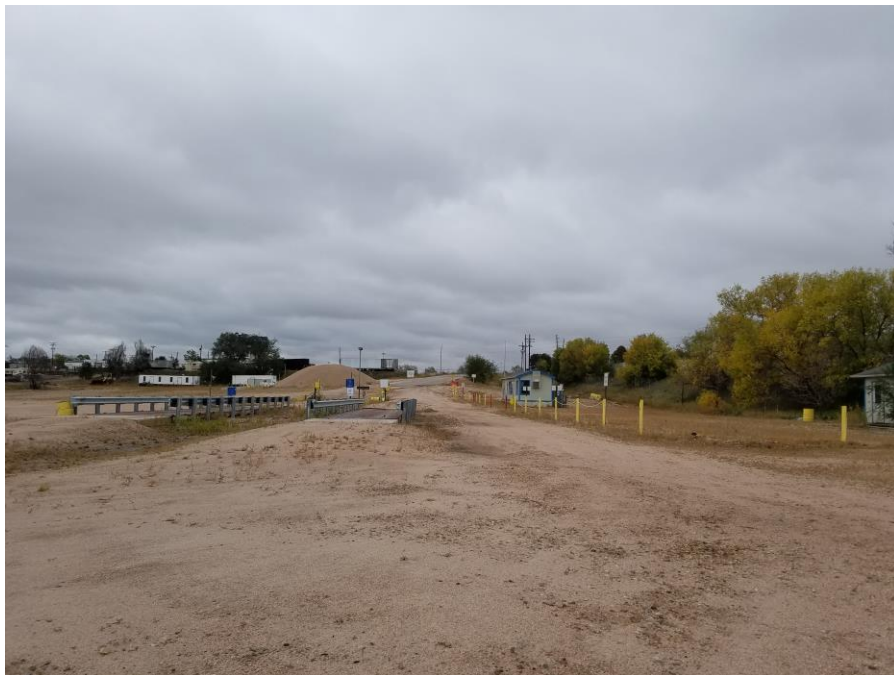
Figure 14. Scale and scale house.

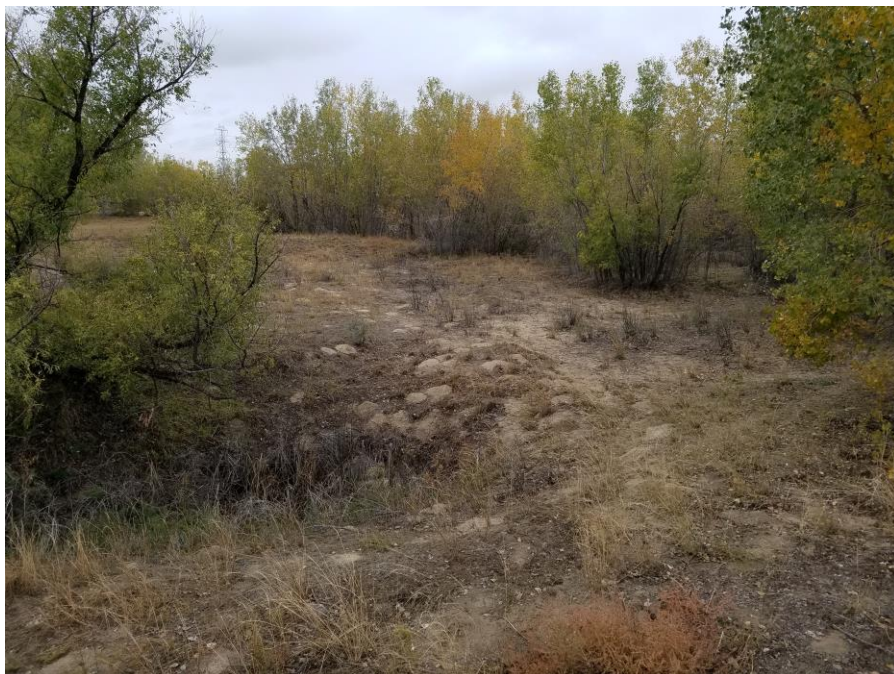
Several areas of exposed groundwater and wetlands exist within the Phase 1 and 5 areas located east of the South Platte River. These areas were observed from their perimeter and it appears dense riparian vegetation has established. The Jeronimus Lake area has been partially filled in with fines from the processing of the aggregate.

Figure 15. Wetland area in the Phase 5 reclamation area east of the South Platte River.

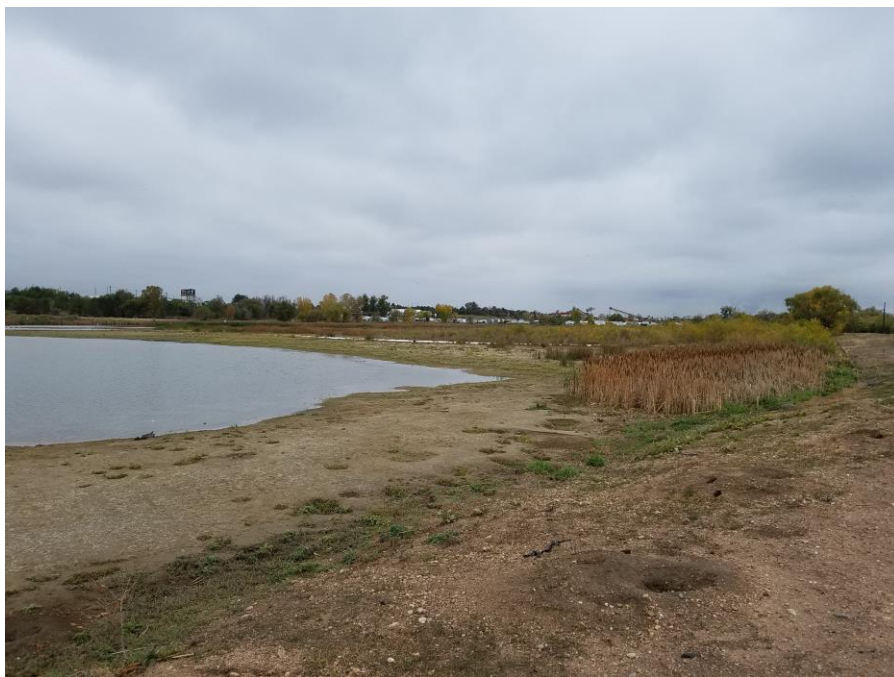
Figure 16. Wetlands established in the Jeronimus Lake area.

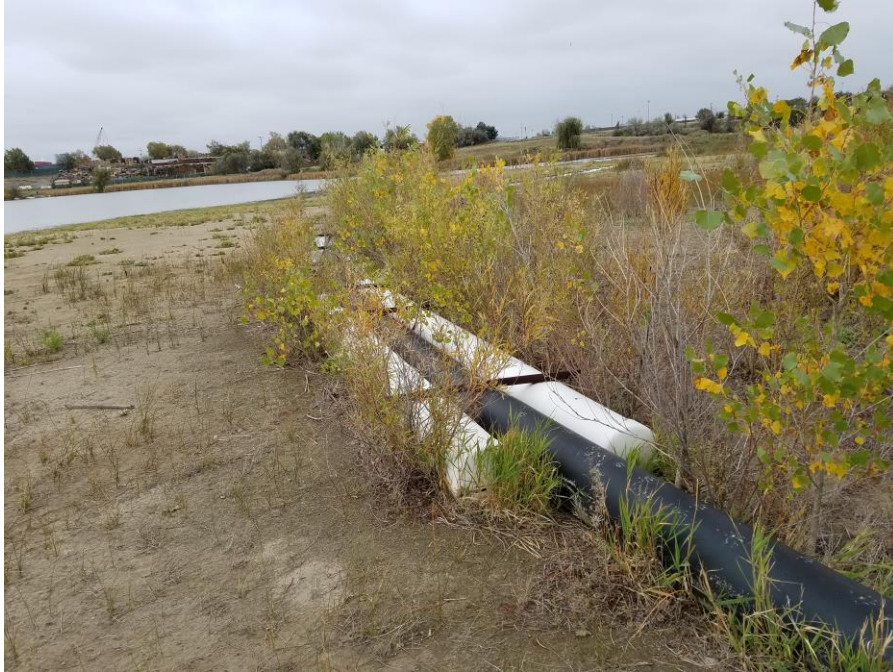
Figure 17. Discharge pipeline in the Jeronimus Lake area.

Wash fines have been backfilled in the Phase 5 and Jeronimus Lake property. The areas where wash fines have been placed have turned into wetland habitat with dense riparian vegetation. However, the pipeline system used to transport the material from the processing area to these areas are still in place at the site and will need to be removed.
