Re: Bowie Resources, LLC, Bowie No. 2 Mine  
Coal Mine Waste Banks & Instrumentation Monitoring  
Pond Quarterly Inspections  
Permit C-1996-083

#### Coal Mine Waste Bank Nos. 1, 2, & 3 Inspections –3<sup>rd</sup> Quarter 2018

Subject: Summary of Instrumentation Monitoring  
3<sup>rd</sup> Quarter 2018  
Bowie Coal Waste Disposal Area No. 3  
Paonia, Colorado

Subject: Summary of Instrumentation Monitoring  
3<sup>rd</sup> Quarter 2018  
Bowie Coal Waste Disposal Area No. 2  
Paonia, Colorado

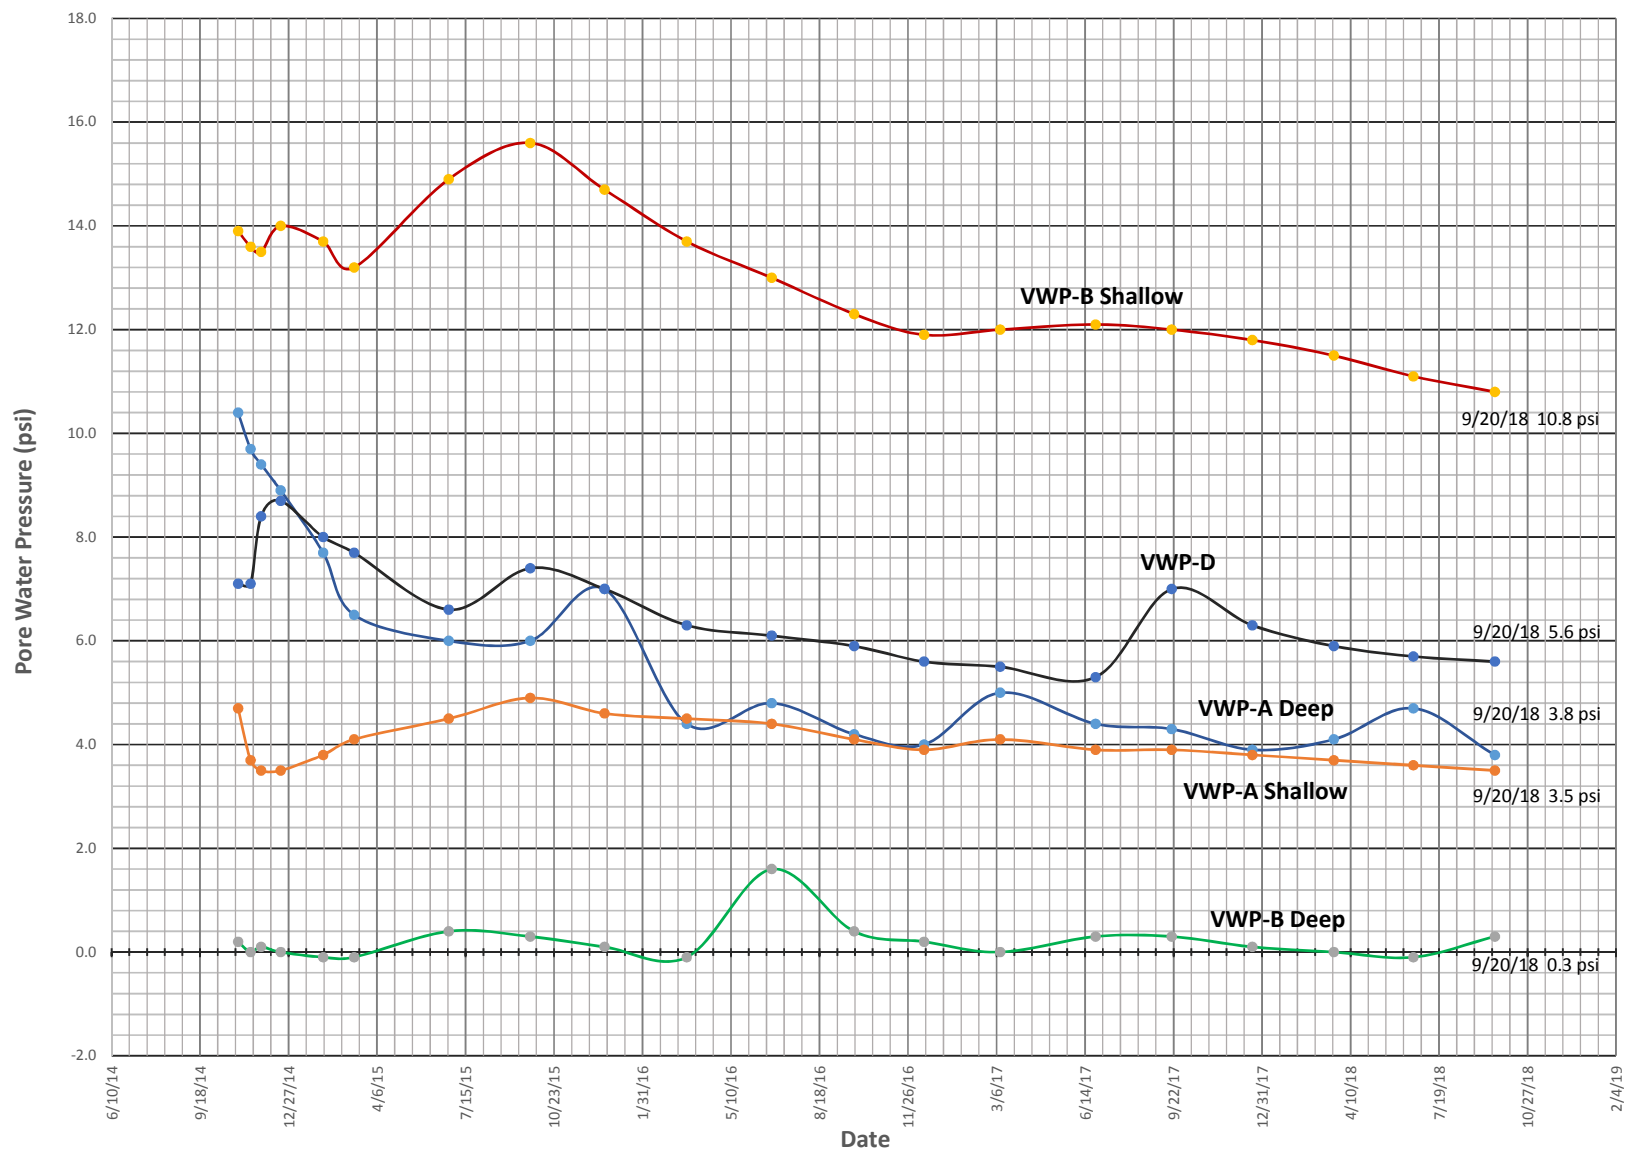
Figure 1 - Bowie Mine #2 - CWDA #3  
Vibrating Wire Piezometer Data

As seen on Figure 1, the readings are either consistent with previous historic readings or show a trend of generally decreasing pore pressure. If you have any questions regarding this letter or the instrumentation monitoring at CWDA #3, please contact me at (907) 562-2000 or [jholland@dowl.com](mailto:jholland@dowl.com).

Based upon the results of the most recent VWP monitoring data, HBET does not believe that there is any reduction in the stability of CWDA No. 3. Due to the limited activity at the mine, HBET recommends that the monitoring frequency be reduced to semi-annually.

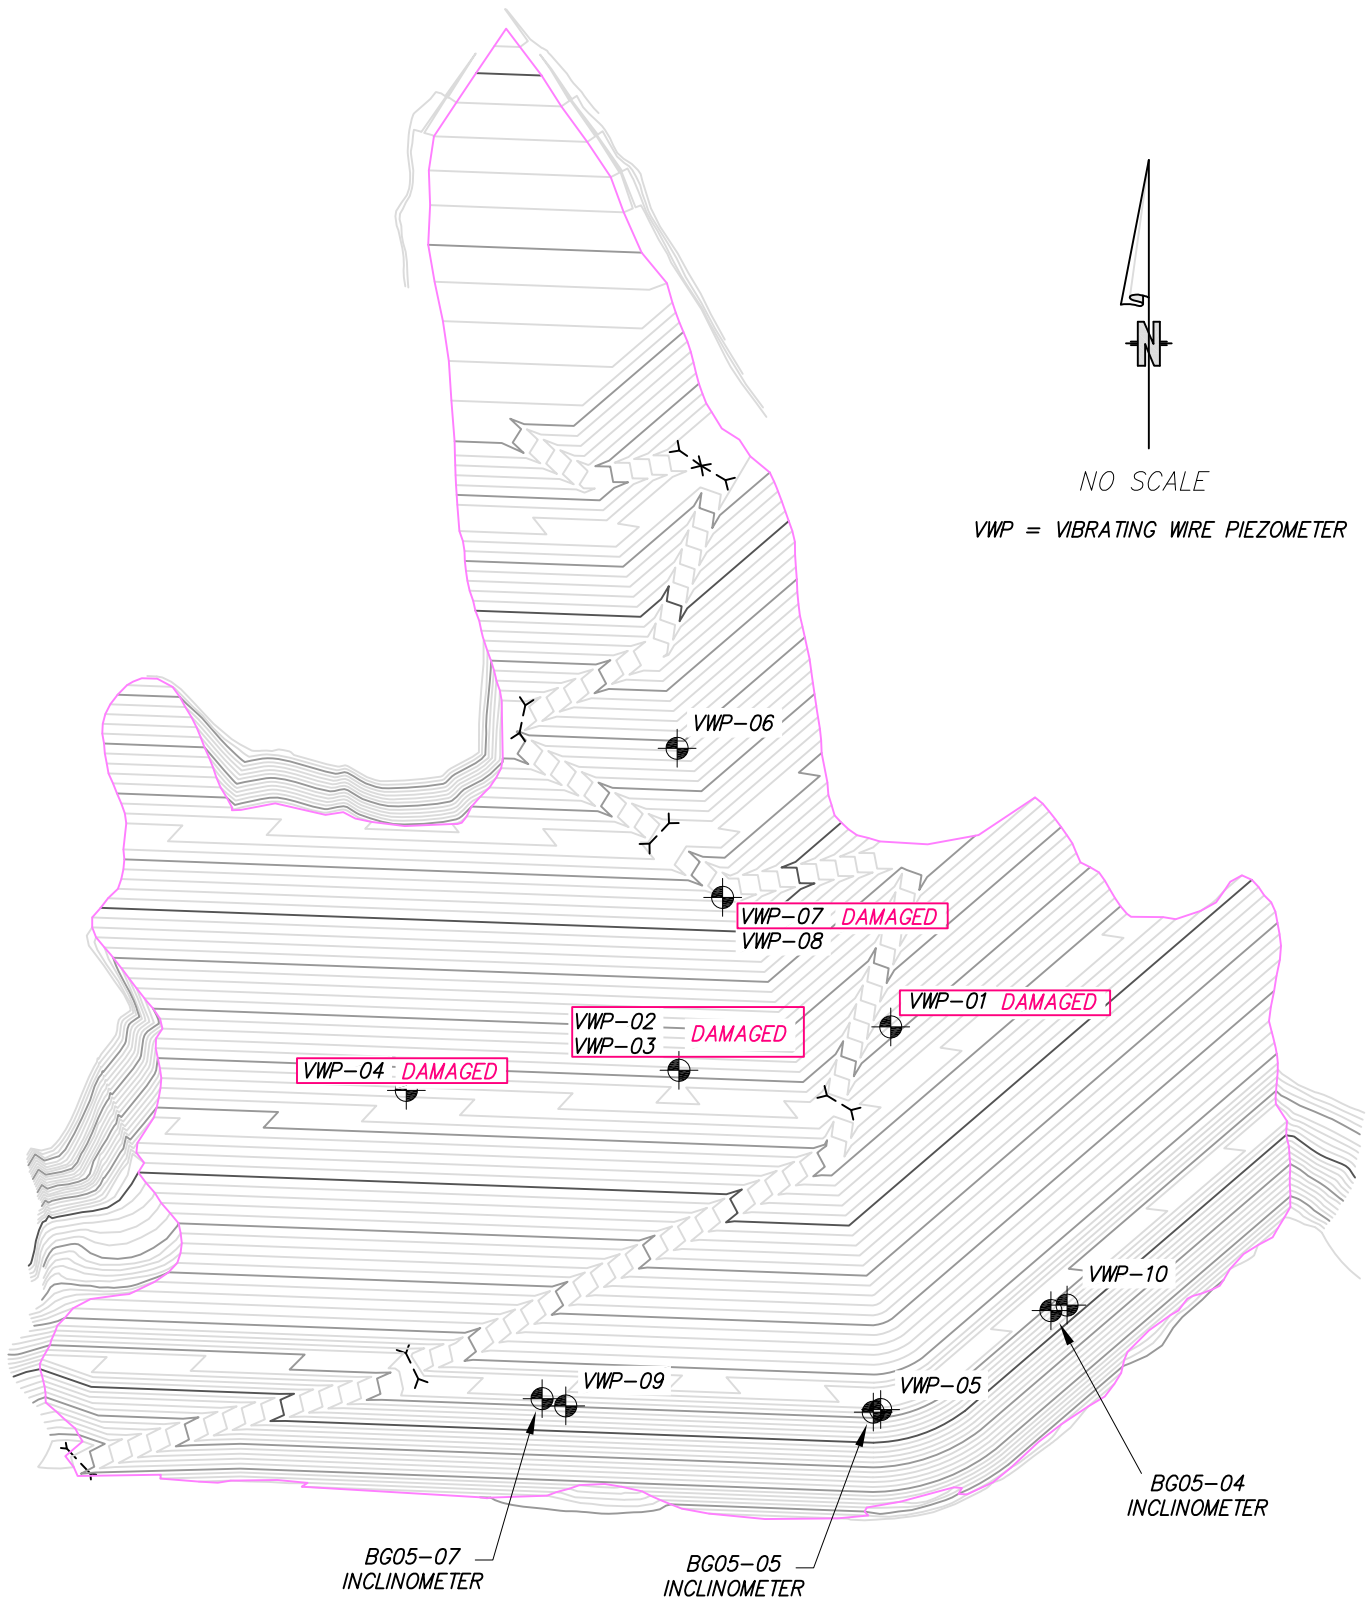
# INSTRUMENTATION SITE PLAN

The physical locations of the piezometers are shown on the attached Instrumentation Site Plan (Map 1). As seen on this map, five of the original VWP's were damaged and some were replaced. Currently, there are five active VWP's and three of them are adjacent to the three inclinometers. The graph of historical data from 5/16/05 through 5/21/14 is presented for reference as Figure 1. A graph of measured pore pressures of active piezometers is presented on the attached Figure 2 and is presented numerically in Table 1 below.

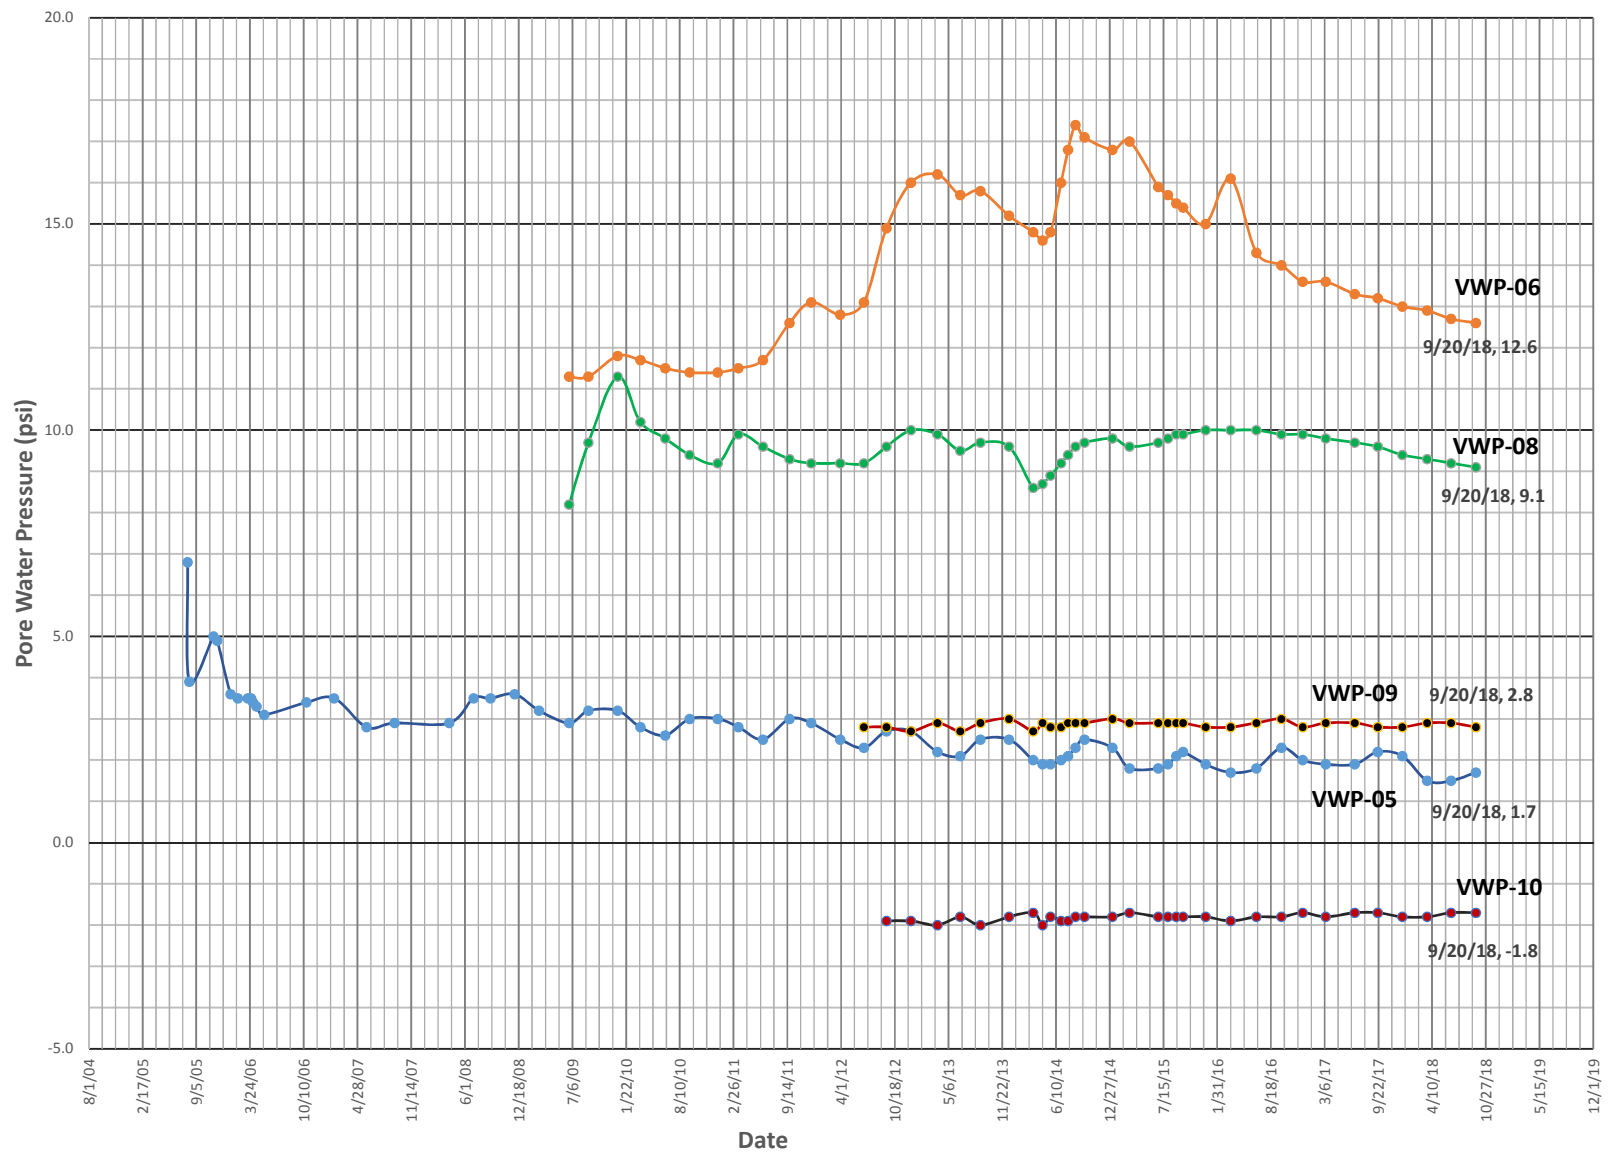
Figure 2 - Bowie Mine #2 - CWDA #2  
Active Vibrating Wire Piezometer Data

VWP-05 was installed on August 3, 2005 near the toe of CWDA No. 2 adjacent to the access road/bench. The pore pressures recorded at VWP-05 have shown some seasonal fluctuations; however, the range of pore pressure changes is fairly small. In general, HBET does not believe that the pore pressures in VWP-05 are cause for concern regarding stability of the gob pile.

VWP-06 was installed on June 5, 2009 near the existing top of CWDA No. 2. The pore pressures recorded at VWP-06 have fluctuated since installation. In general, the fluctuations have been seasonal and reflect the level of coal mine waste placement activity on top of CWDA No. 2. In general, HBET does not believe that the measured pore pressures are an indication of any instability in CWDA No. 2.

VWP-08 was installed on June 5, 2009 at a slightly lower elevation than VWP-06. The pore pressures recorded at VWP-08 have fluctuated since installation. However, the fluctuations have generally been within a narrow range of values. The measured pore pressures are generally consistent with the level of coal mine waste placement activity at CWDA No. 2.

As indicated in the referenced *Stability Evaluation* report, the stability of CWDA No. 2 is sensitive to increases in pore pressures in VWP-08. An increase in the pore pressure of 7 psi in VWP-08 would result in a reduction of the Factor of Safety to below 1.5.

The current pore pressure reflects a piezometric surface elevation of approximately 6097 feet which is much less than the critical elevation of 6113 feet. As a result, HBET does not believe that the measured pore pressures in VWP-08 are any indication of instability in CWDA No. 2.

VWP-09 was installed on May 18, 2012 near the toe of CWDA No. 2. The pore pressures recorded at VWP-09 have been fairly steady since installation. This suggests that dewatering of the gob in this area is likely nearly complete. It is anticipated that the pore pressures at VWP-09 will remain fairly steady over time.

VWP-10 was installed on May 18, 2014 near the toe of CWDA No. 2. The pore pressures recorded at VWP-10 have been fairly steady since installation. This suggests that dewatering of the gob in this area is likely nearly complete. It is anticipated that the pore pressures at VWP-10 will remain fairly steady over time.

In general, based upon the results of the recent VWP and inclinometer monitoring data, HBET does not believe that there is any reduction in the stability of CWDA No. 2. Due to the limited activity at the mine, HBET recommends that the monitoring frequency be reduced to semi-annually.

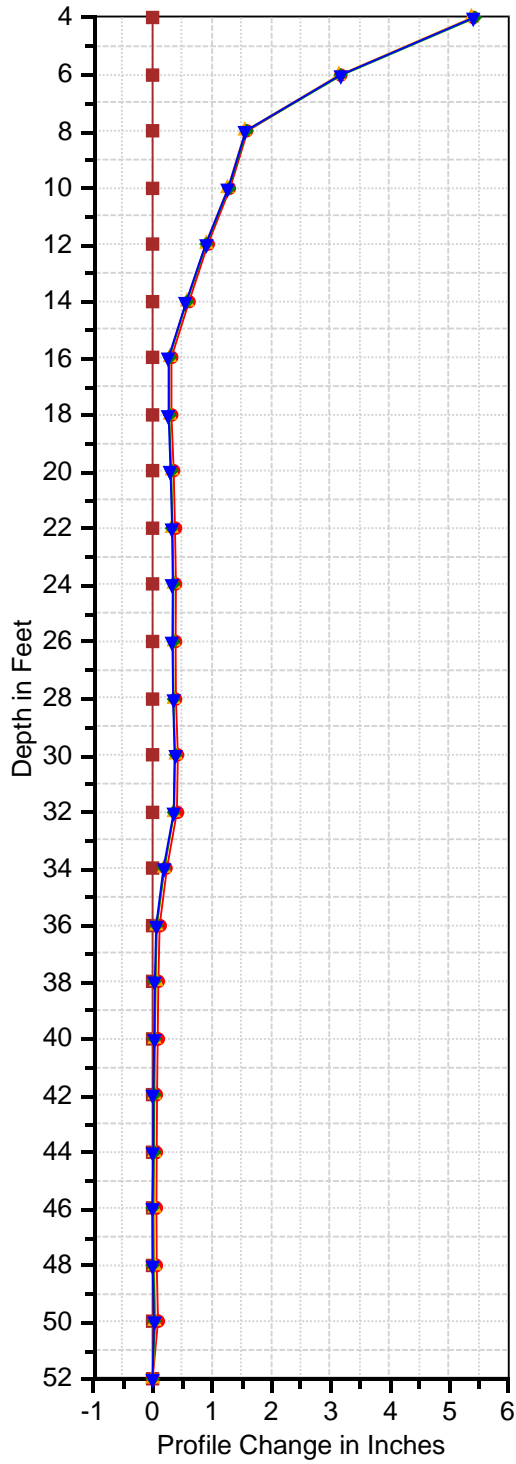
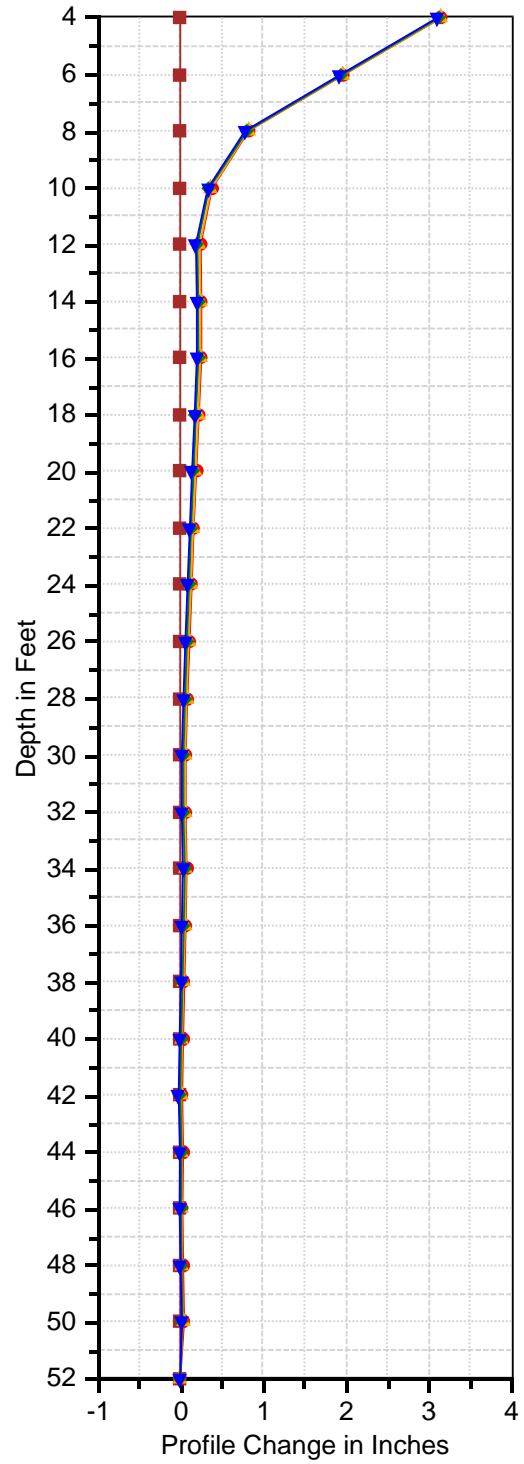
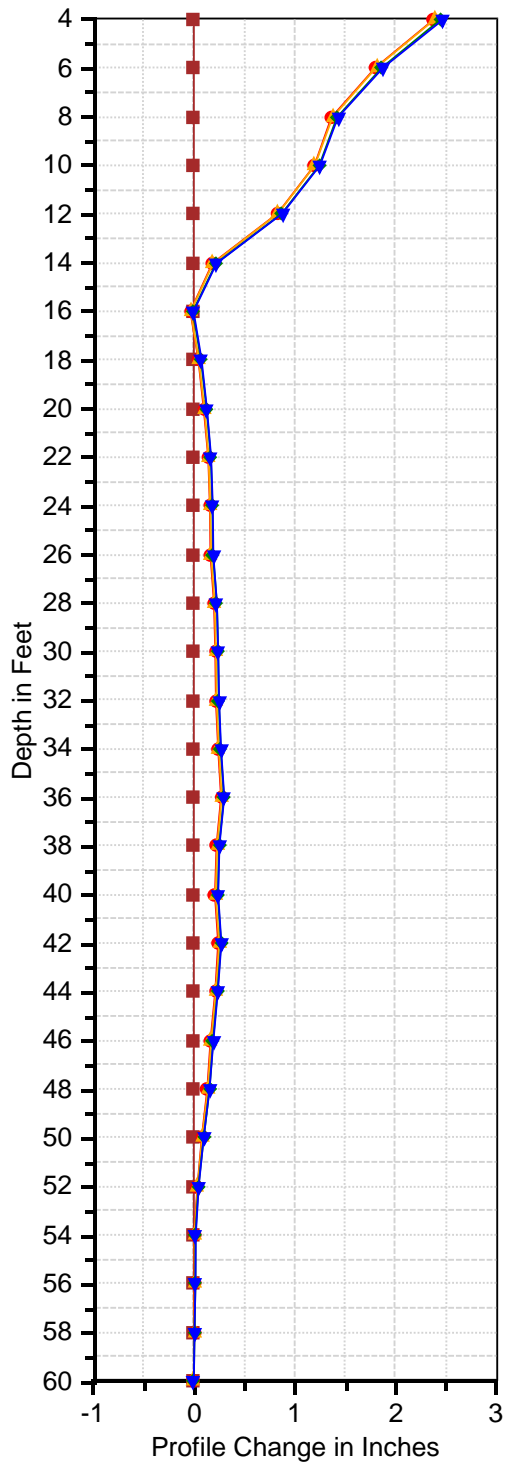
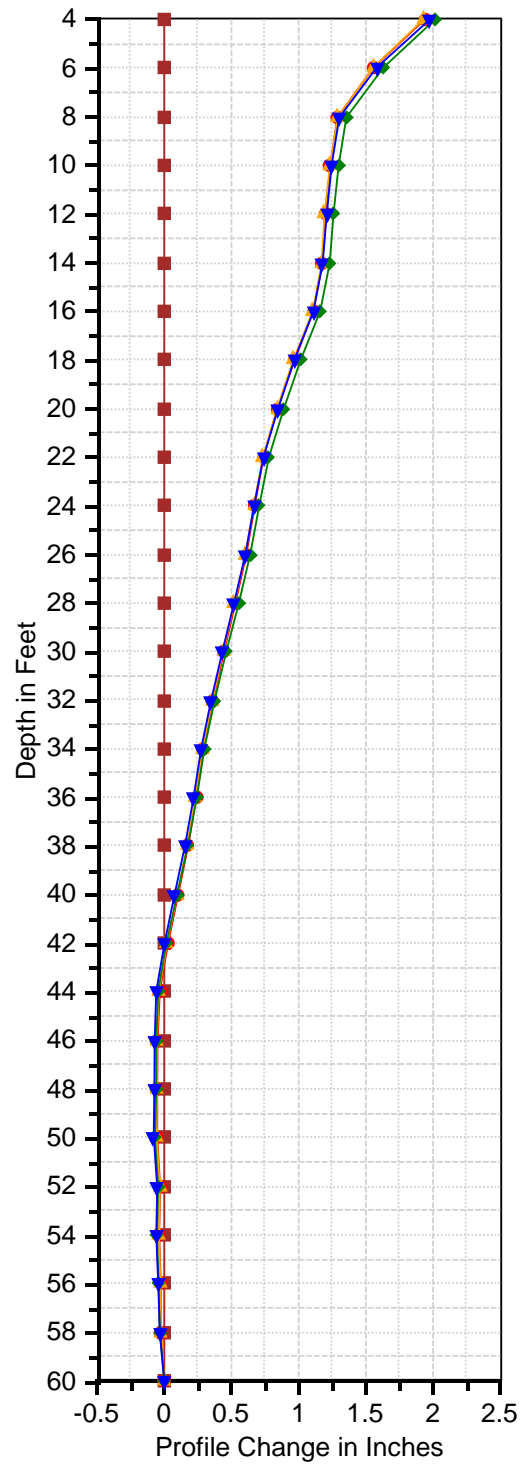
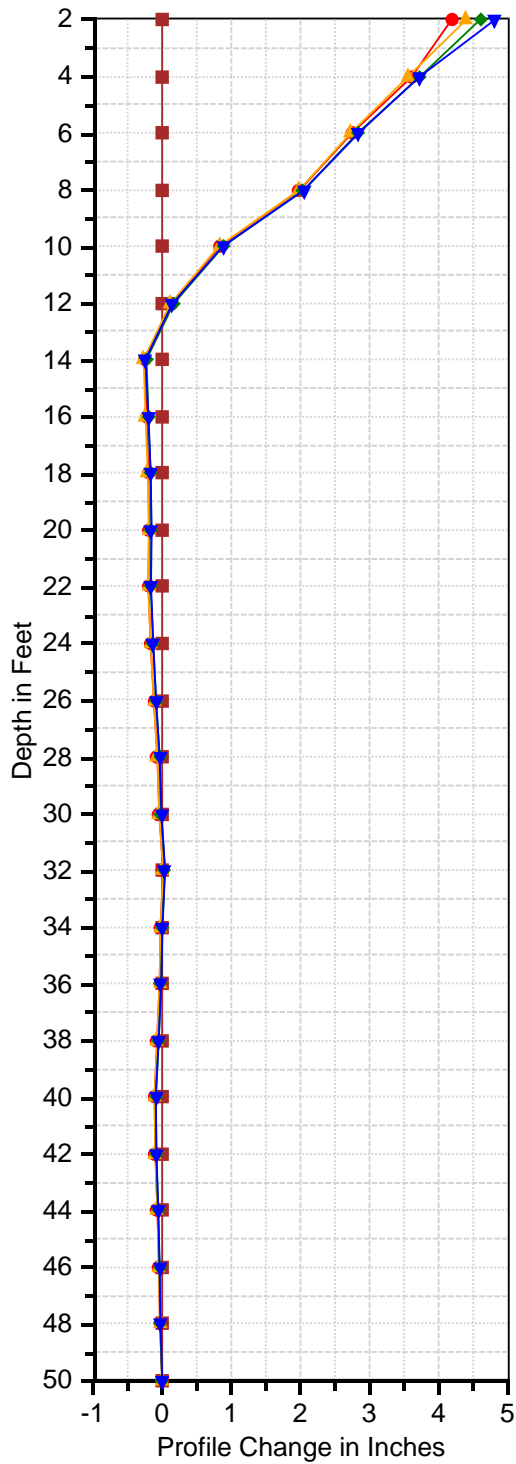
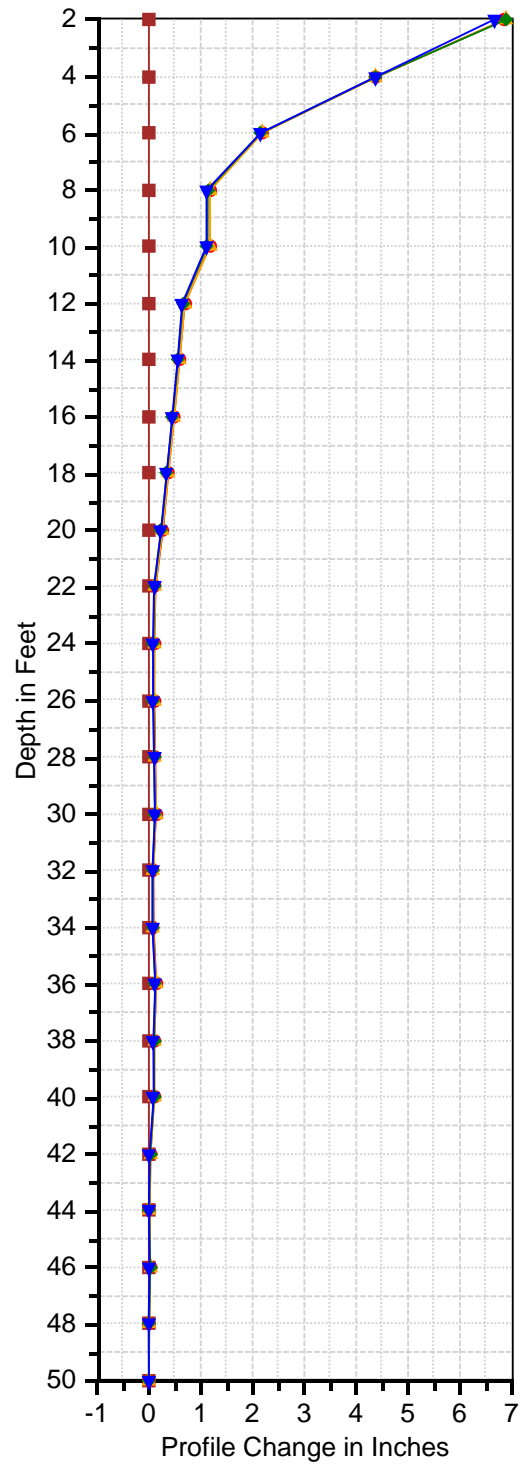
The latest inclinometer readings indicate no major movements since the last quarterly reading. In general, the 3<sup>rd</sup> Quarter 2018 monitoring data does not provide any indication of instability in CWDA No. 2.
