MINERALS PROGRAM INSPECTION REPORT

MINE NAME: Calhan Clay Pit	MINE/PROSPECTING ID#: M-1993-080	MINERAL: Clay (general)	COUNTY: El Paso
INSPECTION TYPE: Monitoring	INSPECTOR(S): Timothy A. Cazier	INSP. DATE: May 9, 2018	INSP. TIME: 16:00
OPERATOR: The Summit Pressed Brick and Tile Company	OPERATOR REPRESENTATIVE: Mike Leidich	TYPE OF OPERATION: 112c - Construction Regular Operation

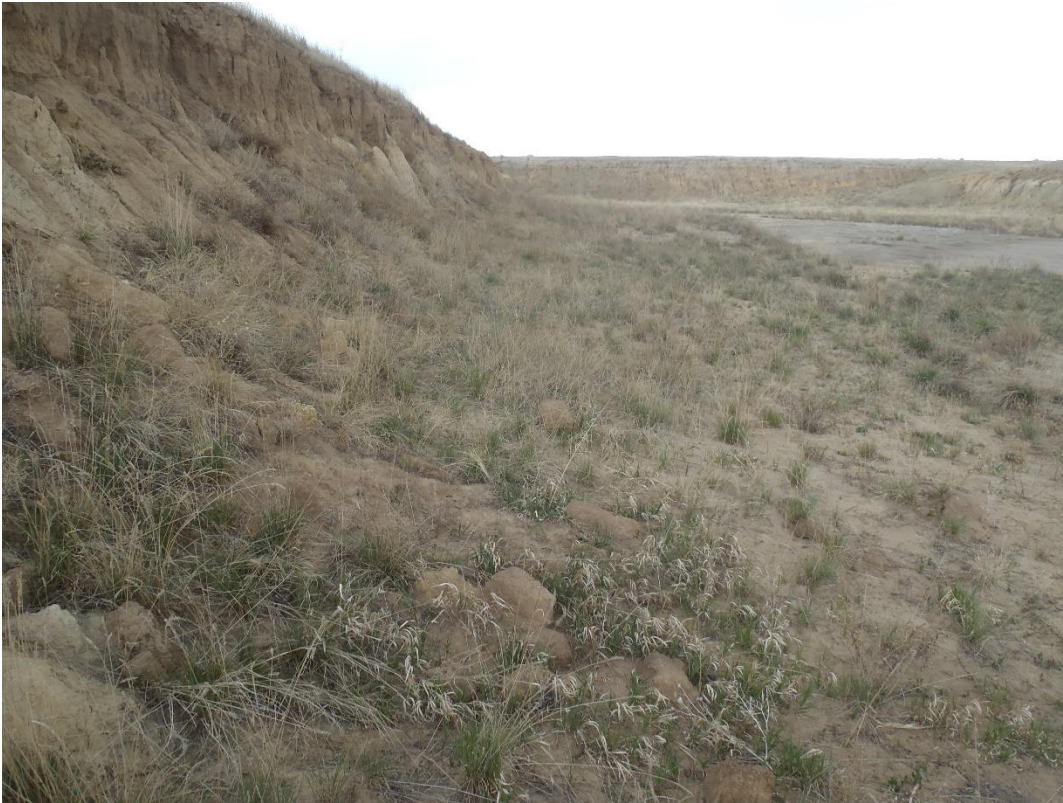
Gen. Compliance with Mine Plan: The operation appeared to be in compliance with the approved mine plan. Google Earth was used to measure the disturbed area, which was estimated to be approximately 8.9 acres, based on June 2017 imagery (see enclosed **Post Inspection Map**). Highwalls were estimated to vary between 8 and 12 feet on the east side and 12 to 15 feet on the west side. The highwalls appeared stable (see **Photo 1**). The pit floor slopes somewhat to the east, and primarily towards the south end (see **Photo 2**).

Photo 1. Stable highwalls (west side, looking north).

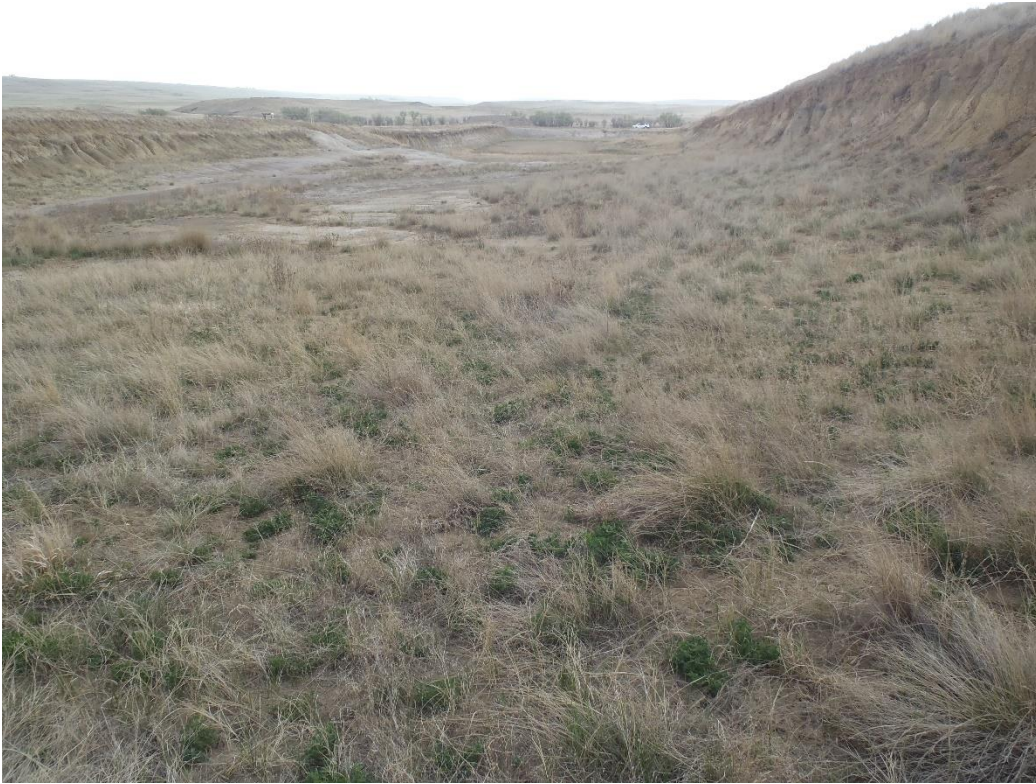
Photo 2. Pit floor, sloping east and south (looking south).

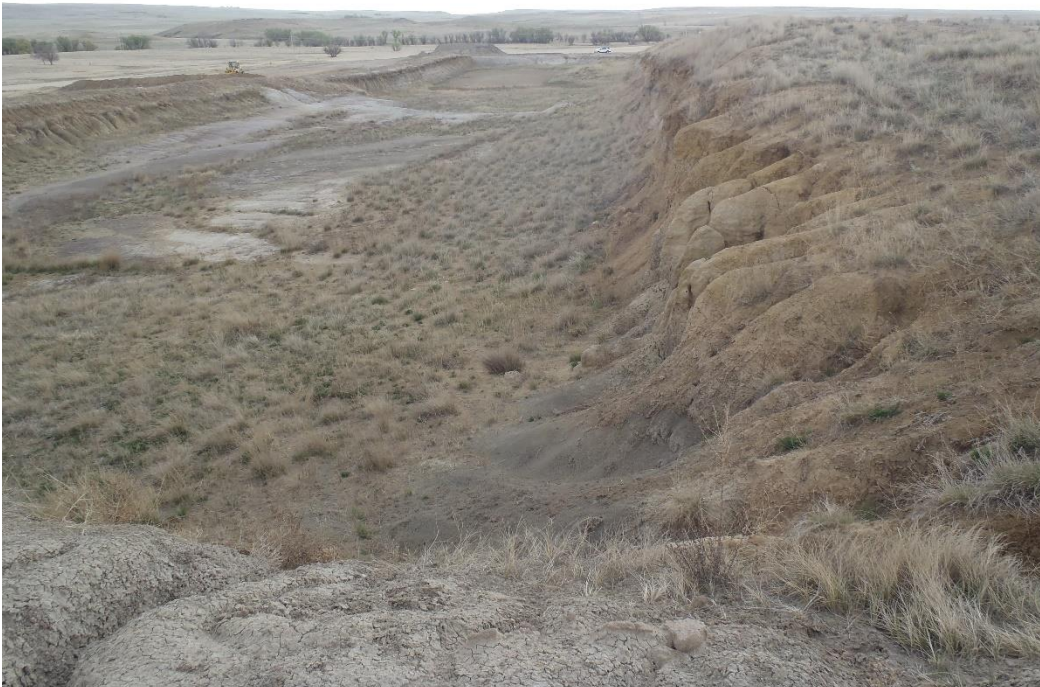
Sediment Control: The pit walls exhibited some erosion (see **Photo 3**), but no BMPs were needed at the time of the inspection.

Photo 3. Pit wall erosion (NW corner, looking south).

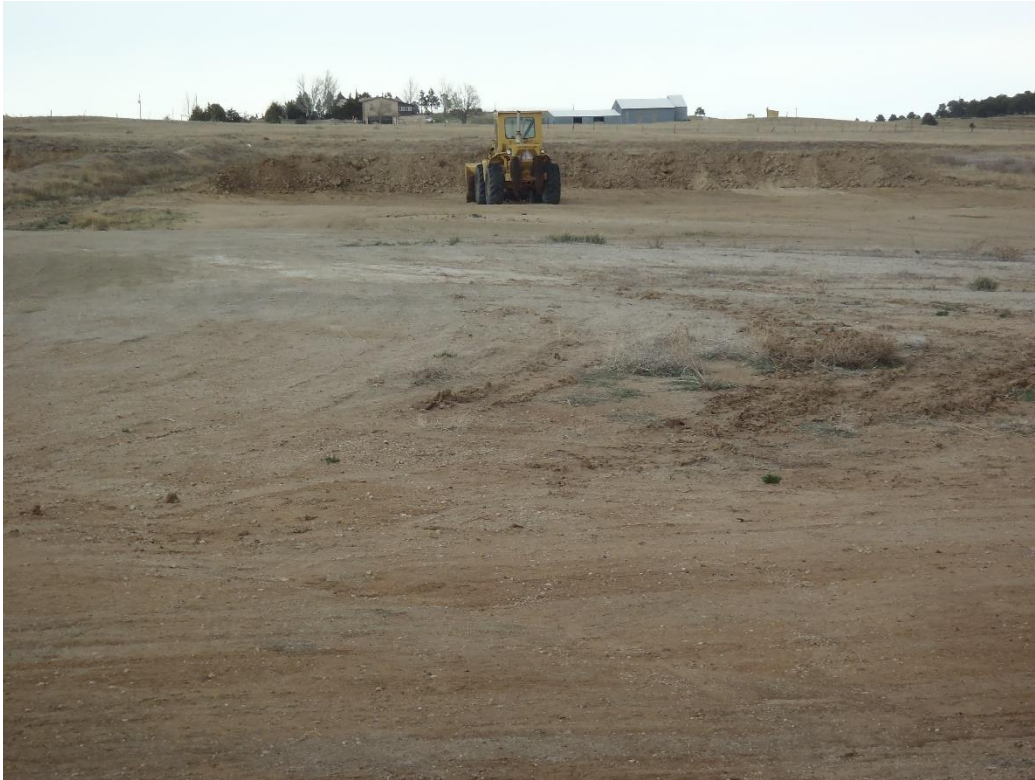
Support Facilities On-site: A loader was observed on site (see **Photo 4**).

Photo 4. Loader (east side, looking north).

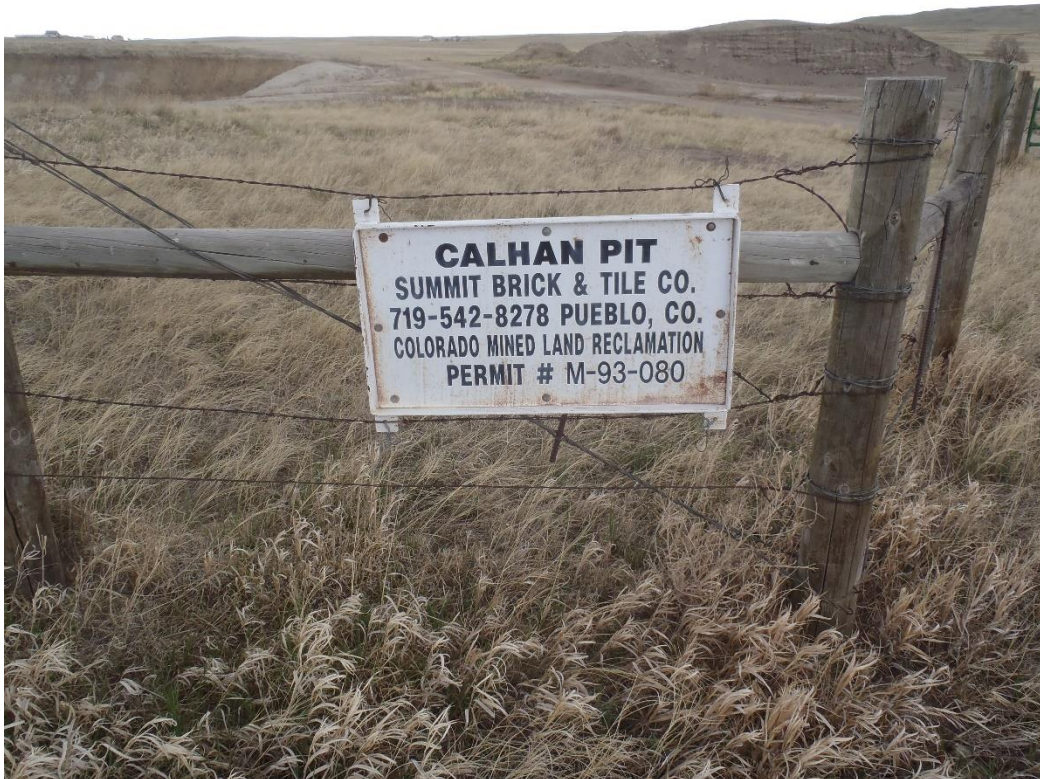
Signs and Markers: The permit sign was properly posted (see **Photo 5**) and boundary markers were observed to delineate the permit boundary in the way of berms on the west, north and east sides (see **Photo 6**). A T-post was observed on the southeast corner (see **Photo 7**).

Photo 5. Permit sign at entrance.

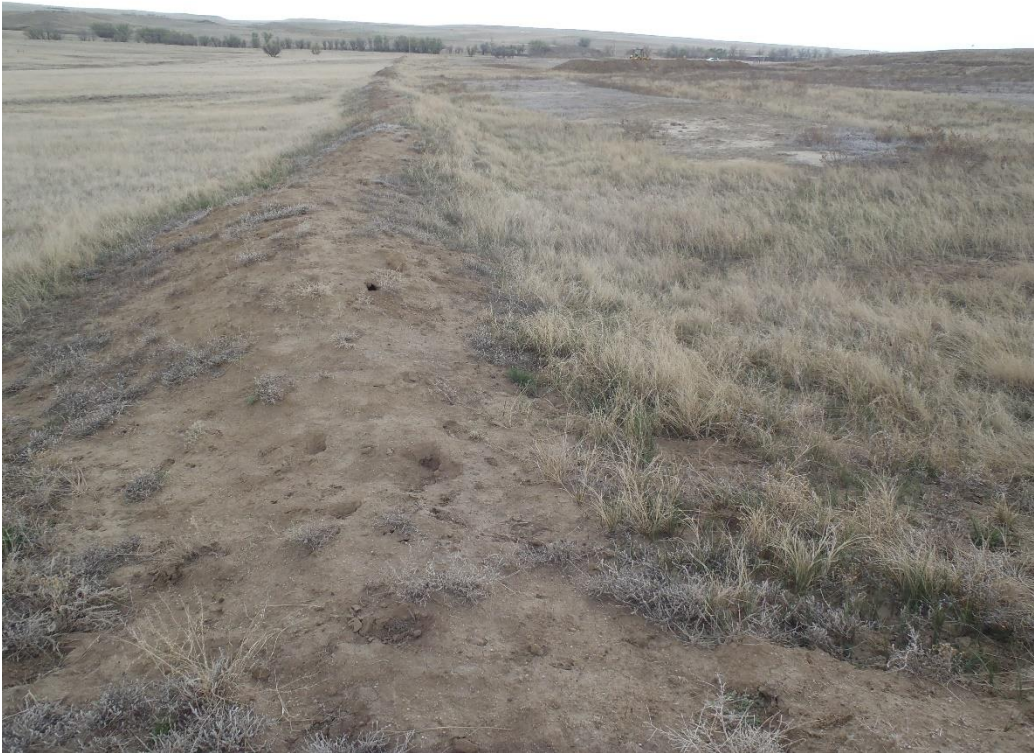
Photo 6. East side berm boundary marker (looking south).

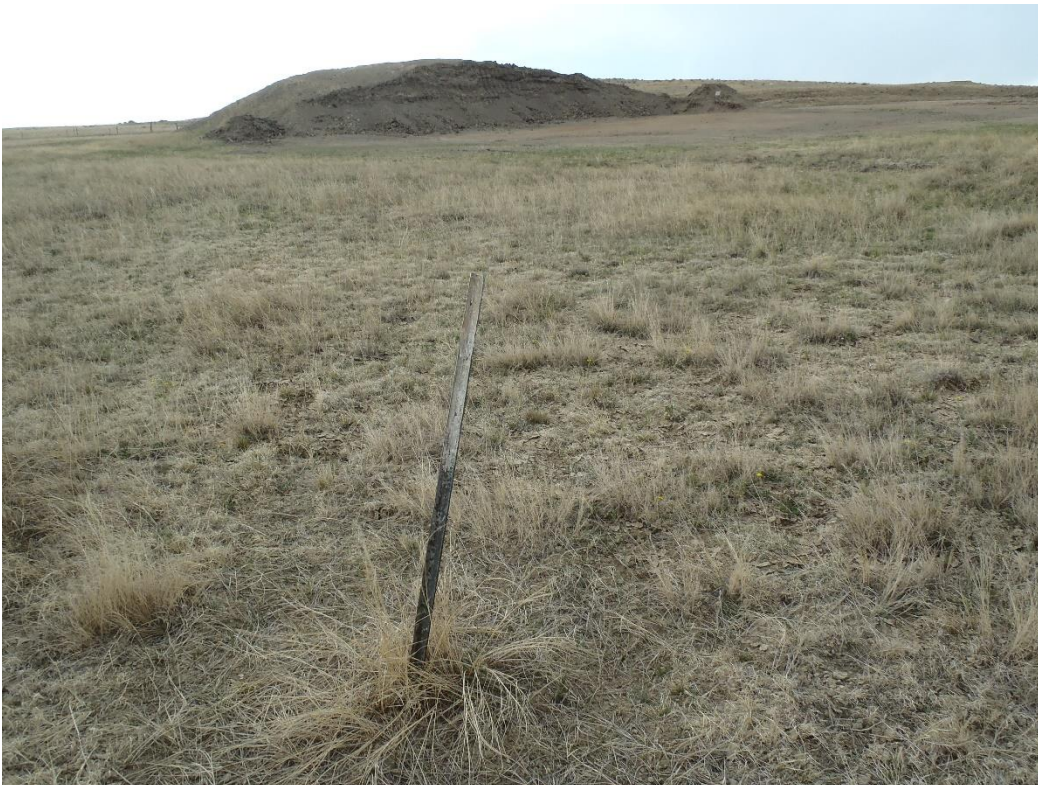
Photo 7. T-post boundary marker (SE corner, looking west).

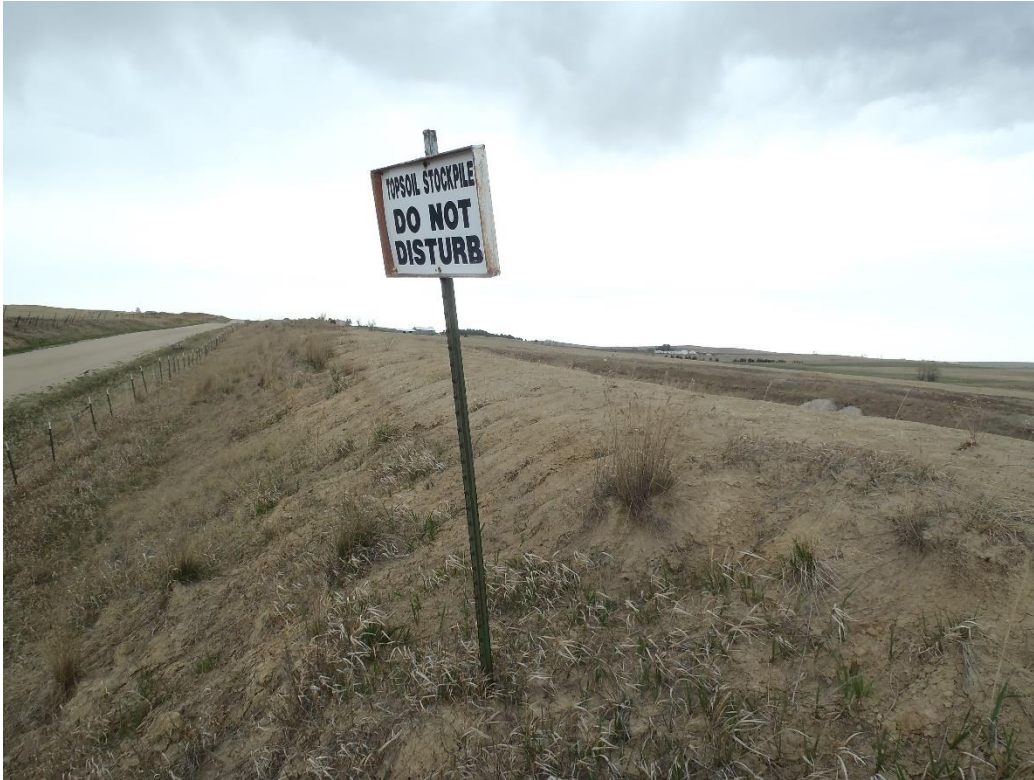
Topsoil: A topsoil stockpile was observed on the west side of the pit, appeared stable and was labeled as such (see **Photo 8**).

Photo 8. Topsoil stockpile with sign (west side, looking north).
