**COLORADO**  
Division of Reclamation,  
Mining and Safety  
Department of Natural Resources

| <b>Permit Number:</b> C-1981-012<br><b>Mine Name:</b> New Elk Mine<br><b>Operator:</b> New Elk Coal Company, LLC<br><b>Operator Address:</b><br>Mr. Louis Head<br>12250 Highway 12<br>Weston, CO 81091 | <b>County:</b> Las Animas<br><b>Operation Type:</b> Underground<br><b>Permit Status:</b> Active<br><b>Ownership:</b> Private |

| <b>Inspection Start Date:</b> October 29, 2018<br><b>Inspection Start Time:</b> 10:00<br><b>Inspection End Date:</b> October 29, 2018<br><b>Inspection End Time:</b> 12:30 | | <b>Inspection Type:</b> Aerial Inspection<br><b>Inspection Reason:</b> Normal I&E Program<br><b>Weather:</b> Clear | |

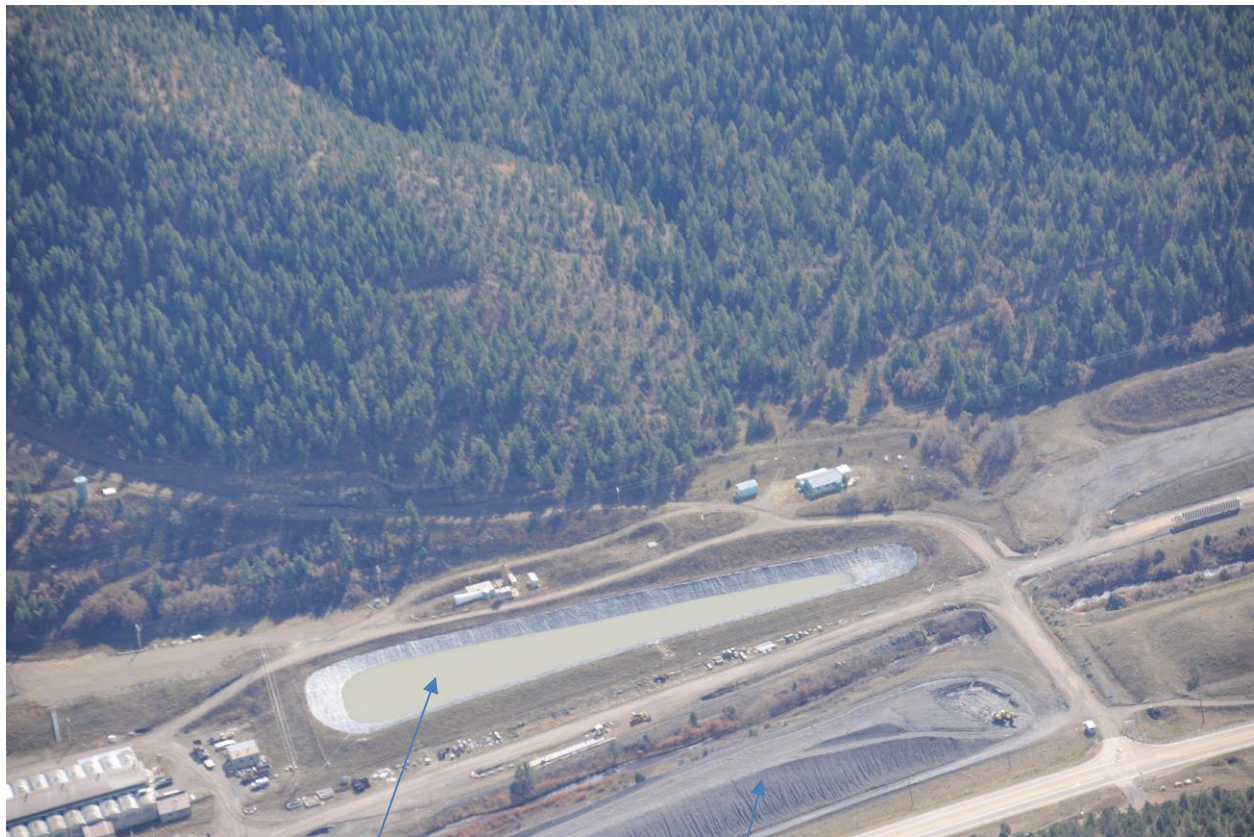
*Pond 001A*

The following ponds were inspected: Pond 001A, Pond 006A, Pond 007A, and Pond 08. All of the ponds were holding water, but the water levels in all ponds looked to be well below their spillways. No issues were identified with any embankments or spillways.

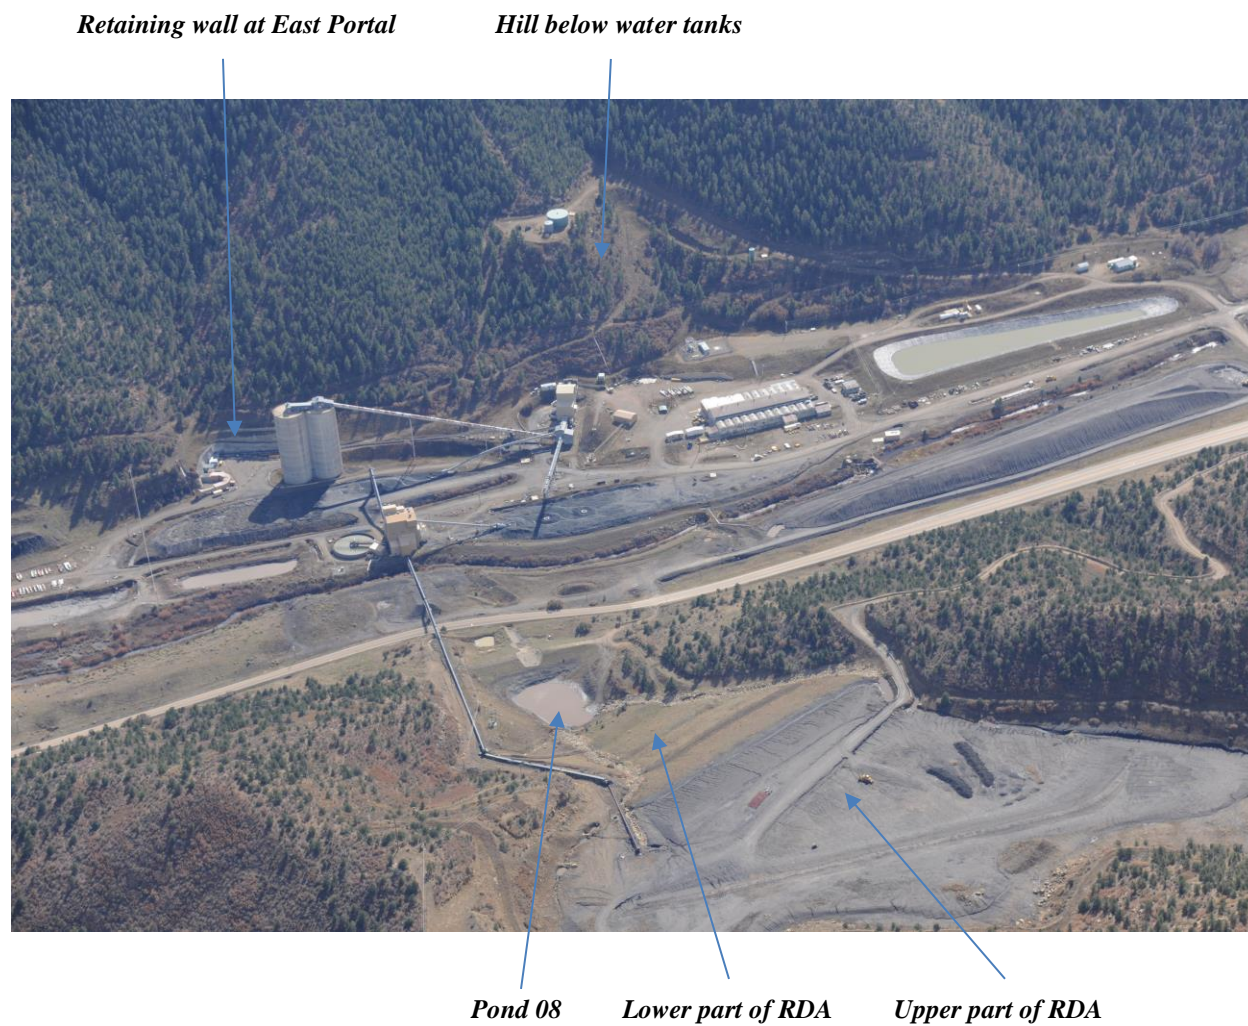
*DWDA#2*

The overall shape of the DWDA#2 looks good, but there are many rills on the sides of this pile. The sump below this pile looks to be functioning well to capture the sediment from the rills.
