**PERMIT INFORMATION**

<b>Permit Number:</b> C-1996-084 <b>Mine Name:</b> Lorencito Canyon Mine <b>Operator:</b> New Elk Coal Company, LLC <b>Operator Address:</b> Mr. Louis Head 12250 Highway 12 Weston, CO 81091	<b>County:</b> Las Animas <b>Operation Type:</b> Surface <b>Permit Status:</b> Permanent Cessation <b>Ownership:</b> Private
	<b>Operator Representative Present:</b>  None
<b>Operator Representative Signature: (Field Issuance Only)</b>

<b>Inspection Start Date:</b> October 29, 2018 <b>Inspection Start Time:</b> 13:00 <b>Inspection End Date:</b> October 29, 2018 <b>Inspection End Time:</b> 15:00		<b>Inspection Type:</b> Aerial Inspection <b>Inspection Reason:</b> Normal I&E Program <b>Weather:</b> Clear	
<b>Joint Inspection Agency:</b>  None		<b>Joint Inspection Contacts:</b>  	
<b>Post Inspection Agency:</b>  None		<b>Post Inspection Contacts:</b>  	
<b>Inspector(s):</b>  Robert D. Zuber, P.E.  Harry B. Ranney	<b>Inspector's Signature:</b>

The Lorencito Canyon Mine was photographed from an airplane by Harry Ranney of DRMS on October 25, 2018. These photos were reviewed by Rob Zuber of DRMS on October 29, 2018. The weather was clear.

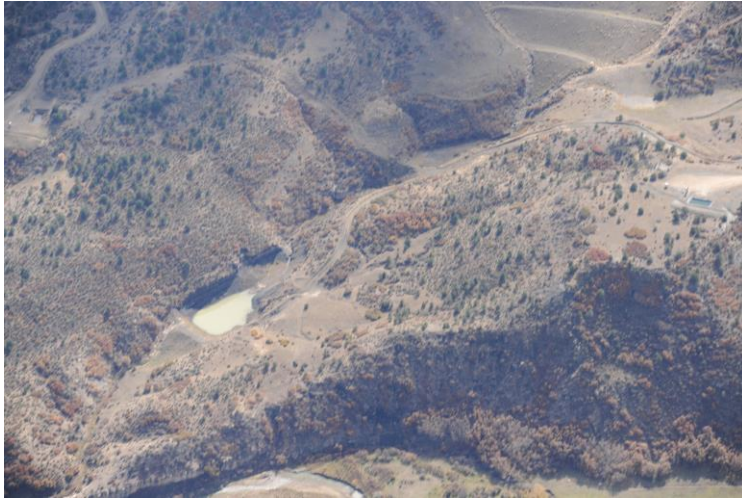
**Pond 8 and lower portion of Fill 8**

No large rills or other problems were identified with Fills 7, 8, or 9.

Ponds 6, 7, 8, 9, and 9A were inspected, and all contained water. No issues were identified with embankments or spillways.

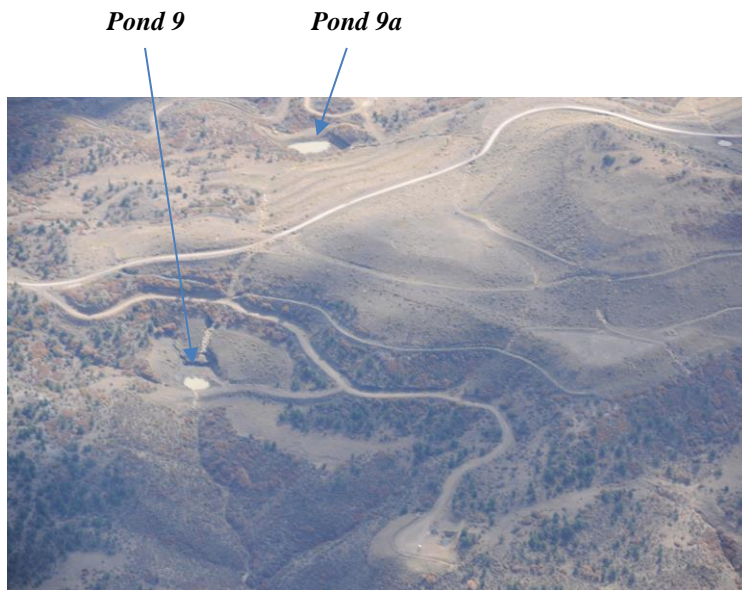
**Fill 9, the eastern portion of “the knob” and two sediment ponds**

The east, west, and north sides of the large hill (aka “the knob”) have many rills. NECC should continue to monitor these to determine which rills require maintenance. The same is true for other hills within the disturbed area, including the hill south of Fill 8 (above the sediment dump area) and the hill above Pond 6.

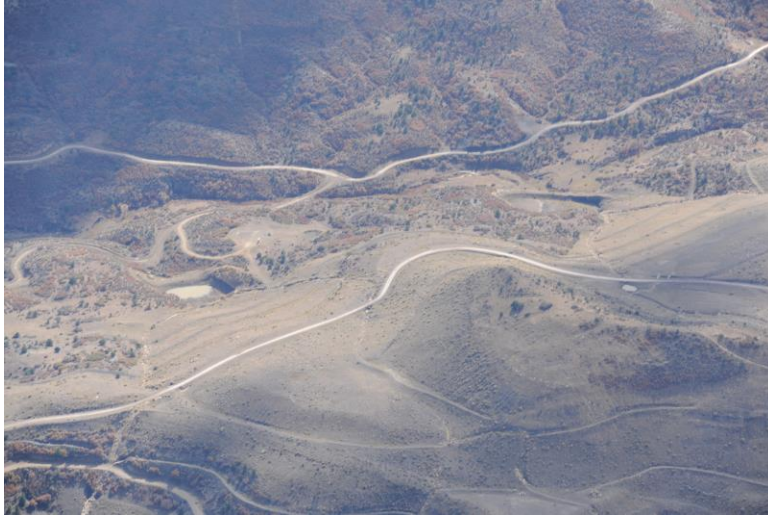
No erosion problems or other issues were identified with any ditches. Check dams in ditches (D5, D8, D9, D64, and D71) also appeared to be functioning well.

**"The knob" with ditches on north side of this hill (in foreground of photo)**

*Shrub plot*

*Area where pond cleanings are placed*

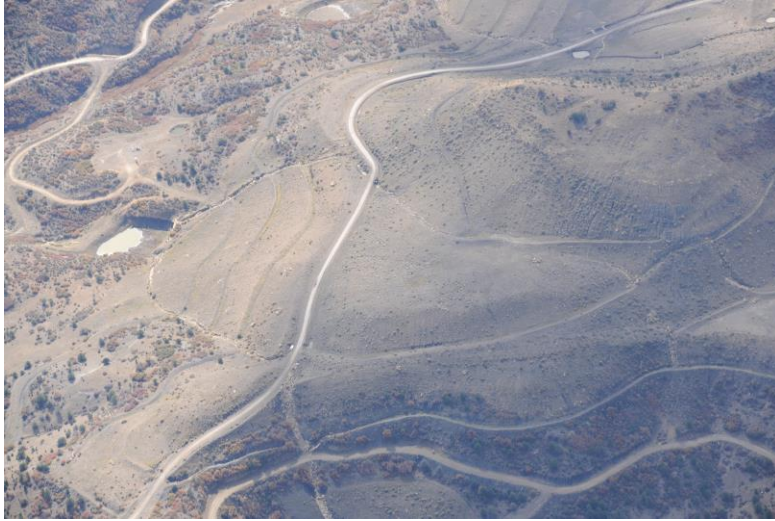
**Fill 9 and Pond 9a (pond on left side of photo)**

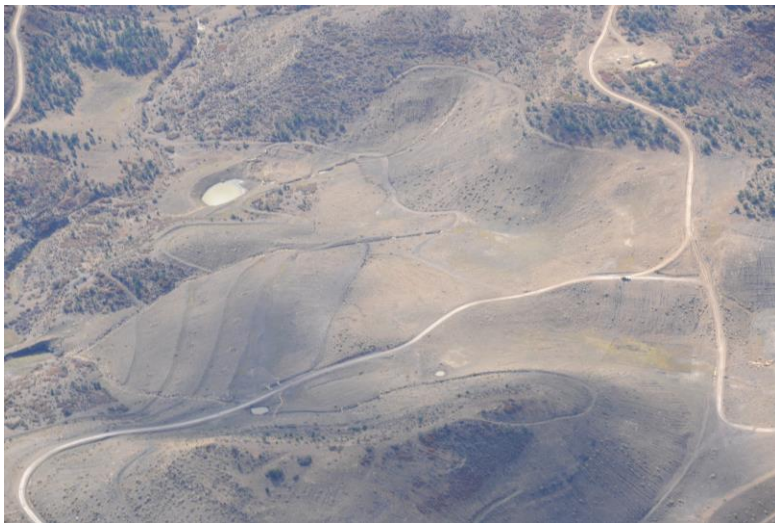
**Fill 7, Pond 7, and Pond 6**
