MINERALS PROGRAM INSPECTION REPORT
PHONE: (303) 866-3567

MINE NAME: Diehl Borrow Pit	MINE/PROSPECTING ID#: M-2018-054	MINERAL: Borrow material for construction	COUNTY: Larimer
INSPECTION TYPE: Preoperation Inspection	INSPECTOR(S): Amy Eschberger	INSP. DATE: October 23, 2018	INSP. TIME: 13:30
OPERATOR: SEMA Construction, Inc.	OPERATOR REPRESENTATIVE: Gavin Madsen	TYPE OF OPERATION: 111 - Construction by Government Agency

REASON FOR INSPECTION: Preoperation Inspection	BOND CALCULATION TYPE: Complete Bond	BOND AMOUNT: To be determined
DATE OF COMPLAINT: NA	POST INSP. CONTACTS: None	JOINT INSP. AGENCY: None
WEATHER: Clear	INSPECTOR'S SIGNATURE:

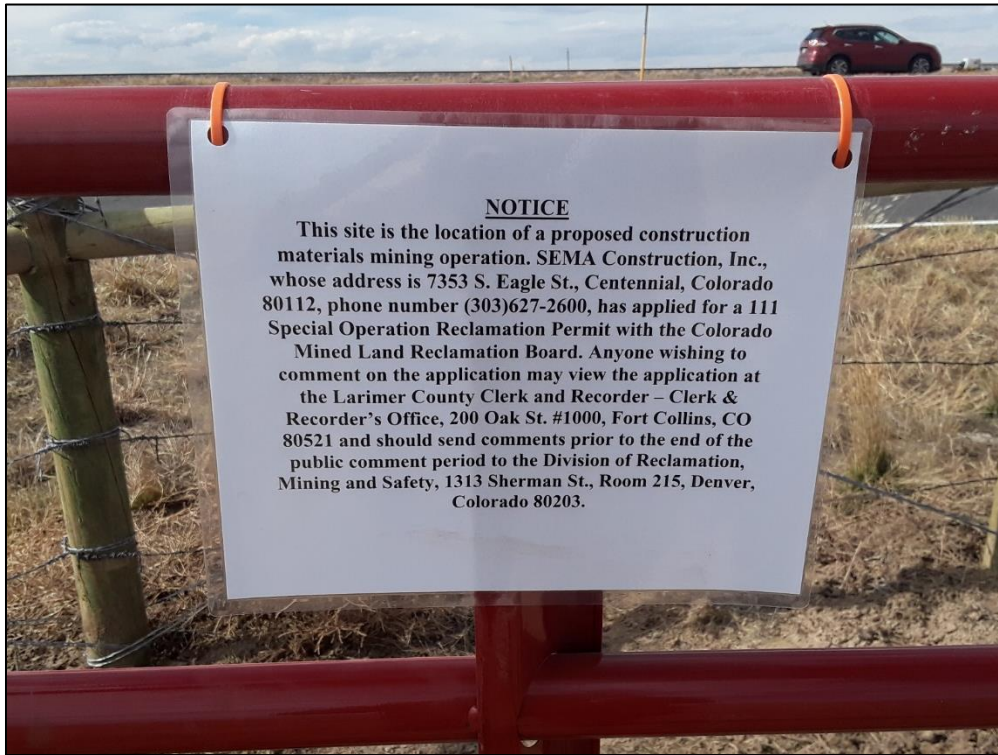
Photo 1. View of notice sign posted at main site entrance.

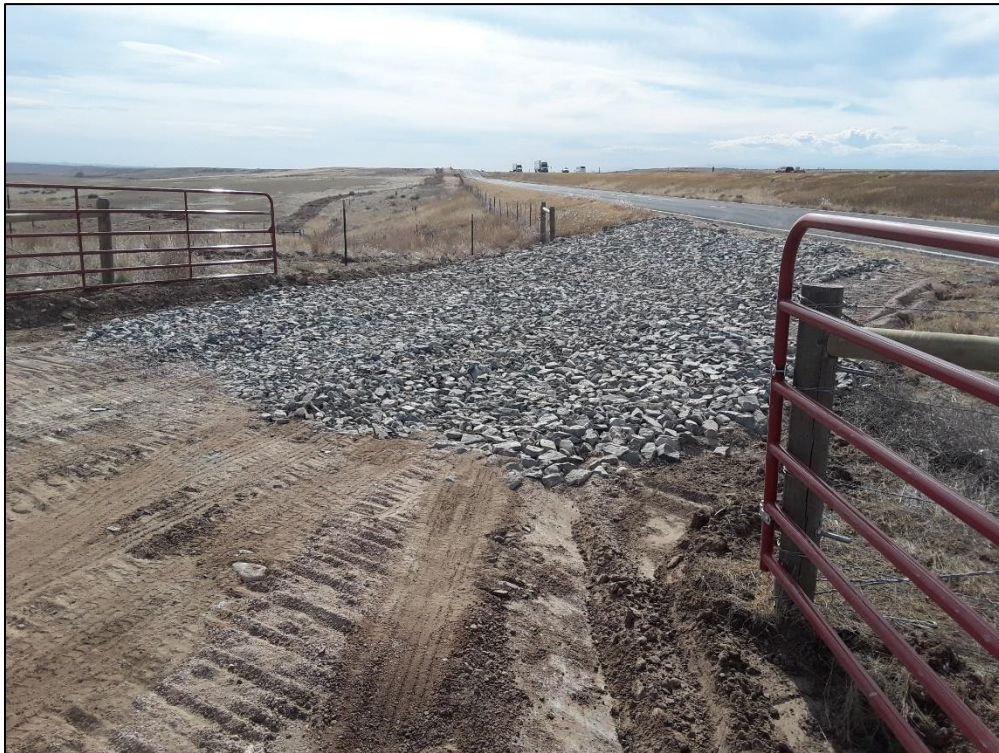
Photo 2. View of existing access road to site off I-25 frontage road.

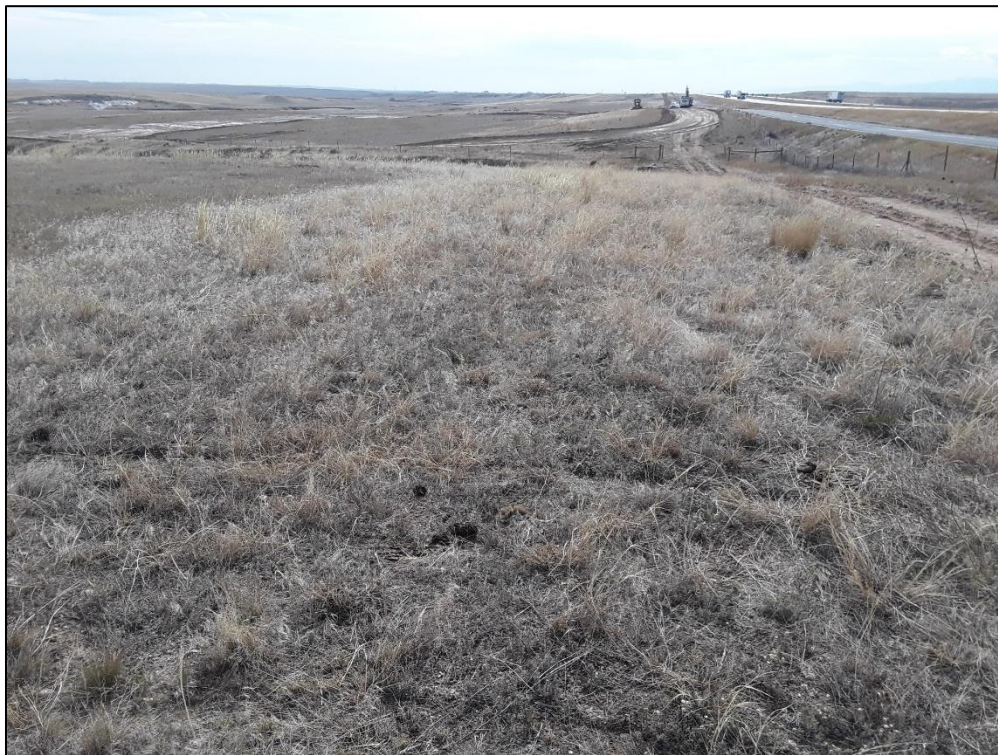
Photo 3. View looking south across northern half of permit area.

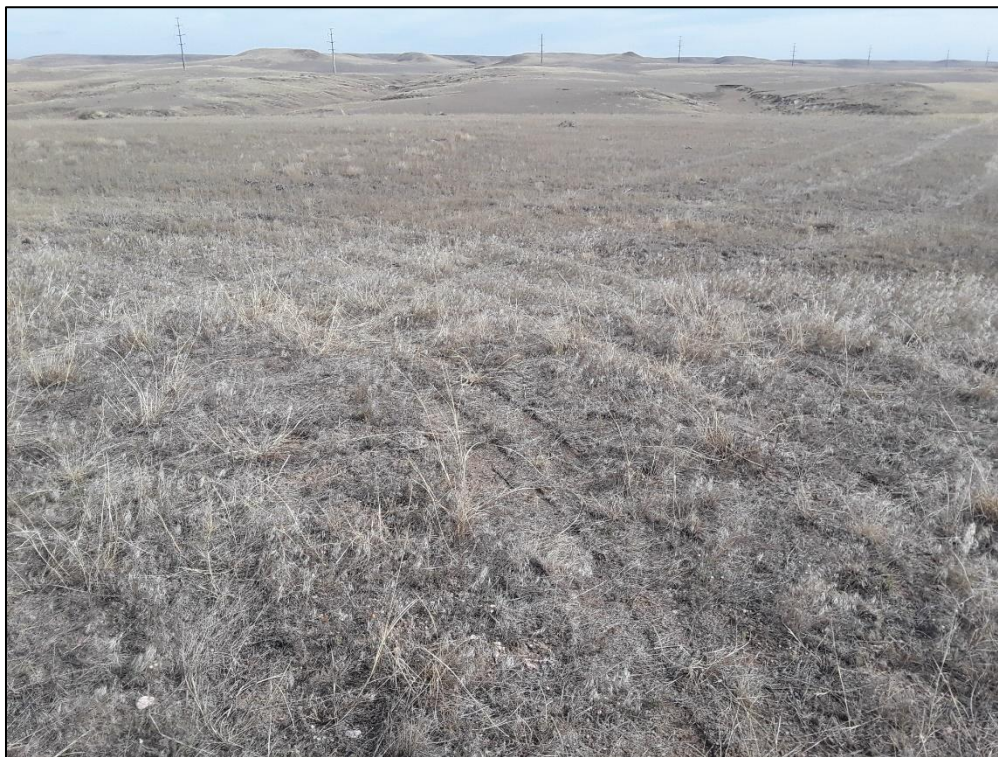
Photo 4. View looking east across northern half of permit area.

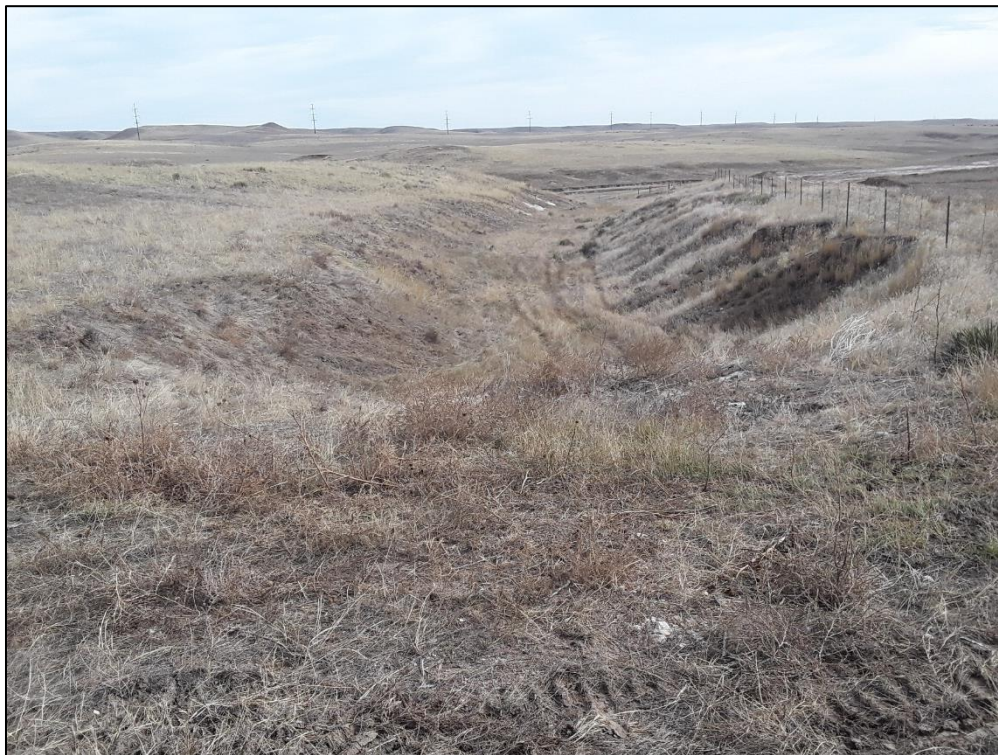
Photo 5. View looking east across drainage separating proposed northern and southern mining areas. Note drainage dry during inspection.

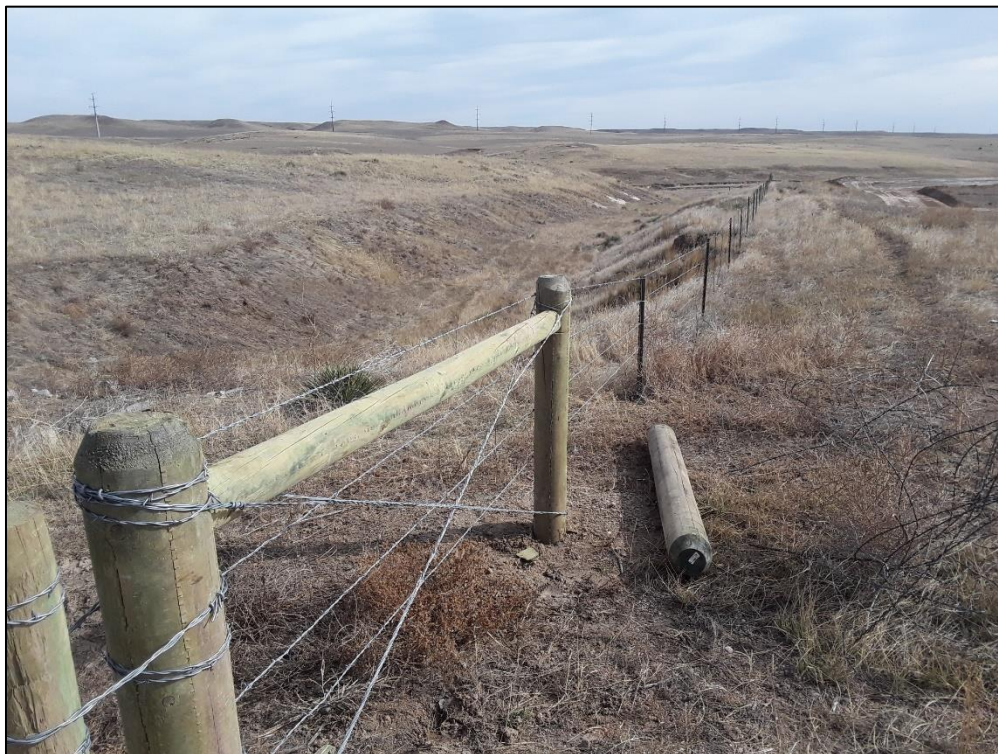
Photo 6. View looking east, showing barbed wire fence that separates the two proposed mining areas. This fence was not shown on the maps submitted.

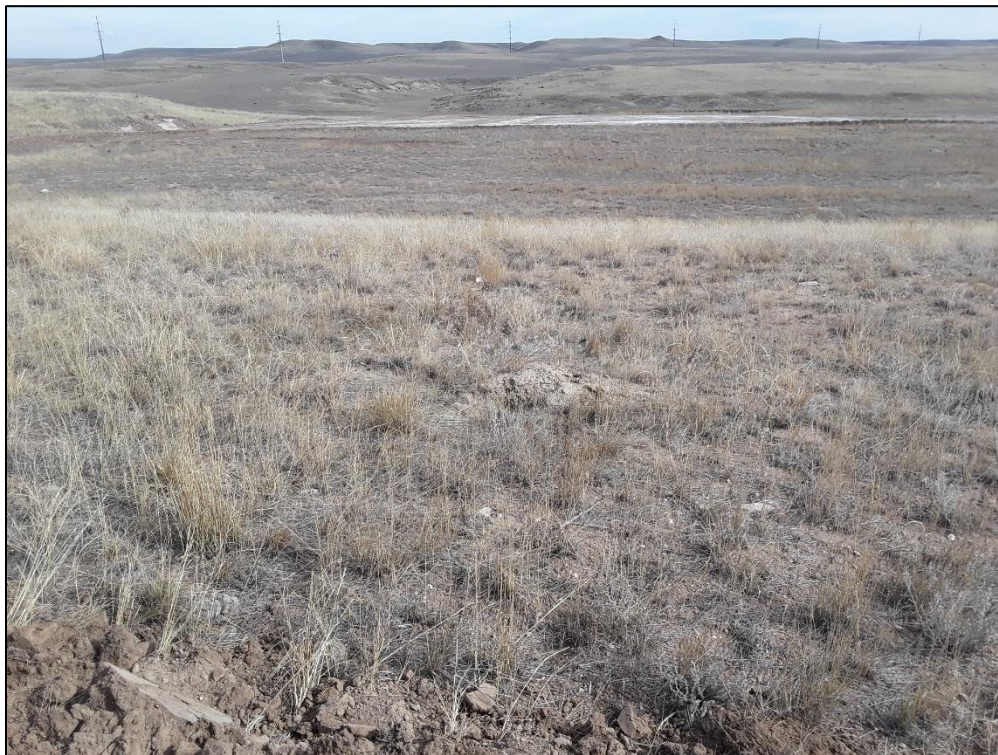
Photo 7. View looking east across southern half of permit area.

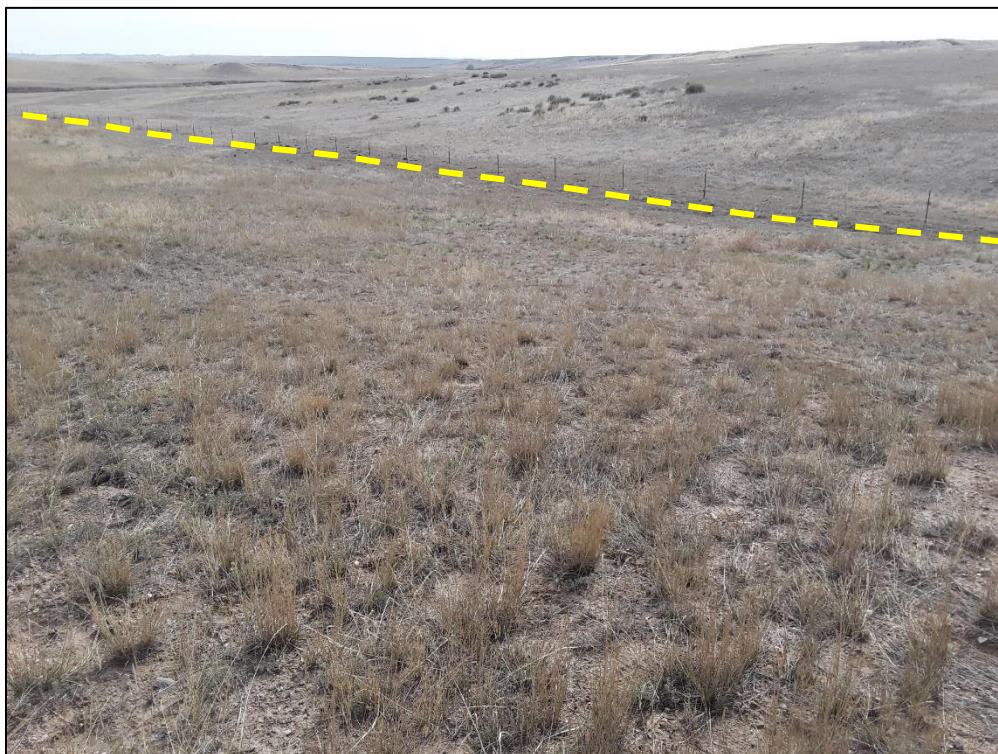
Photo 8. View looking southeast toward southern permit boundary, delineated by an existing property fence (indicated with dashed yellow line).
