| Permit Number: C-1981-028 Mine Name: Keenesburg Strip Mine Operator: Coors Energy Company Operator Address: Mr. Danny Kipp P.O Box 467 Golden , CO 80402 | County: Weld Operation Type: Surface Permit Status: Active Ownership: Private |

| Inspection Start Date: October 30, 2018 Inspection Start Time: 09:45 Inspection End Date: October 30, 2018 Inspection End Time: 11:00 | | Inspection Type: Coal Partial Inspection Inspection Reason: Normal I&E Program Weather: Cloudy | |

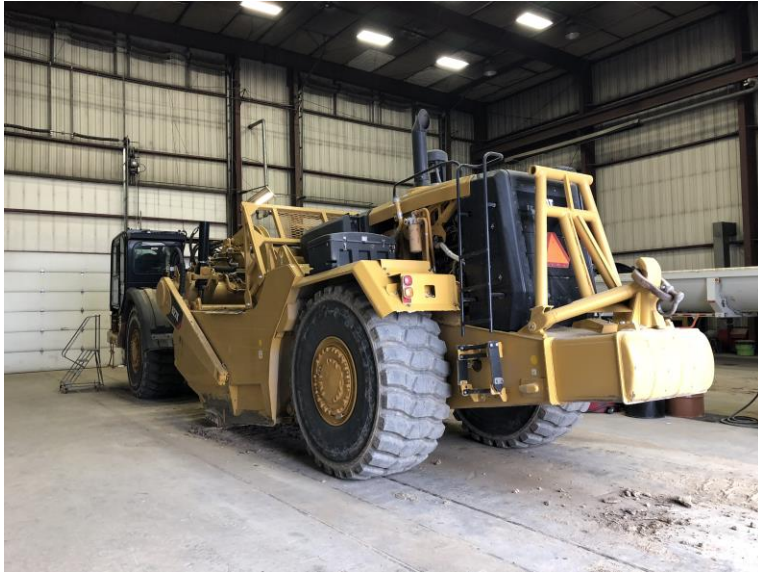
Prior to the inspection, Danny Kipp had been using the scraper (CAT 627K) to backfill the remaining portion of B Pit. During the inspection, Mark Quinby was performing grading operations with a Deere 872 GP at the former pit area. CEC is nearly done scraping material from the road southwest of the Dugout Pond and will soon begin work on the road at the north end of the site. Weather permitting, Mr. Kipp anticipates that the B&G work (prior to moving topsand) will be done around the end of November 2018.

Caterpillar scraper – had been operating in morning before inspection

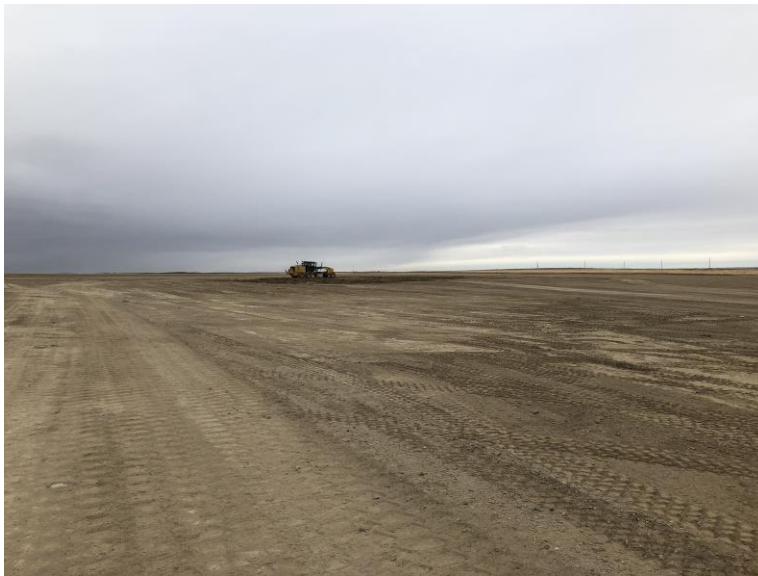
Deere grader operating at former B Pit area during inspection

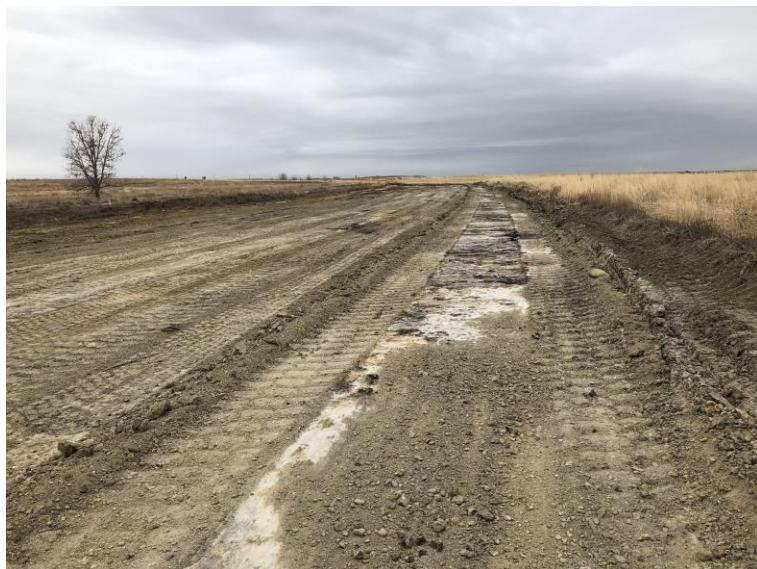
As mentioned in the BACKFILLING AND GRADING section, CEC has begun to reclaim the roads. No problems with roads were found.

Scraped road south of Area 25

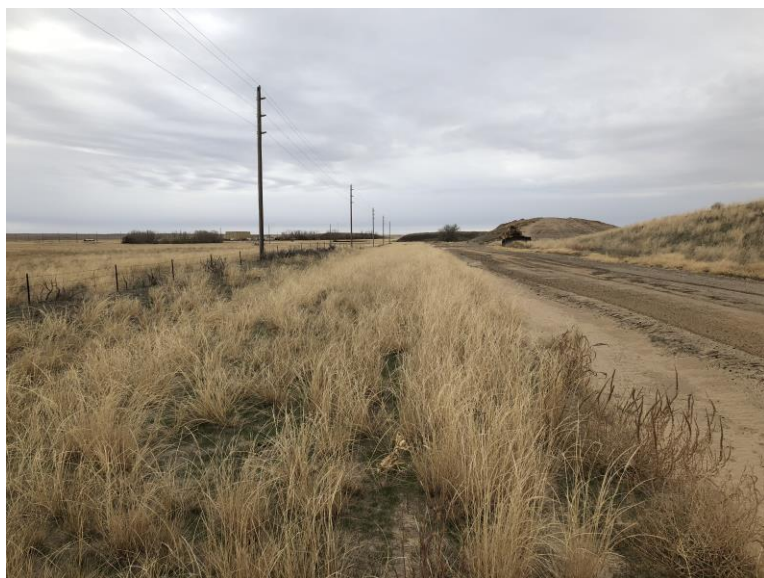
The ditches along the north side of the site were inspected; no problems were seen.

North end of site, looking east

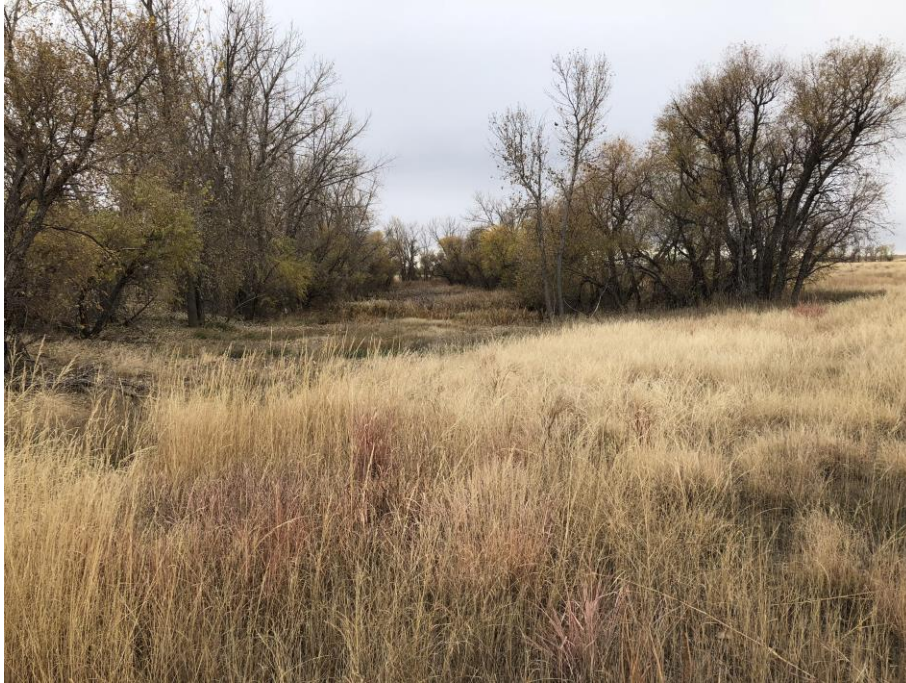
Standing water was observed in Sediment Pond 2 but well below the emergency spillway. The Dugout Pond appeared dry or had only a little water in it (thick vegetation precludes easy viewing of the pond bottom). Neither pond was discharging during the inspection. No problems were observed with the two ponds.

Dugout Pond
