MINERALS PROGRAM INSPECTION REPORT
PHONE: (303) 866-3567

MINE NAME: 83rd Joint Venture	MINE/PROSPECTING ID#: M-1992-069	MINERAL: Sand and gravel	COUNTY: Weld
INSPECTION TYPE: Monitoring	INSPECTOR(S): Peter S. Hays	INSP. DATE: October 30, 2018	INSP. TIME: 10:00
OPERATOR: Aggregate Industries - WCR, Inc.	OPERATOR REPRESENTATIVE: Connie Davis	TYPE OF OPERATION: 112c - Construction Regular Operation	
REASON FOR INSPECTION: Priority	BOND CALCULATION TYPE: None	BOND AMOUNT: \$10,237,994.00	
DATE OF COMPLAINT: NA	POST INSP. CONTACTS: None	JOINT INSP. AGENCY: None	
WEATHER: Clear	INSPECTOR'S SIGNATURE:

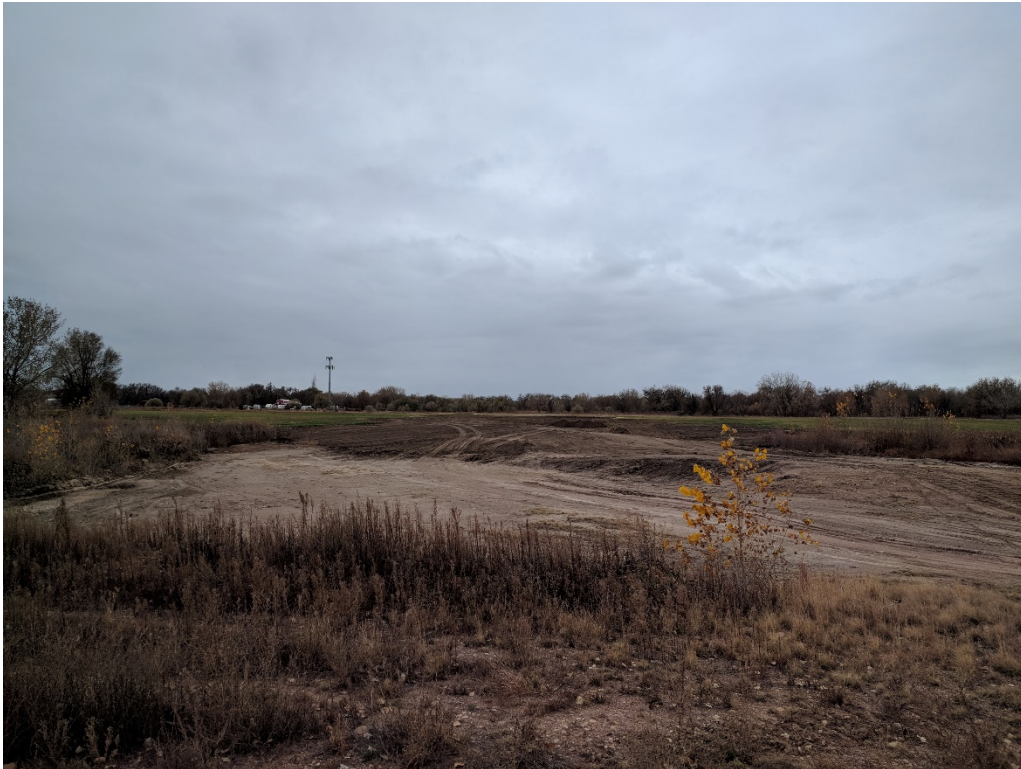
View of backfilled field from the 83rd site looking west

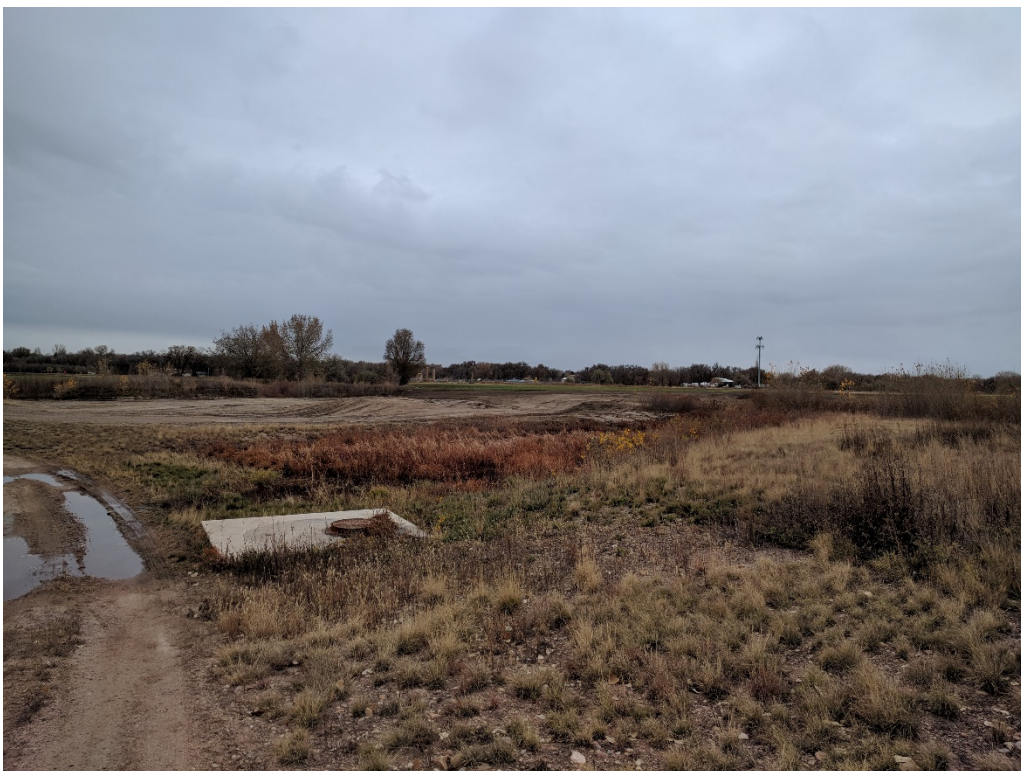
View of backfilled field from the 83rd site looking southwest

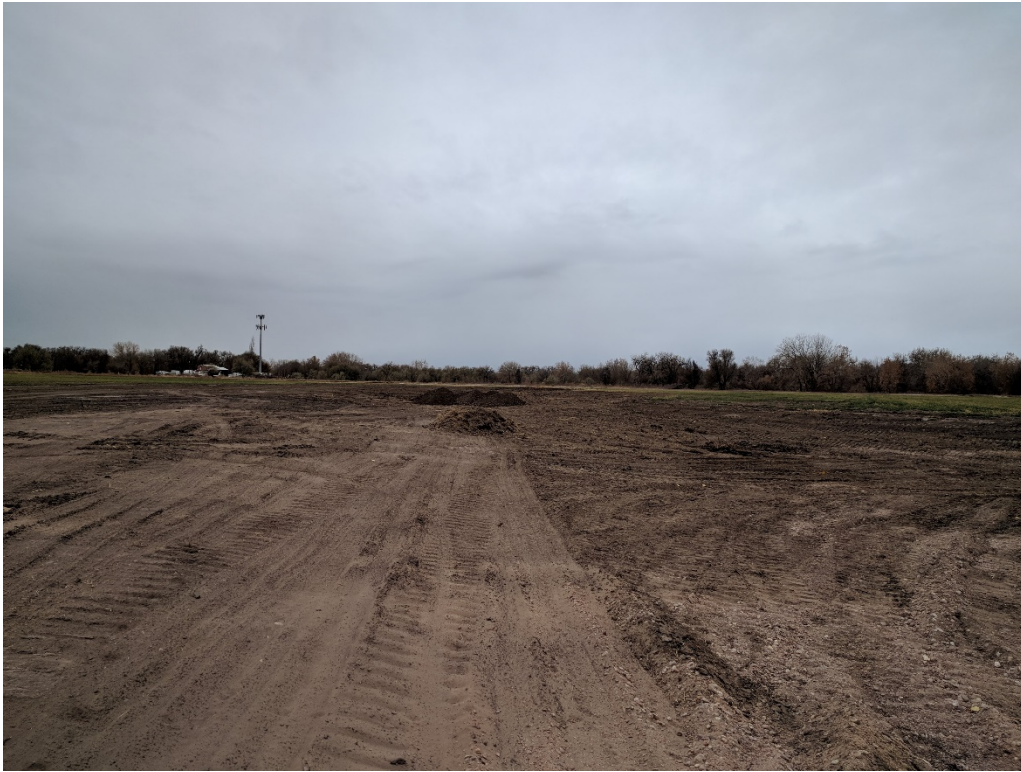
View of backfilled field looking west at stockpiles

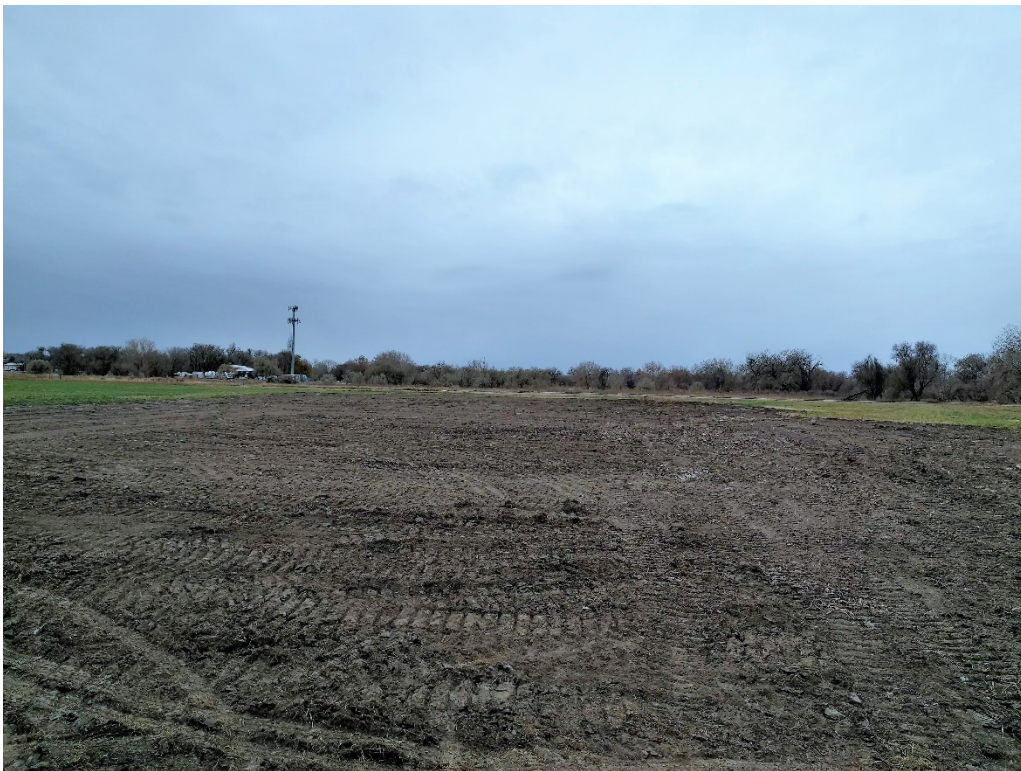
View of backfilled field from the middle of the field looking west

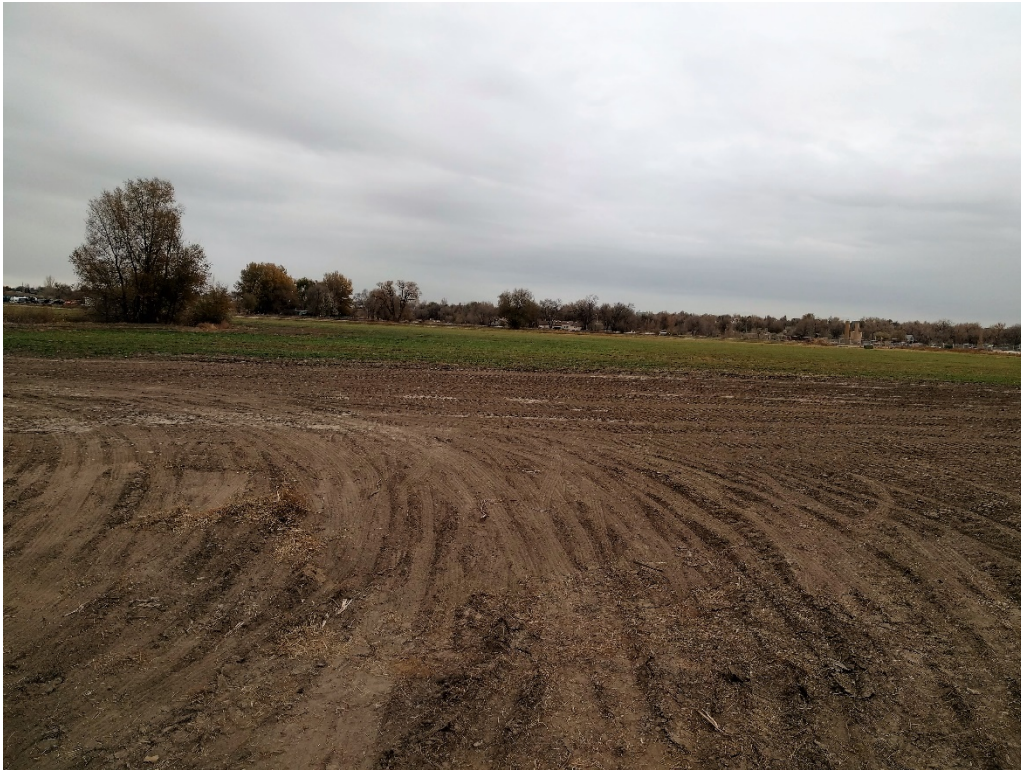
View of backfilled field from the middle of the field looking south

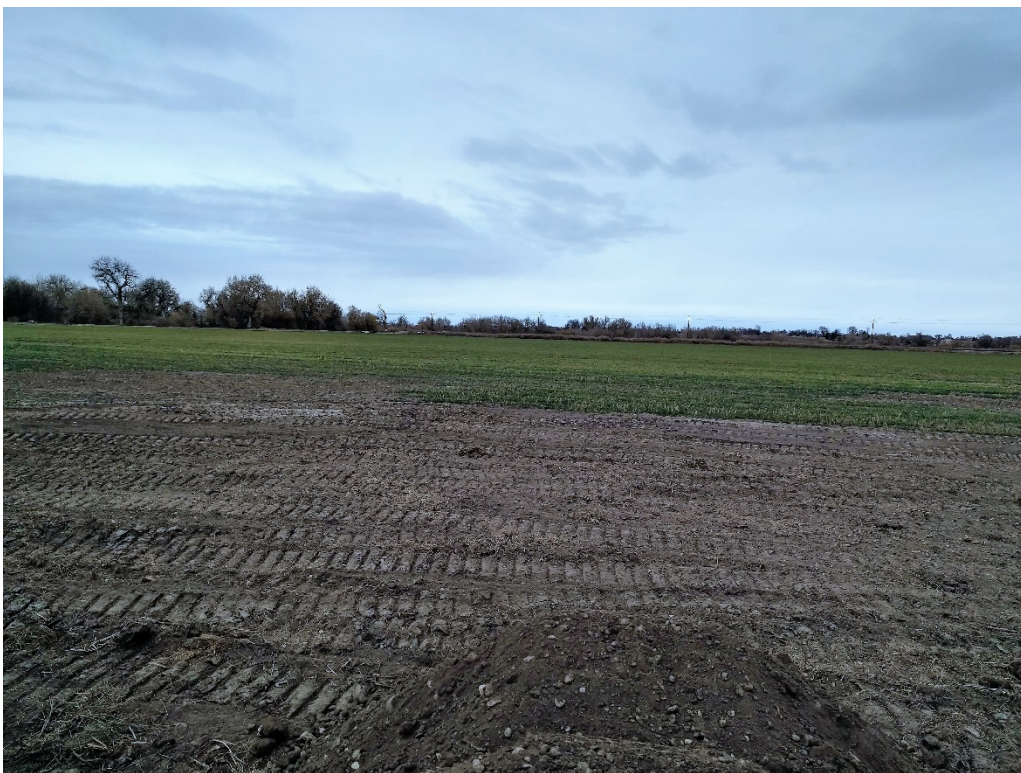
View of backfilled field from the middle of the field looking north

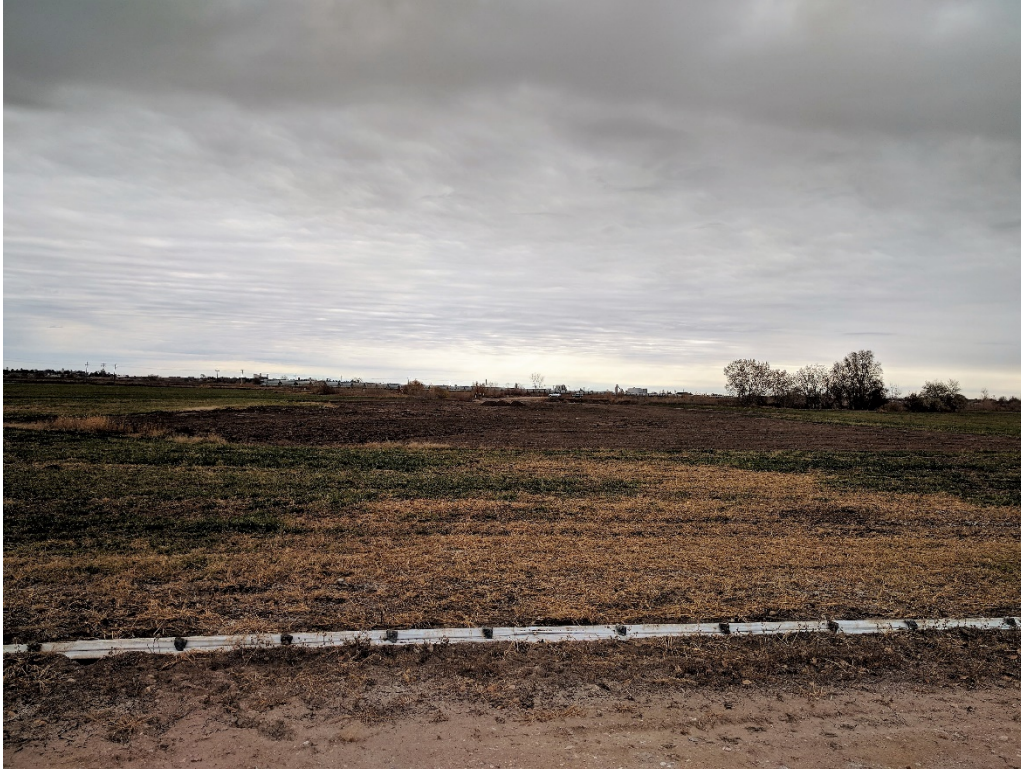
View of backfilled field from the west end of the field looking east

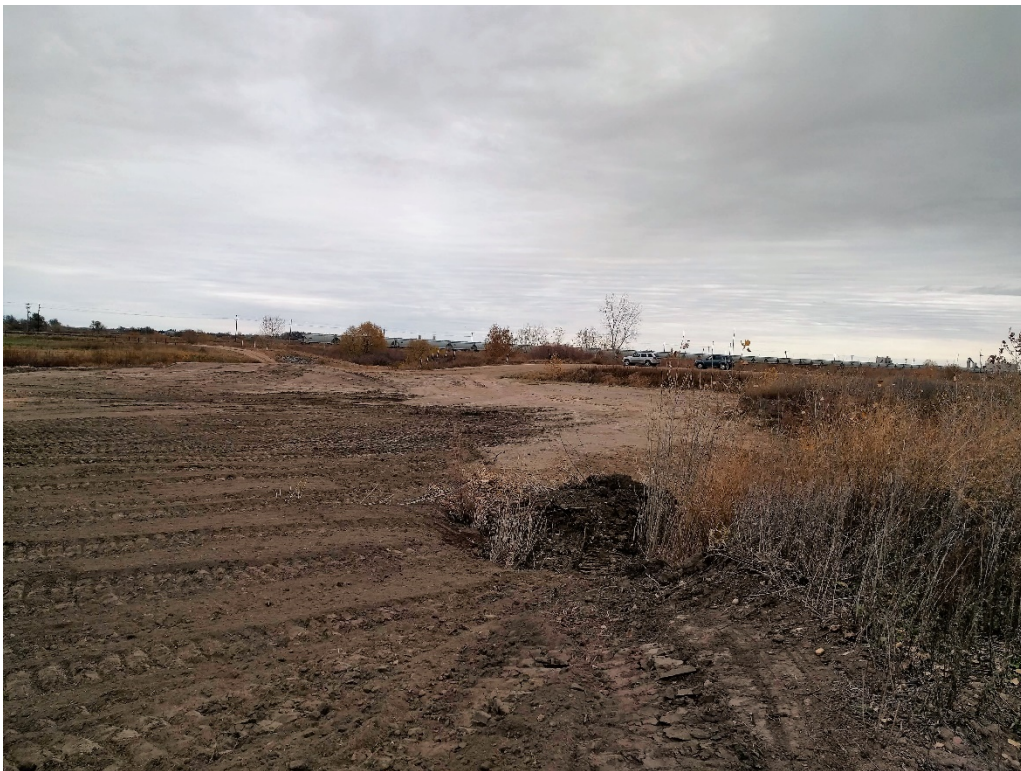
The large erosion features on the City of Greeley parcel of land located west of the 83rd Joint Venture site have been backfilled since the last inspection, presumably by the City of Greeley. The western half of the erosion features were backfilled to match the elevation of the agricultural field. The eastern half of the erosion features were contour backfilled below the field elevation. Stockpiles of end-dumped imported material were observed in the eastern half of the erosion area. It could not be determined during the inspection if the eastern erosion feature area would be backfilled to the field grade or left contour graded to transition into the 83rd Joint Venture grades.

View of backfilled field and transition to the 83rd site grading

The Operator stated they were in discussions with the landowner to determine the future of the site, which may include the property being transferred to AI. The Division requested AI contact the City of Greeley to discuss the backfilling of the erosion features and the required stabilization and reclamation of the properties. The Division will expect an update at the upcoming meeting. Photographs taken during the inspection are attached.
