Re: Bowie Resources, LLC, Bowie No. 2 Mine
Coal Mine Waste Banks & Instrumentation Monitoring
Pond Quarterly & Yearly Inspections
Permit C-1996-083

Coal Mine Waste Bank Nos. 1, 2, & 3 Inspections –1st Quarter 2018

Subject: Summary of Instrumentation Monitoring
1st Quarter 2018
Bowie Coal Waste Disposal Area No. 2
Paonia, Colorado

Subject: Summary of Instrumentation Monitoring
1st Quarter 2018
Bowie Coal Waste Disposal Area No. 3
Paonia, Colorado

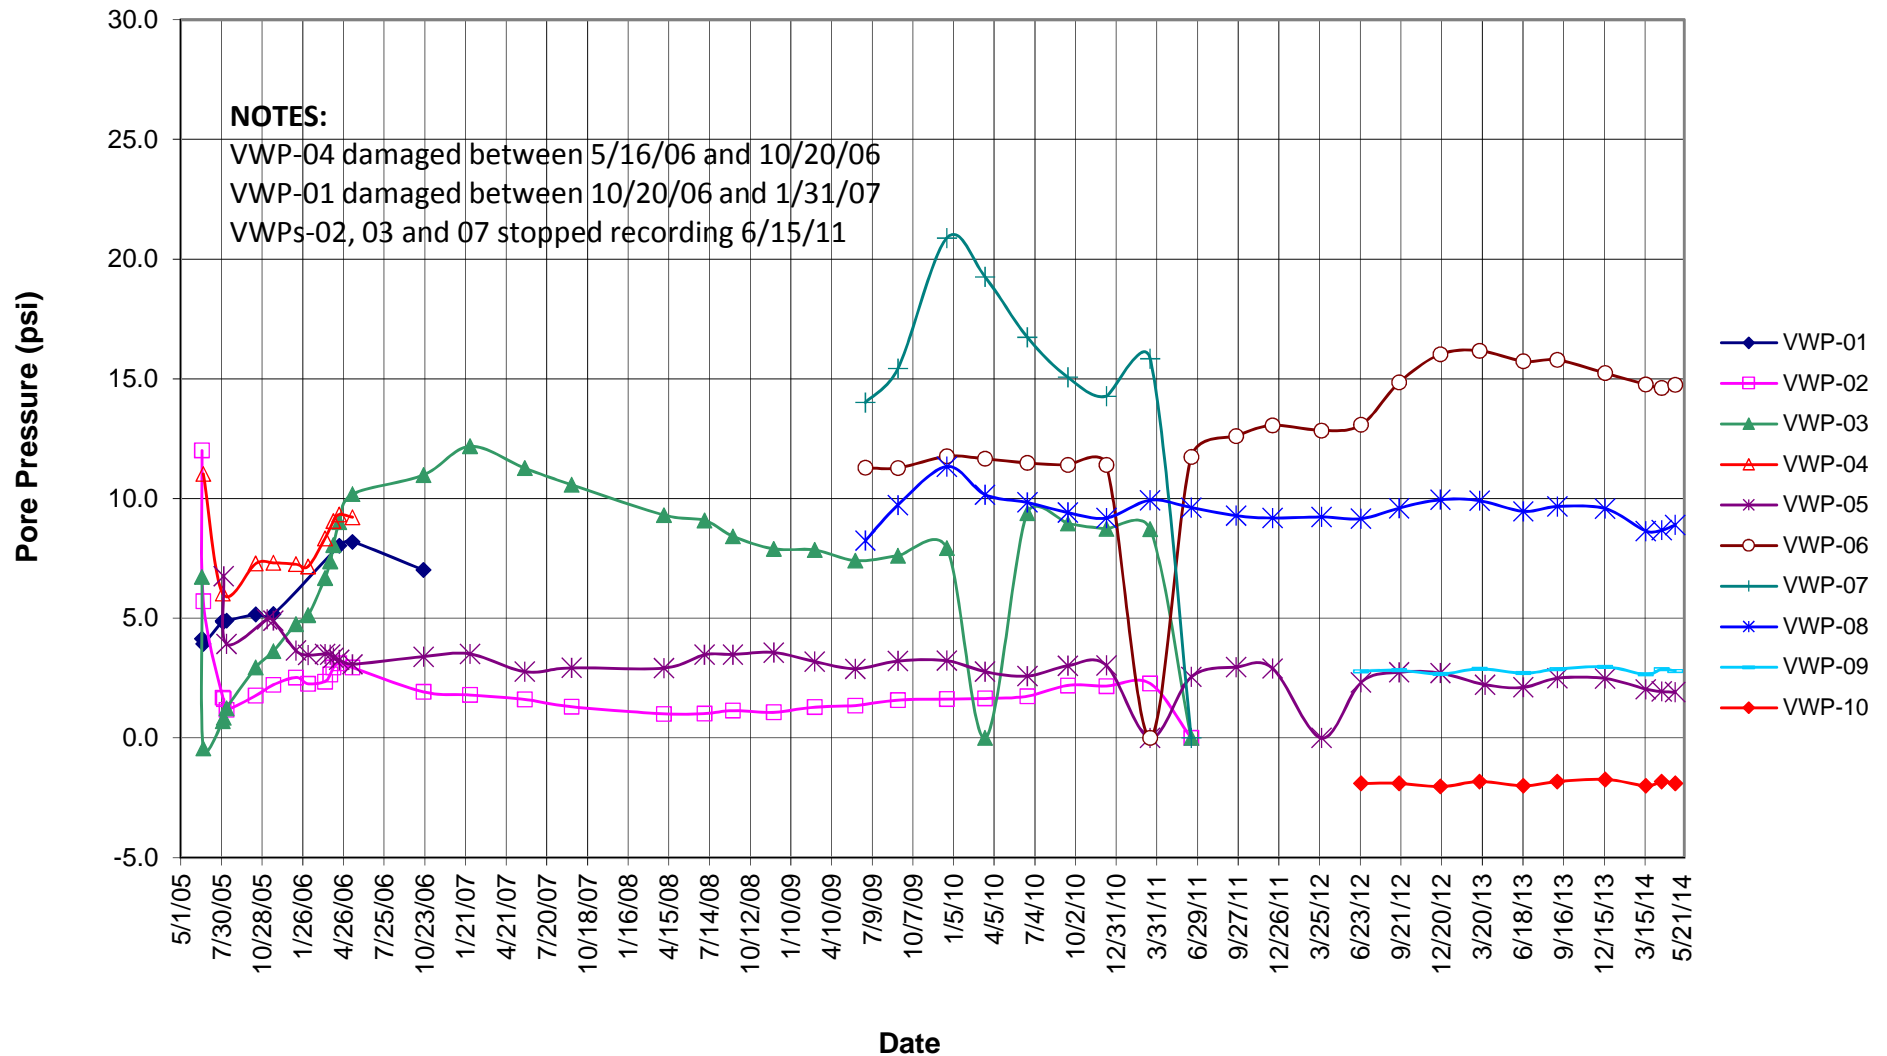
Figure 1 - Bowie Mine #2 - CWDA #2
Active and Damaged Vibrating Wire Piezometer Data

Between 2005 and 2012, a total of ten vibrating wire piezometers were installed in CWDA No. 2. However, several of the piezometers have been damaged or have otherwise ceased to function. Currently, five of the piezometers are functional.

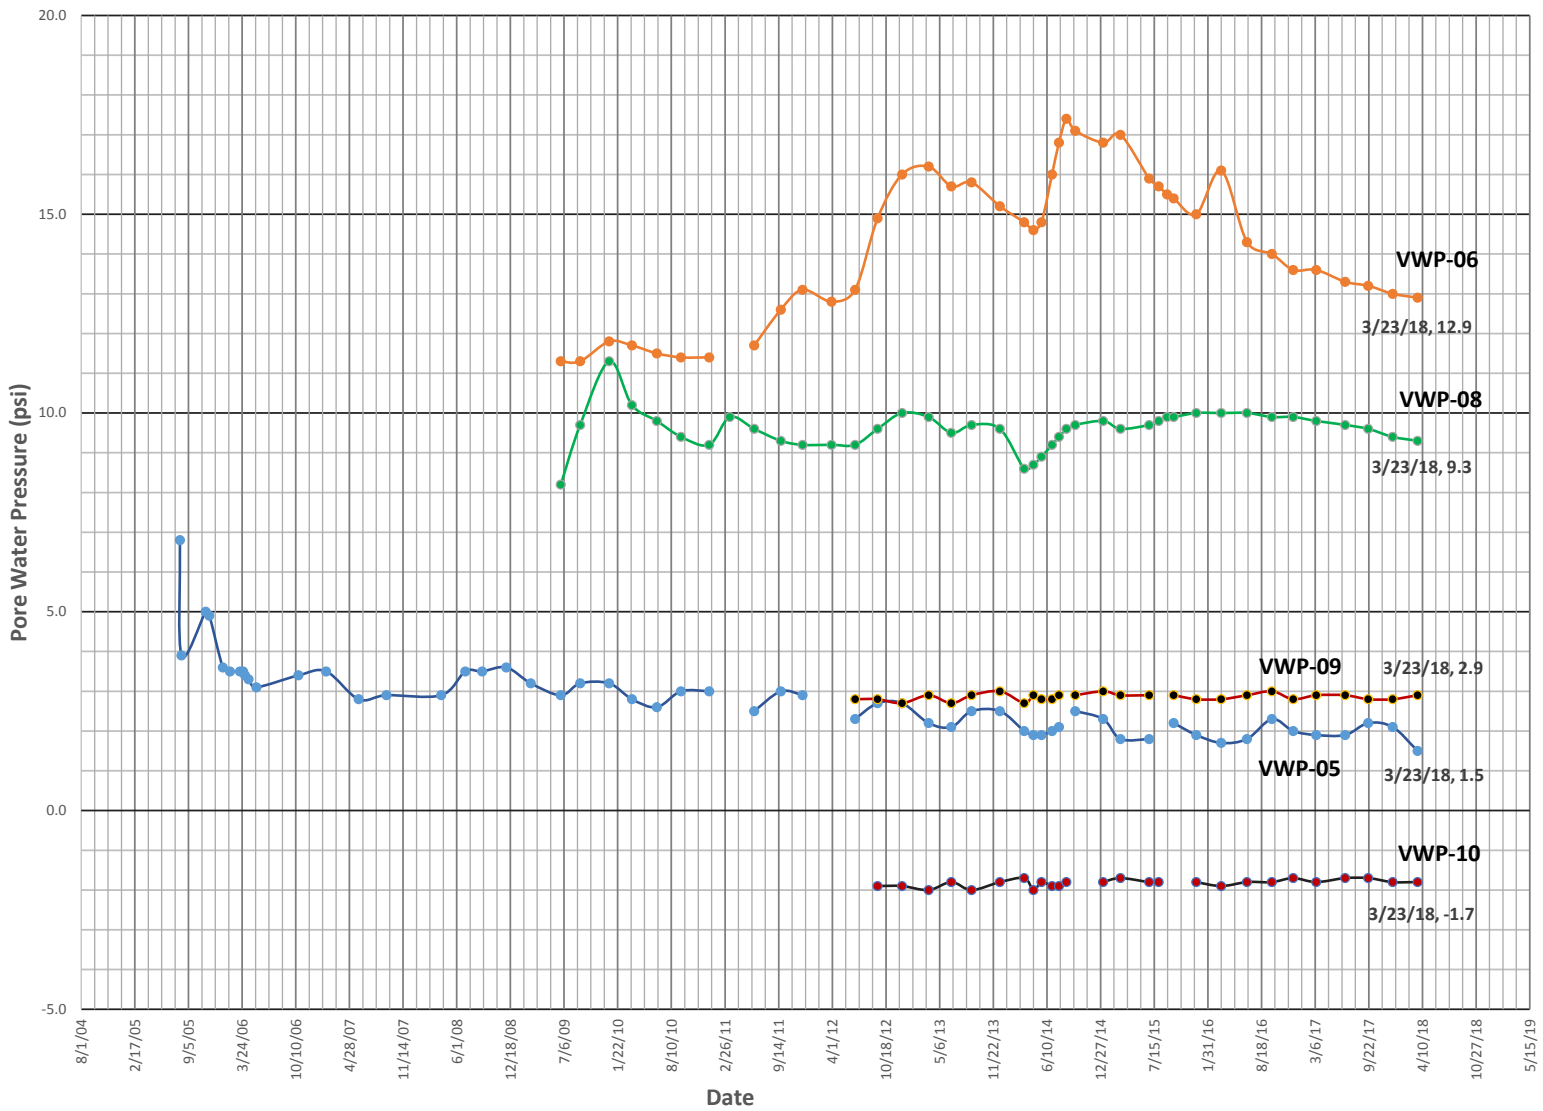
Figure 2 - Bowie Mine #2 - CWDA #2
Active Vibrating Wire Piezometer Data

The latest inclinometer readings indicate no major movements since the last quarterly reading. Some variability was present in the data for BG05-7 along the A-axis; however, the variation is primarily only at the ground surface and likely reflects operator error. In general, the 1st Quarter 2018 monitoring data does not provide any indication of instability in CWDA No. 2.

The current pore pressure reflects a piezometric surface elevation of approximately 6097 feet which is much less than the critical elevation of 6113 feet. As a result, HBET does not believe that the measured pore pressures in VWP-08 are any indication of instability in CWDA No. 2.

In general, based upon the results of the recent VWP and inclinometer monitoring data, HBET does not believe that there is any reduction in the stability of CWDA No. 2. Due to the limited activity at the mine, HBET recommends that the monitoring frequency be reduced to semi-annually.

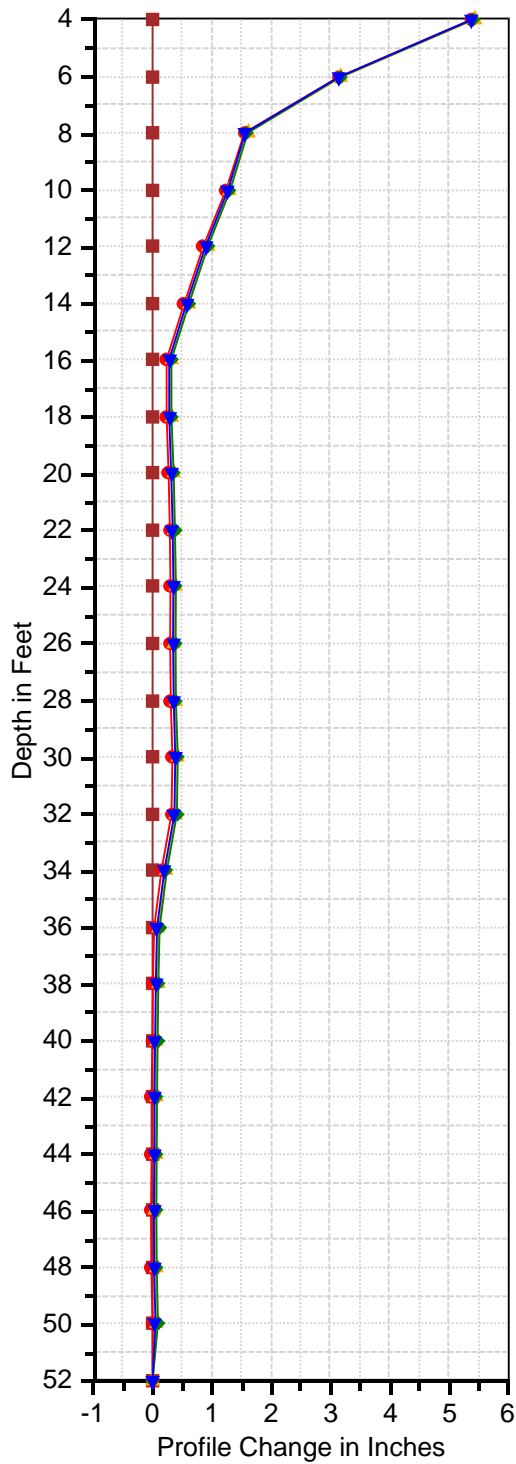
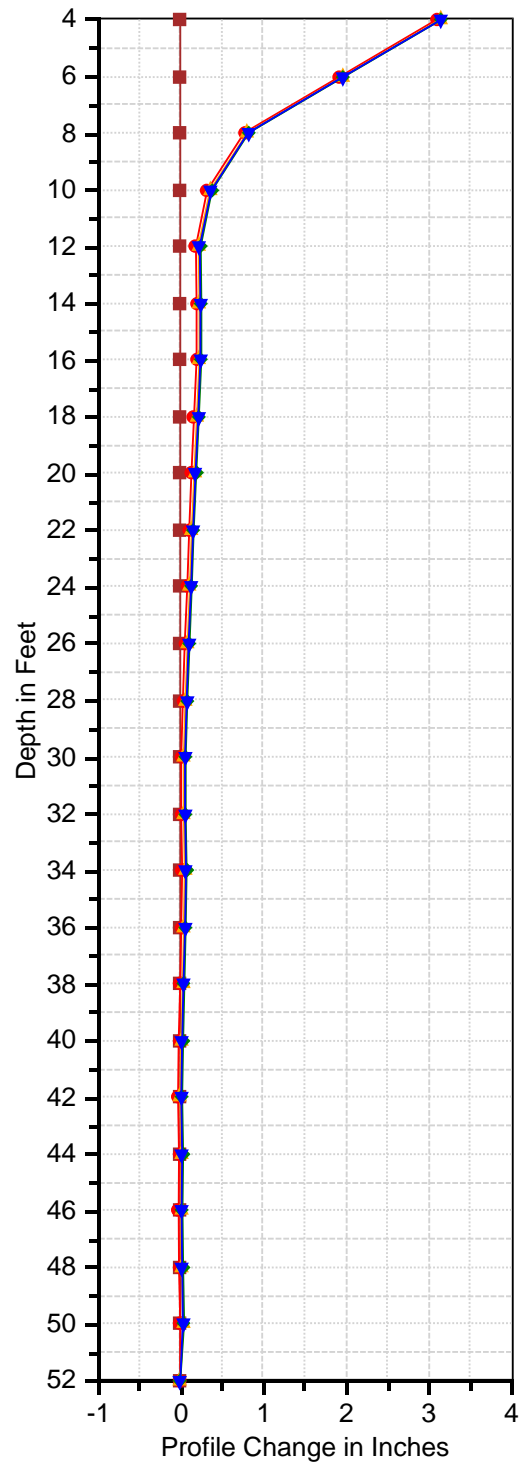
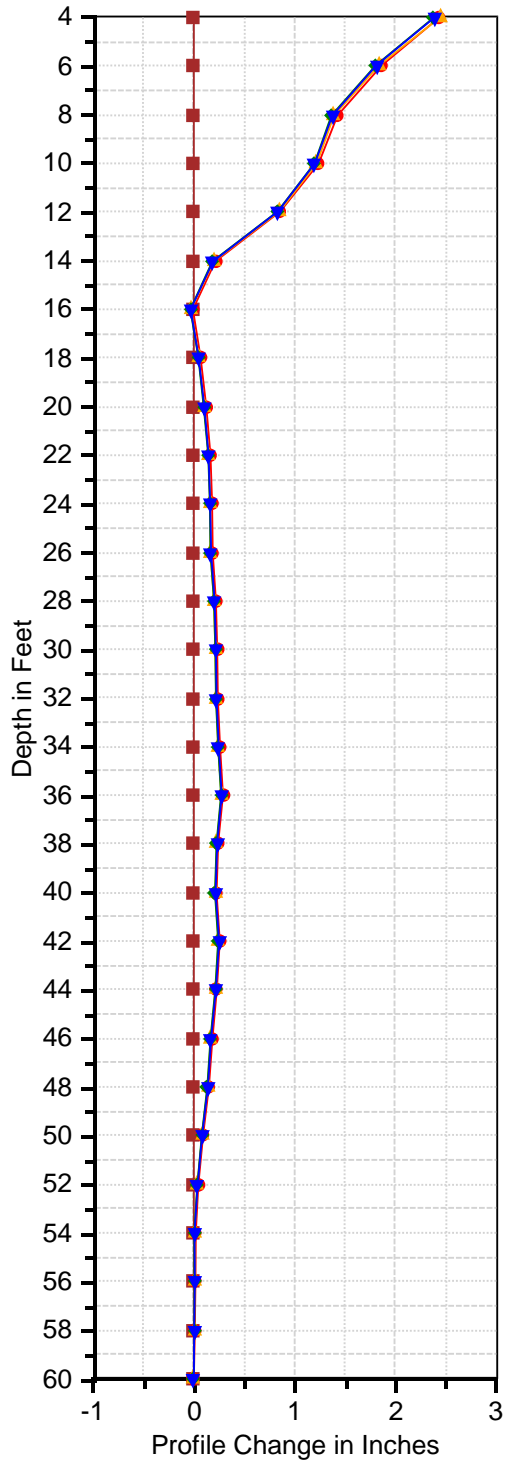
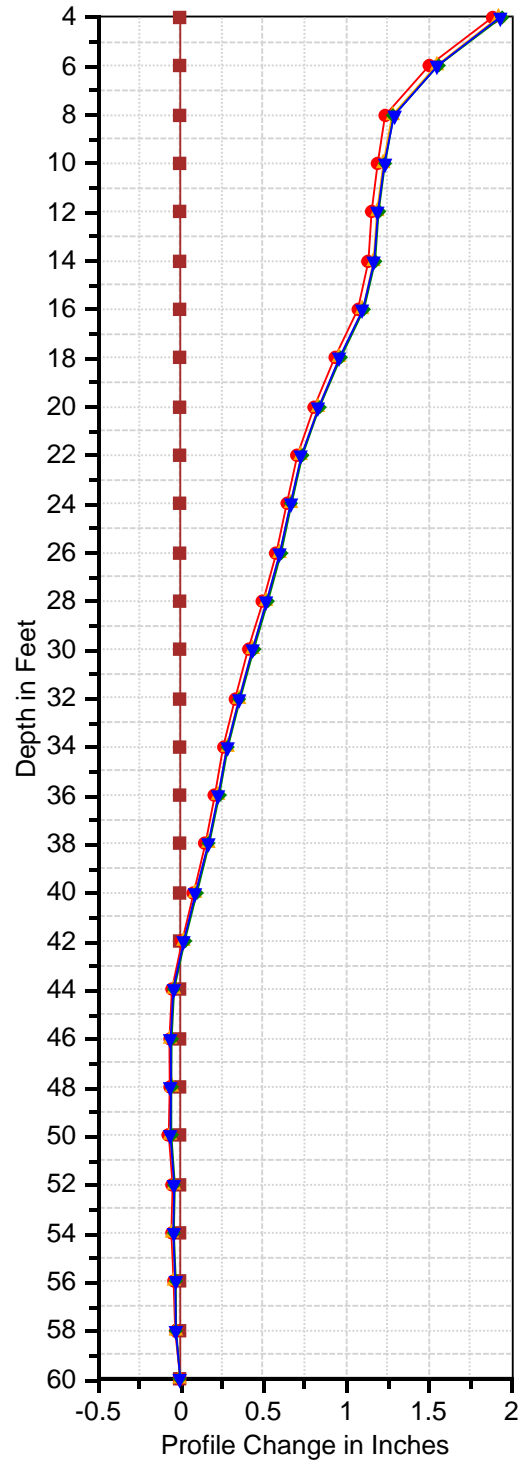
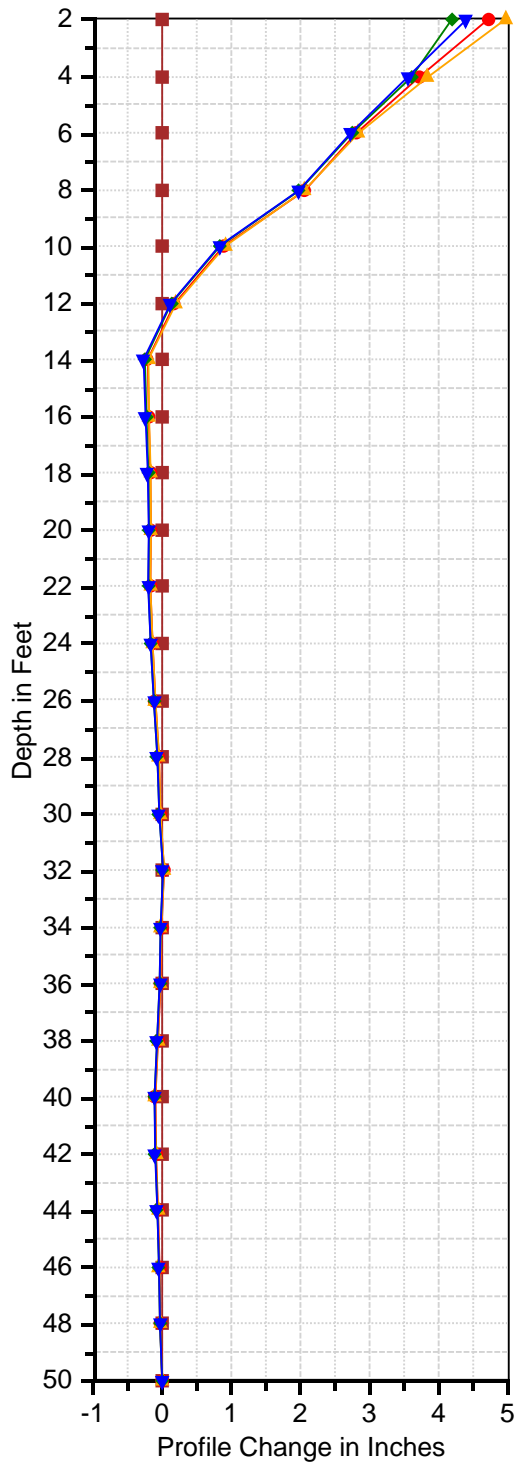
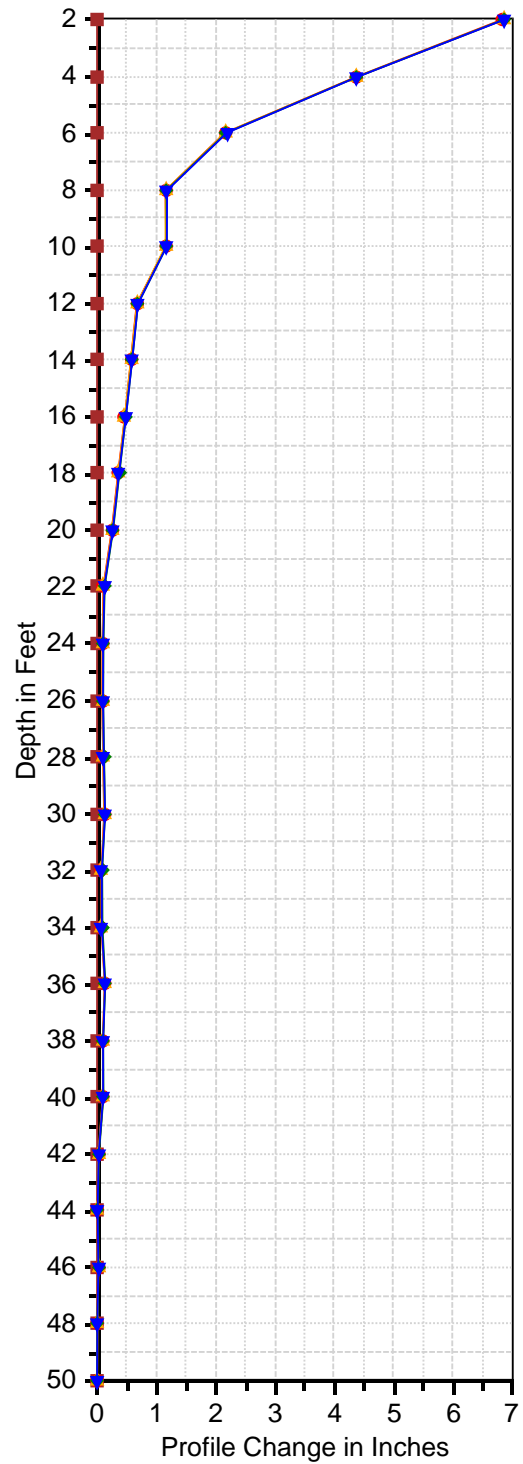
Figure 3 - Inclinometer Displacement Curves
 Bowie Mine #2, CWDA #2
 2018 Qtr 1

Three inclinometers, designated BG05-4, BG05-5, and BG05-7, were installed at CWDA #2 in August 2005. The inclinometers were installed through the coal refuse and approximately 20 feet into the native foundation soils. The physical locations of the inclinometers are shown on the attached Instrumentation Site Plan (Map 1). Baseline readings were taken on 8/10/05 and subsequent readings have generally been taken quarterly since that time. Displacement curves for each of the three inclinometers for the current and prior 2017 readings are presented as attachments to this letter in Figure 3. Axis "A" reflects deformation with depth in the direction of anticipated movement (downslope), while Axis "B" is orthogonal to Axis A. As described in previous reports, we believe historic displacements indicated on the plots for the approximate upper ten feet of the inclinometers are likely due to placement of cover soil on the face of the waste bank during normal operations for maintenance and revegetation. Recent readings are consistent with previous readings, except for BG05-7 which has a couple of anomalous readings in previous quarters near the surface compared to the latest reading.

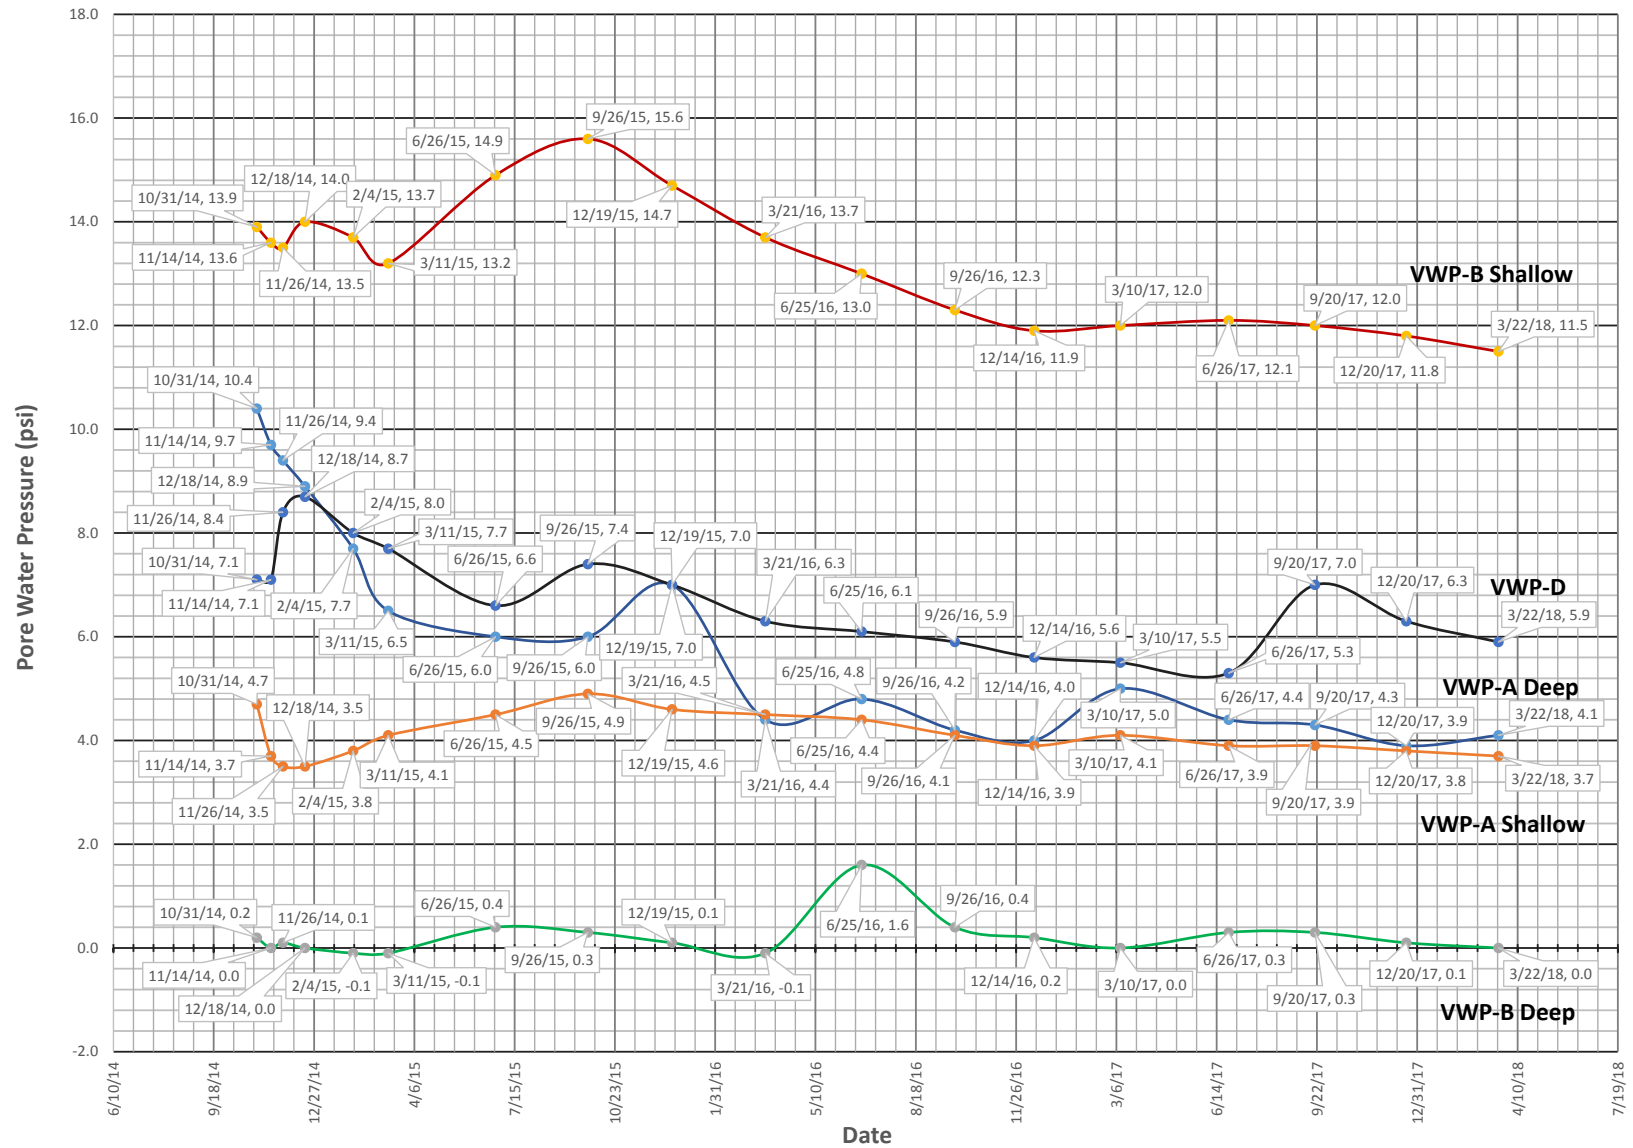
Figure 1 - Bowie Mine #2 - CWDA #3
Vibrating Wire Piezometer Data

Based upon the results of the most recent VWP monitoring data, HBET does not believe that there is any reduction in the stability of CWDA No. 3. Due to the limited activity at the mine, HBET recommends that the monitoring frequency be reduced to semi-annually.
